Inspection Photos
Operator: BP America
API#: 067-06546
Date: 5/20/2020

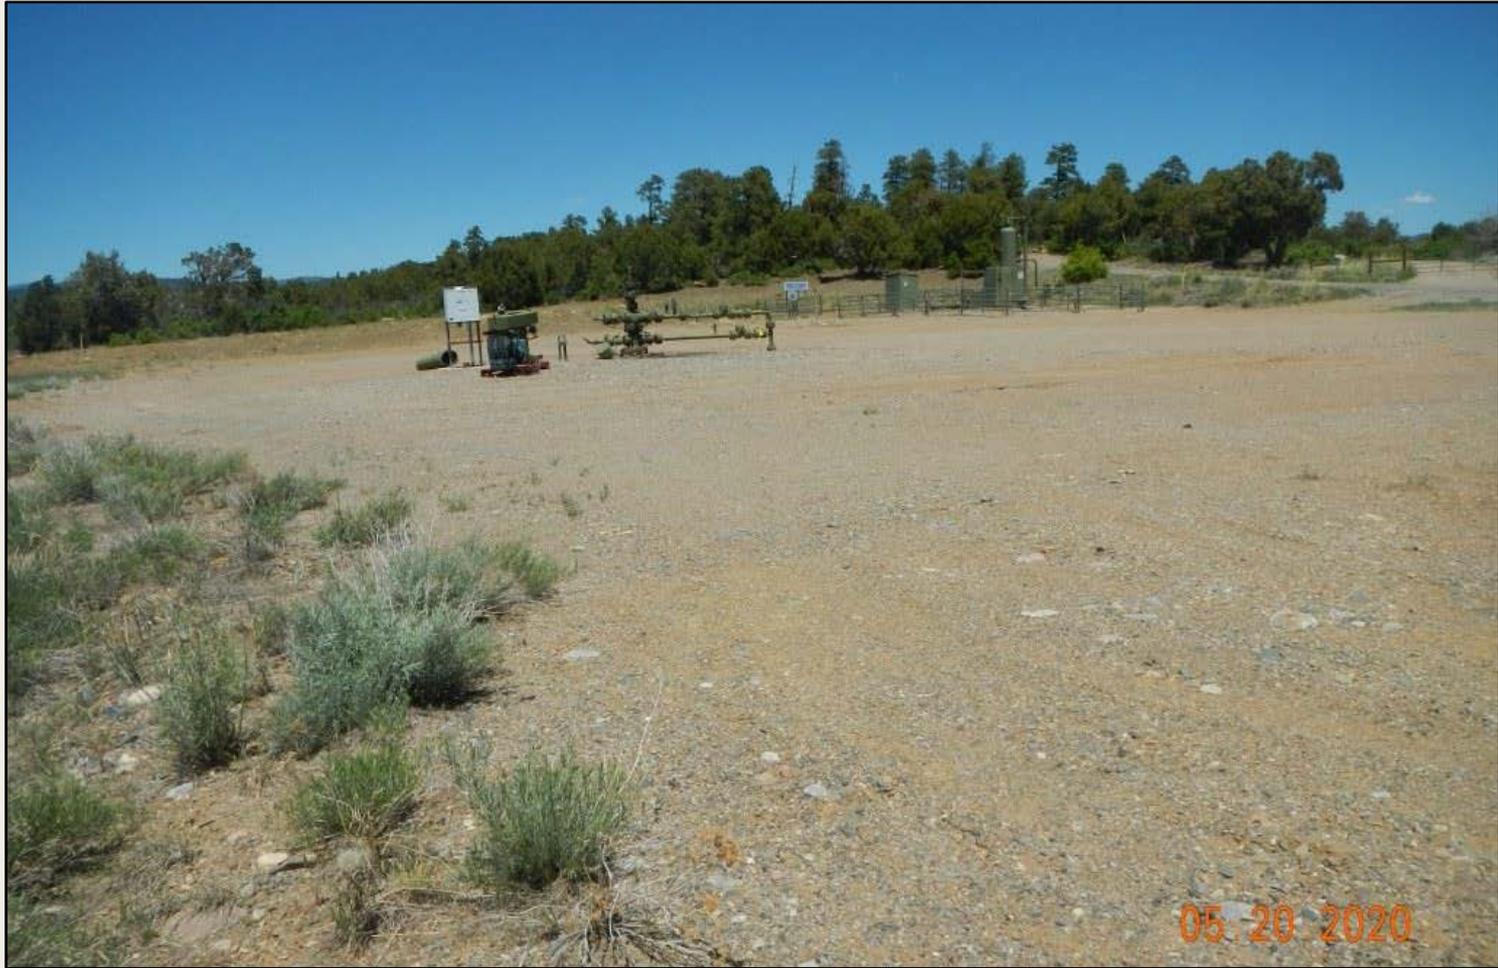
Photo 1. View of the project area from the southwestern corner facing center.

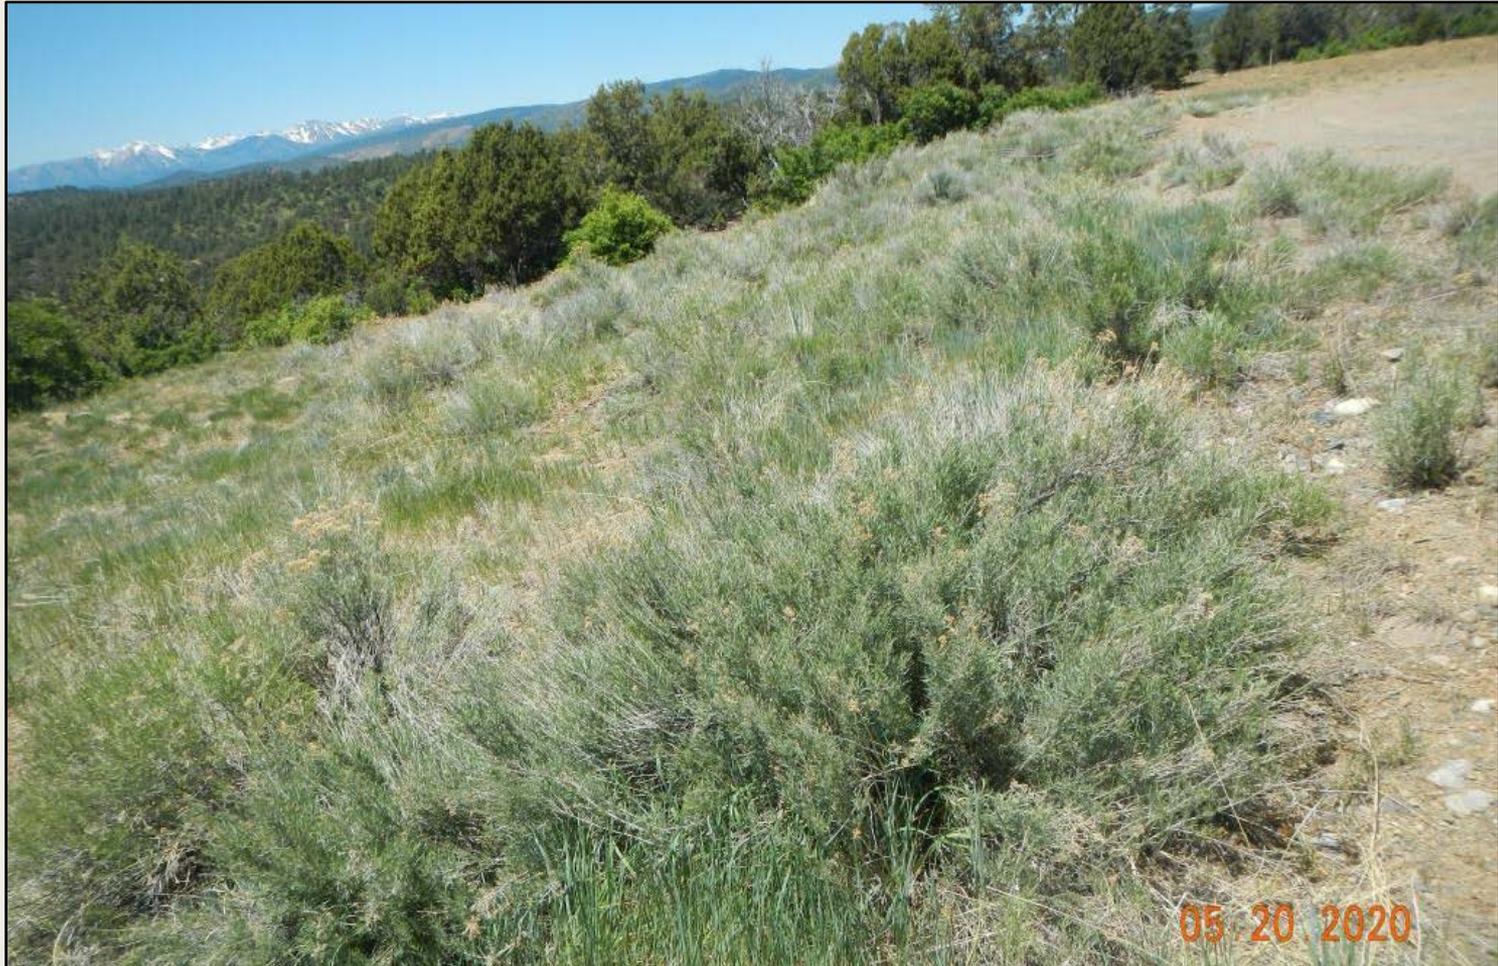
Photo 2. View of the western fill slope from the southwestern corner facing northward. Revegetation is progressing on the slope with grasses such as western wheatgrass and smooth brome, as well as shrubs such as rubber rabbitbrush.

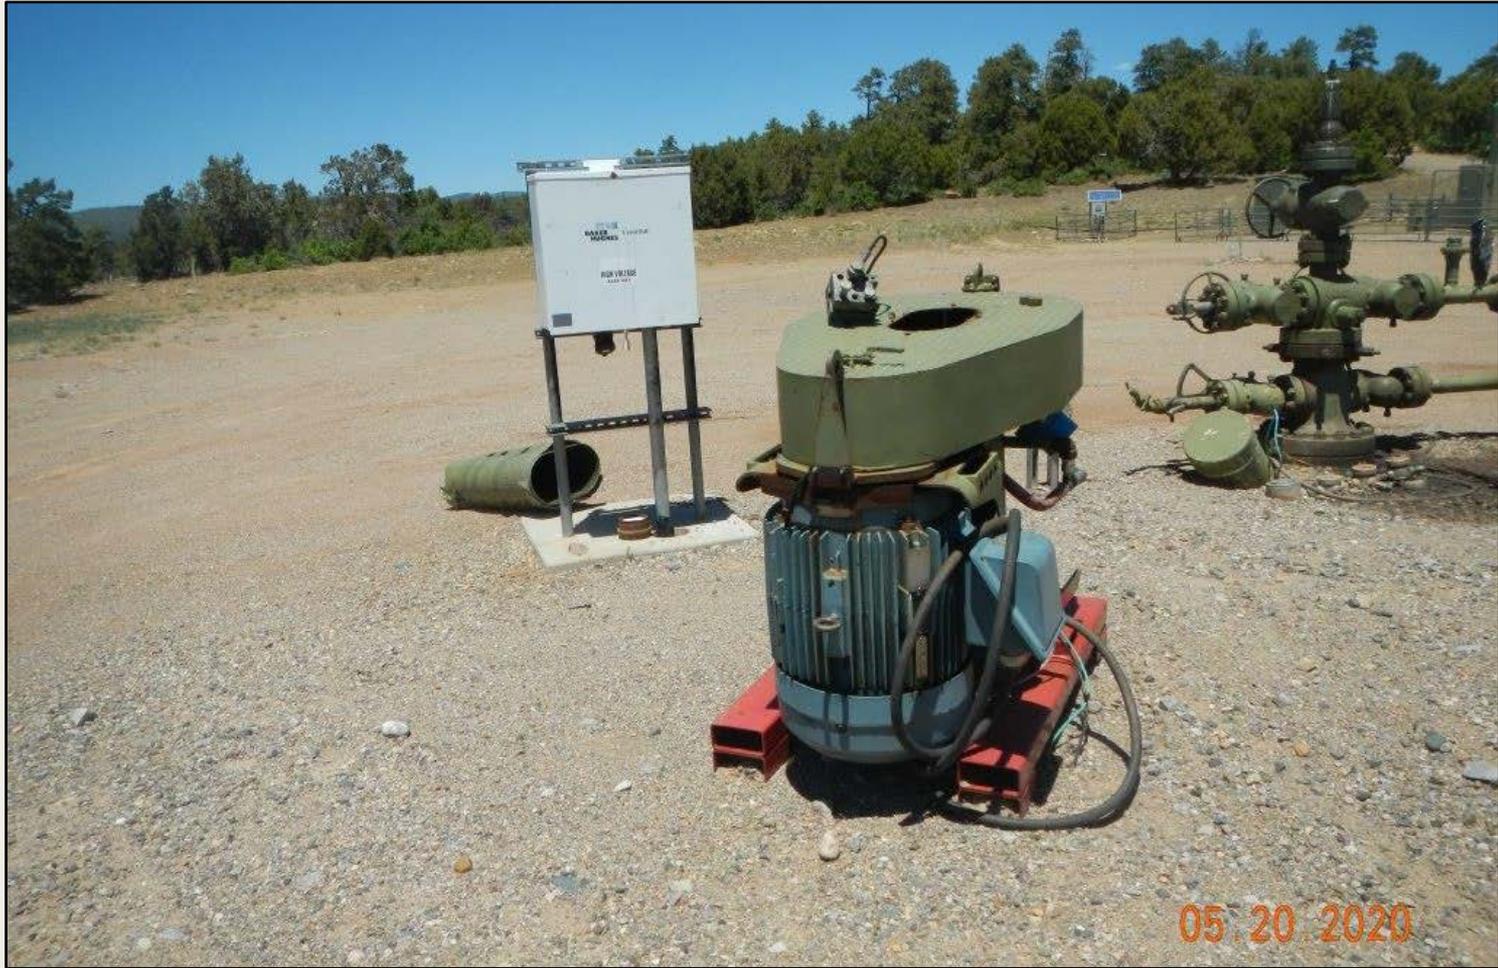
Photo 3. View of equipment that is not in use, near the wellhead.

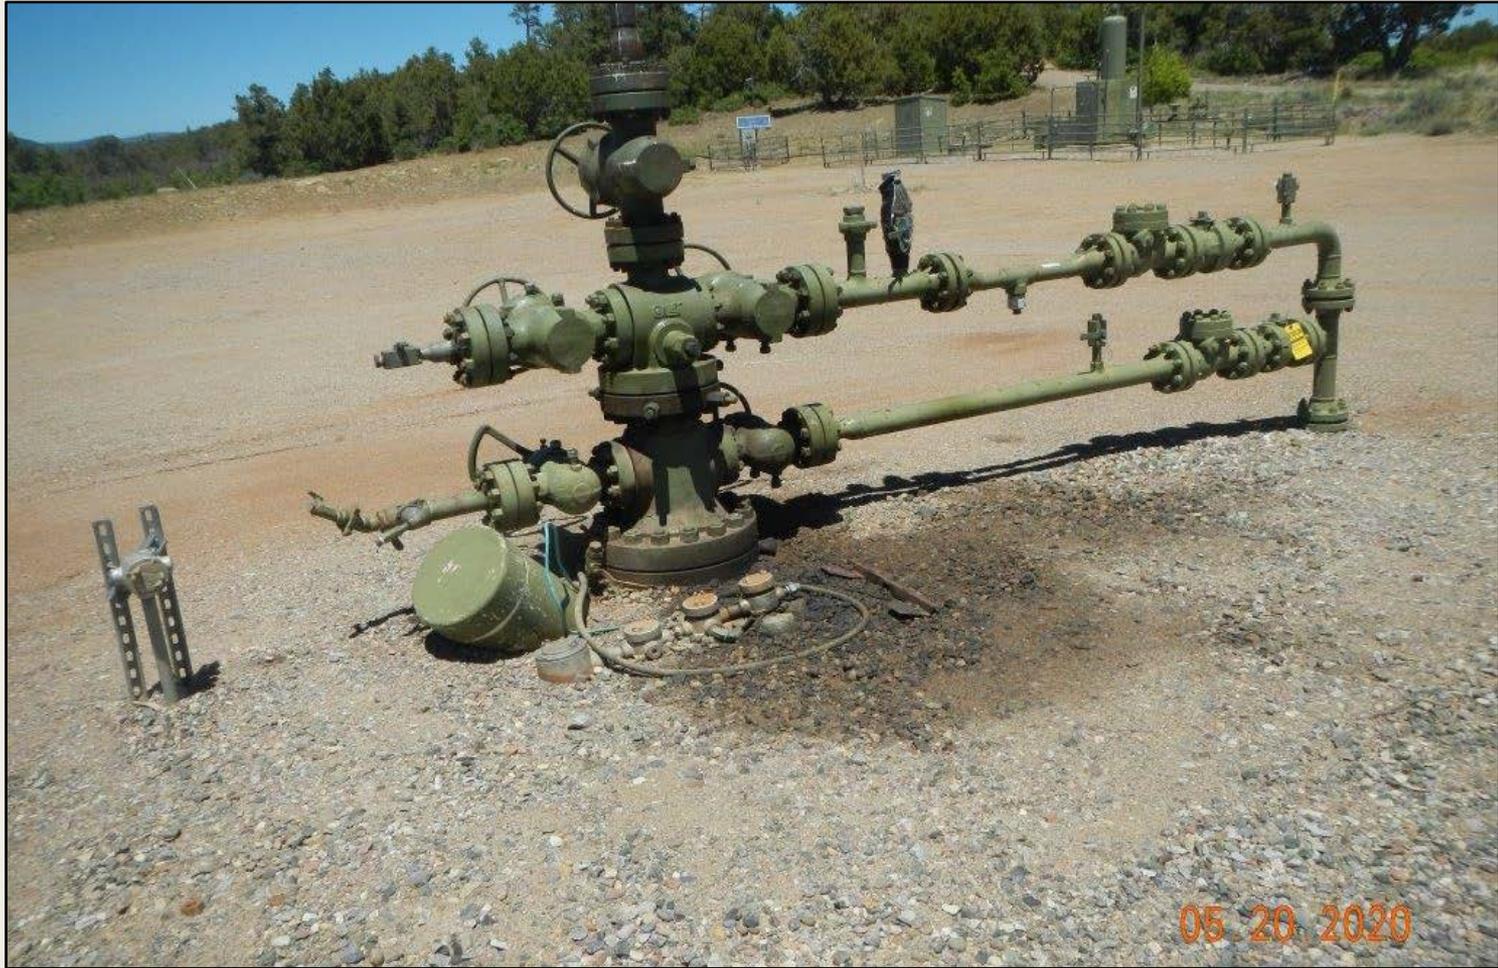
Photo 4. View of stained soils around the wellhead.

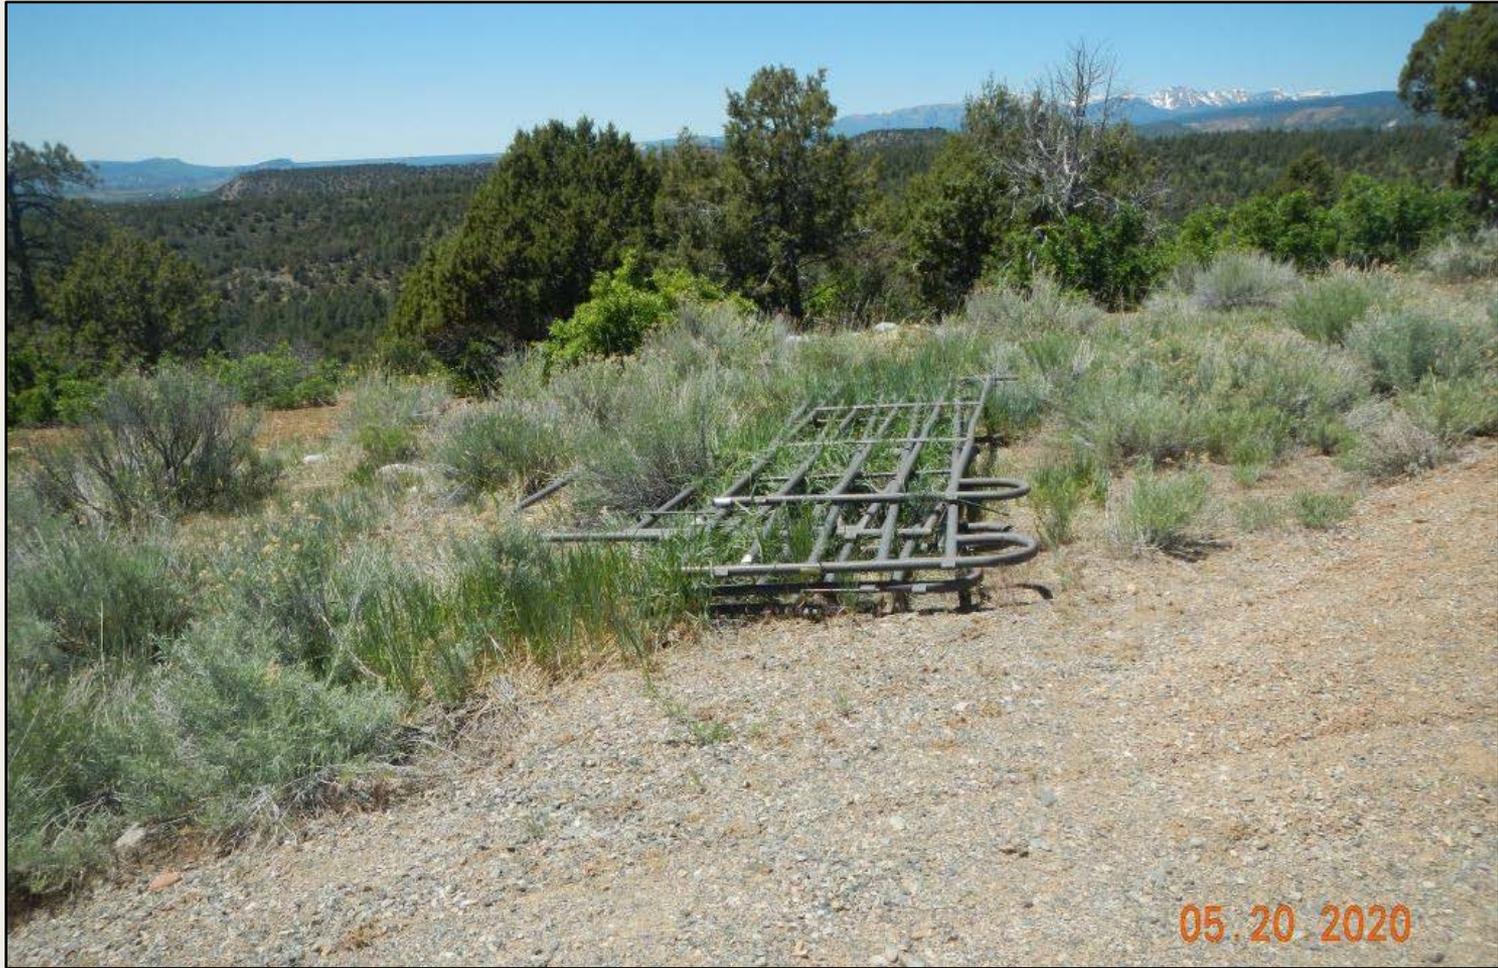
Photo 5. View of unused fencing materials within the western project area.

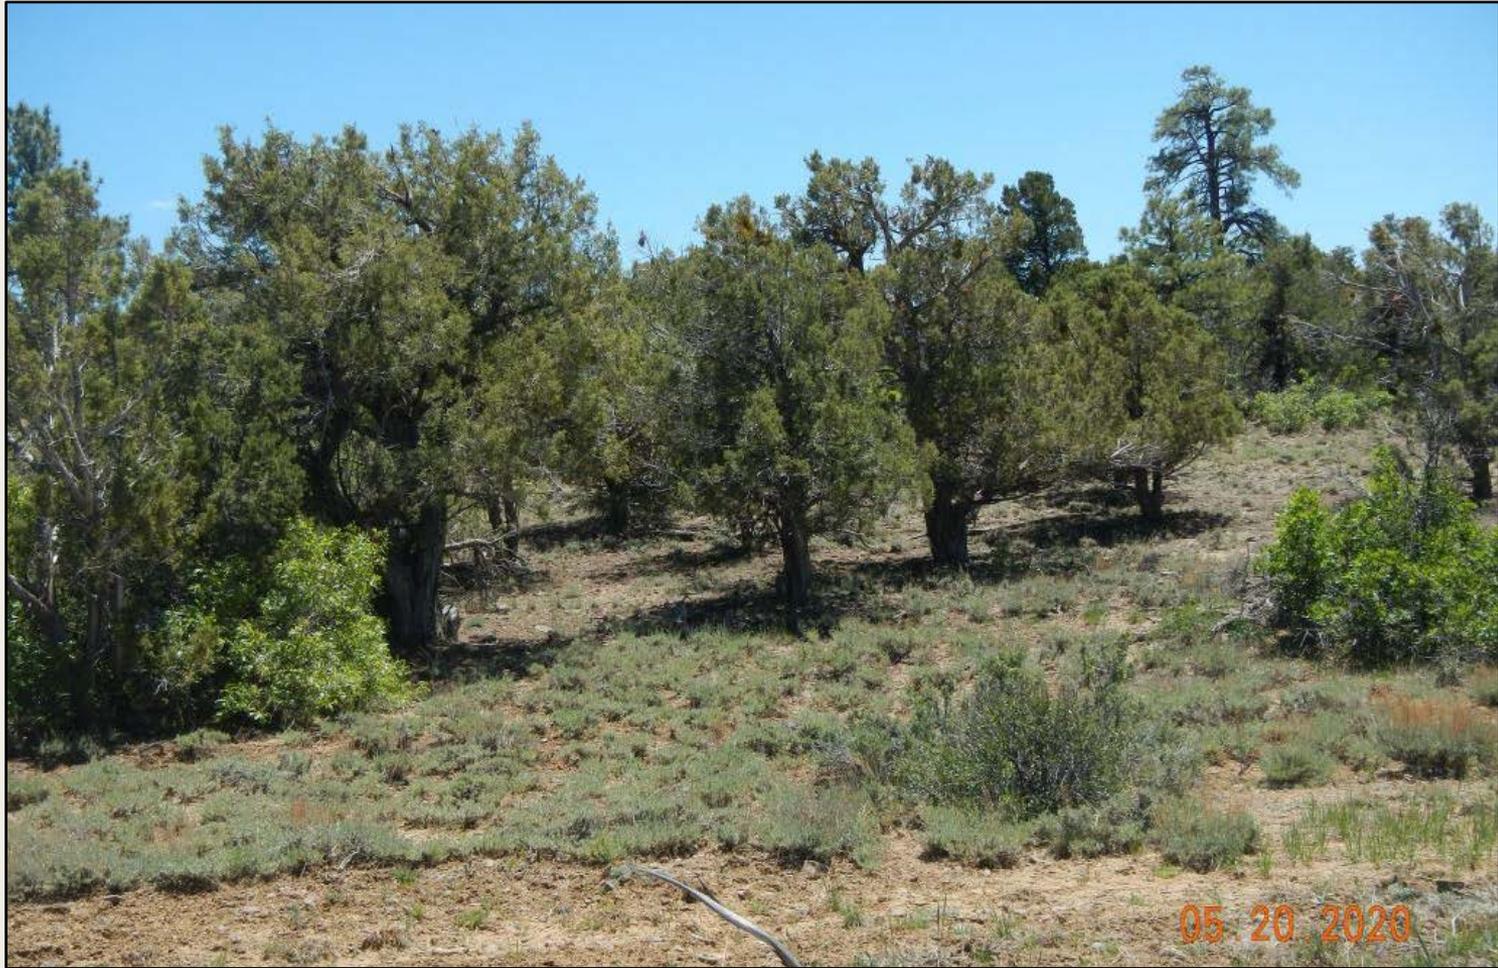
Photo 6. View of reference area vegetation comprised of pinyon-juniper woodland with understory of gambel oak, black sage, and mutton grass.
