Inspection Photos

API: 061-06294

Operator: STRACHAN EXPLORATION INC

Inspection Date: 5/26/2020

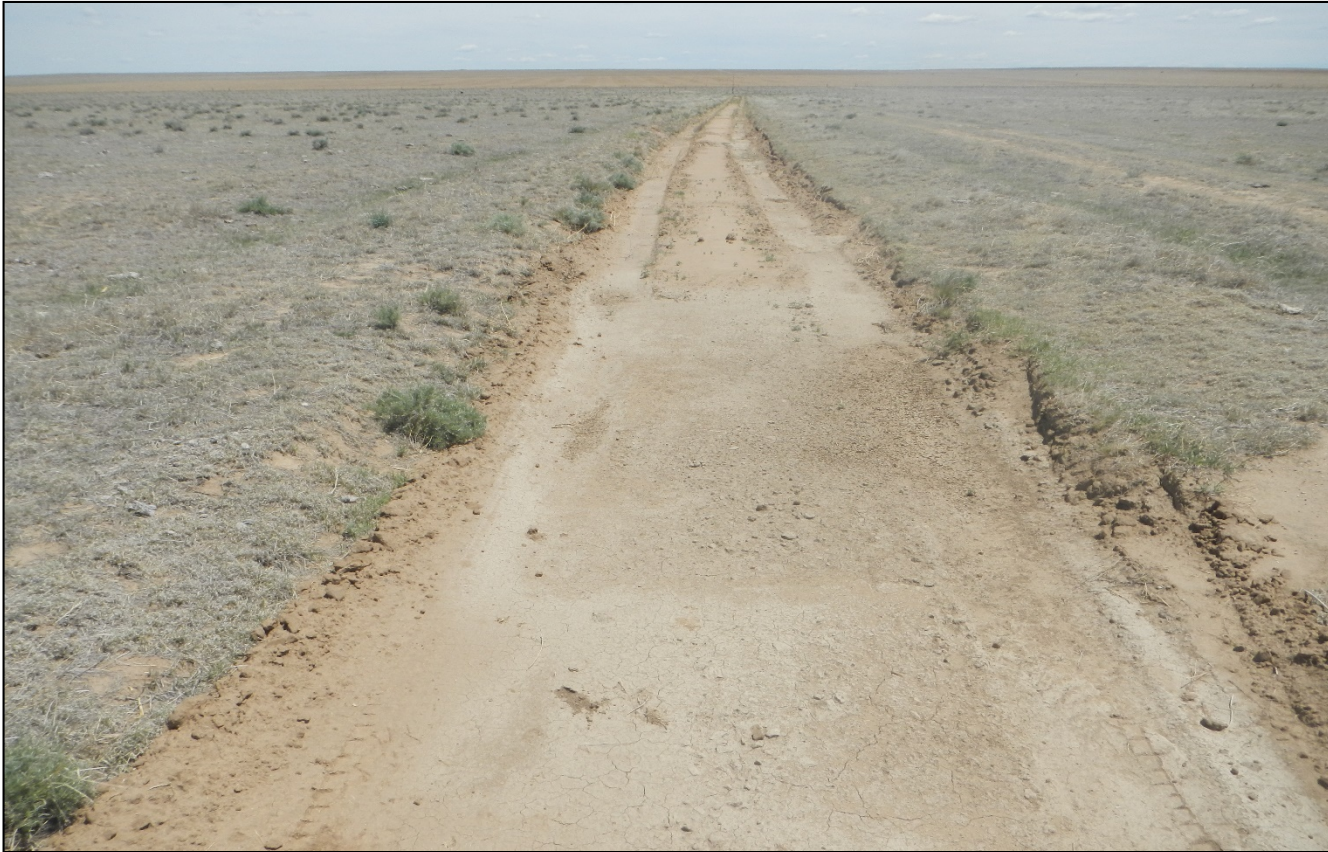
Photo 1. Facing east along the road used to access the well site. This road is rutting and degraded and needs to be repaired.

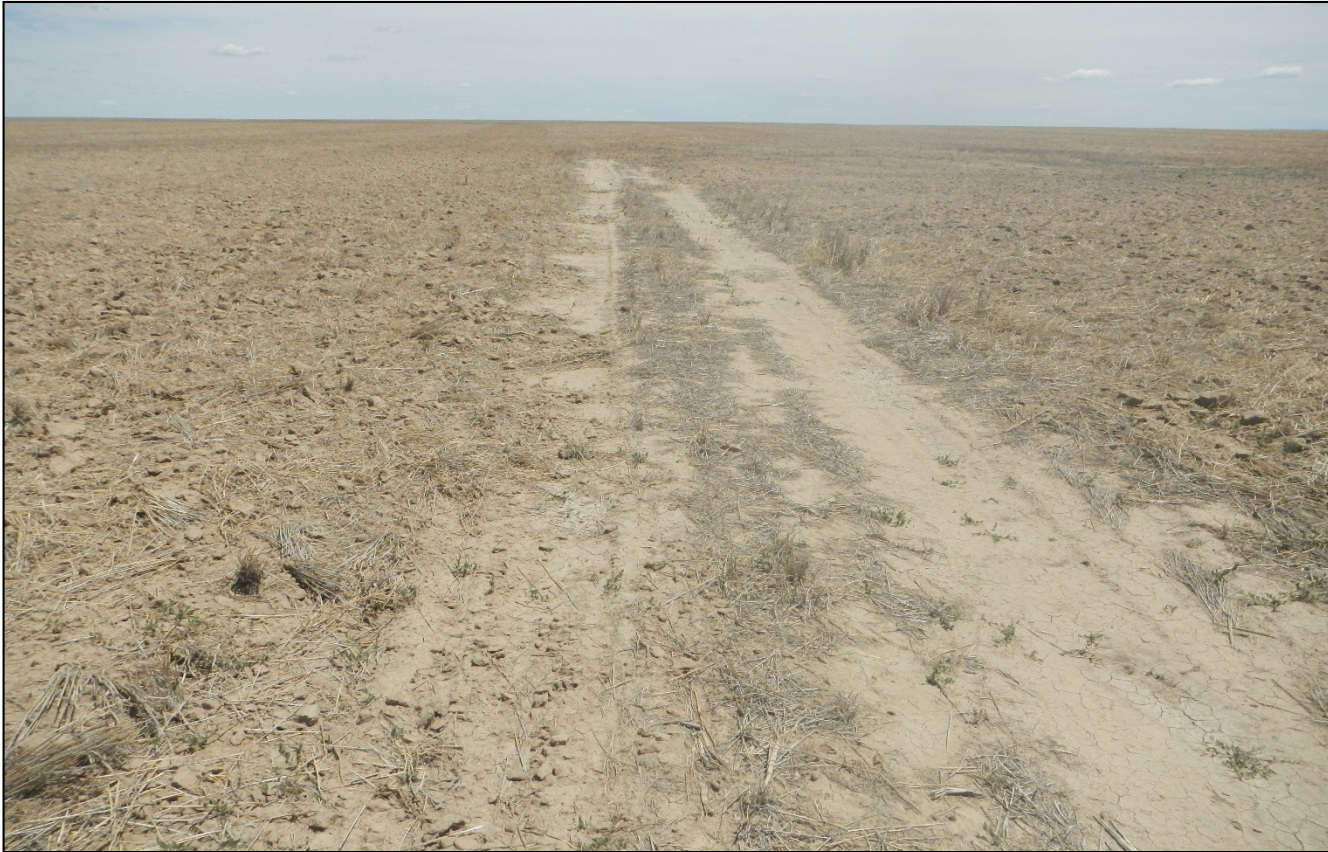
Photo 2. Facing east toward the access road which travels through the cropland. The former road has not been properly decompacted by ripping to 18 inches.

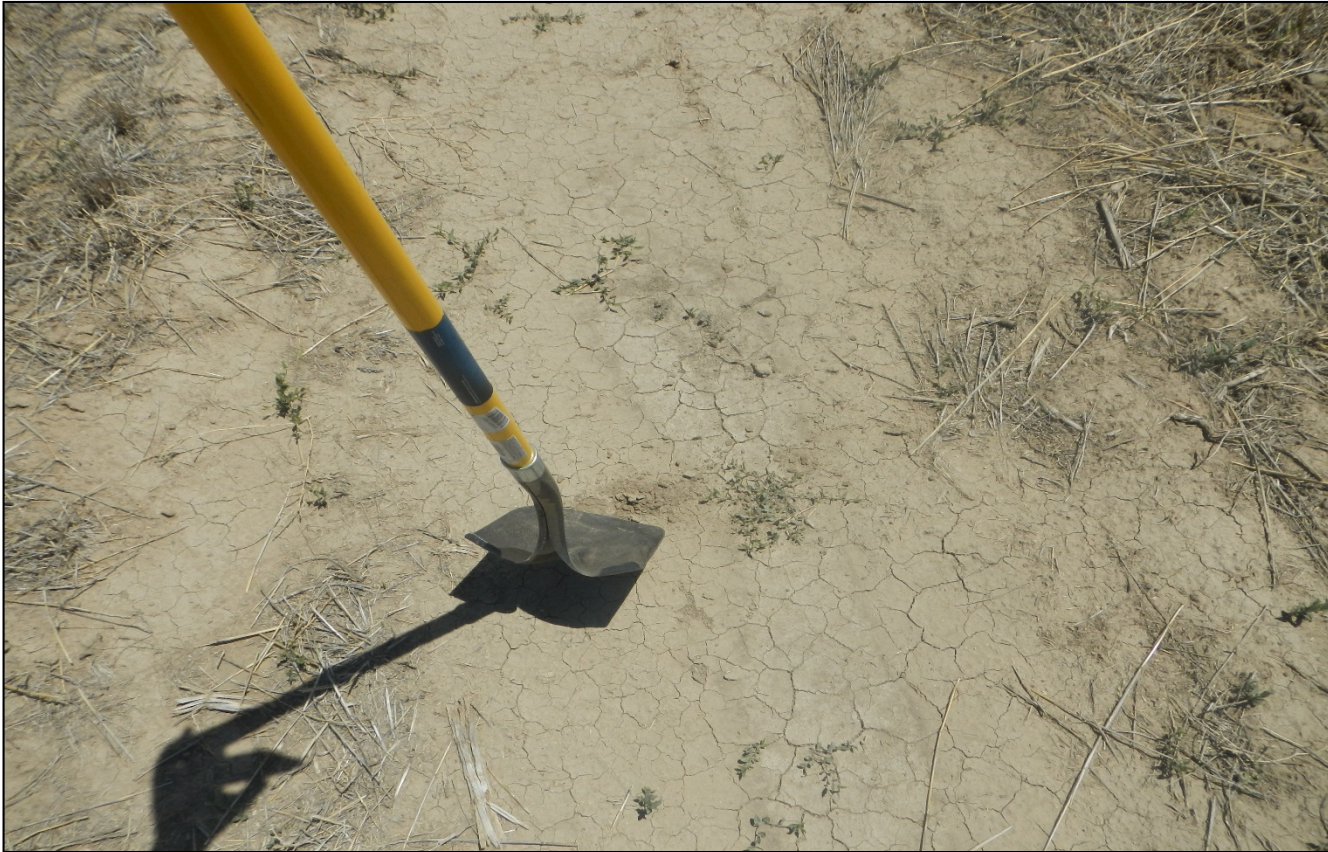
Photo 3. The shovel was used to test for soil compaction along the access road and location. The soils were compacted and the shovel was not able to penetrate the surface with pressure.

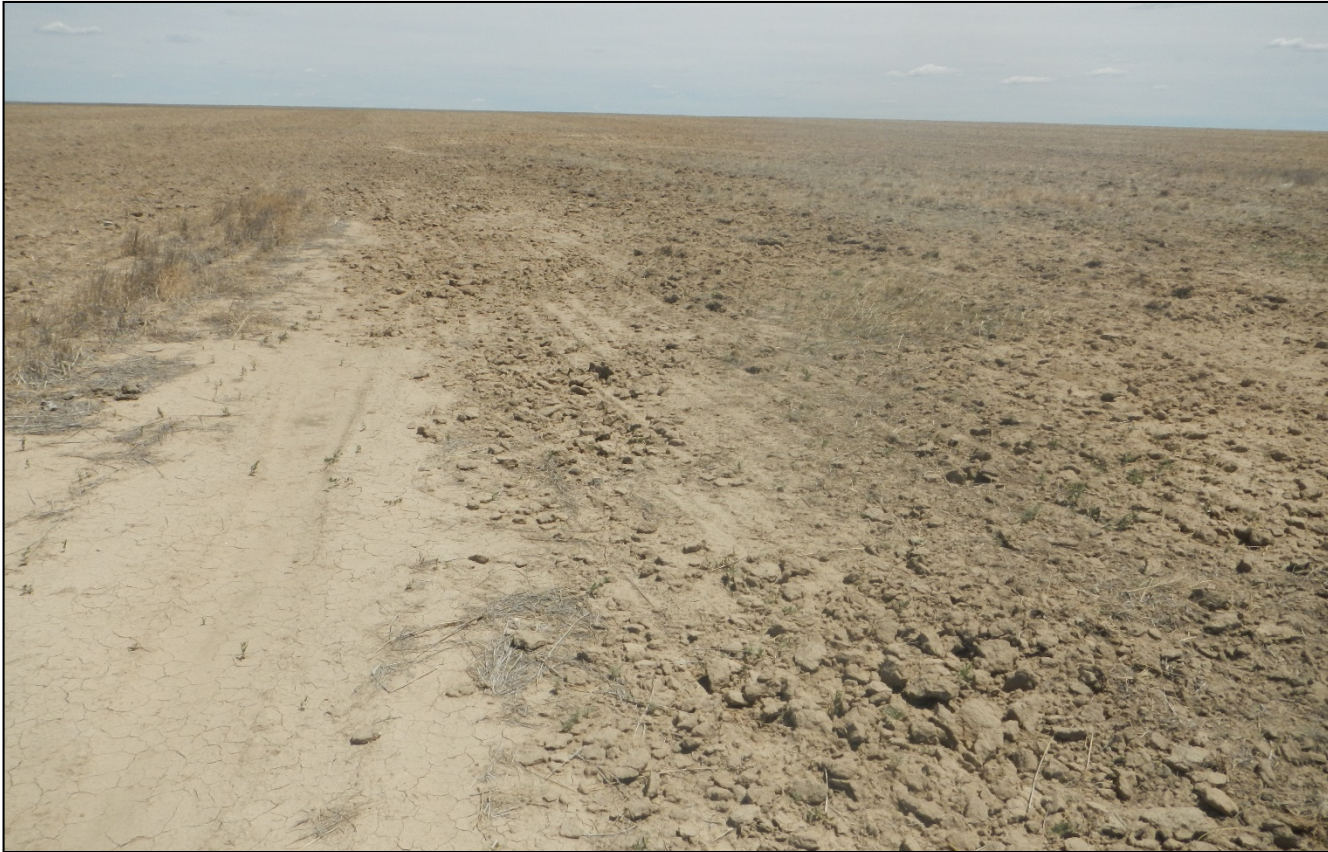
Photo 4. Facing east along the former access road toward the location.

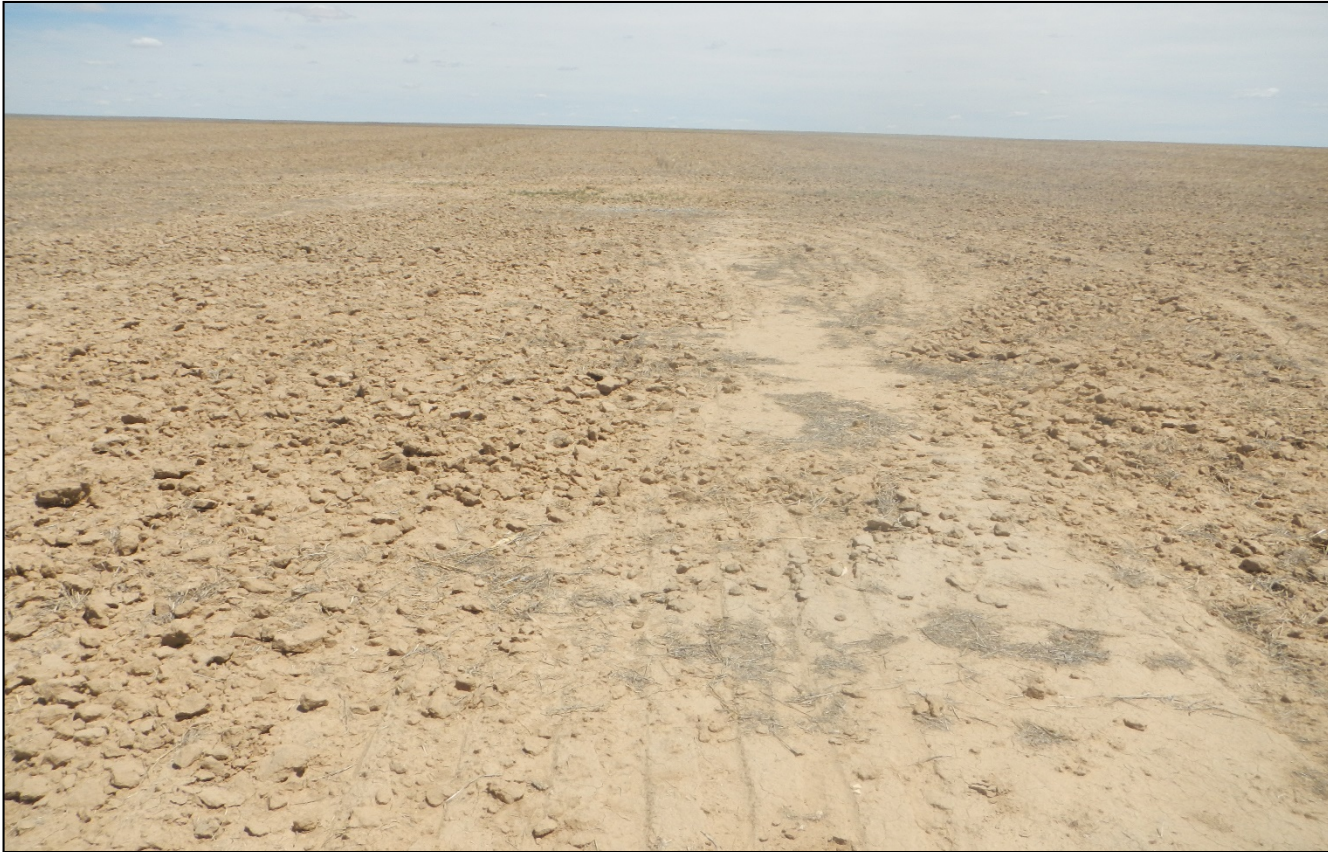
Photo 5. Facing east toward the location. All equipment has been removed from the location. The soils at the location are compacted and must be cross ripped to a depth of 18 inches.

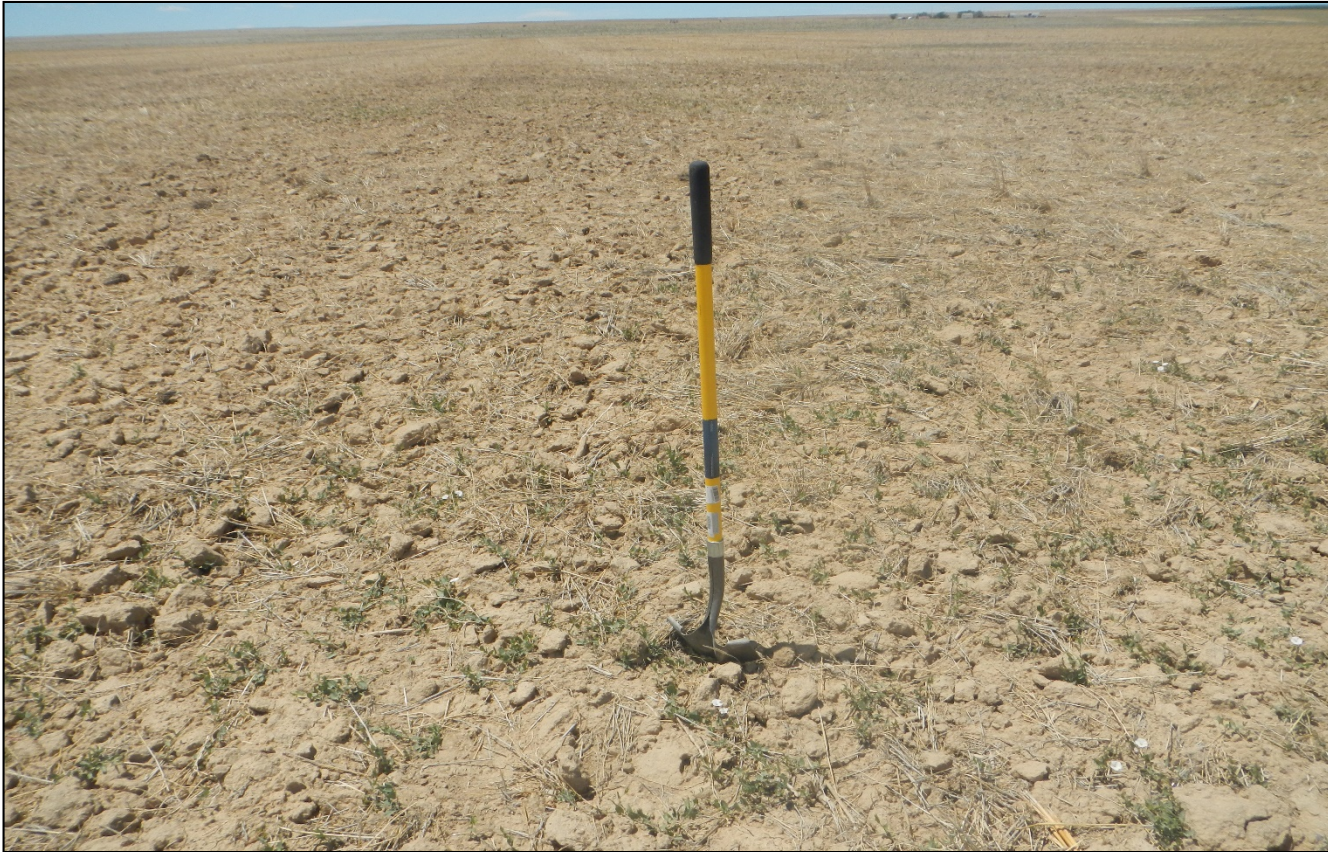
Photo 6. Photo above was taken outside of the location where soils are not compacted.
