# Interim Reclamation and Stormwater Inspection

May 29, 2020

Operator: PDC ENERGY INC - 69175

Location ID: 441696

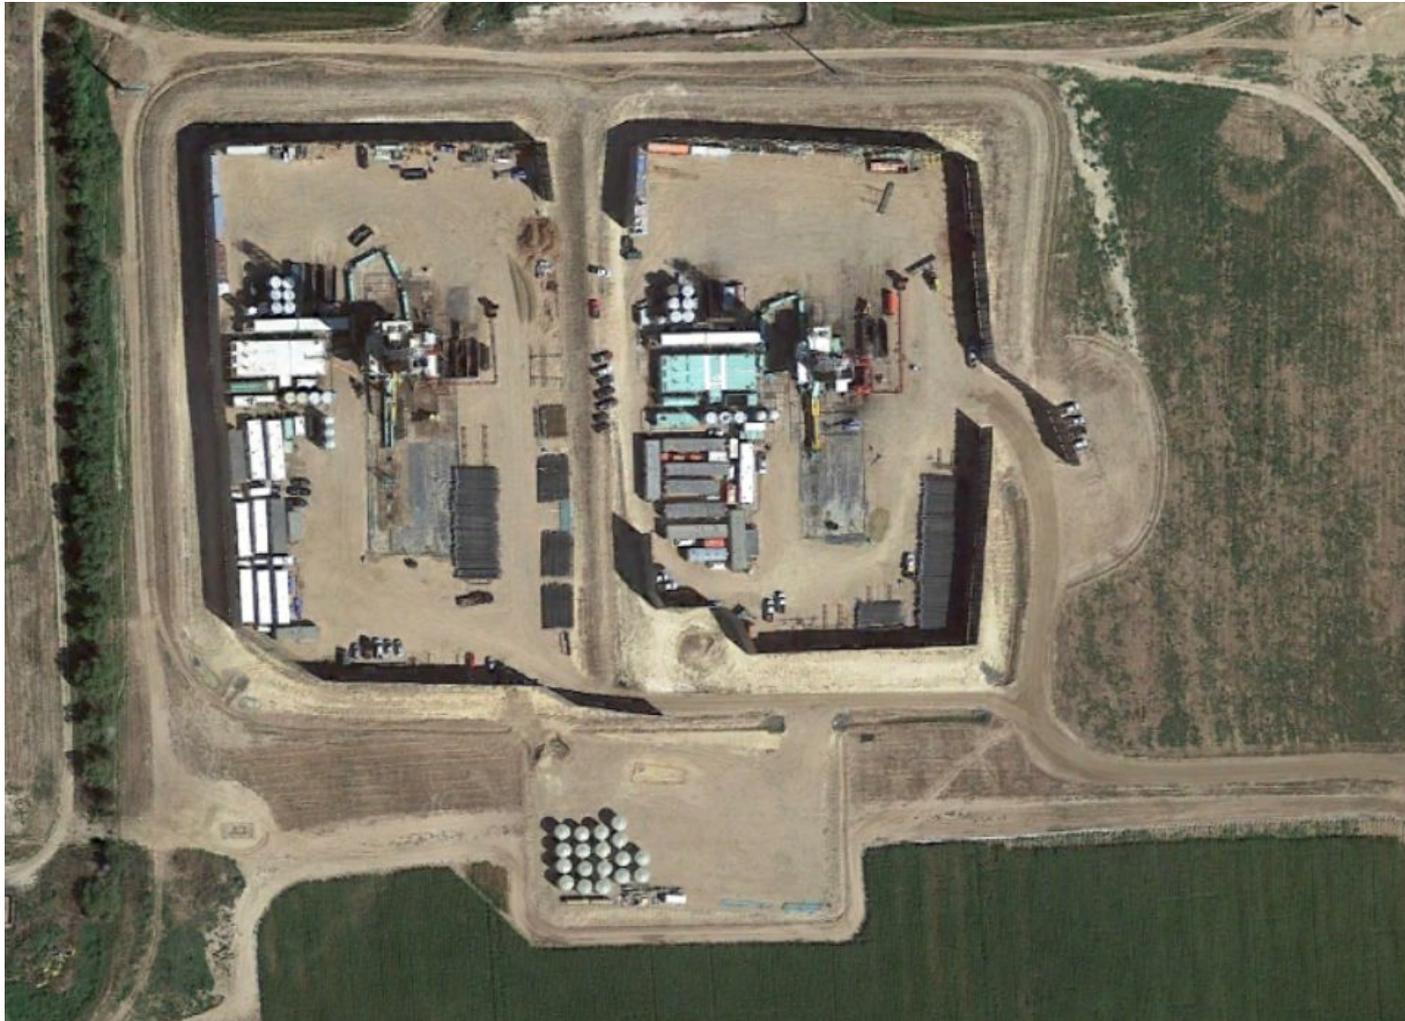
**Photo 1.** Google Earth aerial imagery taken 9/7/2016 during active drilling operations. Imagery illustrates total disturbance areas associated with drilling operations.

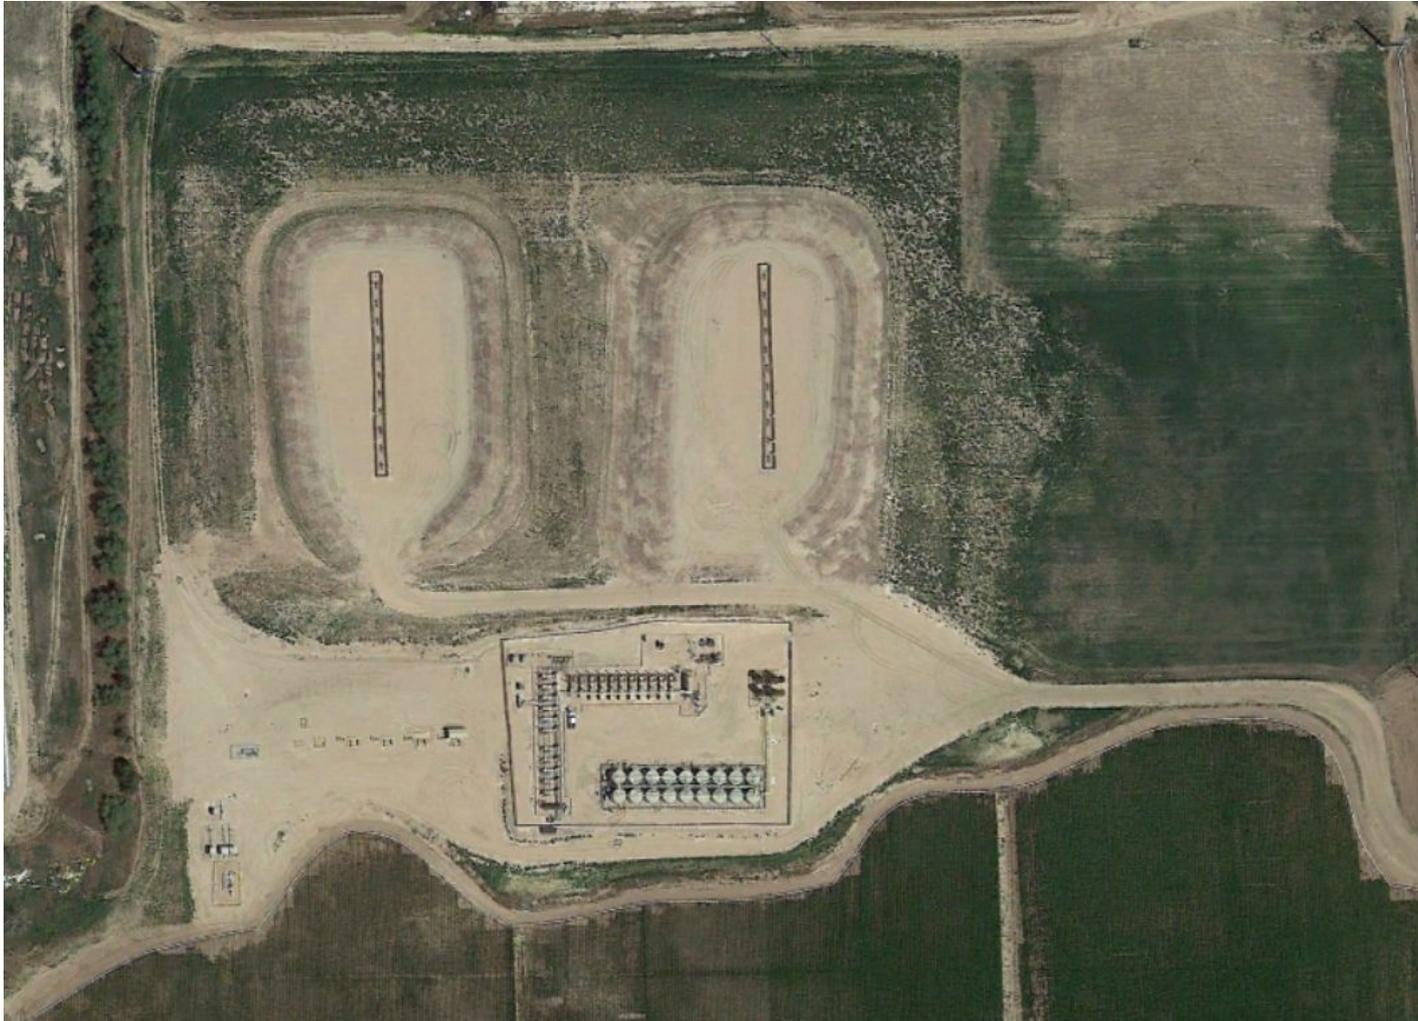
**Photo 2.** Google Earth aerial imagery taken 7/17/2019 after all 22 wells have been on production. Imagery illustrates Operator has performed interim reclamation activities to reduce disturbance areas only needed for production operations.

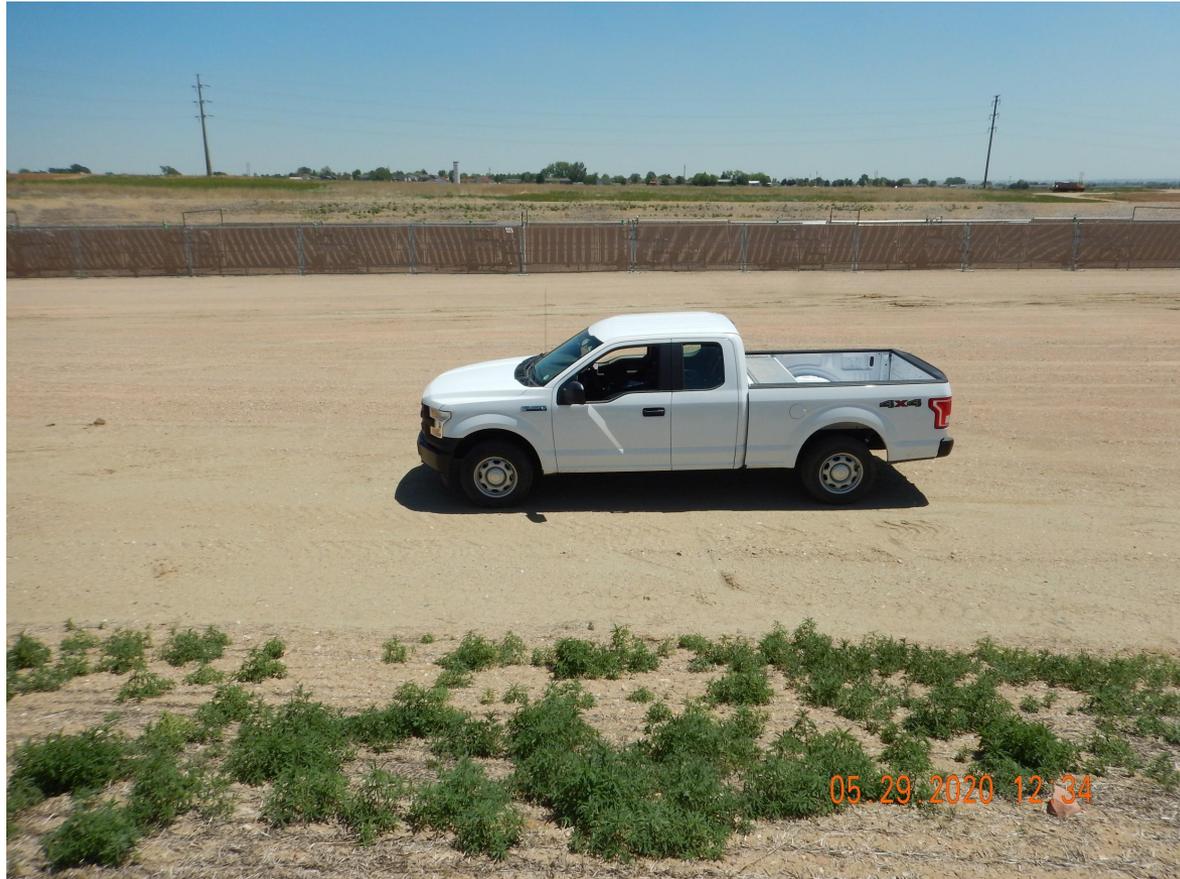
**Photo 3.** Photo taken from the eastern set of wells, facing East. Photo illustrates Operator has performed interim reclamation activities to reduce disturbance areas only needed for production operations.

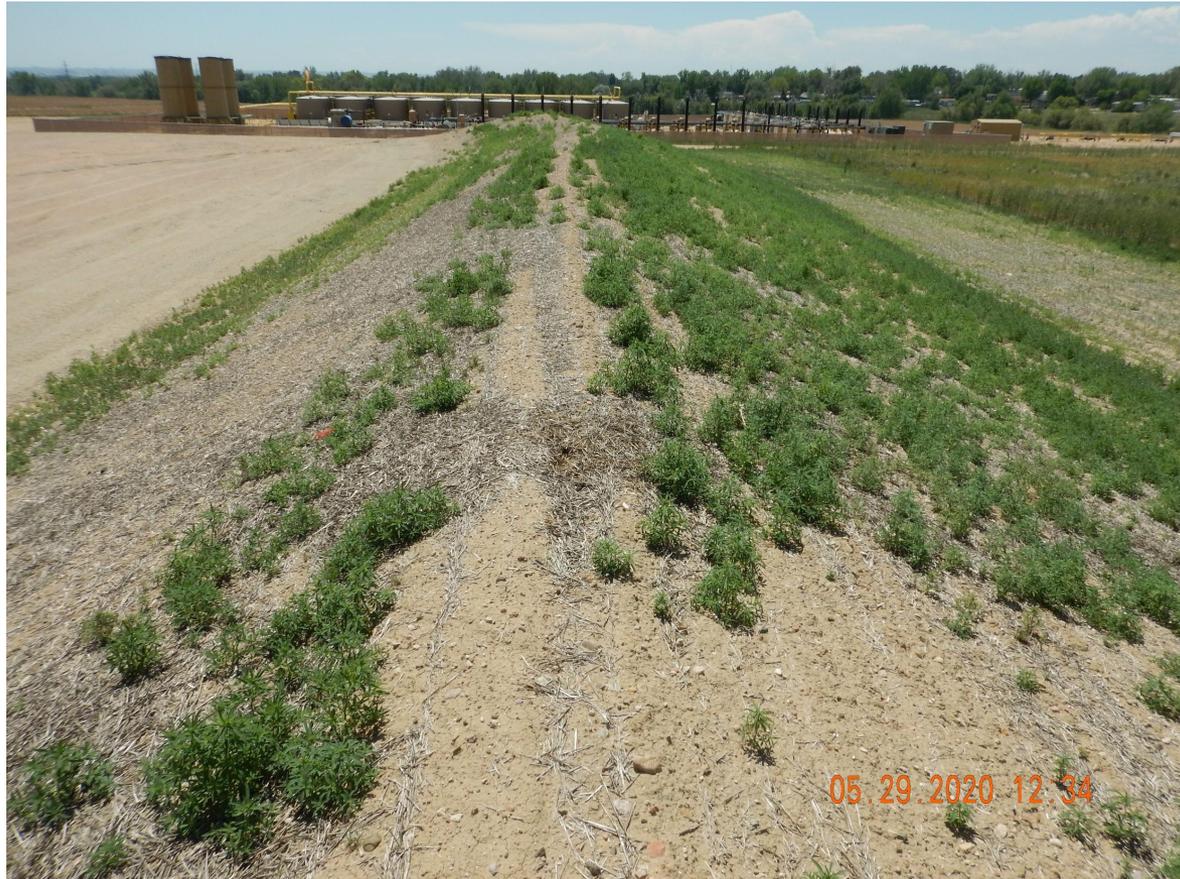
**Photo 4.** Photo taken from the eastern set of wells, facing South. Photo illustrates a stockpile that has been temporarily stabilized with equipment tracking. Operator has attempted to seed into the stockpile with the evidence of drill rows and straw crimped mulch. However, there was little establishment of desirable species and currently has mostly Kochia establishment.

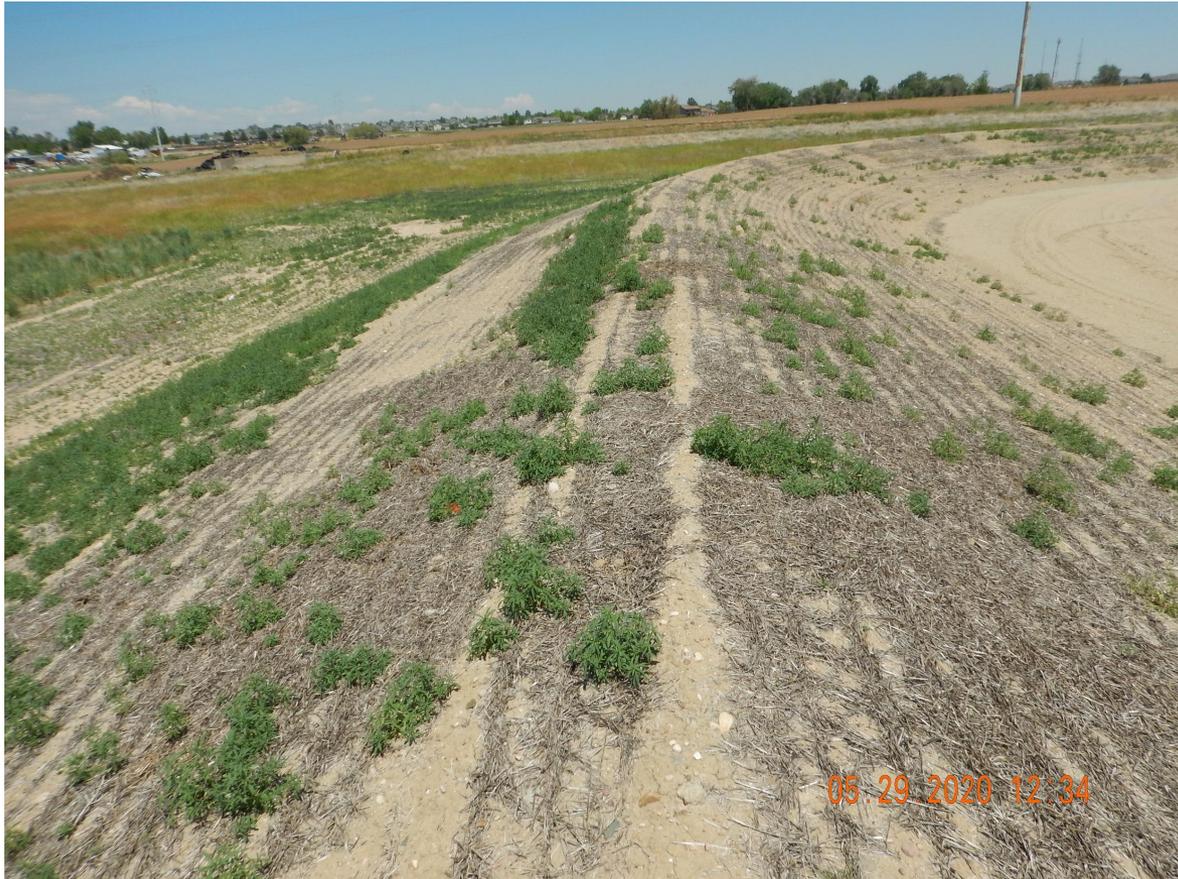
**Photo 5.** Photo taken from the eastern set of wells, facing North. See comments under Photo 4.

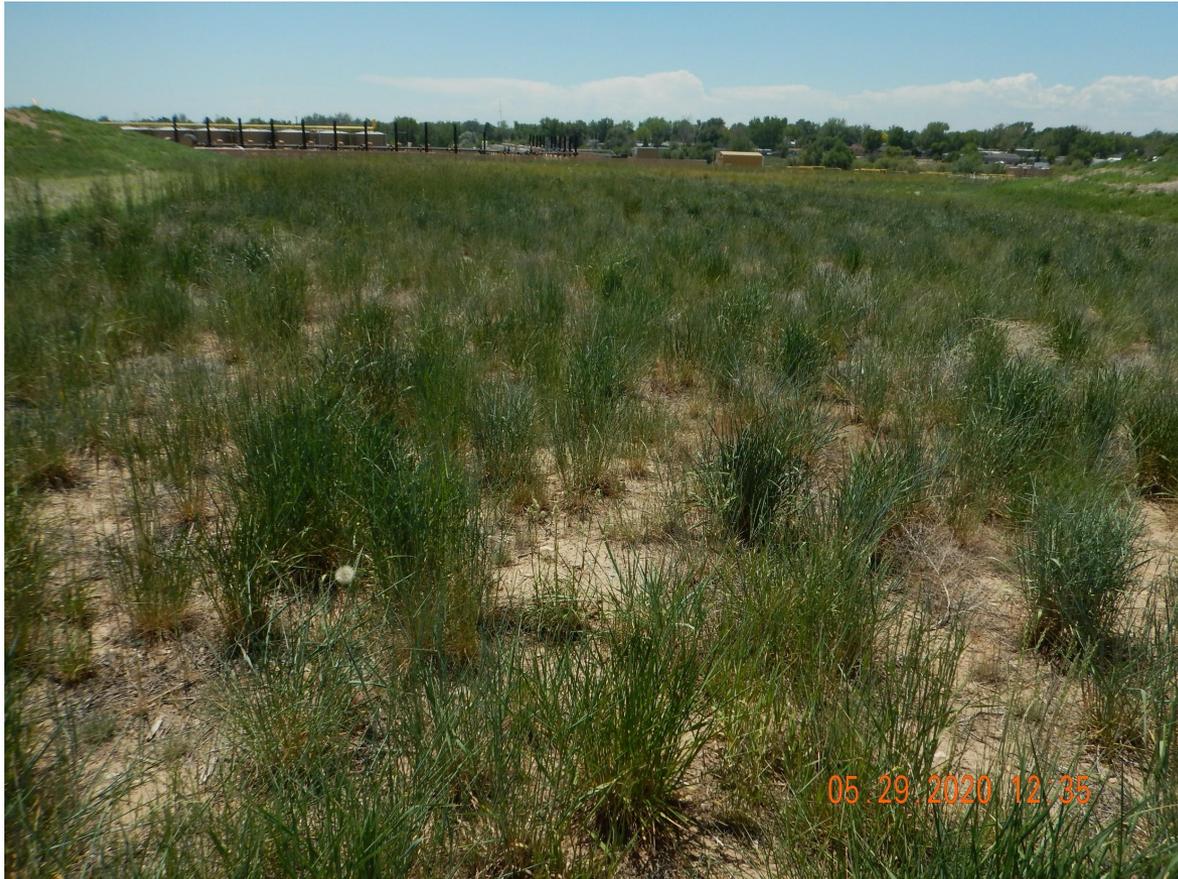
**Photo 6.** Photo taken between the two sets of wells, facing South. Photo illustrates Operator has revegetated the interim area including but not limited to the following: smooth brome, crested wheatgrass, intermediate wheatgrass, western wheatgrass, orchard grass, and indian rice grass.

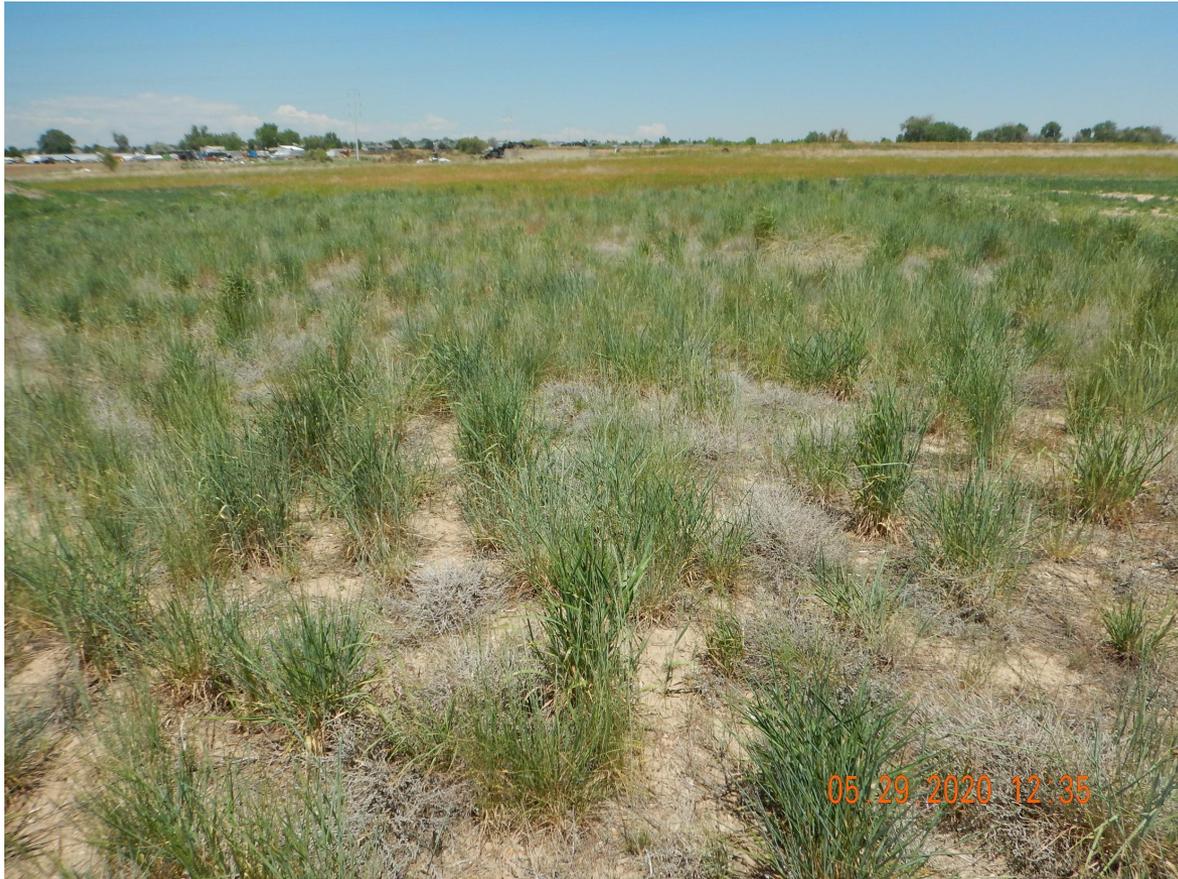
**Photo 7.** Photo taken between the two sets of wells, facing North. See comments under Photo 6.

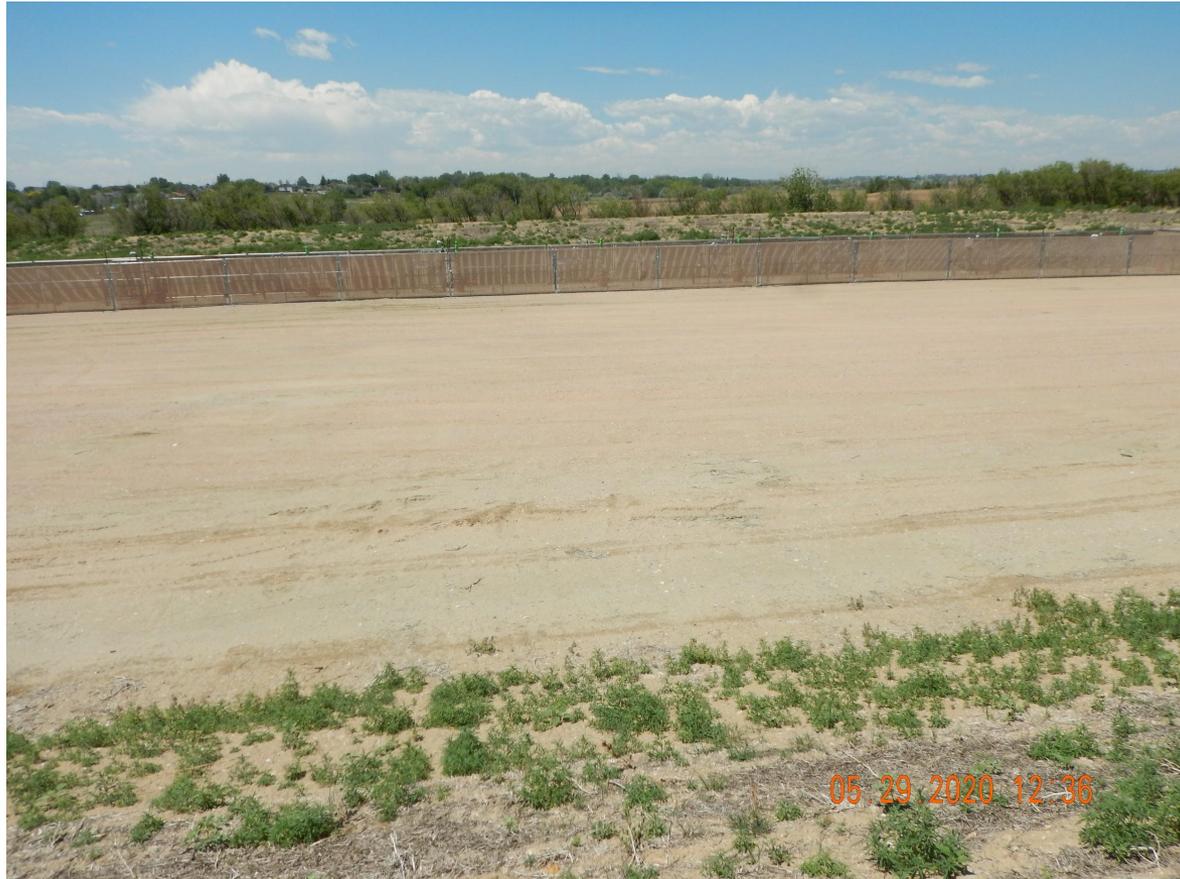
**Photo 8.** Photo taken from the western set of wells, facing West. Photo illustrates Operator has performed interim reclamation activities to reduce disturbance areas only needed for production operations.

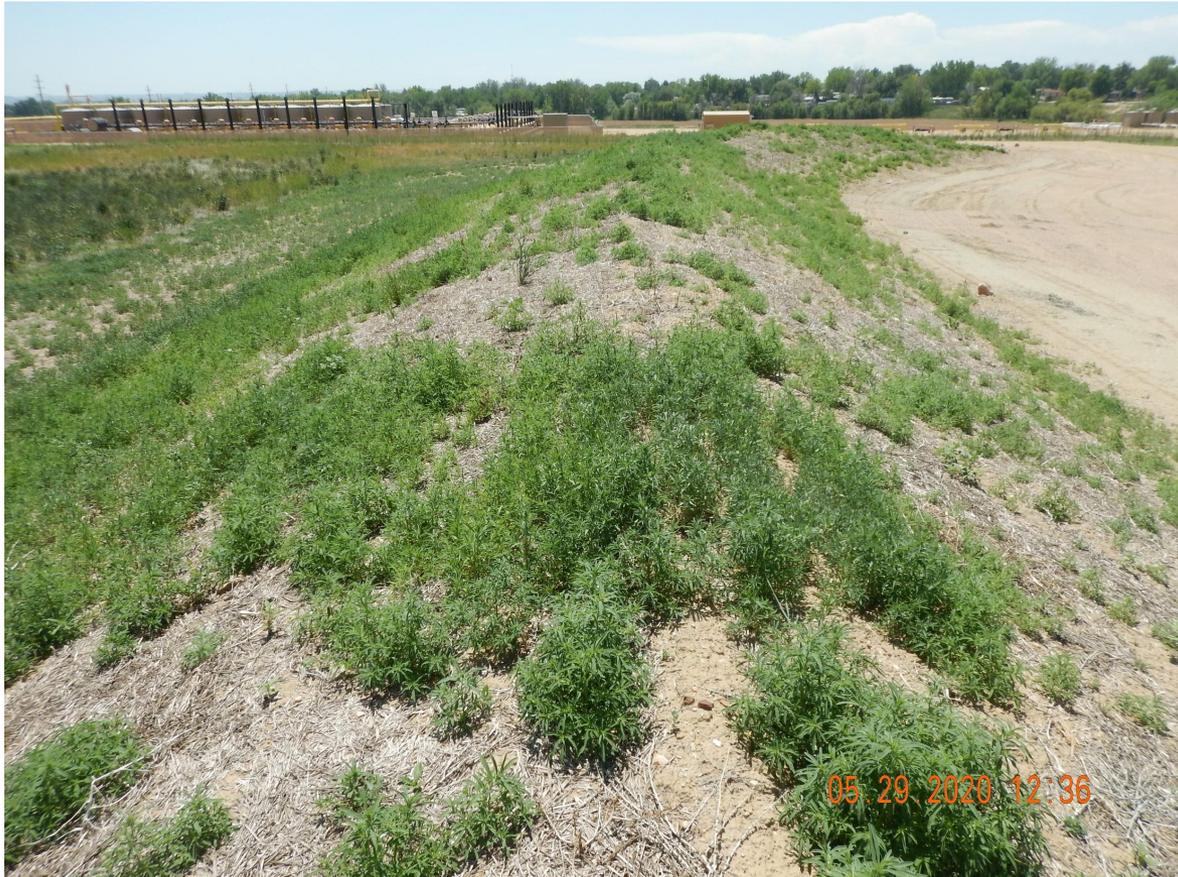
**Photo 9.** Photo taken from the western set of wells, facing South. Photo illustrates a stockpile that has been temporarily stabilized with equipment tracking. Operator has attempted to seed into the stockpile with the evidence of drill rows and straw crimped mulch. However, there was little establishment of desirable species and currently has mostly Kochia establishment.

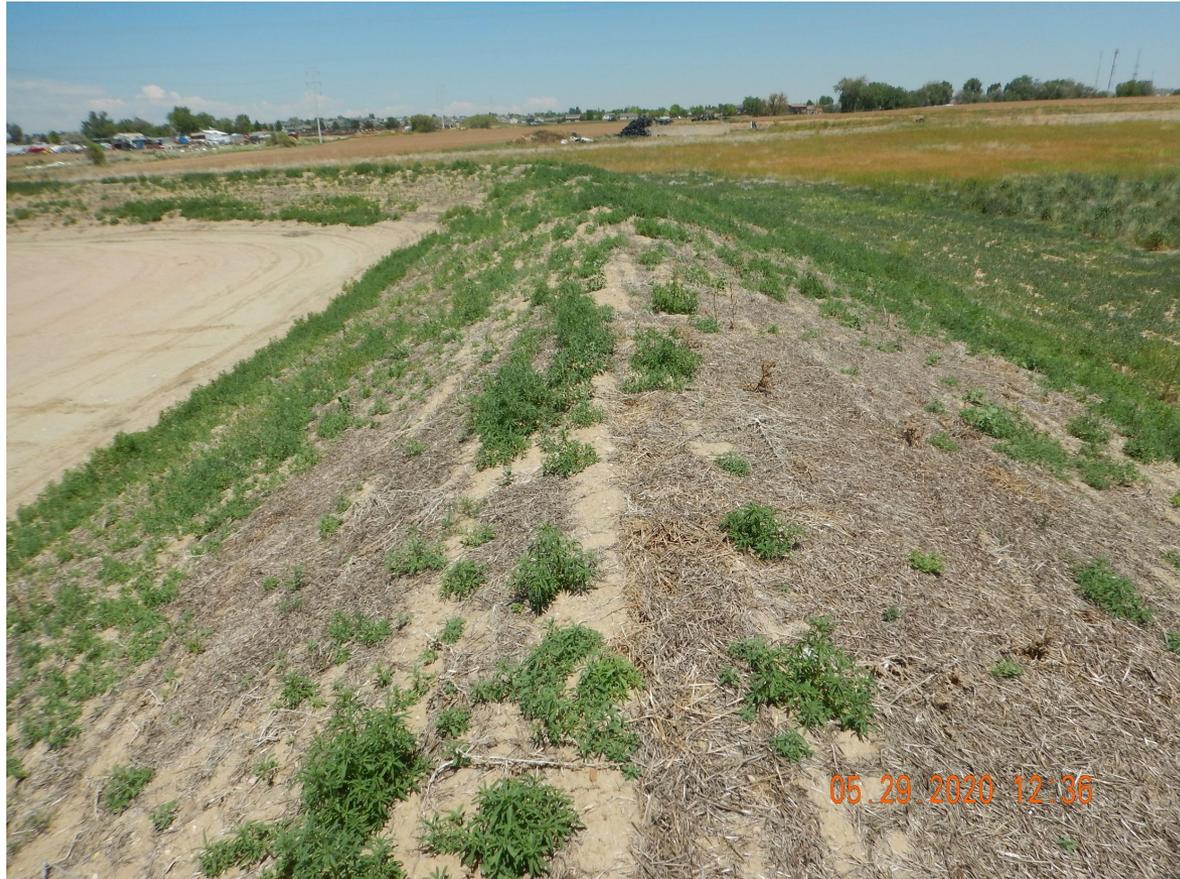
**Photo 10.** Photo taken from the western set of wells, facing North. See comments under Photo 9.

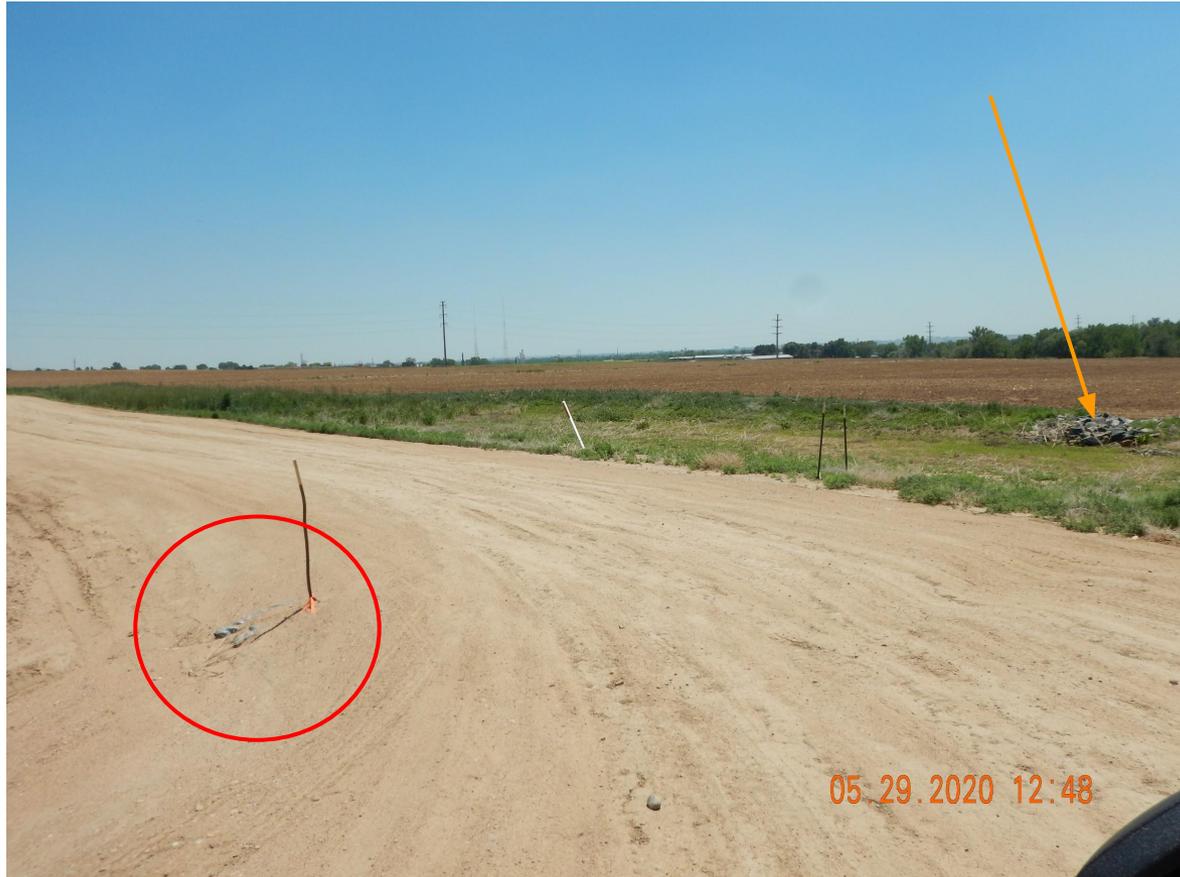
**Photo 11.** Photo taken from the southern location, facing Southeast. Photo illustrates a culvert needing repair. Culvert directs stormwater to a stabilized outlet area (orange arrow).

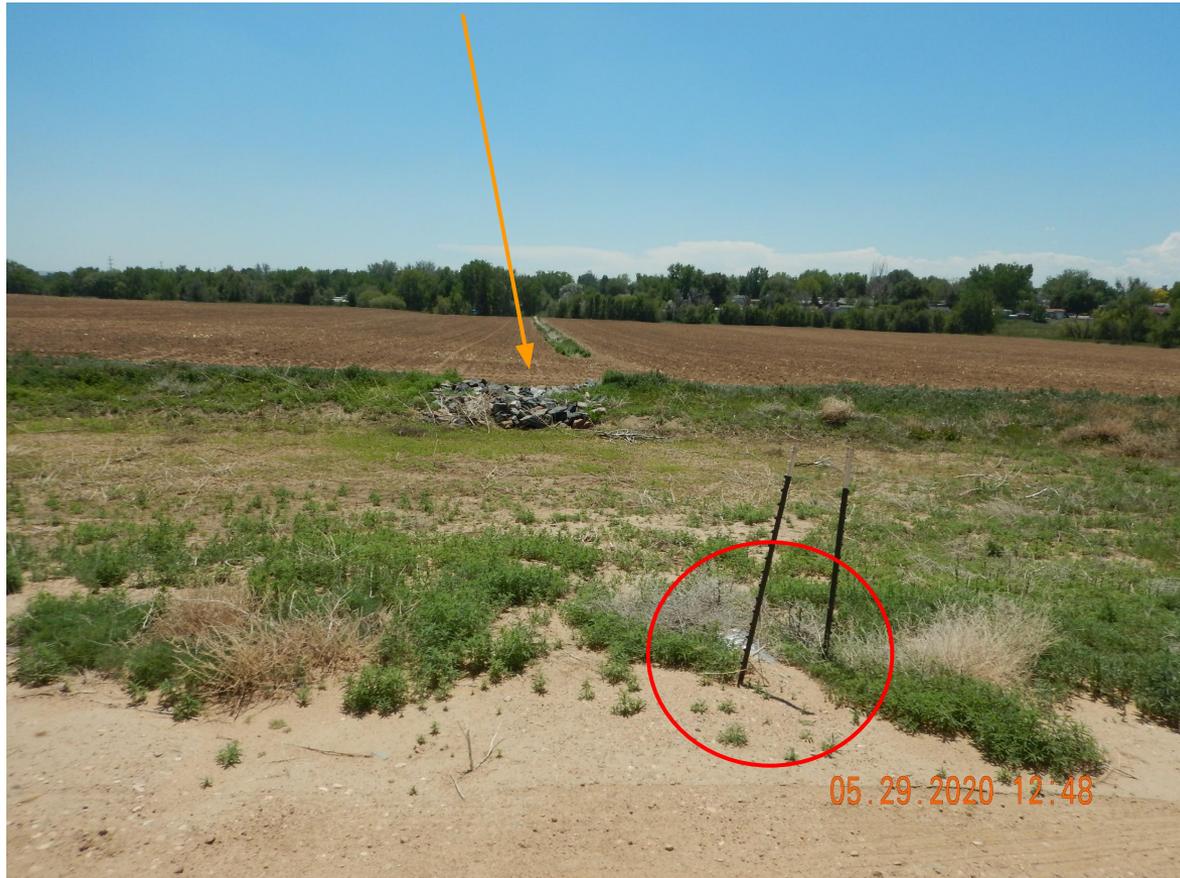
**Photo 12.** Photo taken from the southern location, facing South. Photo illustrates the outlet of the culvert that directs stormwater to a stabilized outlet area (orange arrow).
