Inspection Photos

Location Name: Mautz Ranch Centralized E&P Waste Management Facility

Facility ID: 44493

Inspection Date: May 21, 2020

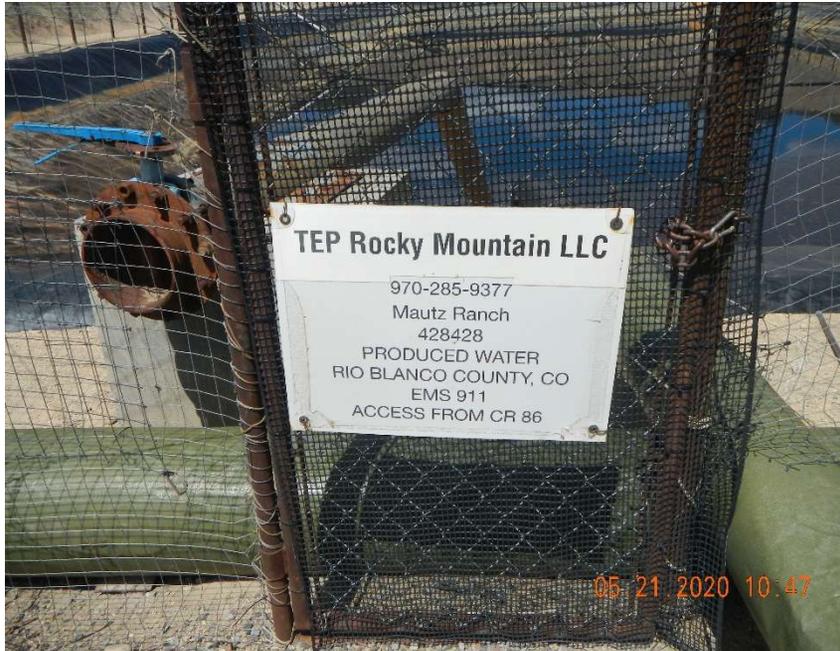
Pit sign

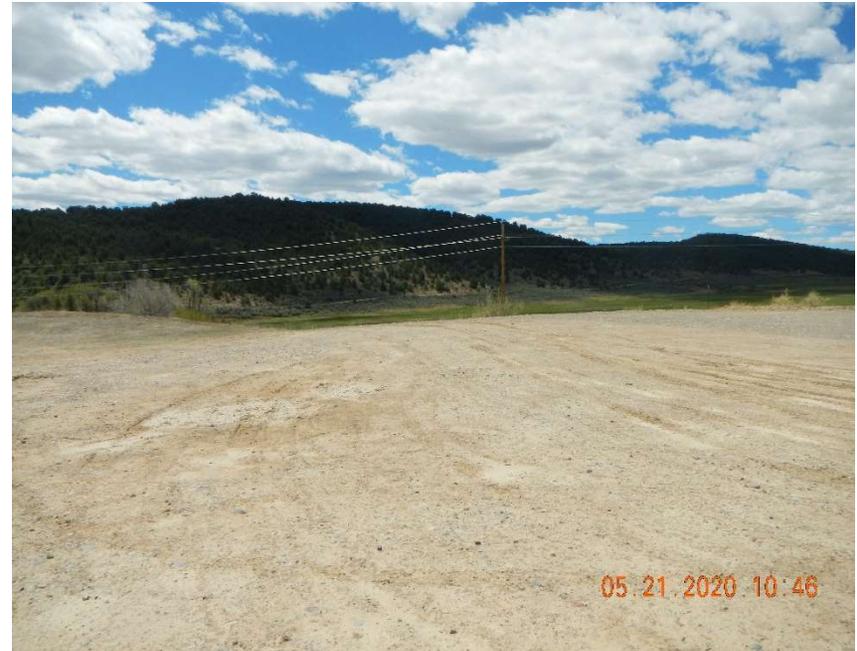
Uncontrolled access to the location, CE&P sign not posted

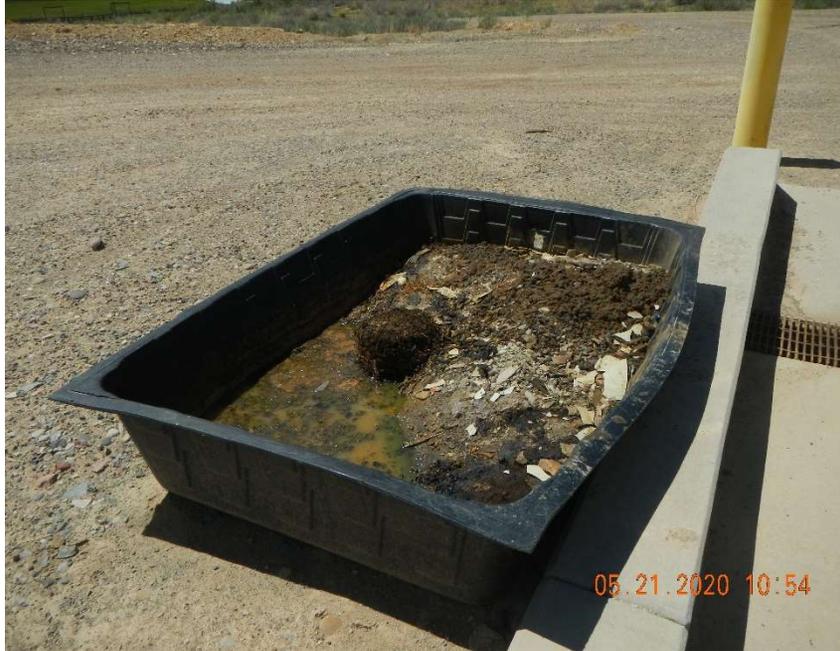
Trough containing E&P waste

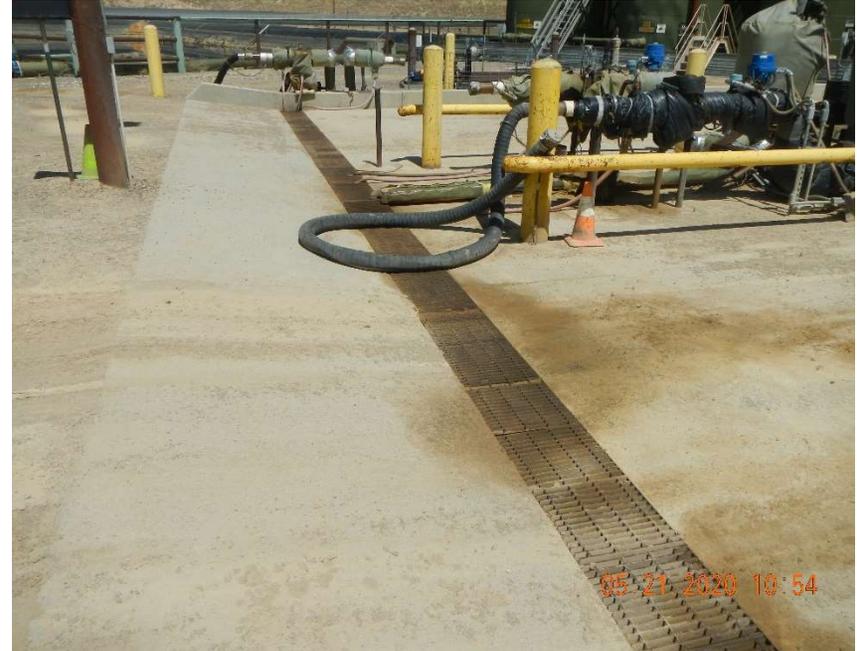
Localized accumulation of oily waste

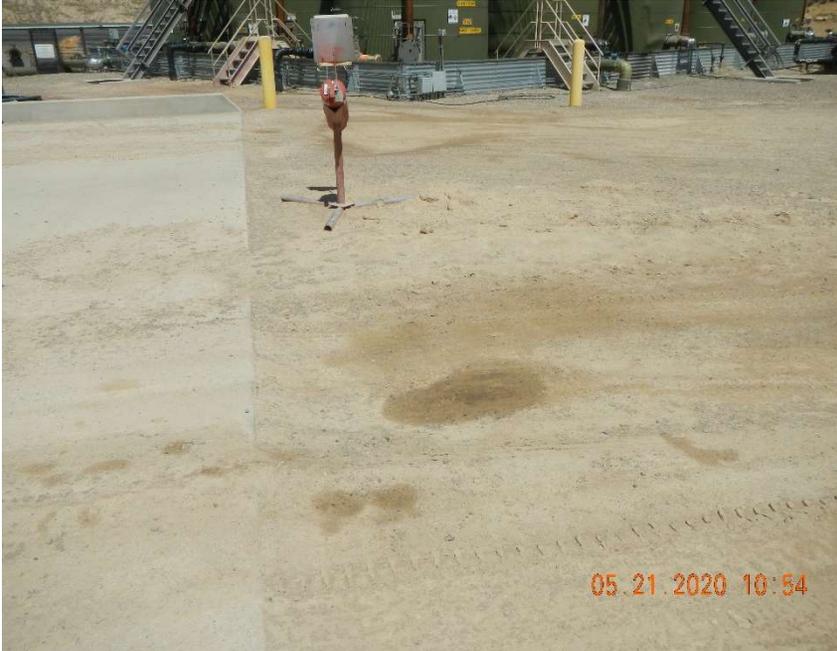
Localized accumulation of oily waste

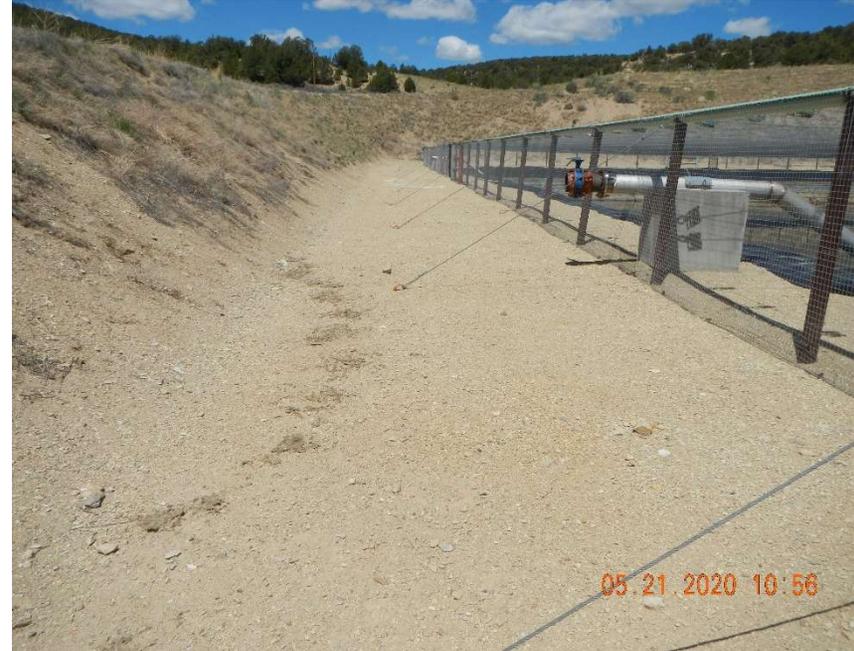
Evidence of livestock within CE&P Facility

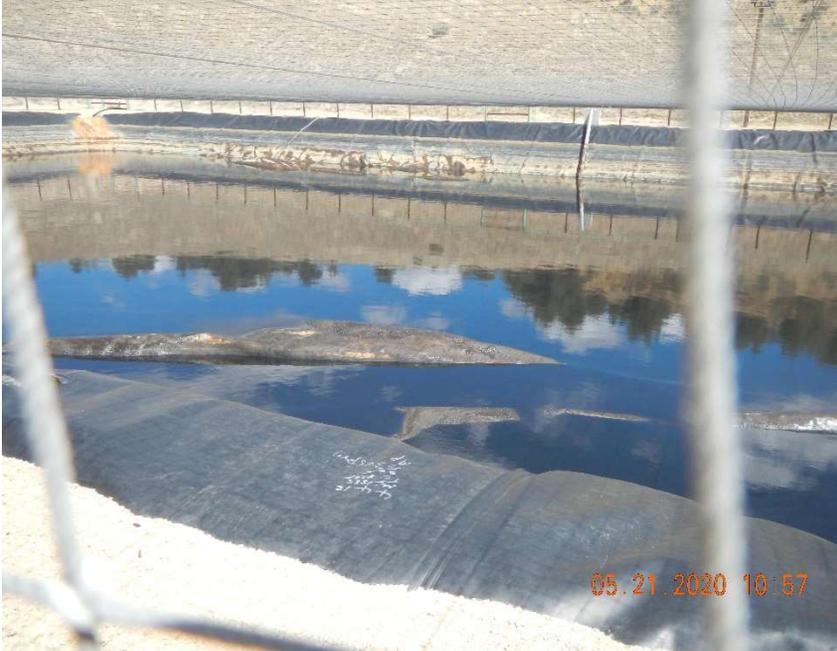
Pit liner bubbling up to the fluid level surface

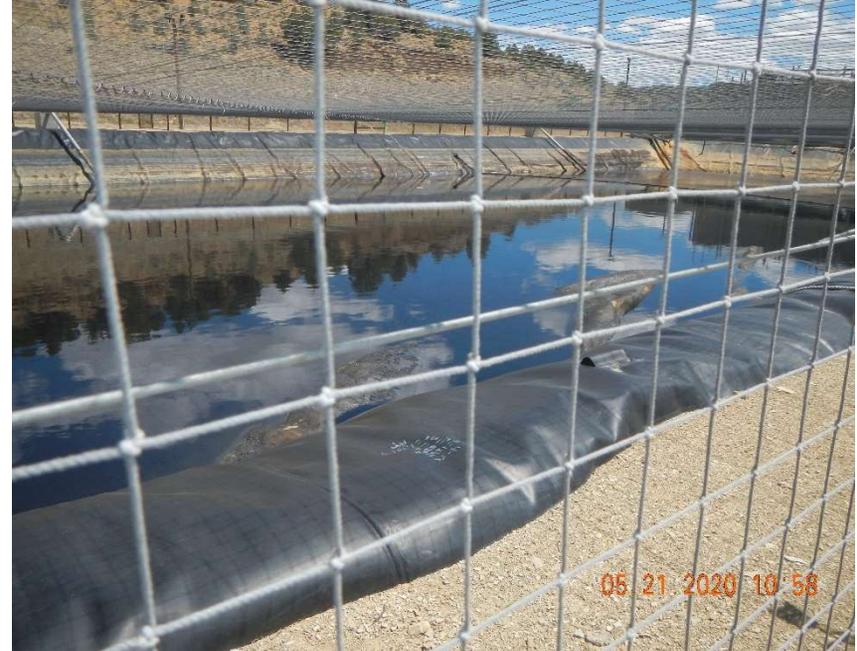
Pit liner bubbling up to the fluid level surface

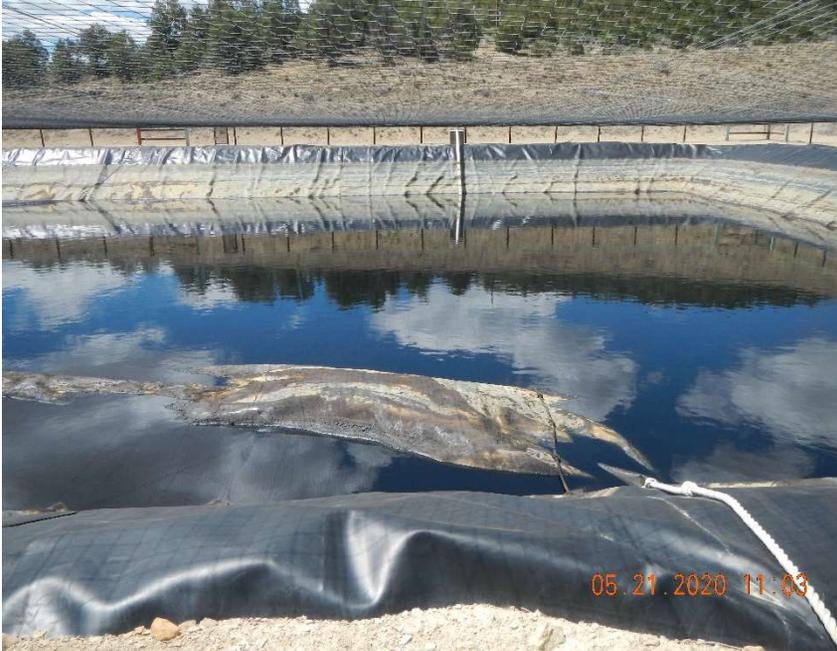
Pit liner bubbling up to the fluid level surface

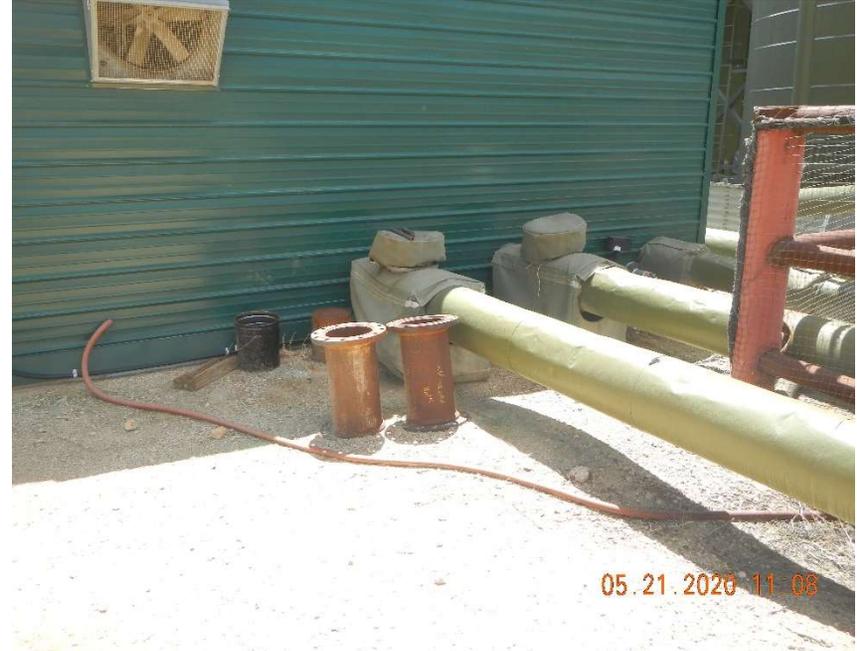
Unused equipment

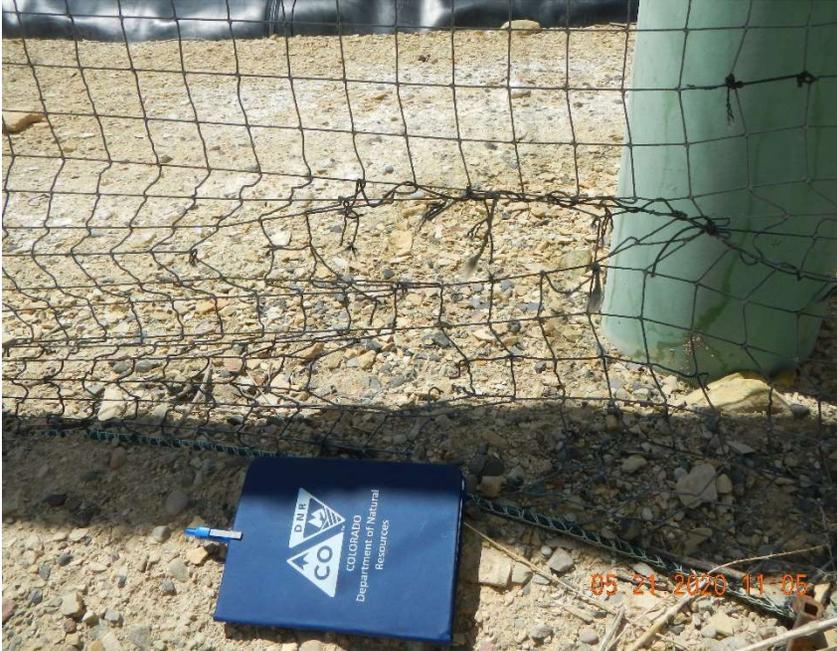
Hole in pit mesh

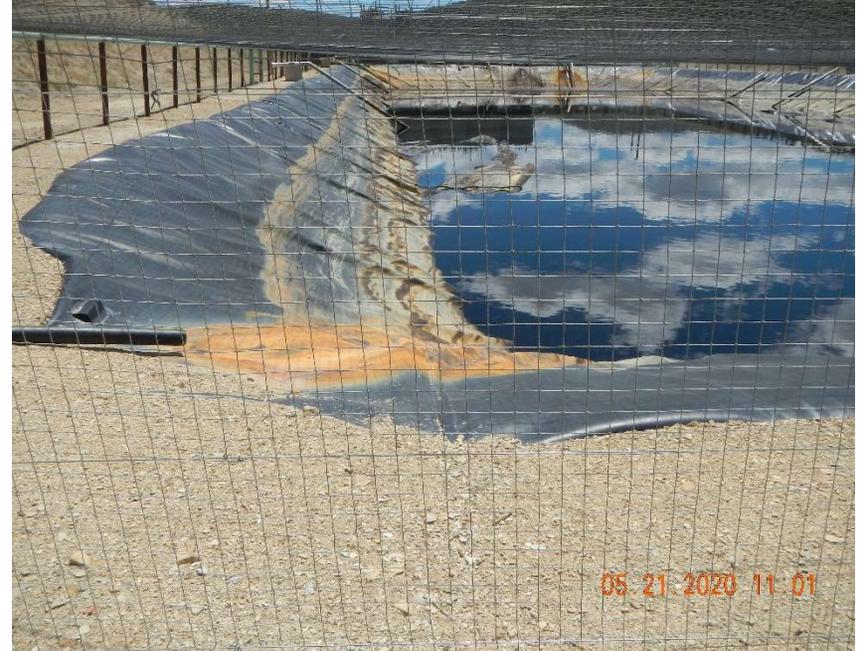
Sediment encroaching on pit liner and poly line directly on pit liner

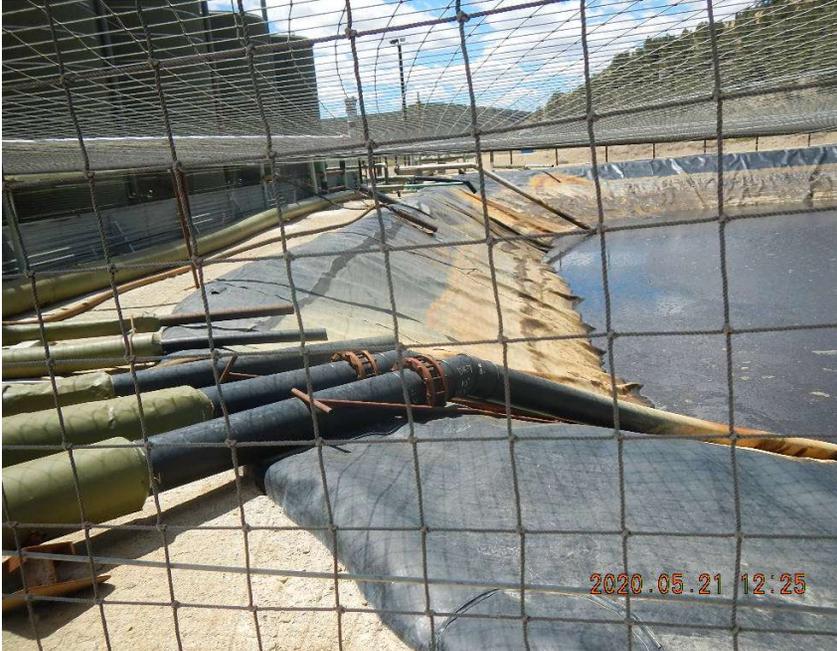
Hoses, pipes, and metal directly on pit liner.

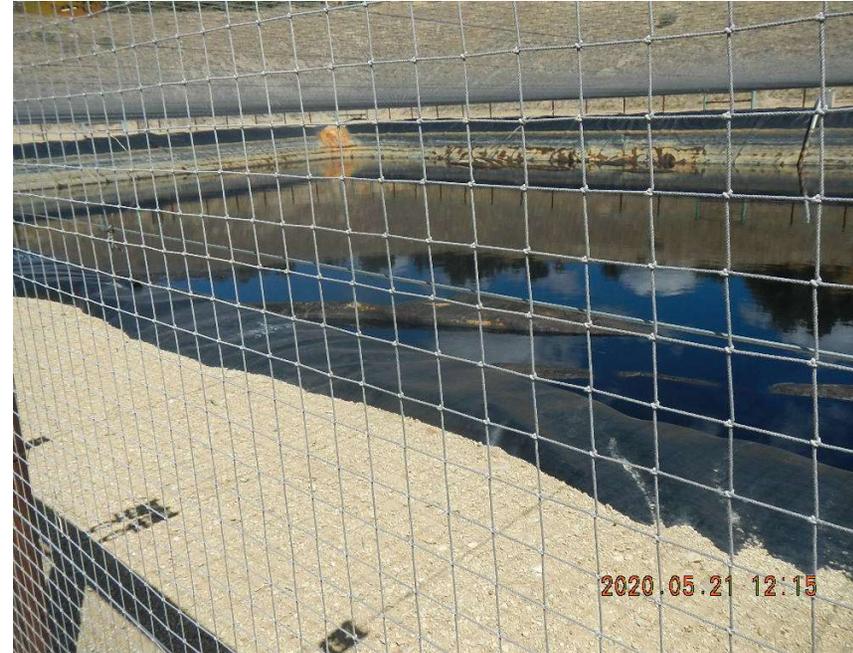
Free board at 10-12 feet from top of pit, and fluid surface 100% covered with hydrocarbons.
