Inspection Photos  
Operator: Catamount Energy  
API#: 067-08193  
Date: 6/1/2020

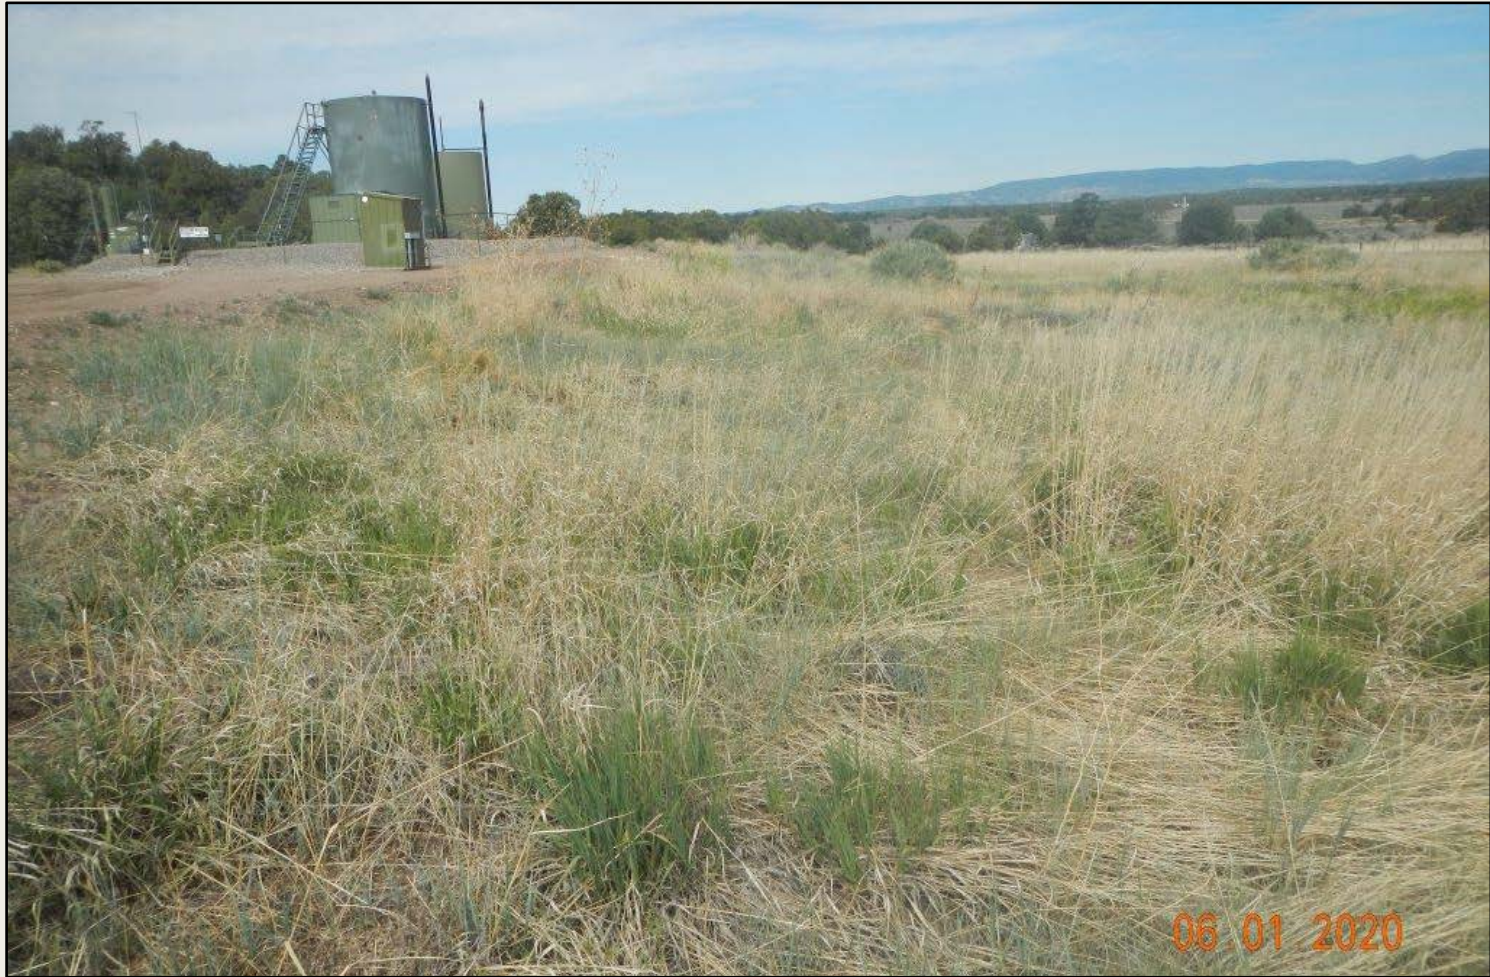
Photo 1. View of the northern fill slope from the northeastern corner facing westward. Revegetation is progressing, largely with grasses such as smooth brome, western wheatgrass, and intermediate wheatgrass.

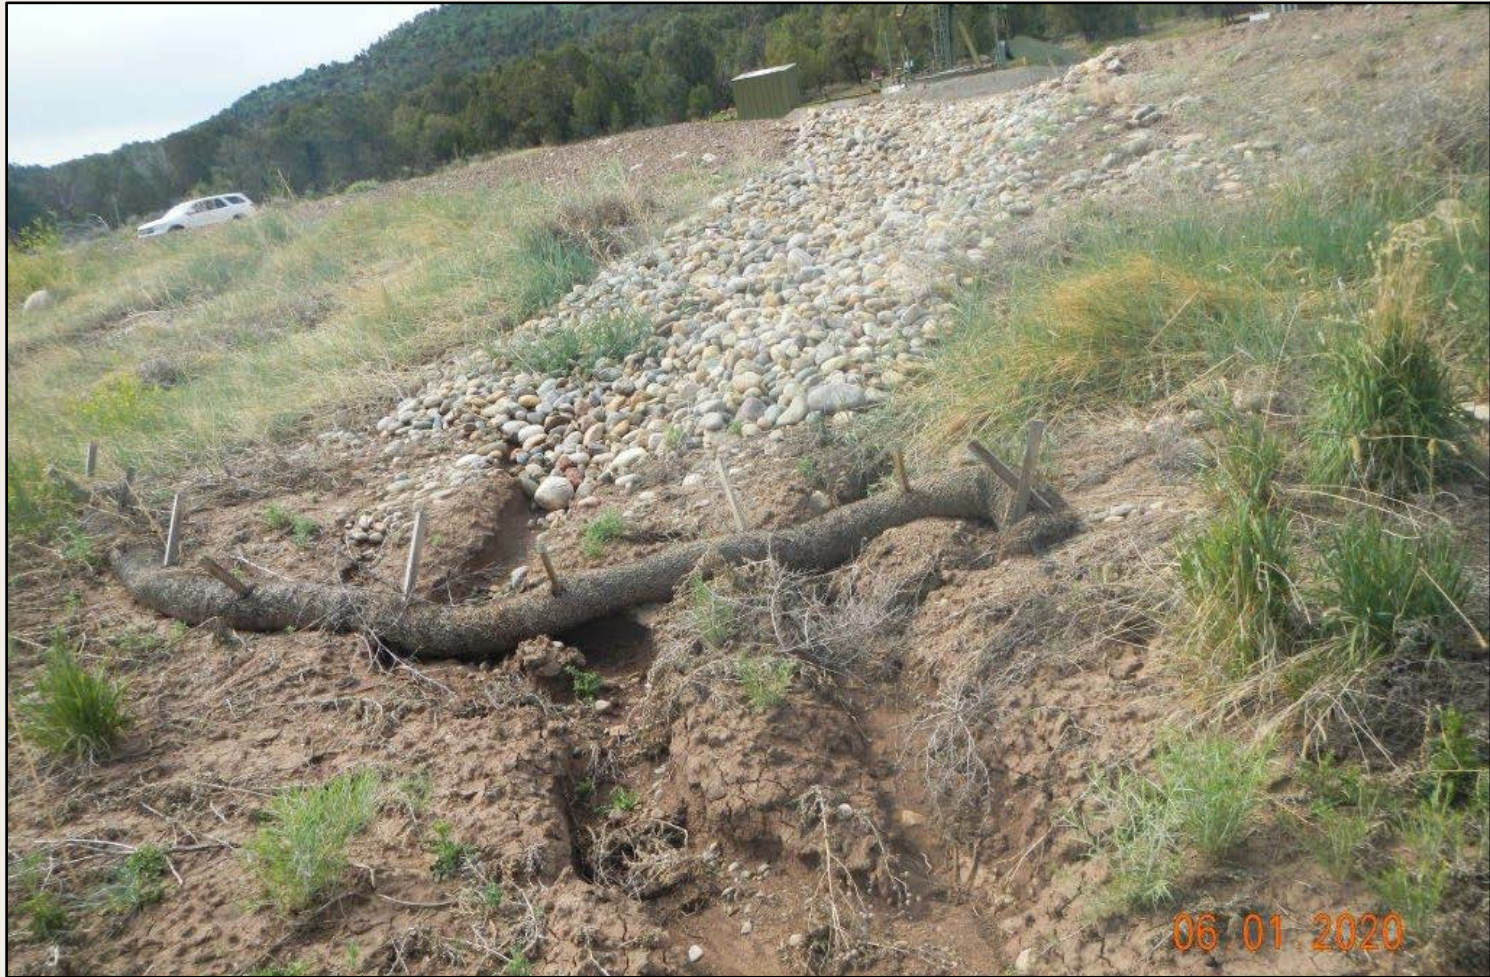
Photo 2. View of erosional channeling occurring downstream from cobble BMP in the northern project area. Wattle is failed. Cobbles are not sufficient to stabilize stormwater flows in this area.

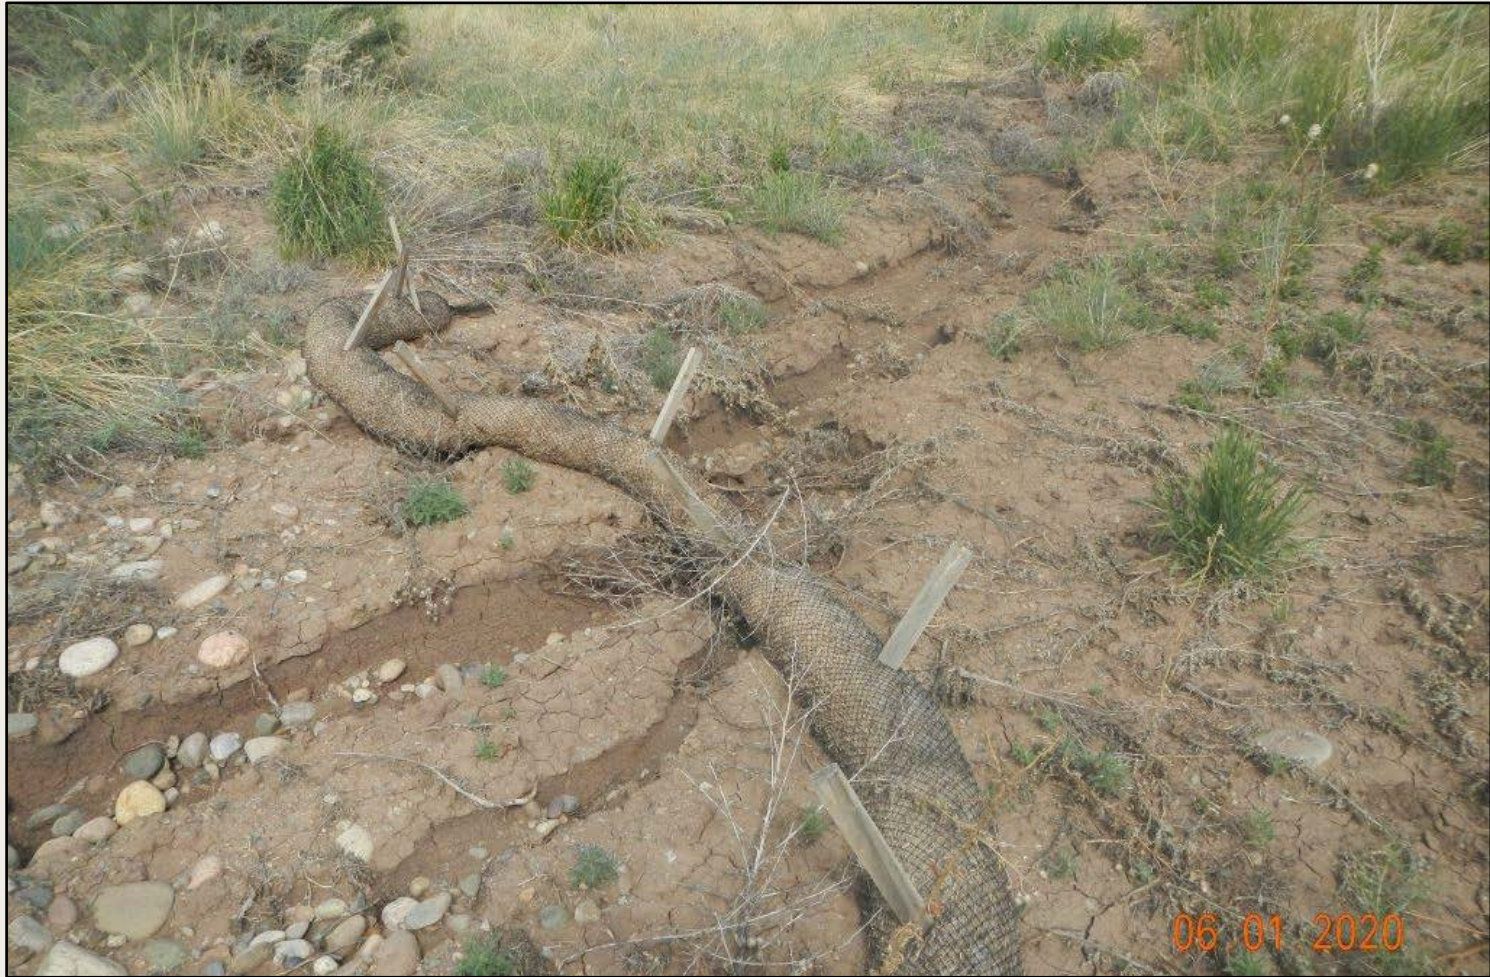
Photo 3. View of erosional channeling in Photo 2, facing downstream. Erosional channel is approximately 2 feet wide and 1 foot deep.

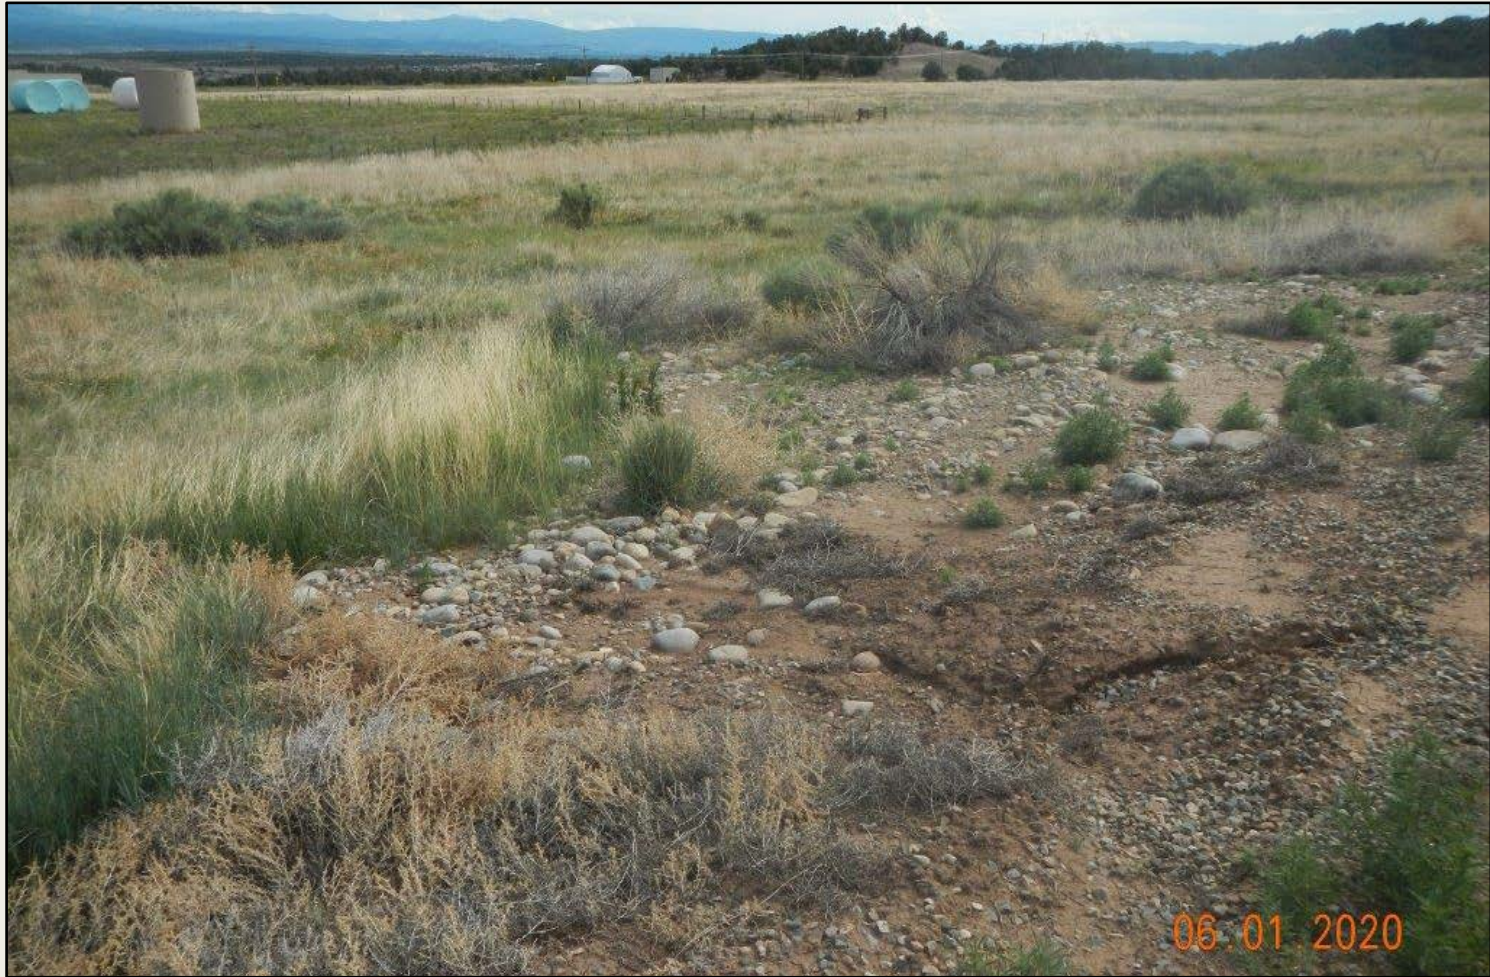
Photo 4. View of sediment deposition and cobble that is washed off of the project area. Reclamation and remediation is needed in these areas.

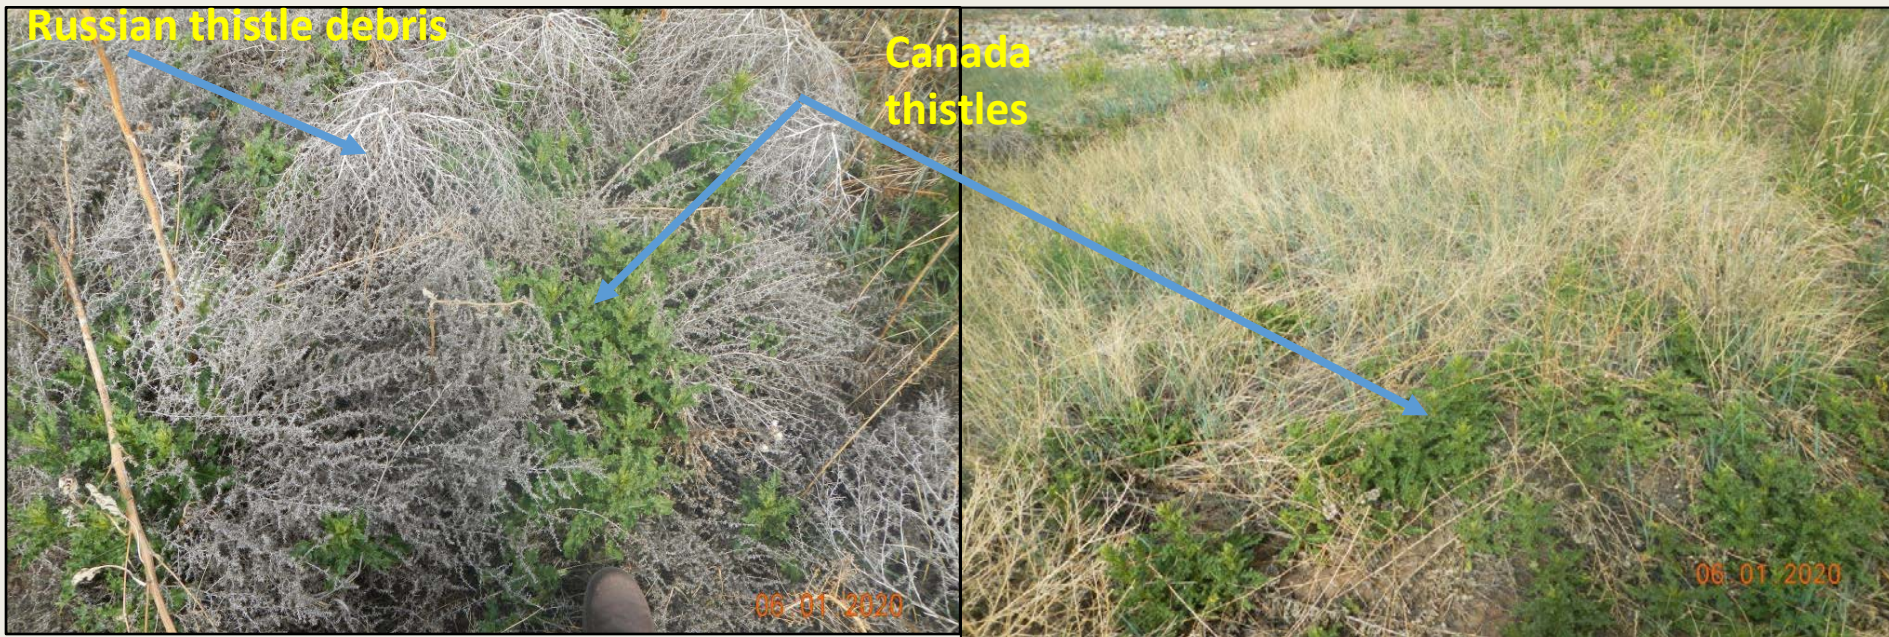
Photo 5/6. View of dense Canada thistles and Russian thistle debris within the northern project area.

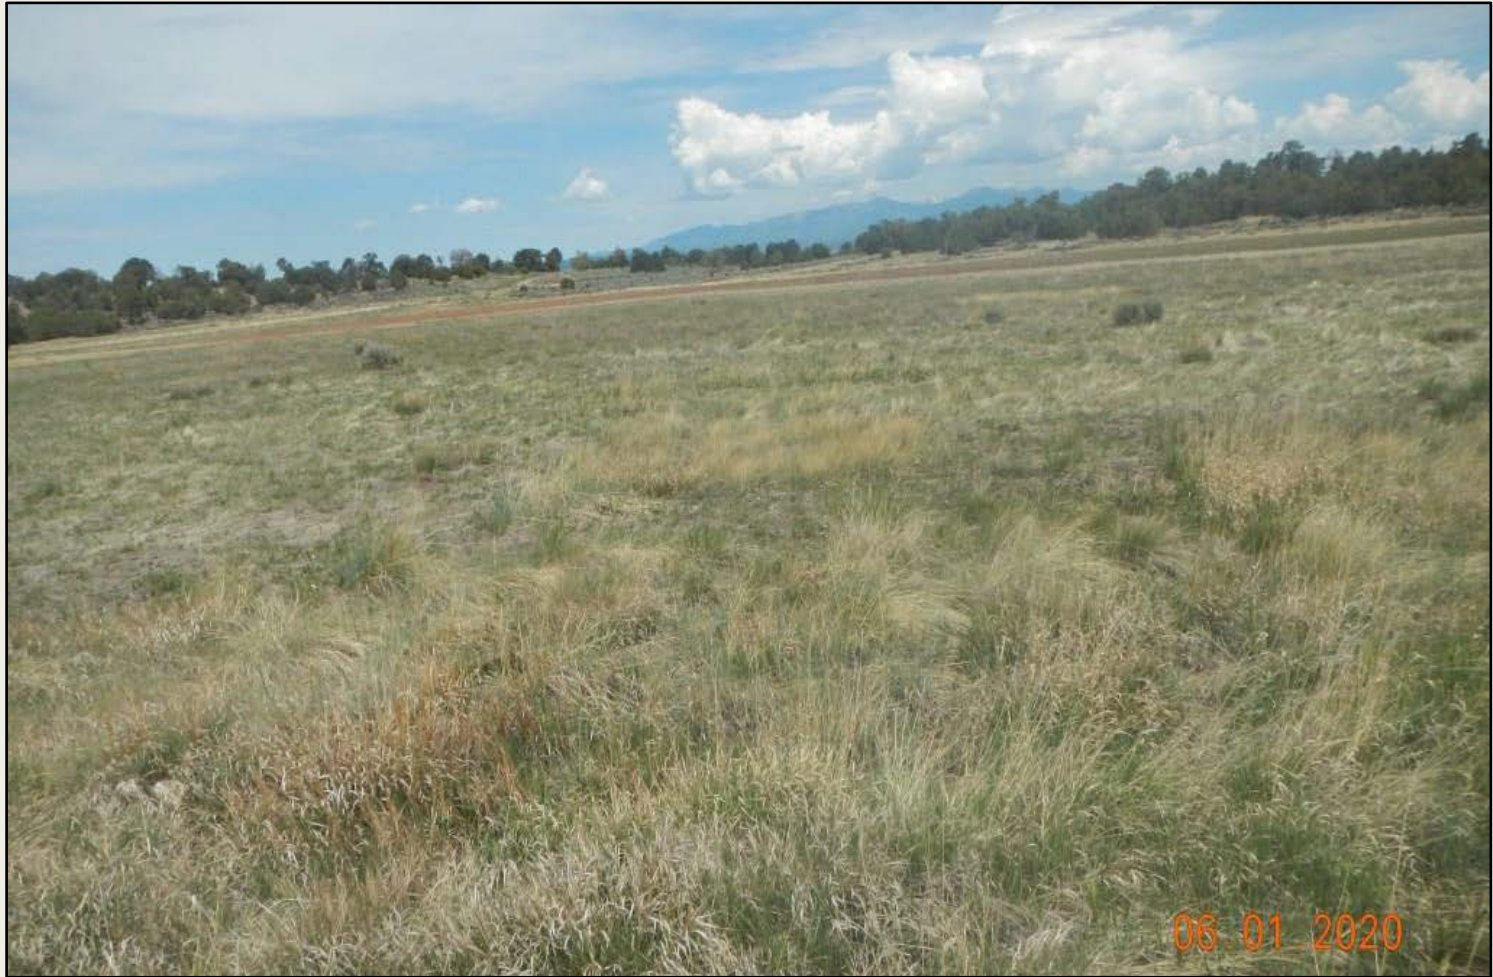
Photo 7. View of reference area comprised of open grass field with grasses such as smooth brome and western wheatgrass.
