Inspection Photos

Operator: Catamount Energy
API#: 067-09911
Date: 6/1/2020

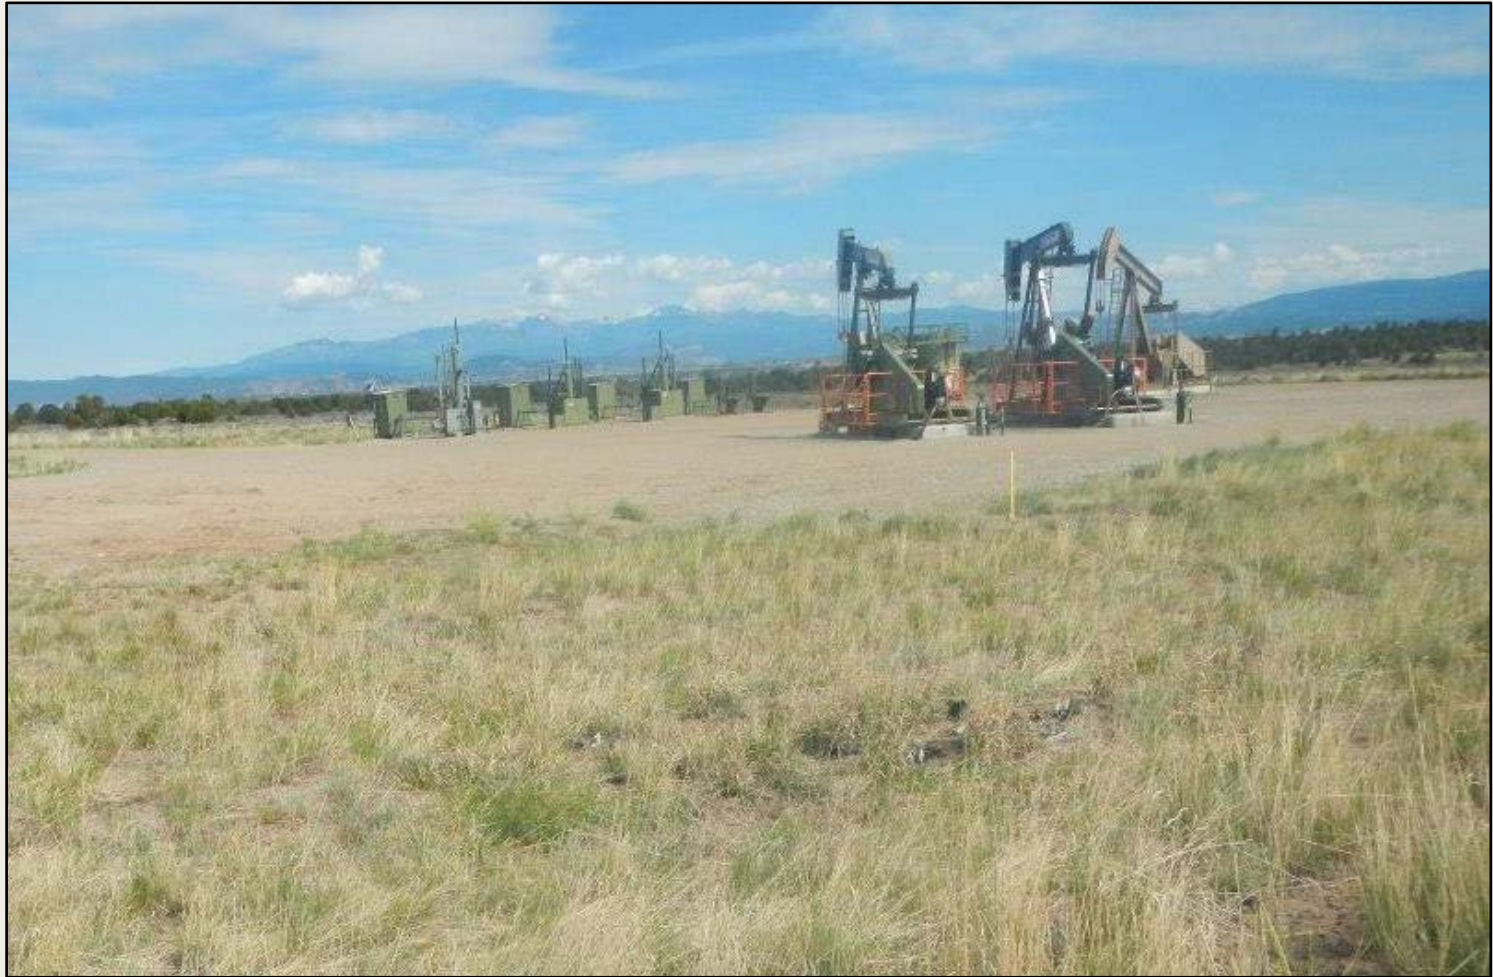
Photo 1. View of the project area from the southeastern corner facing center.

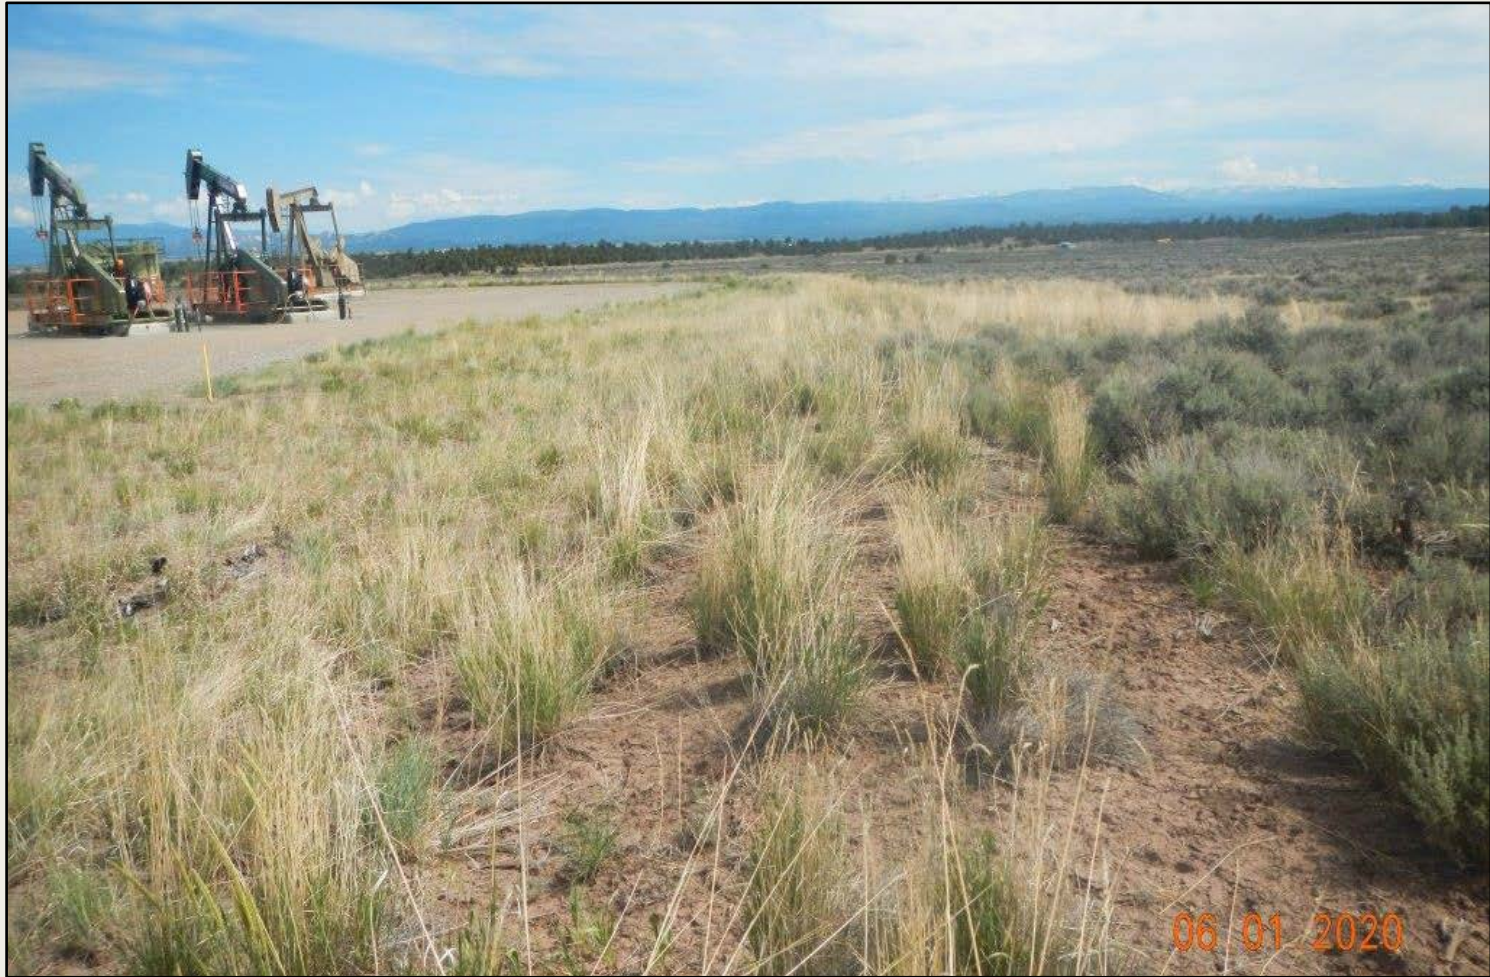
Photo 2. View of the eastern project area from the southeastern corner facing northward. Revegetation is progressing with a mix of native and non-native grasses such as crested wheatgrass, smooth brome, and western wheatgrass.

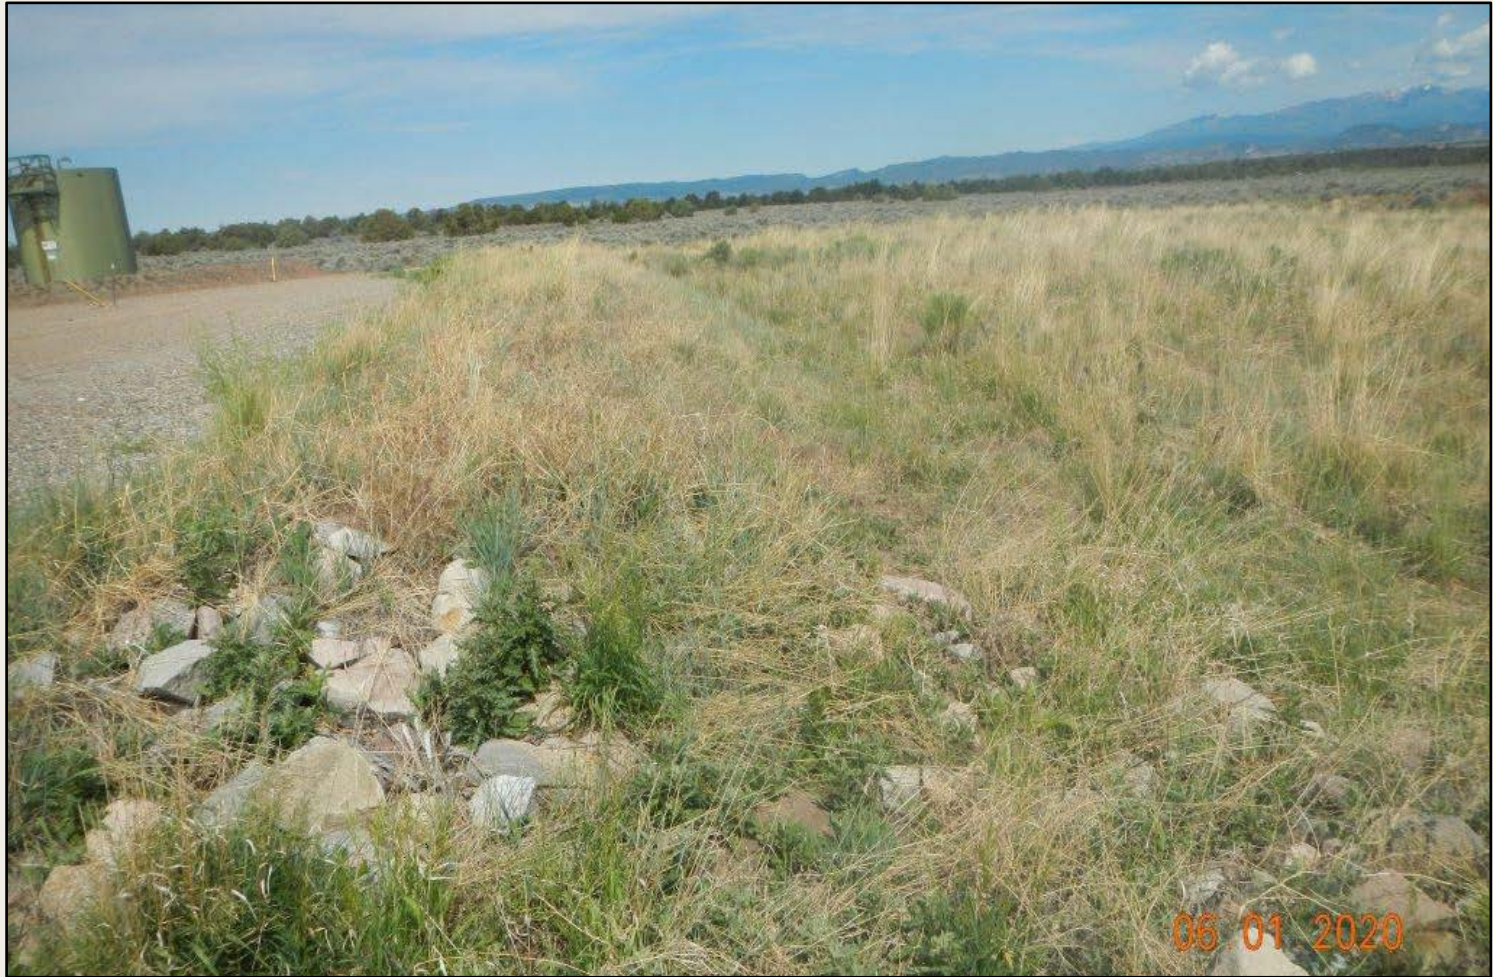
Photo 3. View of the northern project area from the northeastern corner facing westward.

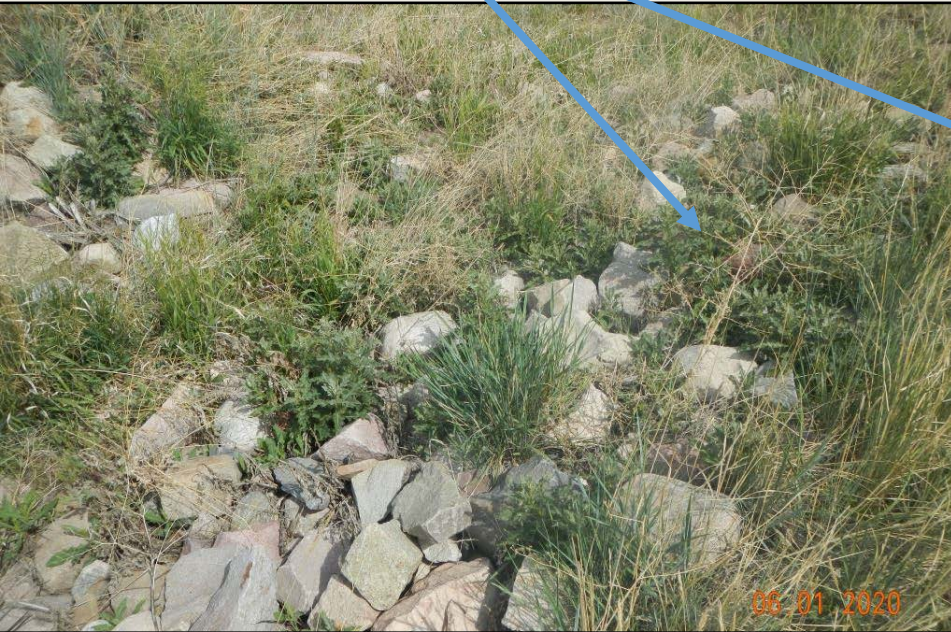
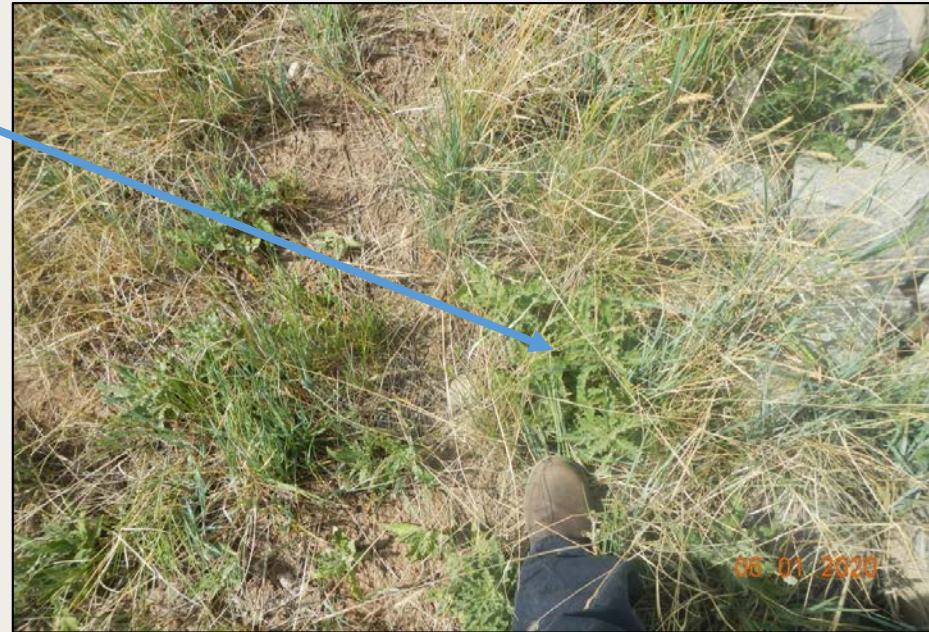
Photo 4/5. View of Canada thistles observed within the northeastern project area. Approximately 200 individuals observed.

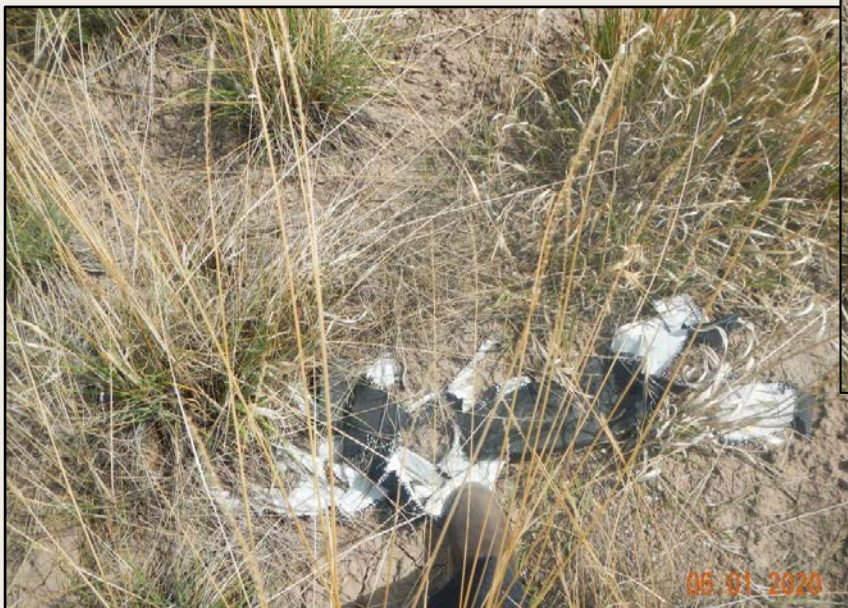
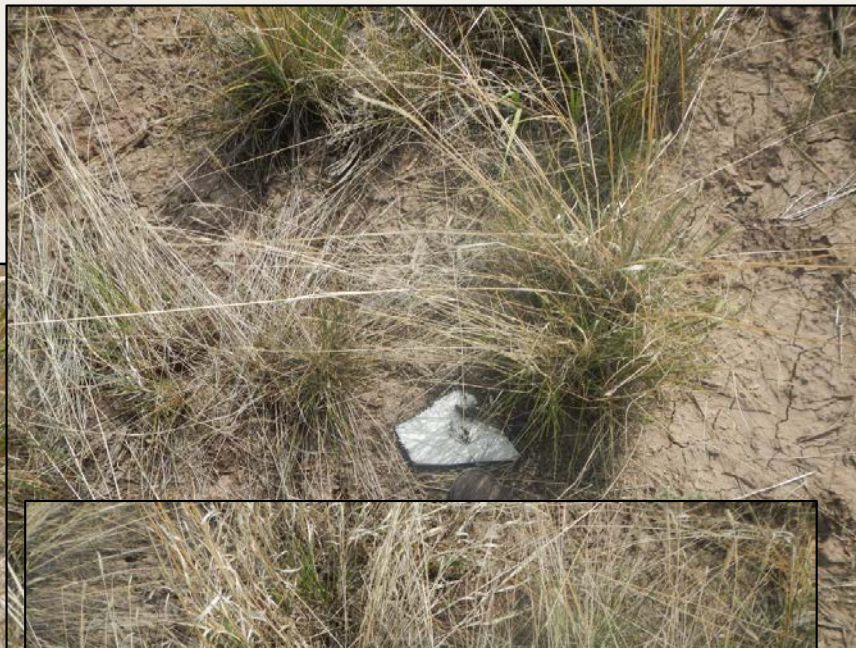
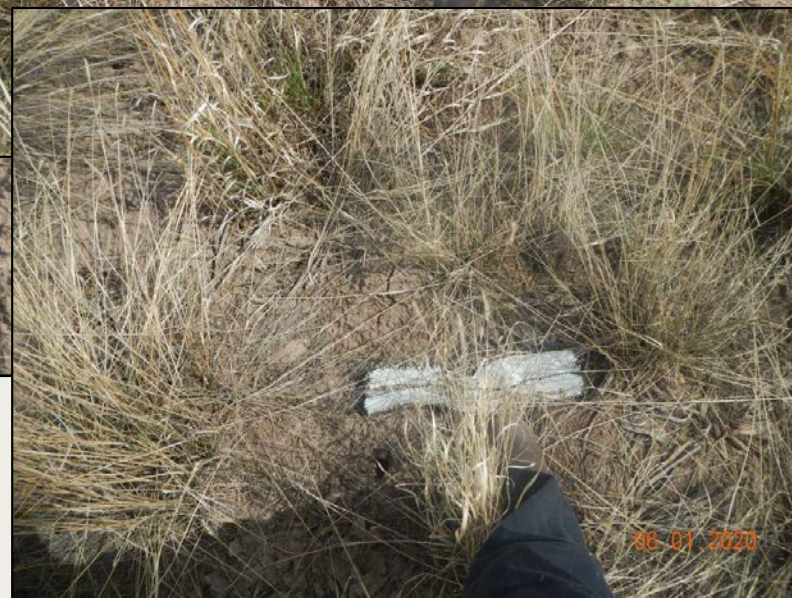
Photos 6/7/8. View of liner debris within the eastern project area.

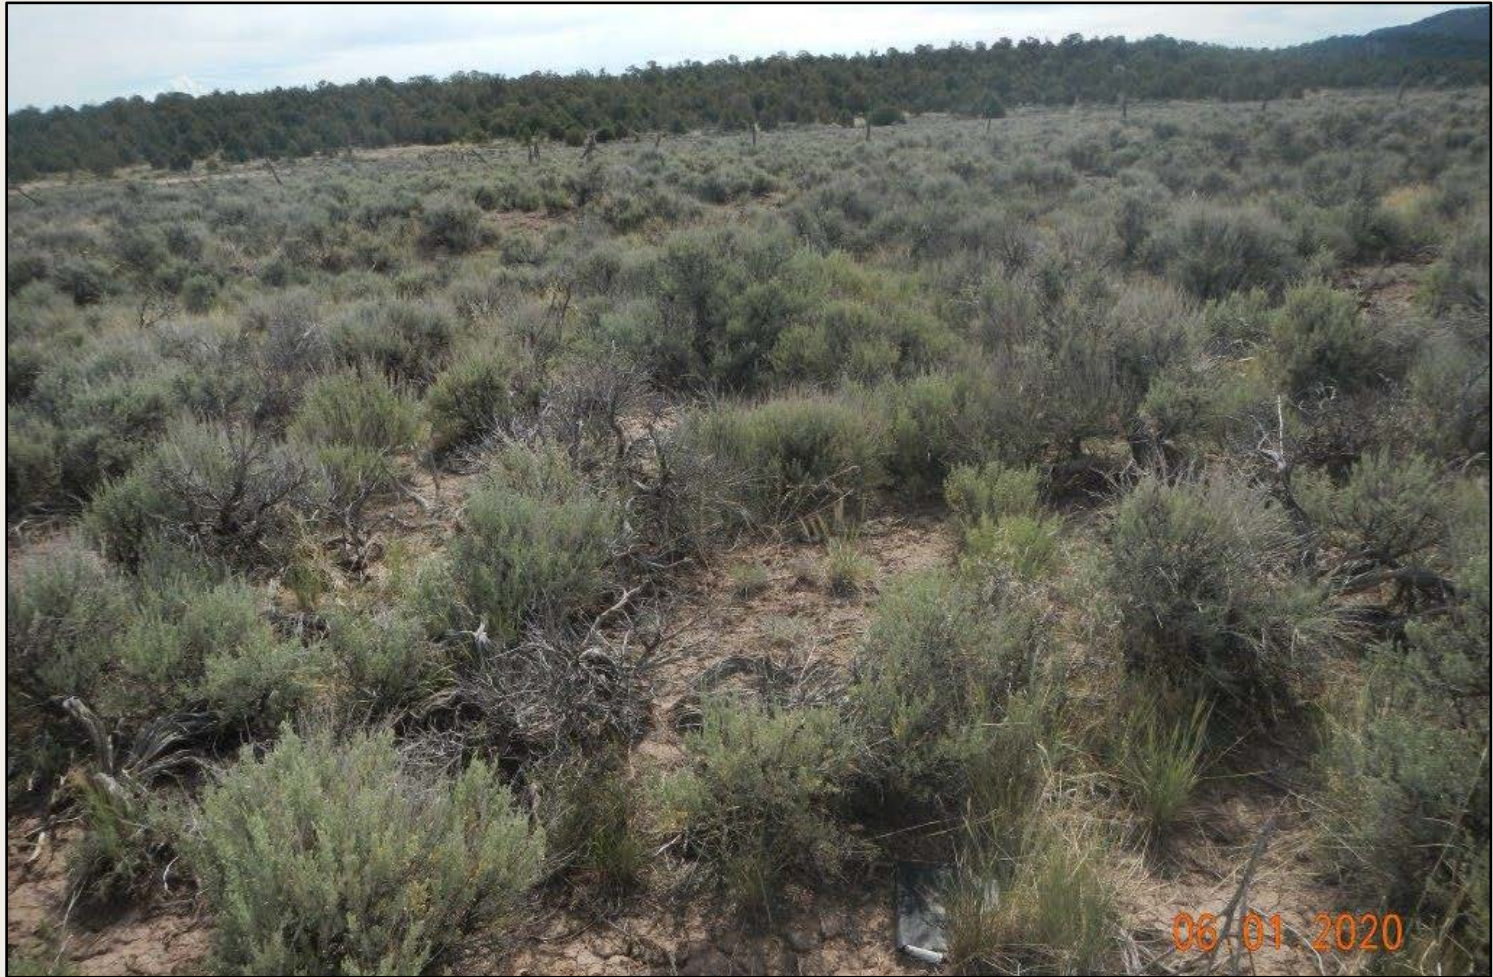
Photo 9. View of reference area comprised of sagebrush shrubland with an understory of squirreltail, blue grama, and Navajo tea.
