# Inspection Photos

API: 071-07517

Operator: EVERGREEN NATURAL RESOURCES

Inspection Date: 5/20/2020

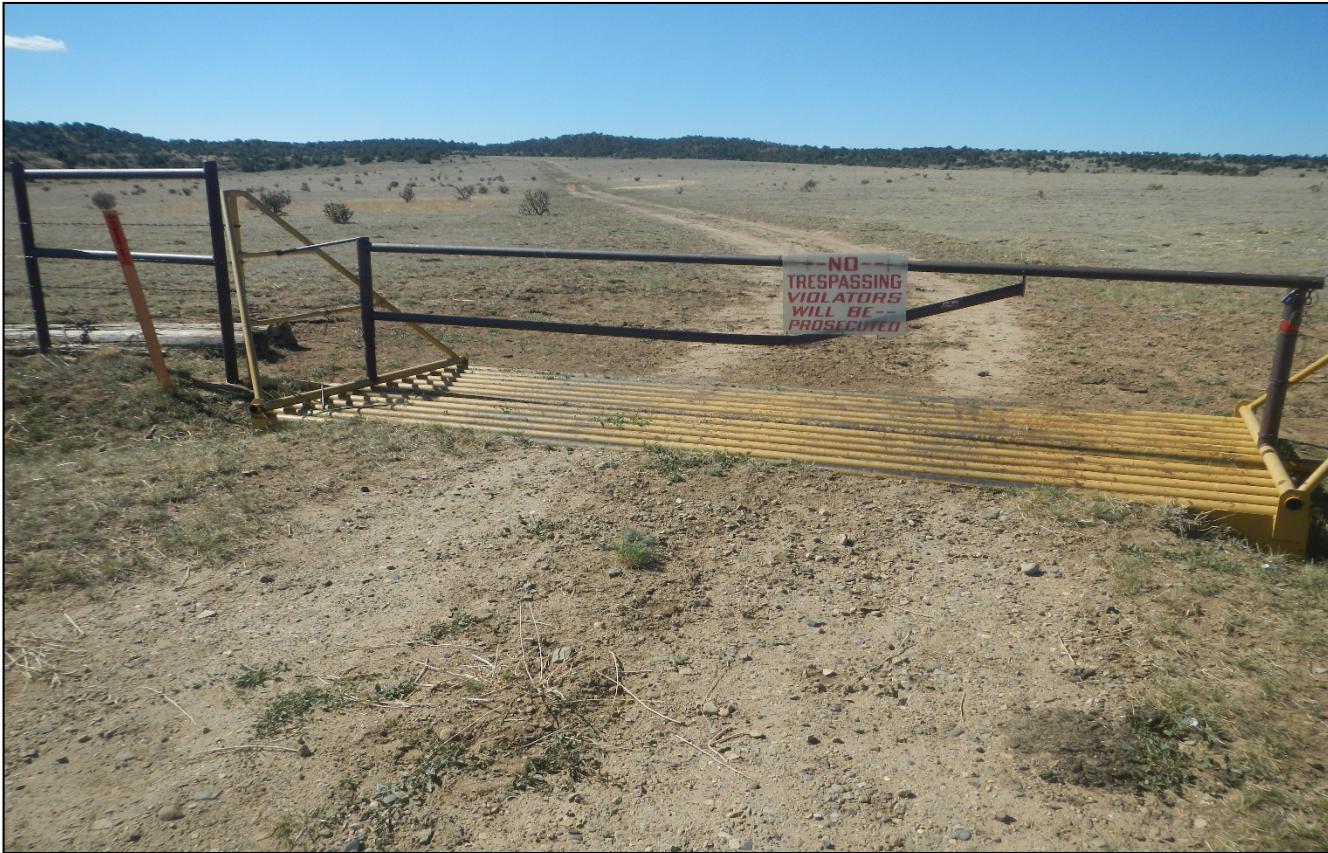
**Photo 1.** Facing southeast at the beginning of the access road. The cattleguard and road remain with approved variance.

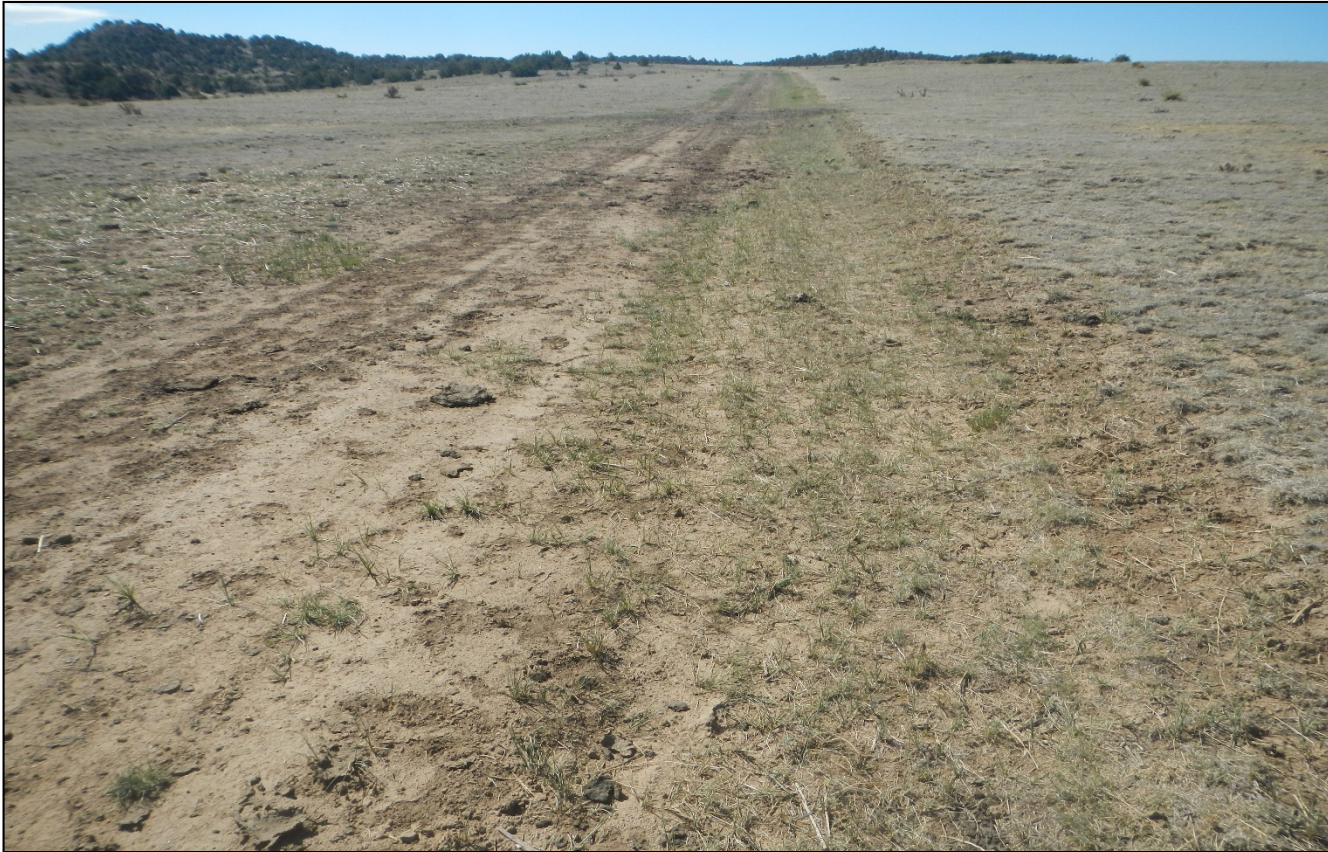
**Photo 2.** Facing southeast along the access road. Desirable vegetation is establishing along the road side and the road appears to be stabilized.

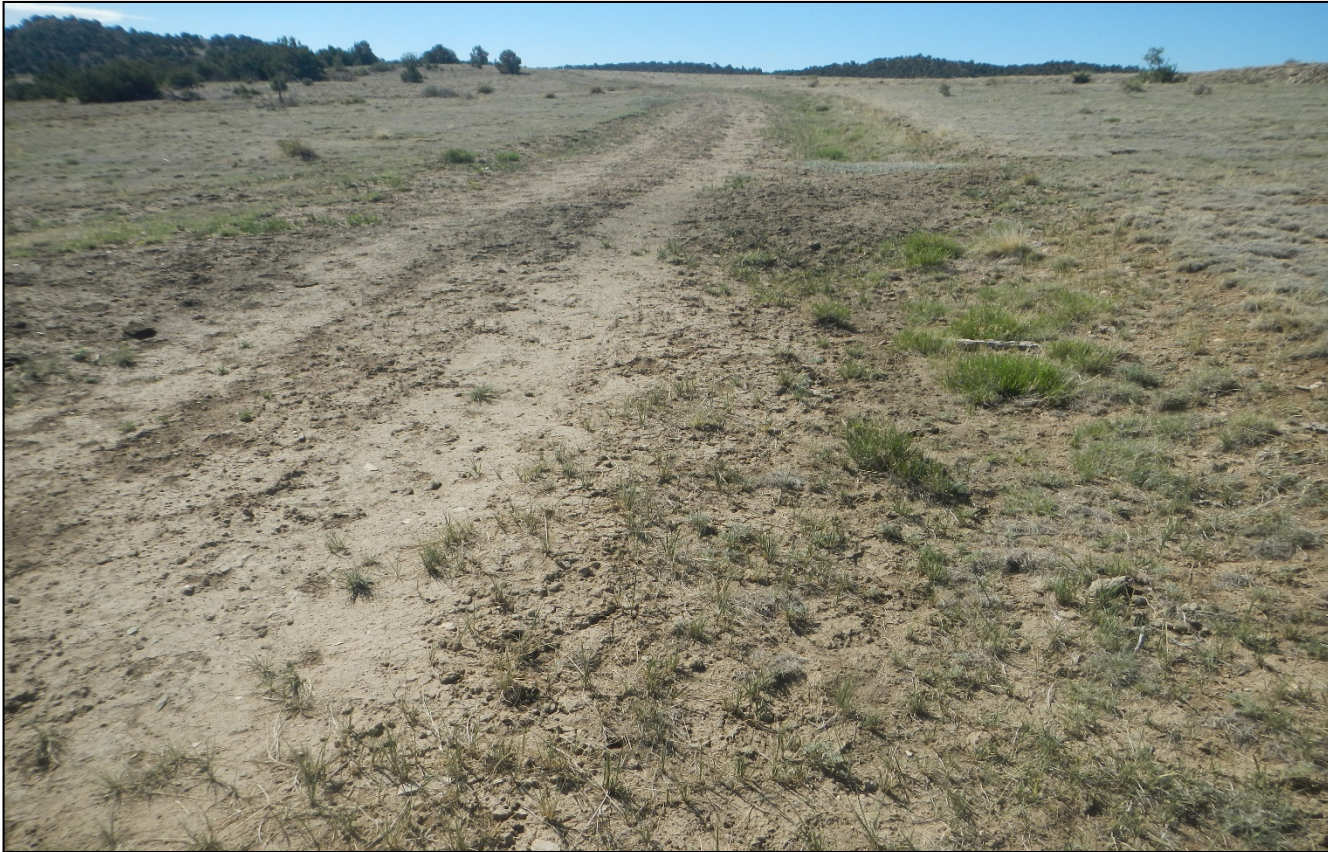
**Photo 3.** Facing southeast along the access road. There are water bars installed along the road to divert stormwater off the road.

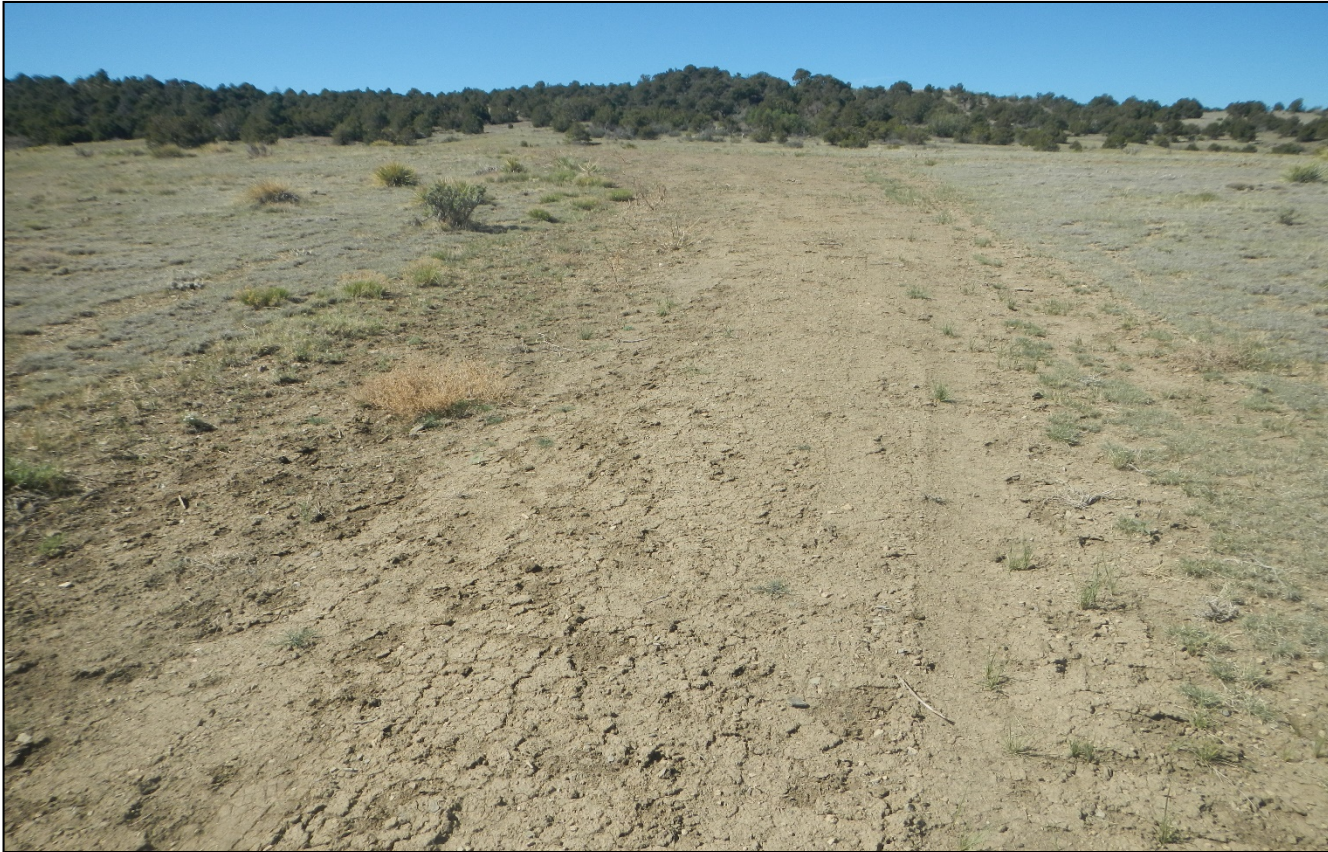
**Photo 5.** Facing south along the access road. Areas of erosion along the road previously observed have been repaired and appear to be stabilized.

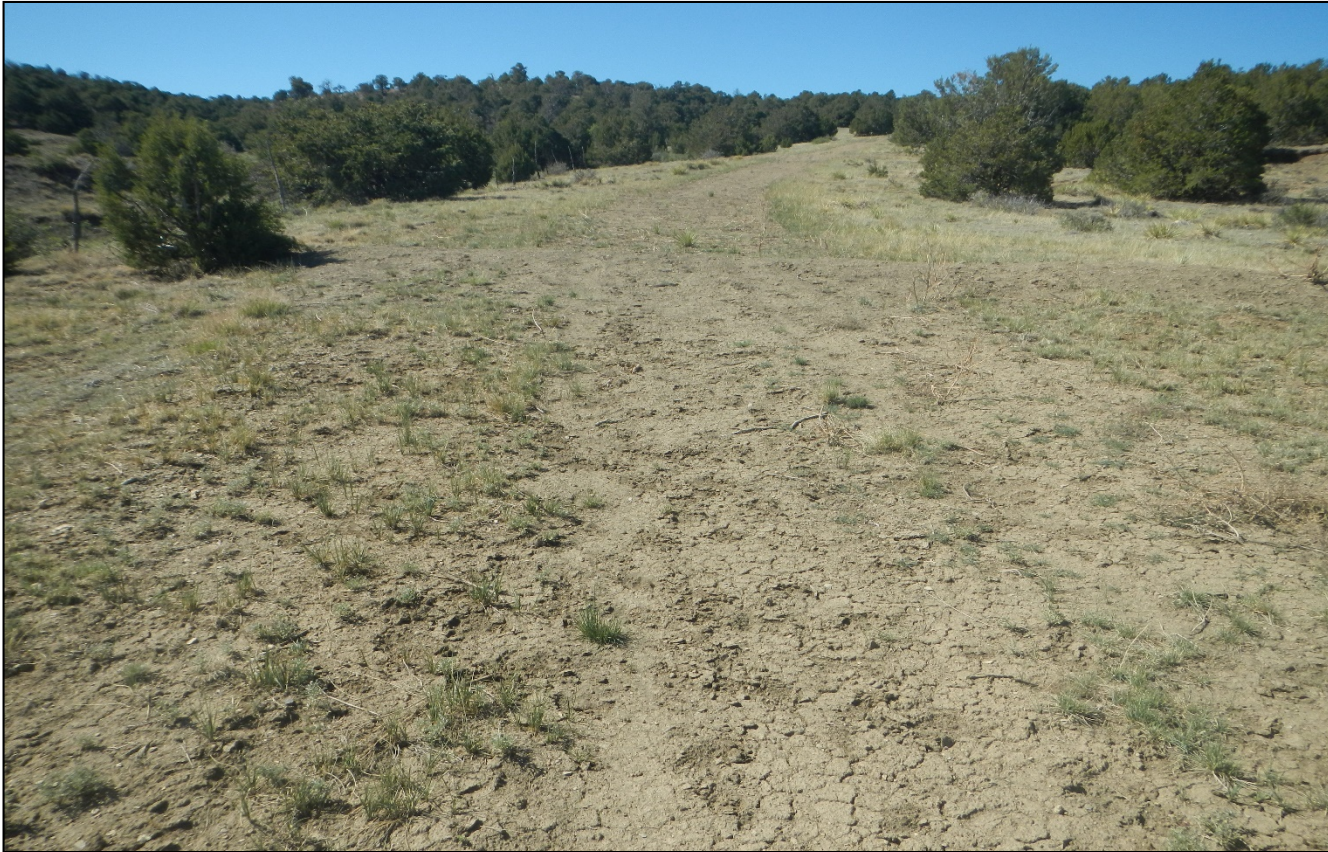
**Photo 6.** Facing south along the access road. This water bar/berm has been installed along the road which extends out toward the right of the photo. The area to the right is shown in the next photo.

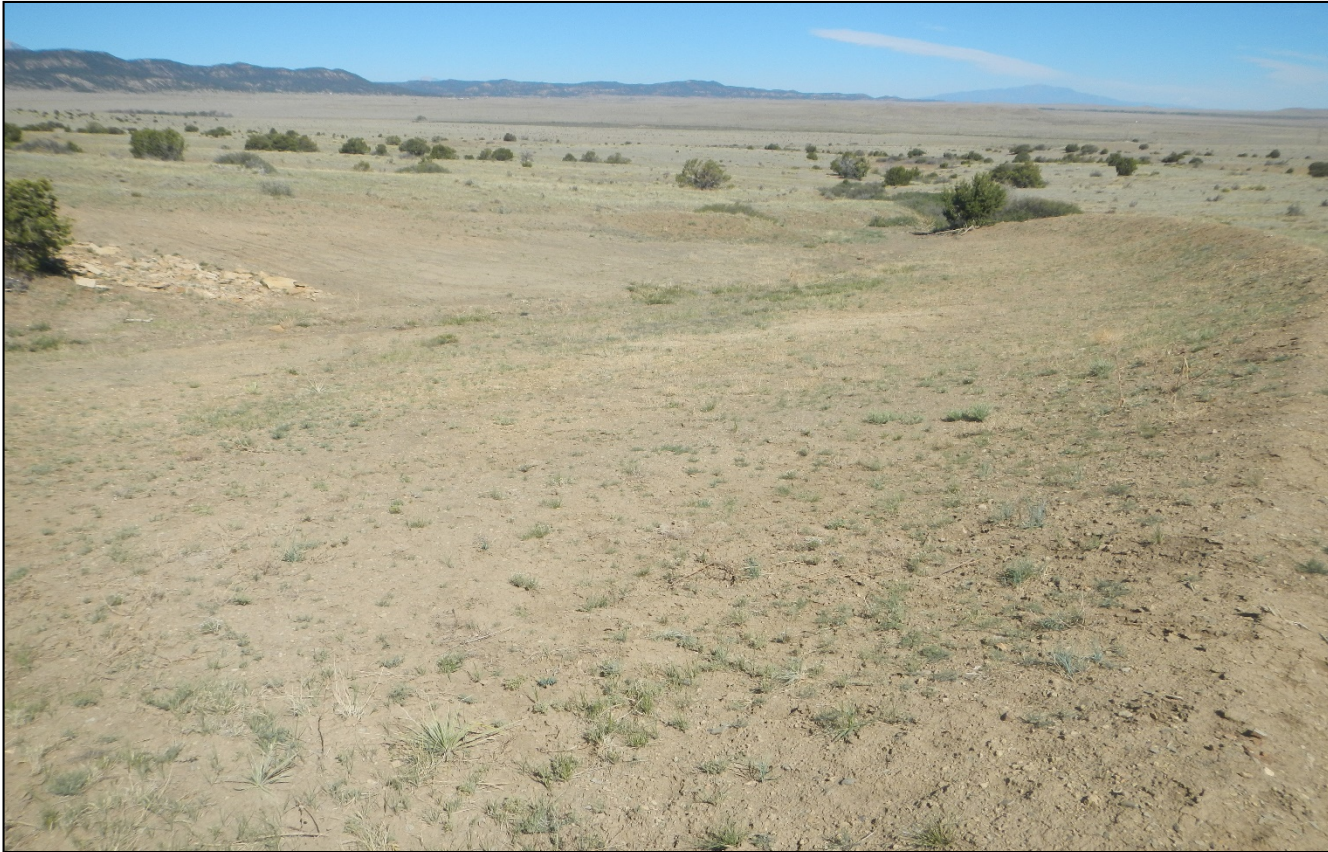
**Photo 7.** Facing northwest toward the reclaimed area and berm which extends out from the road. This area has not adequately re-established vegetation and needs additional seeding.

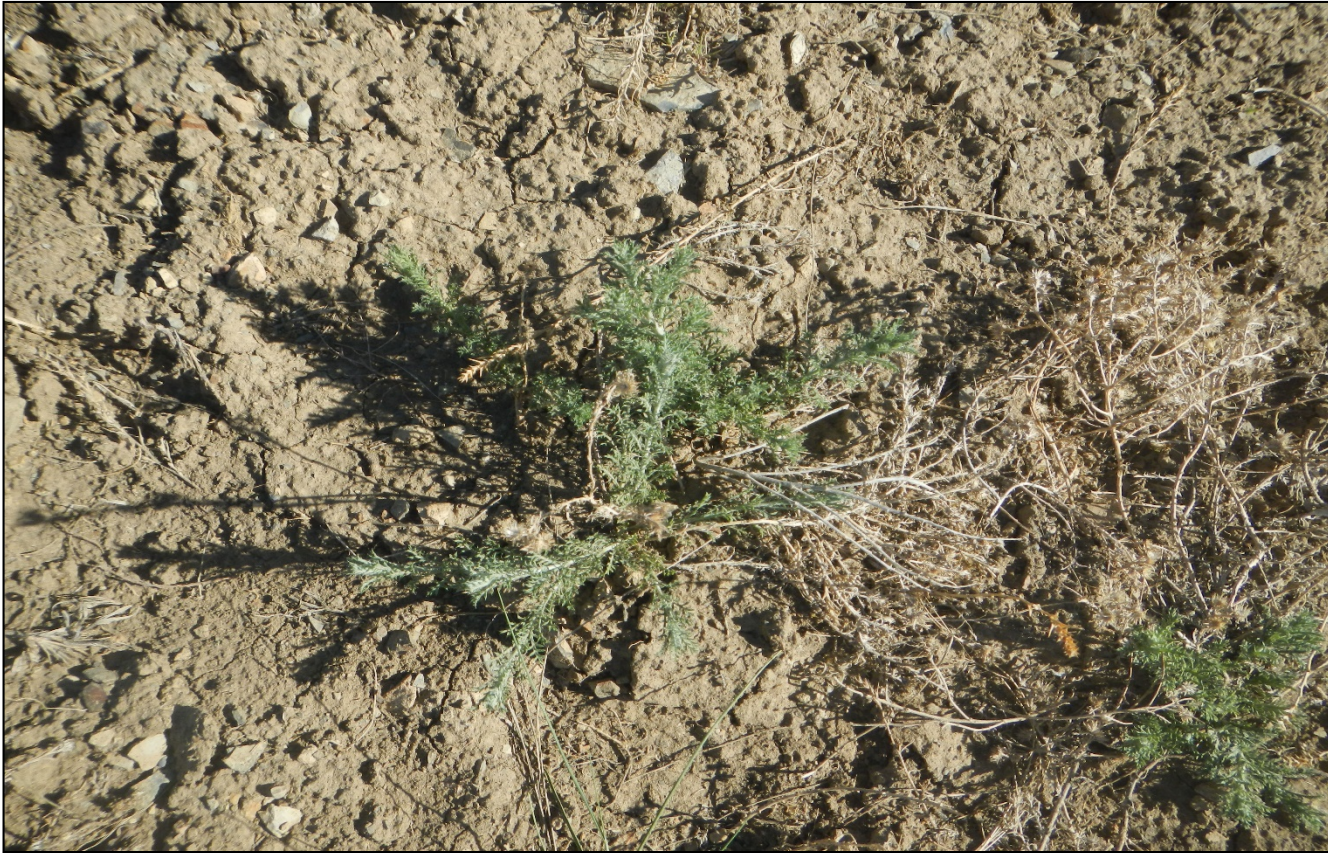
**Photo 8.** This plant was found in the area of the previous photo and appears to be Diffuse knapweed. Only a few plants were observed which should be controlled before spreading.

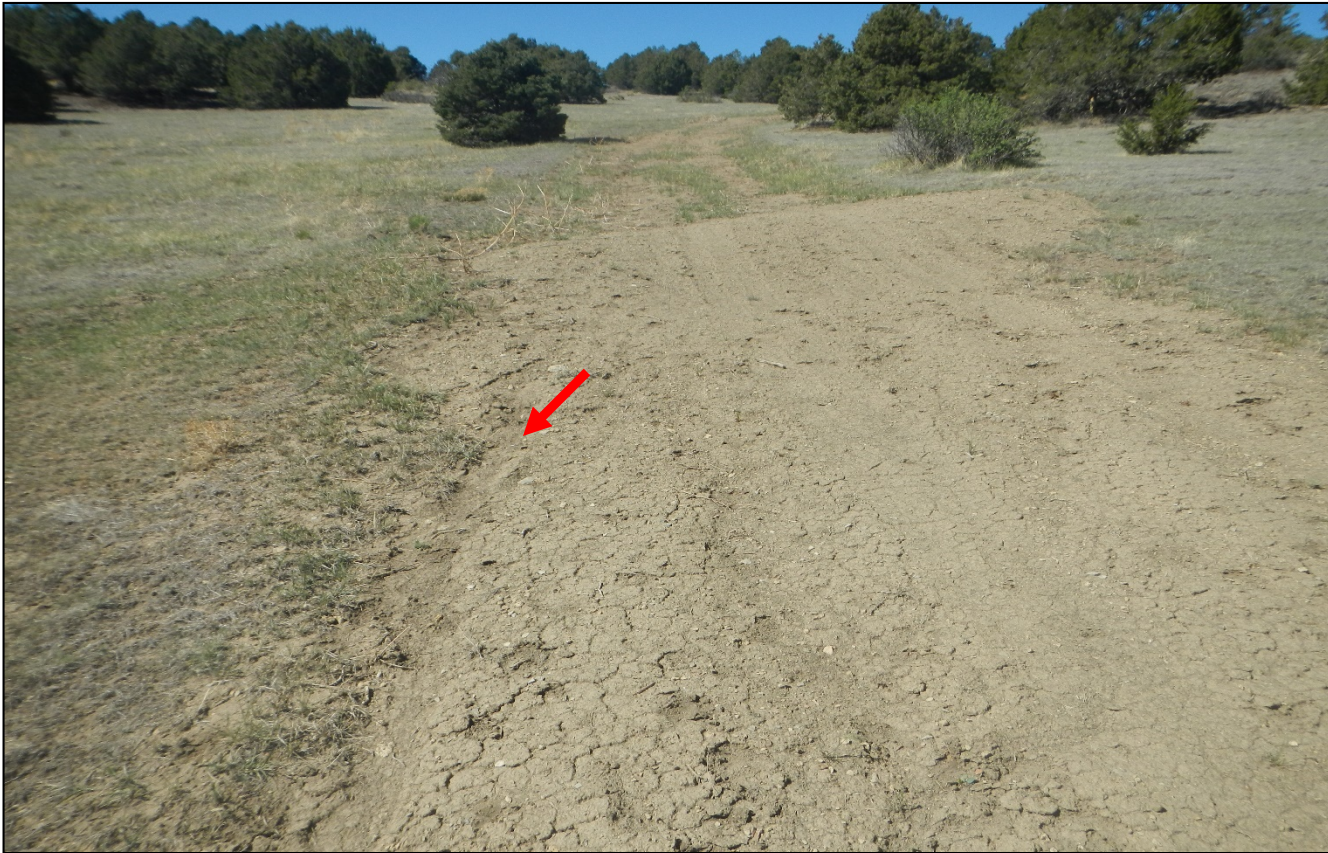
**Photo 9.** Facing southwest along the access road ascending toward the location. Water bars are installed along the road. This one can use minor maintenance as signs of stormwater are shown at red arrow.

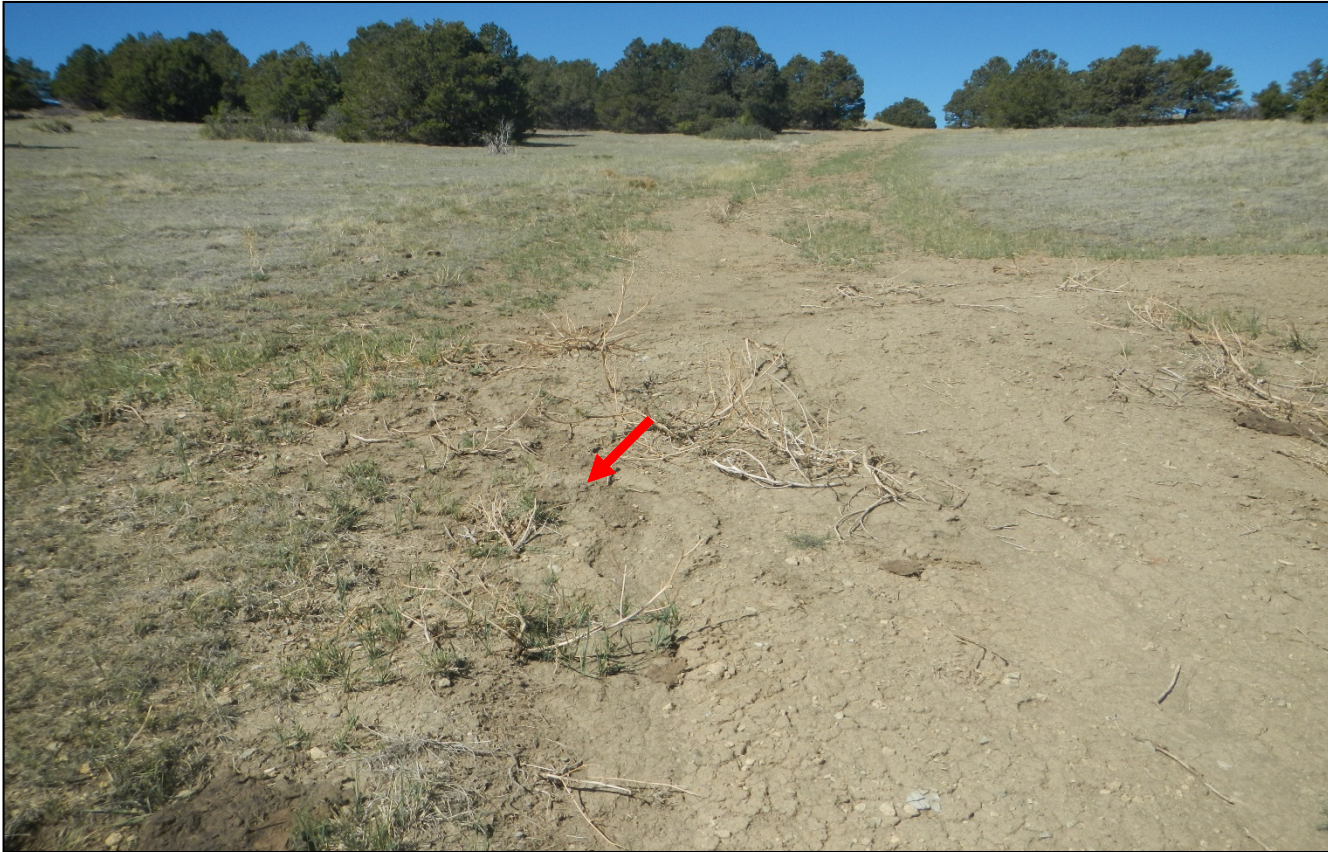
**Photo 10.** Facing southwest along the access road ascending toward the location. Water bars are installed along the road. This one can use minor maintenance as signs of stormwater are shown at red arrow.

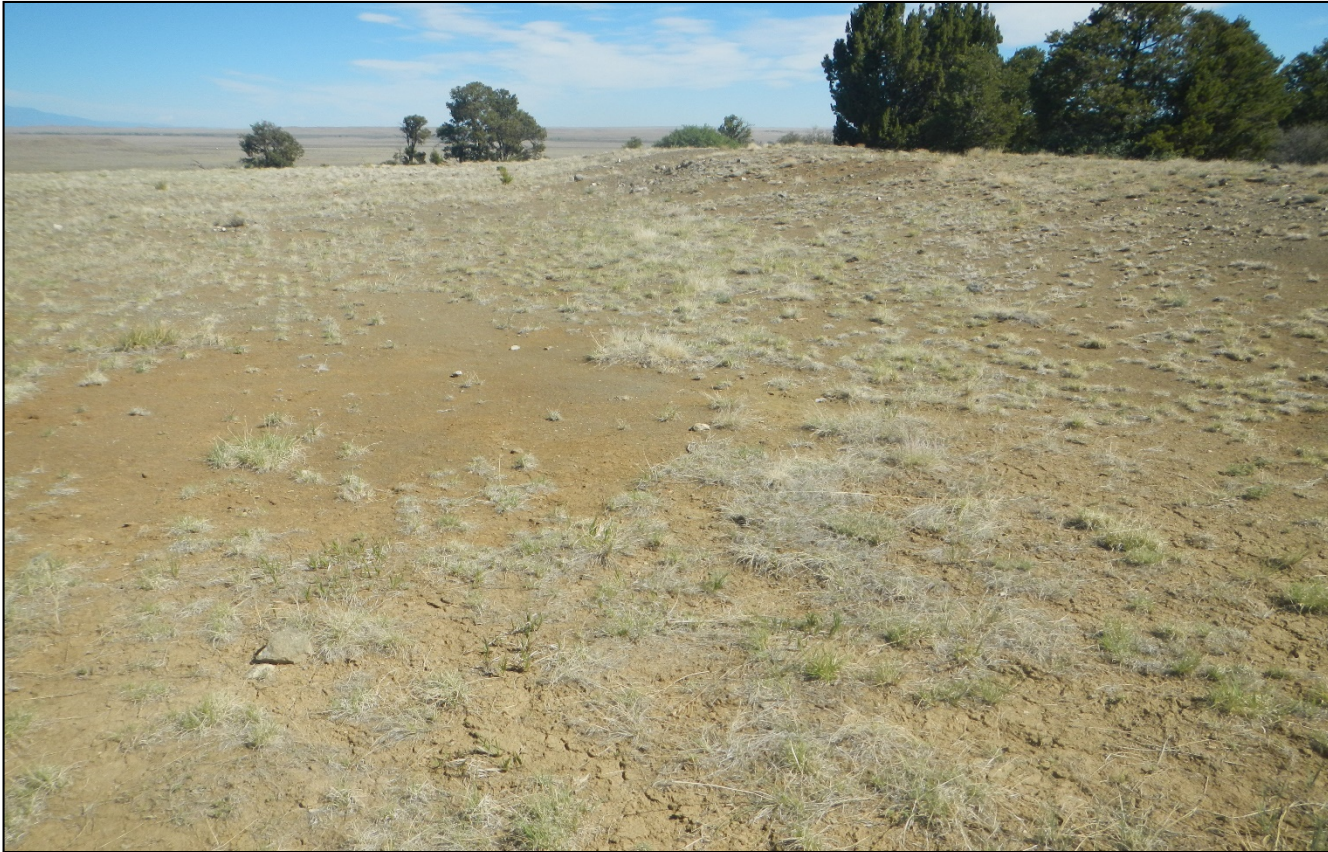
**Photo 11.** Facing north toward the location. This area has some bare areas which could use touch up hand seeding.

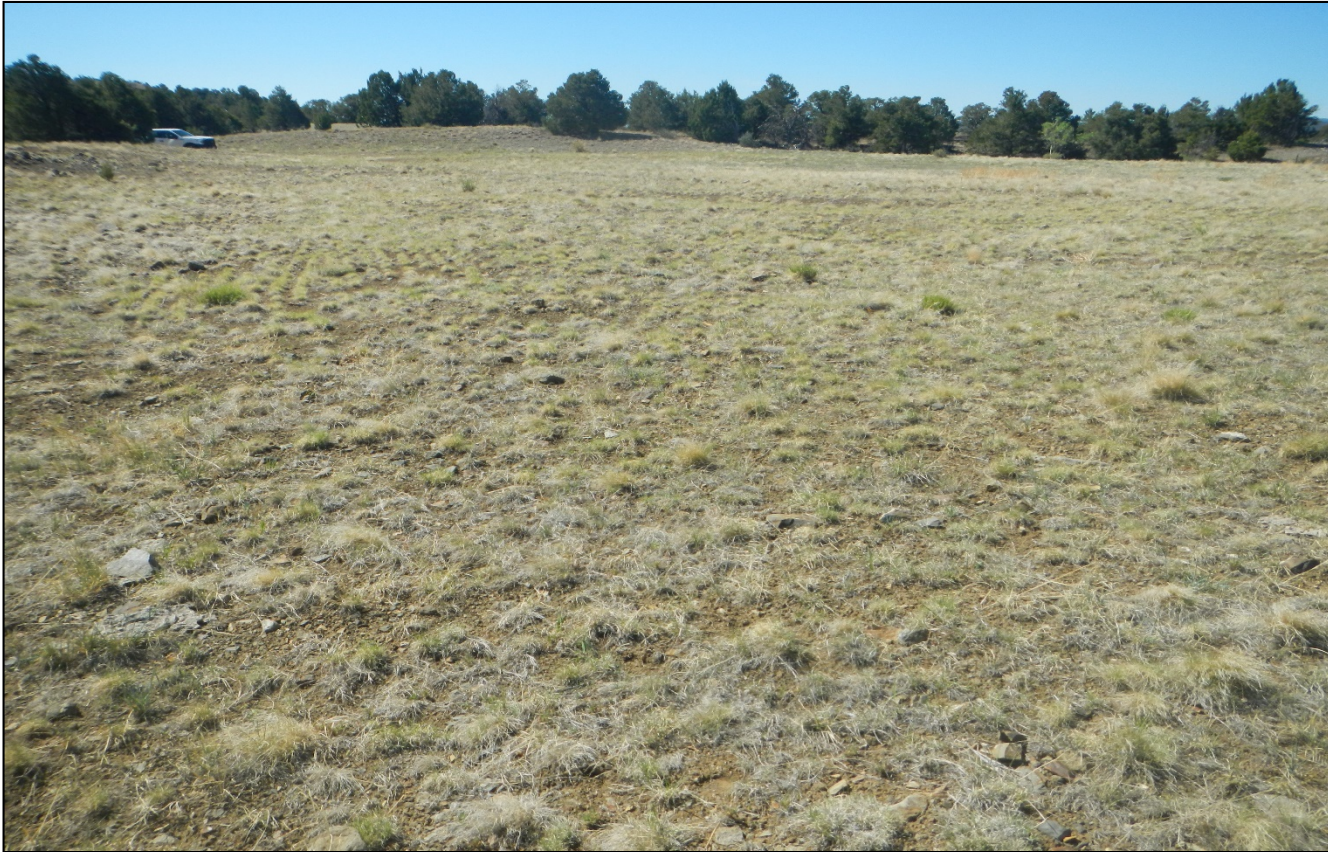
**Photo 12.** Facing south toward the location. The vegetation is establishing well throughout the location.

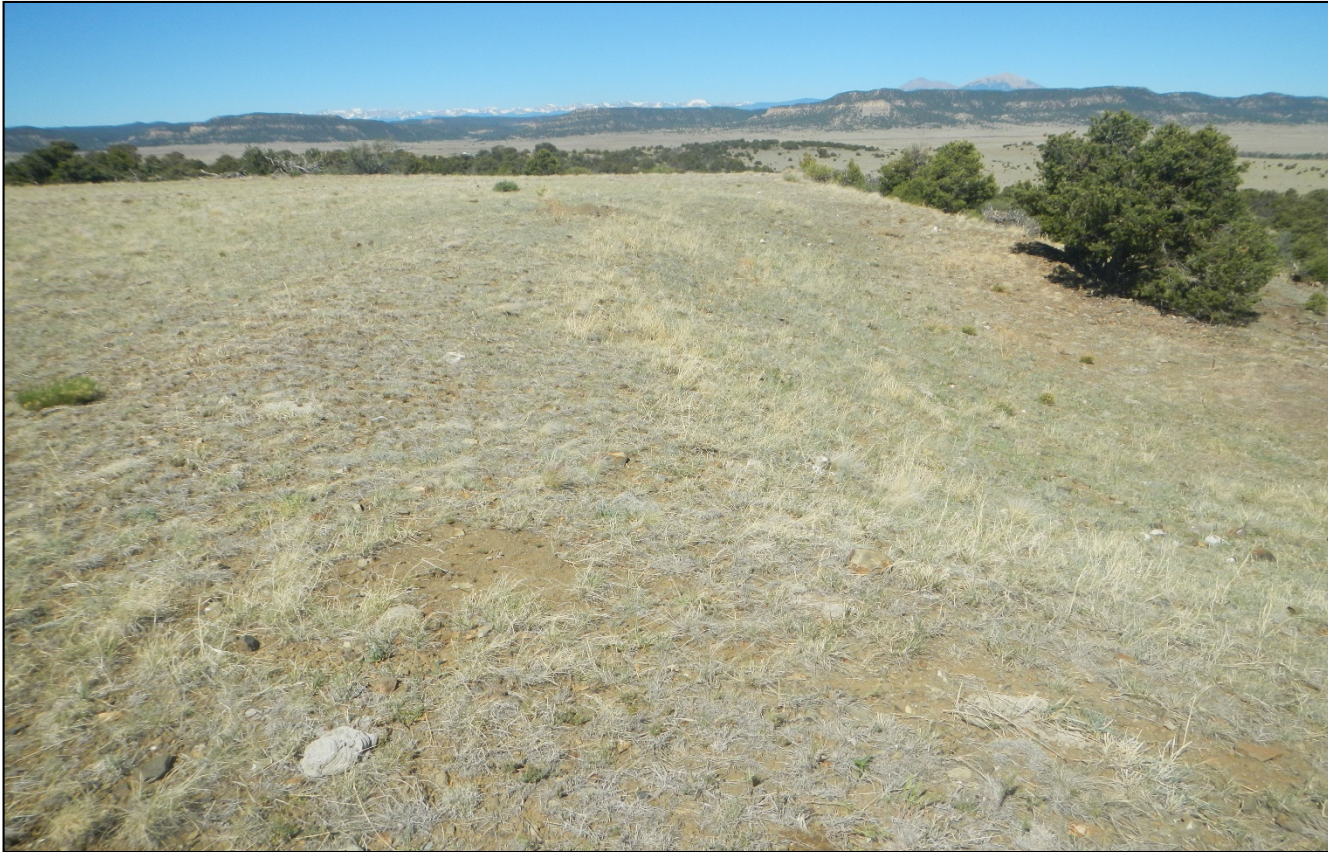
**Photo 13.** Facing west toward the fill slope. This area is stabilized with vegetation.

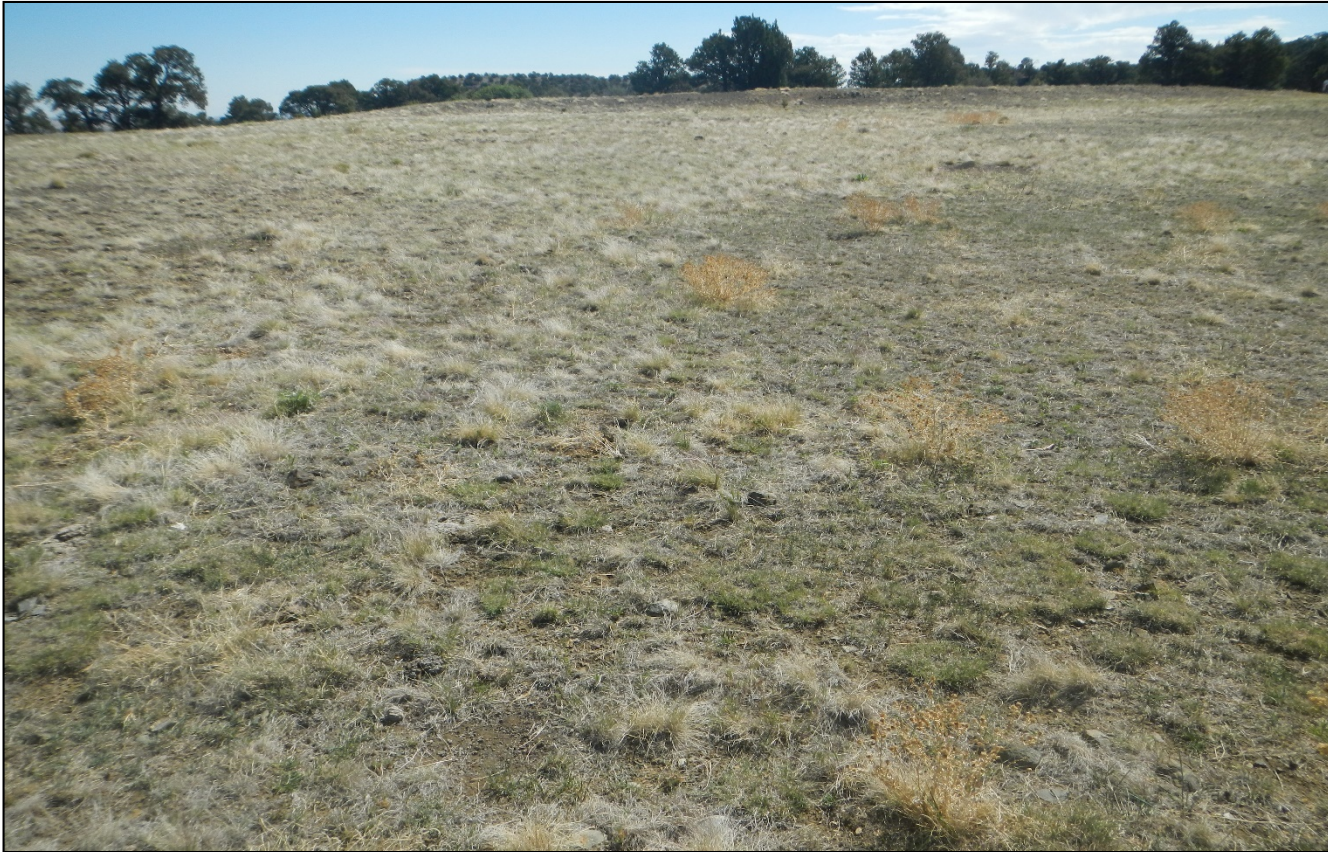
**Photo 14.** Facing south toward the location. The vegetation is establishing well throughout the location.

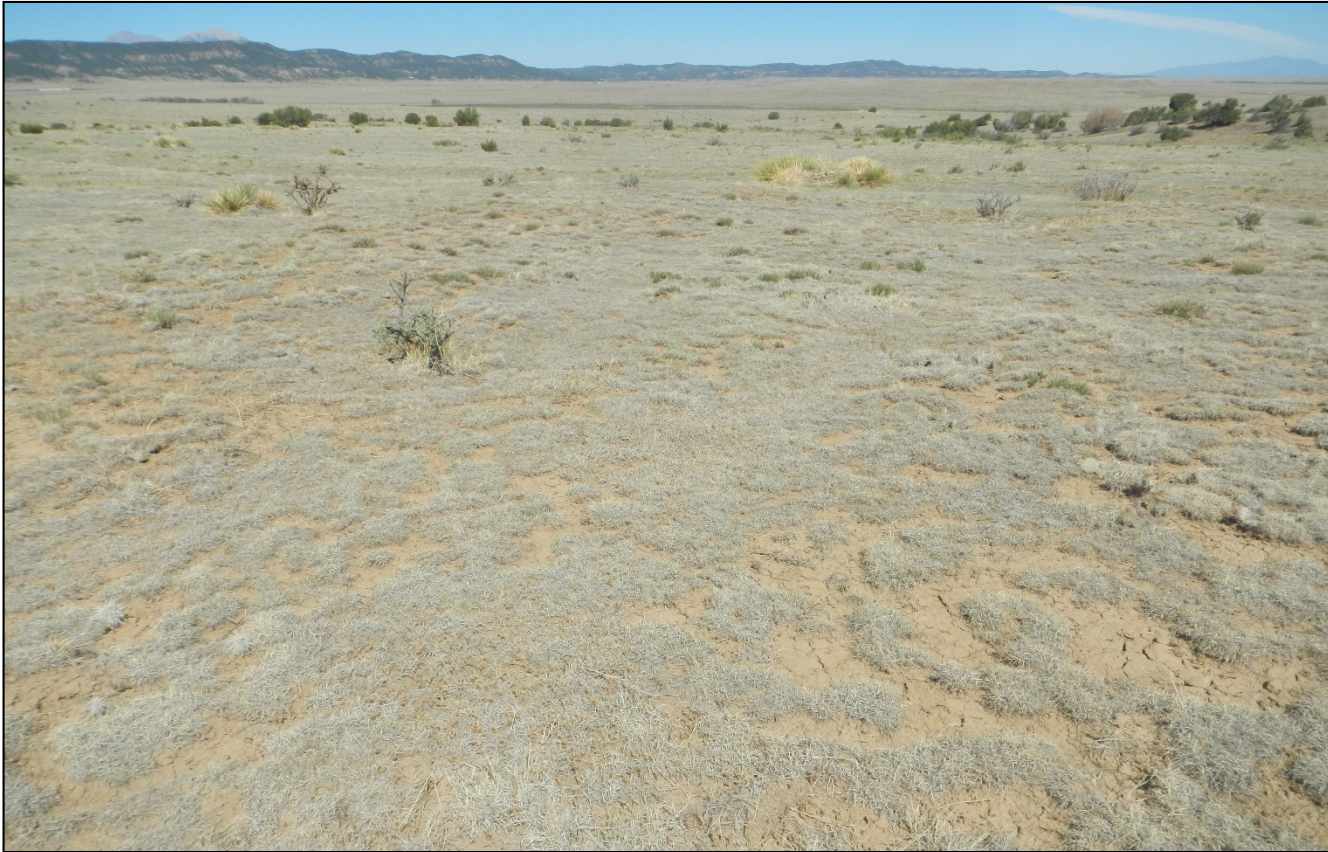
**Photo 15.** Facing south toward the surrounding undisturbed reference vegetation cover.
