Inspection Photos

API: 05-071-06094

Operator: AMOCO PRODUCTION COMPANY

Inspection Date: 5/29/2020

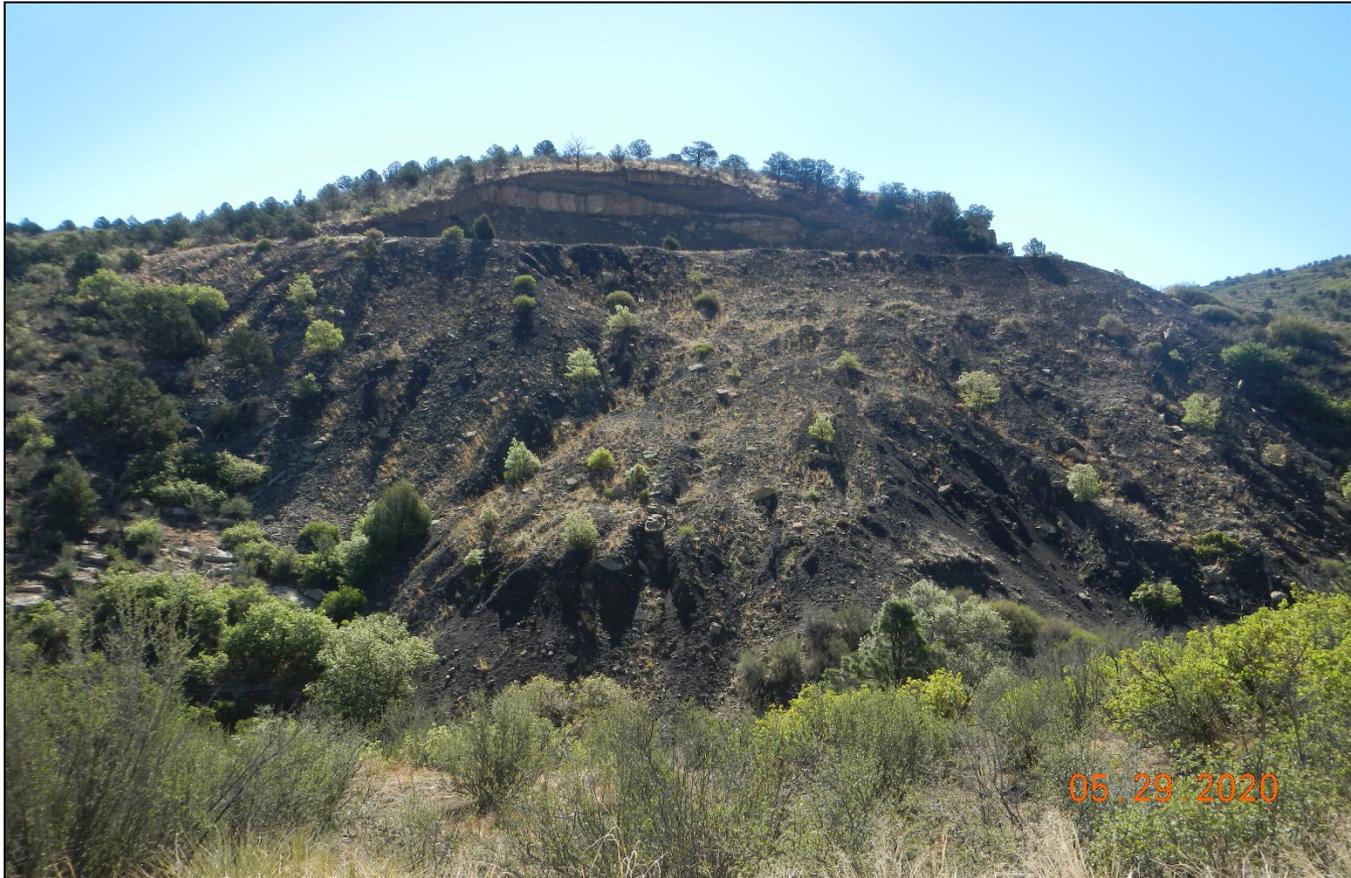
Photo 1. Facing east toward the location from across the canyon. Reclamation has not been performed. This photo was taken on 05/29/2020. The following photos were taken during previous inspections.

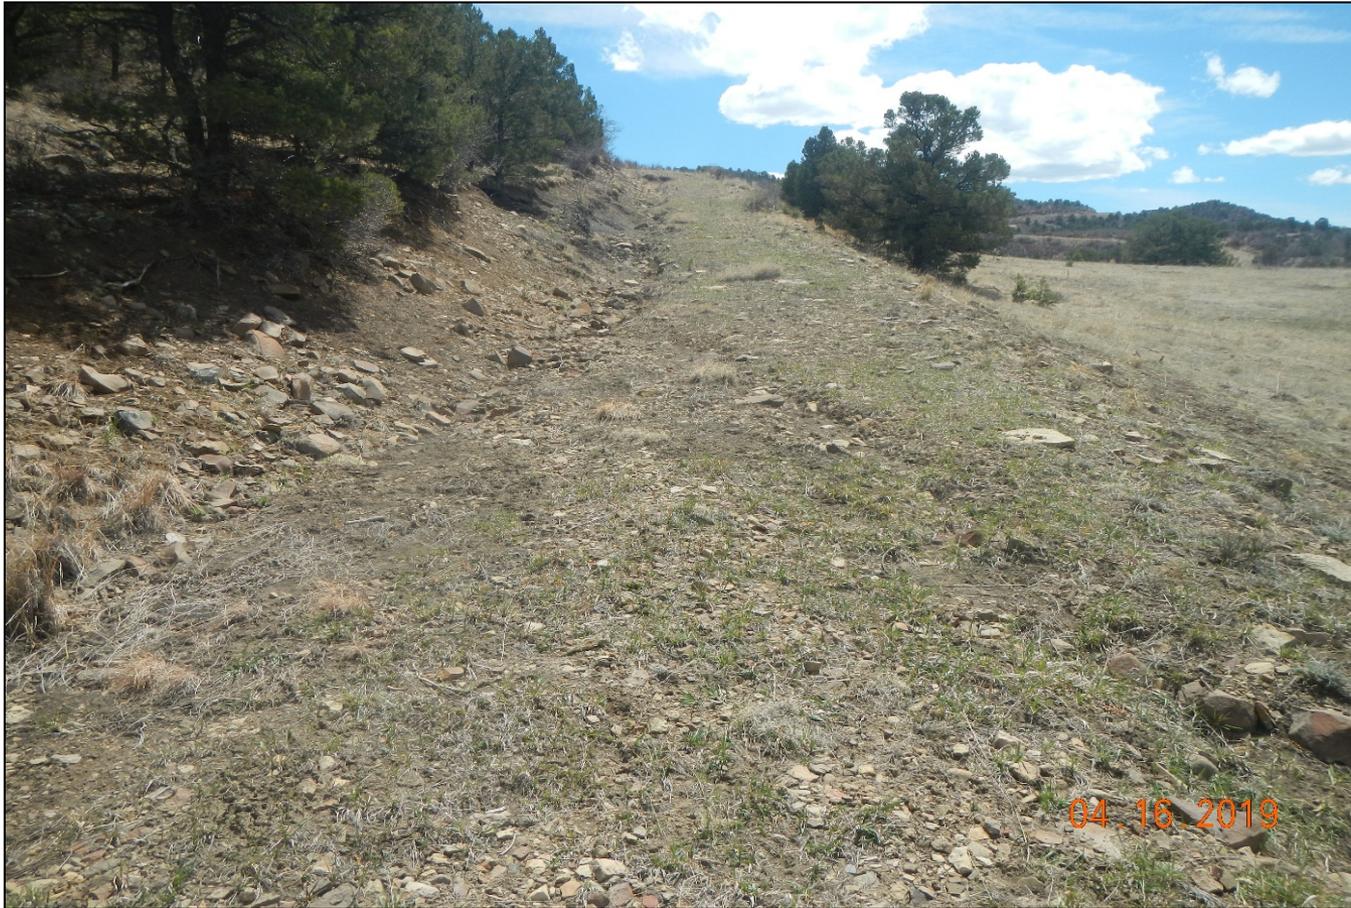
Photo 2. Facing south at the beginning of the access road.

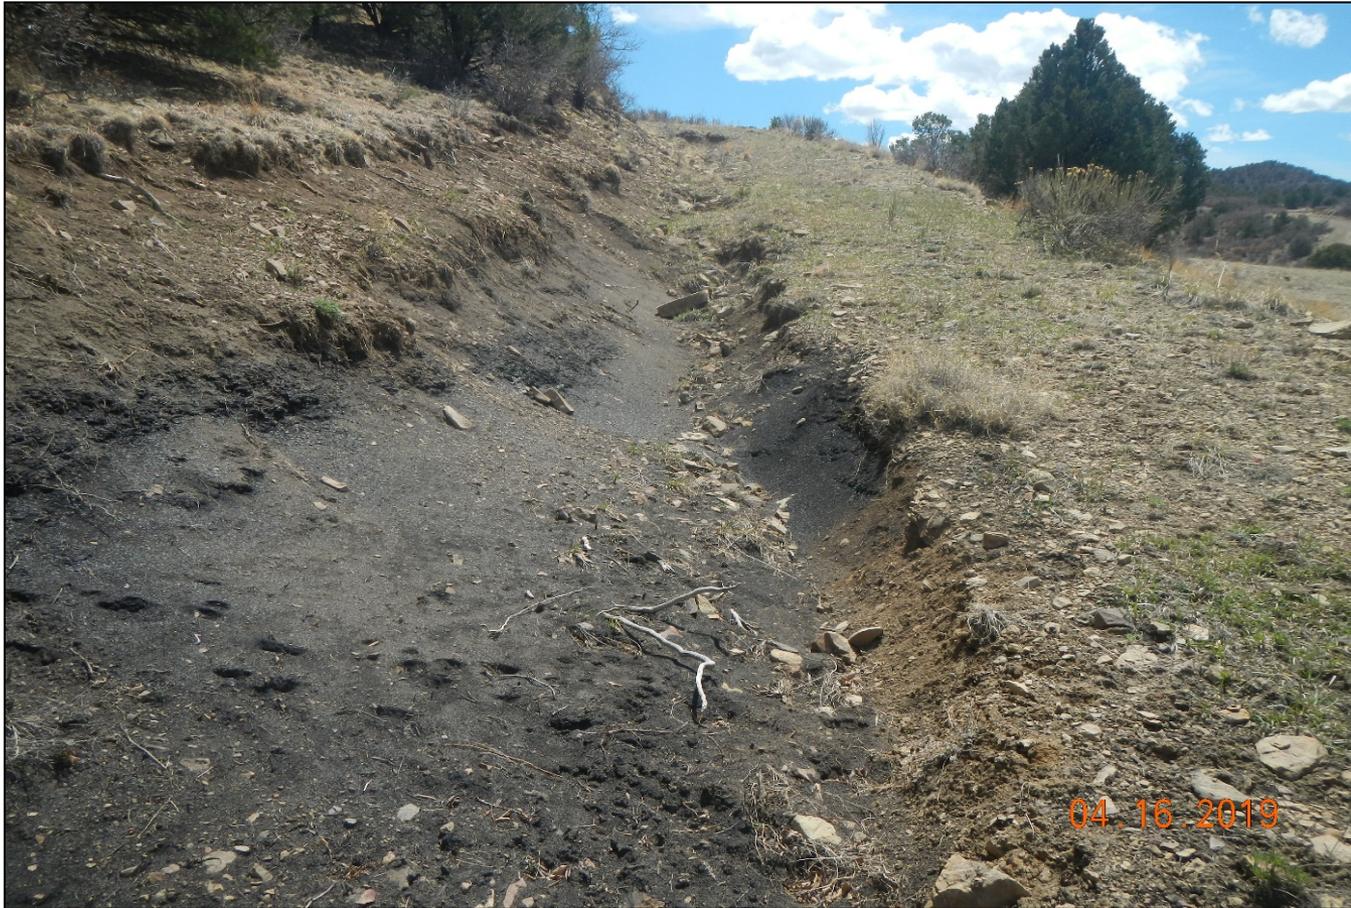
Photo 3. Photo shows erosion along the access road. Access road has not been recontoured and reclaimed.

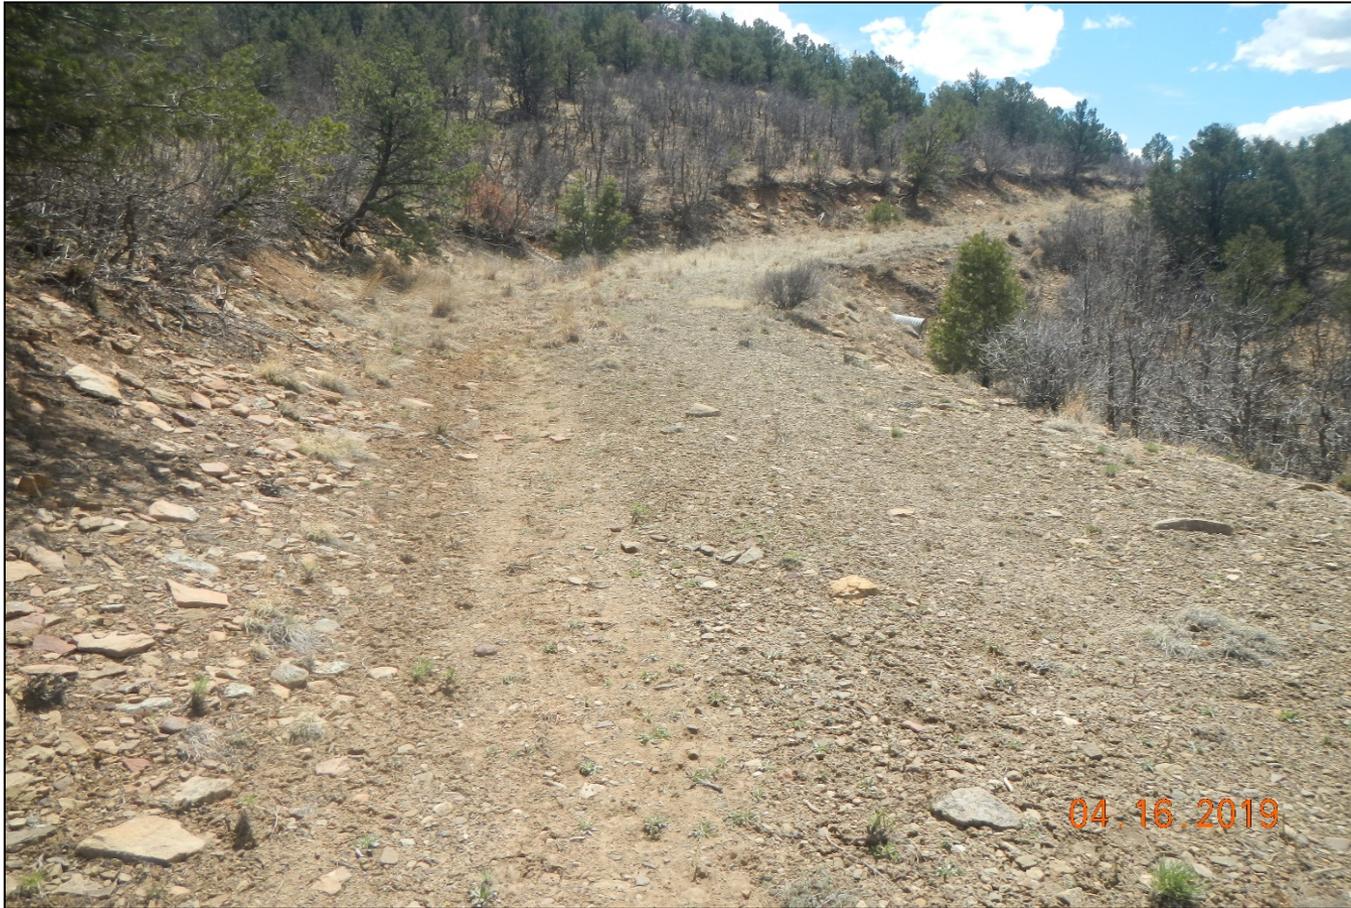
Photo 4. Further along the road. Access road has not been recontoured and reclaimed.

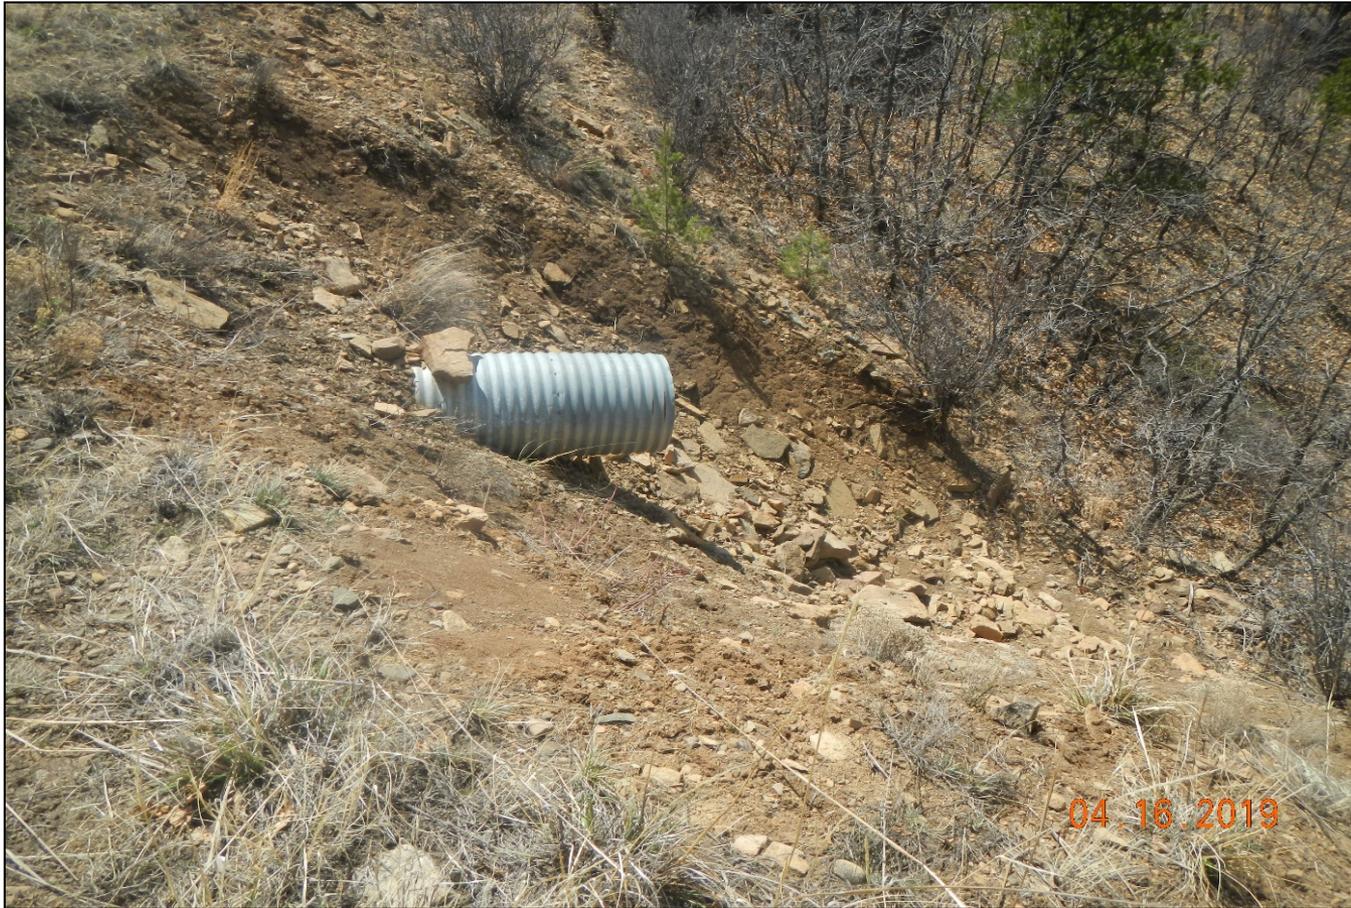
Photo 5. Culvert remains along the road. Erosion is occurring around the outlet.

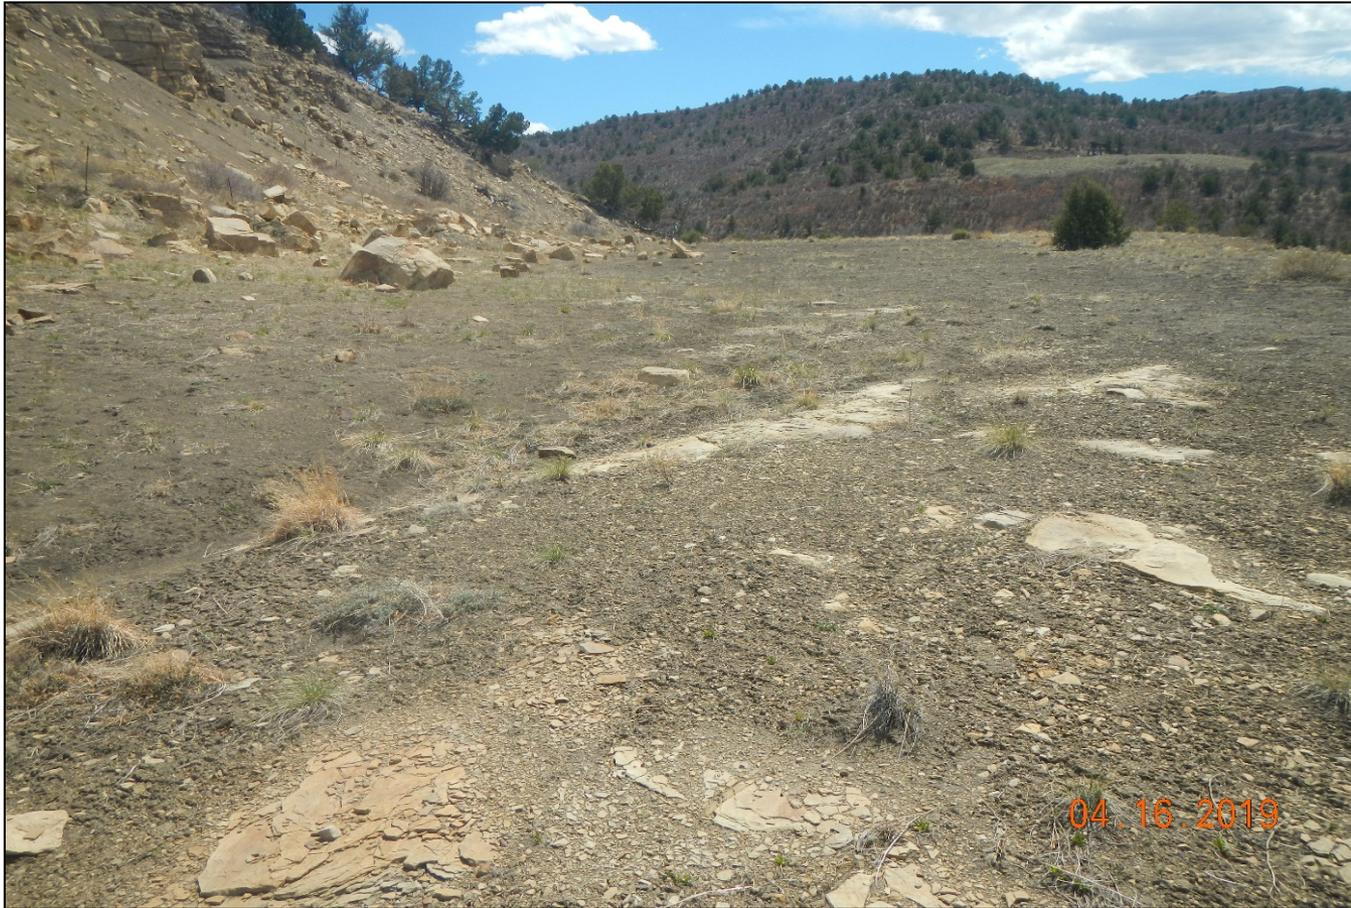
Photo 6. Facing southeast toward the location. The pad has not been recontoured.

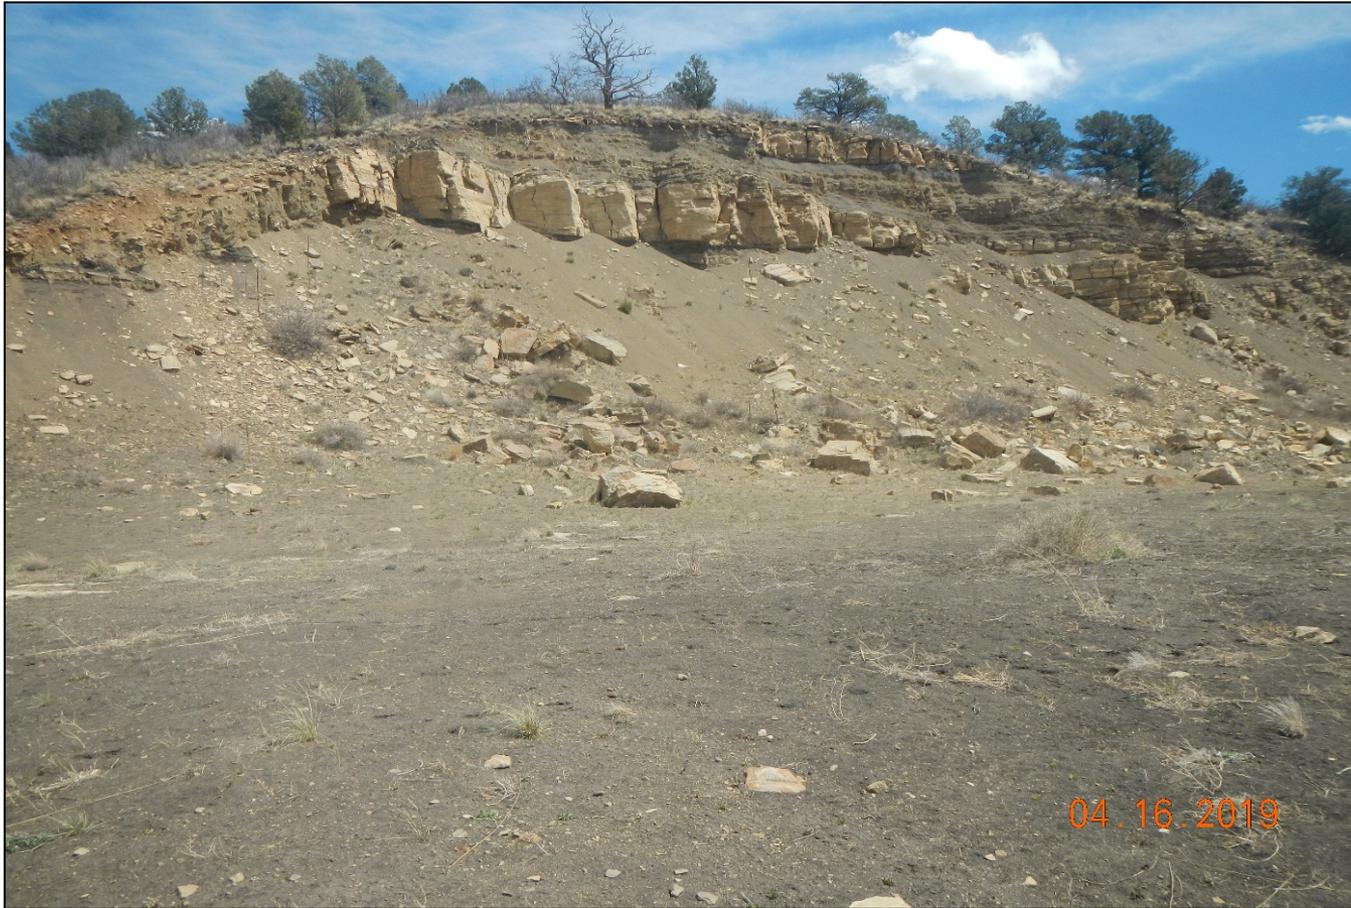
Photo 7. Facing towards the unstable vertical cut slope. Estimated to be 75' high.

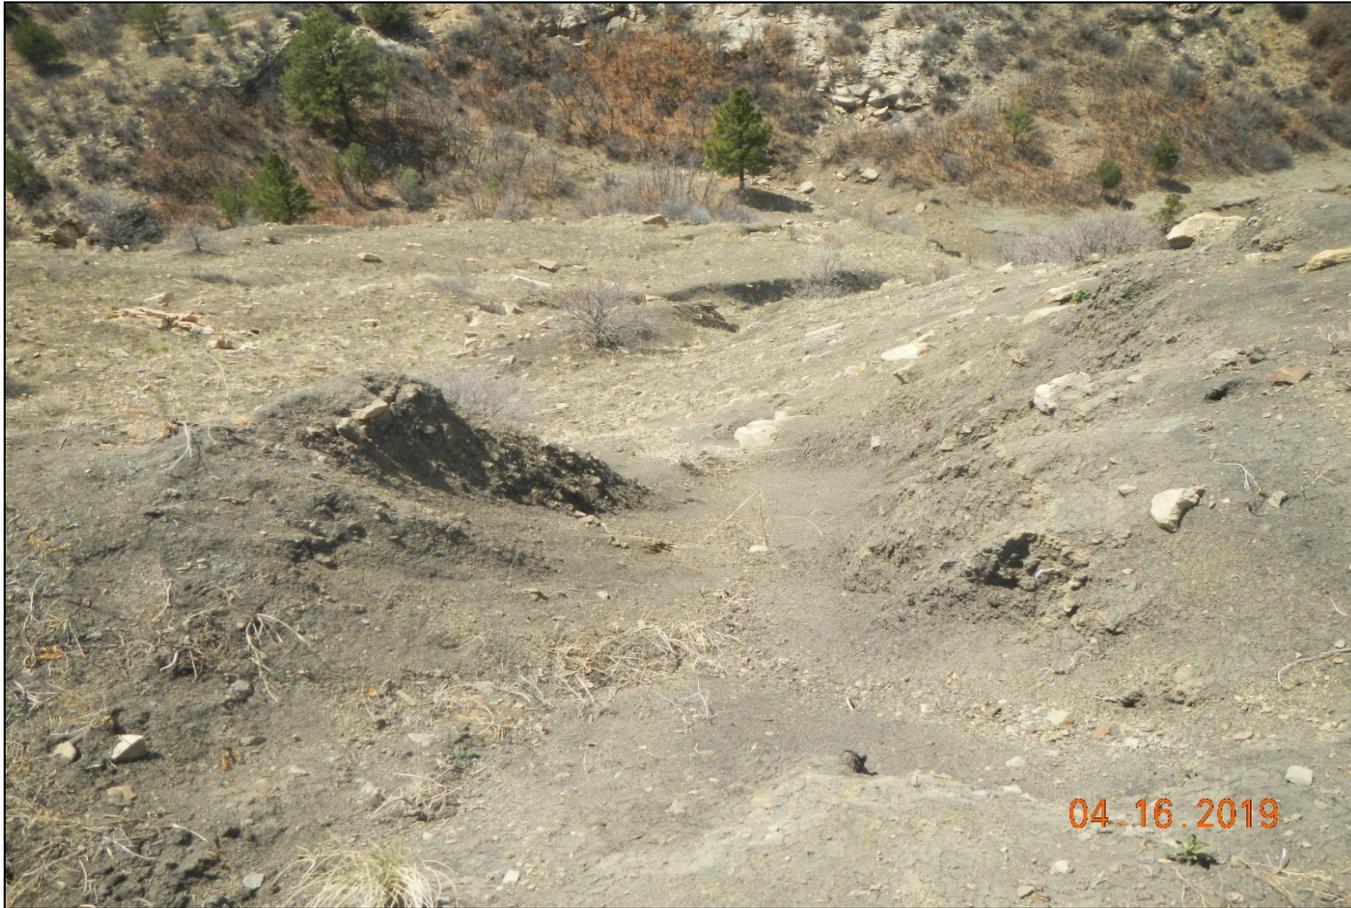
Photo 8. Facing down the fill slope shows signs of erosion.

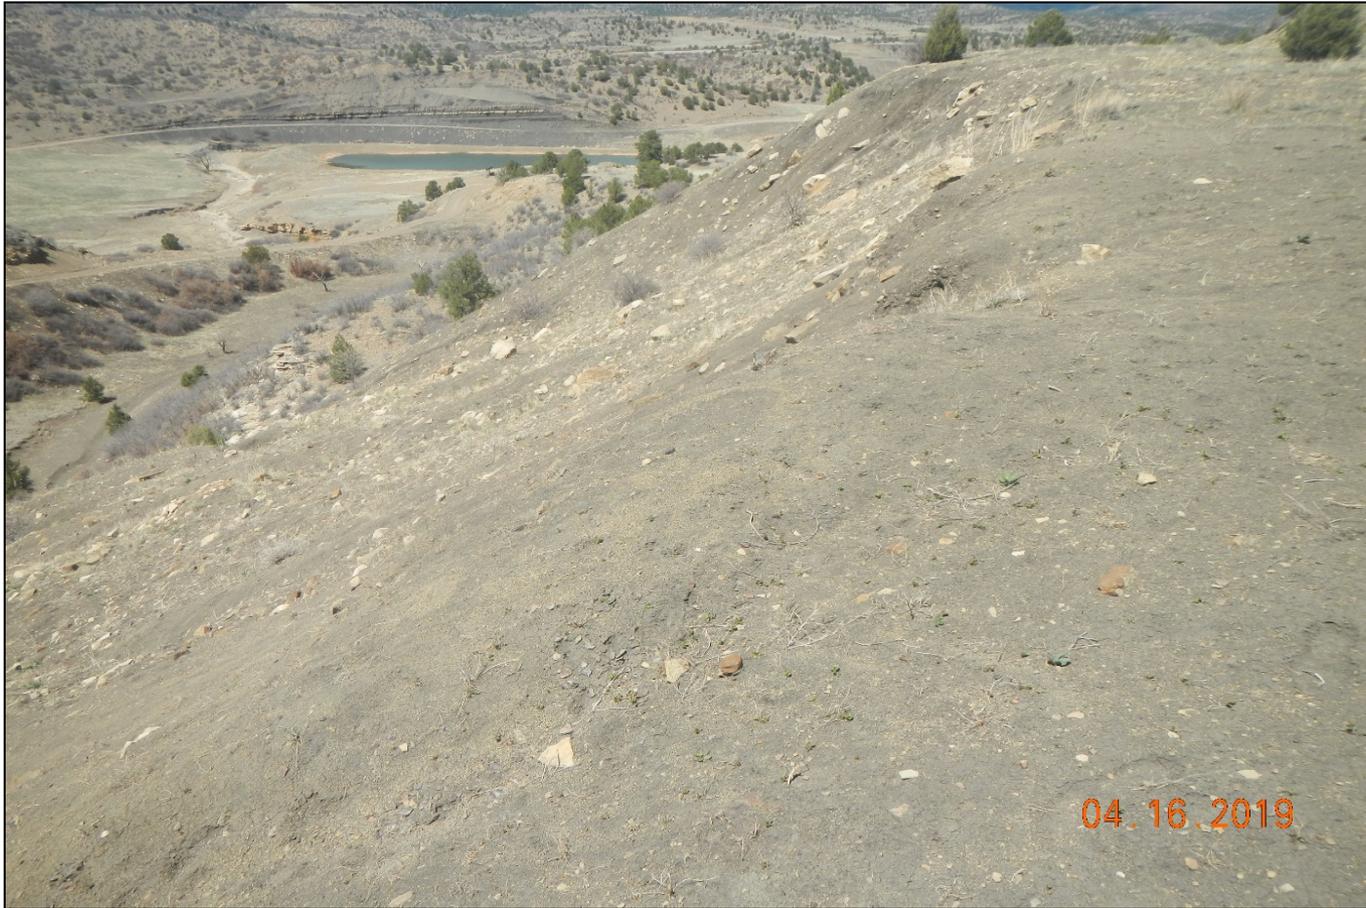
Photo 9. Facing toward the fill slope of the location.

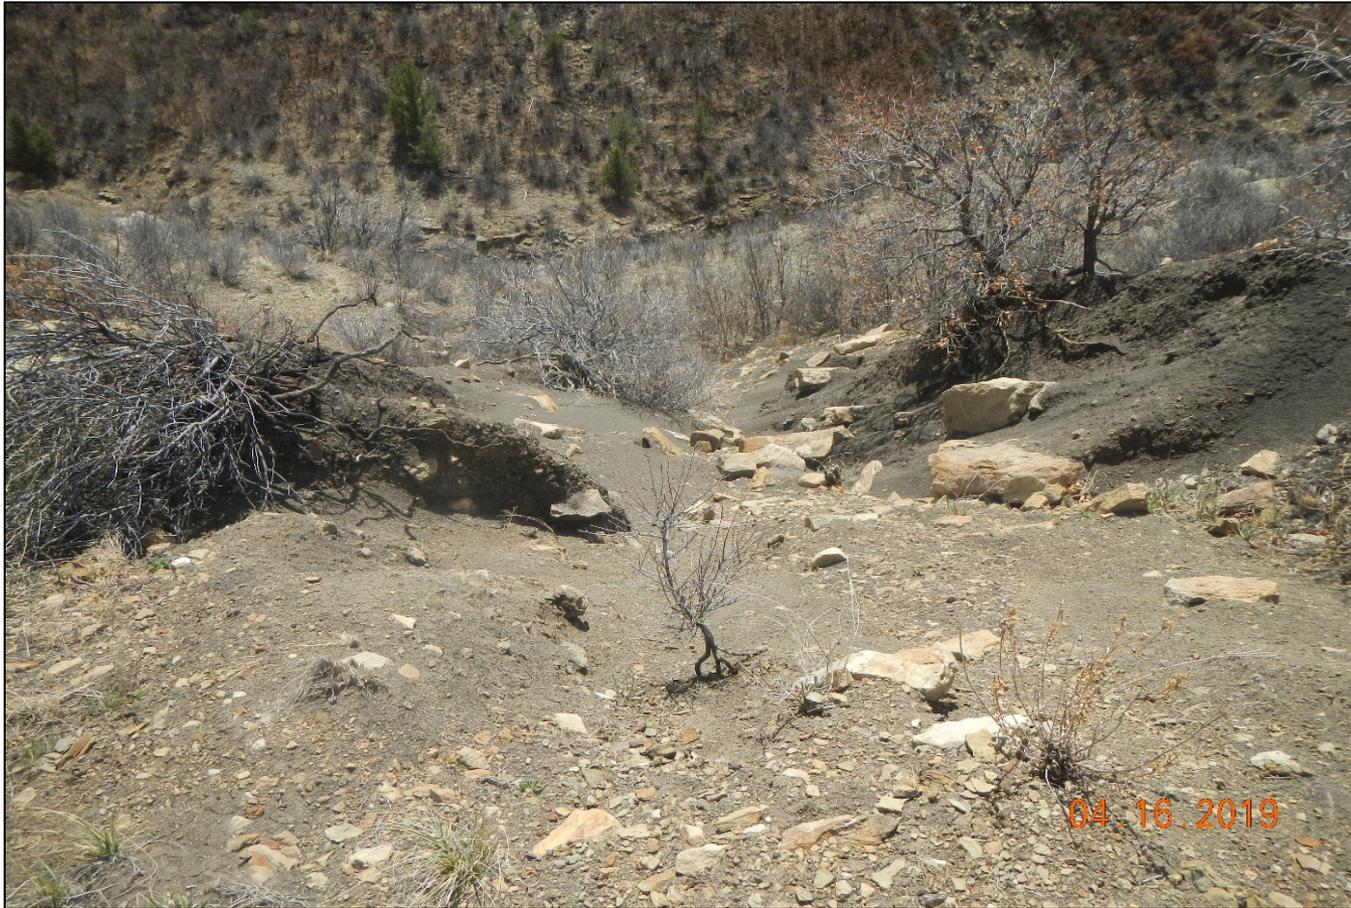
Photo 10. There is significant signs of erosion off the southeast fill slope.

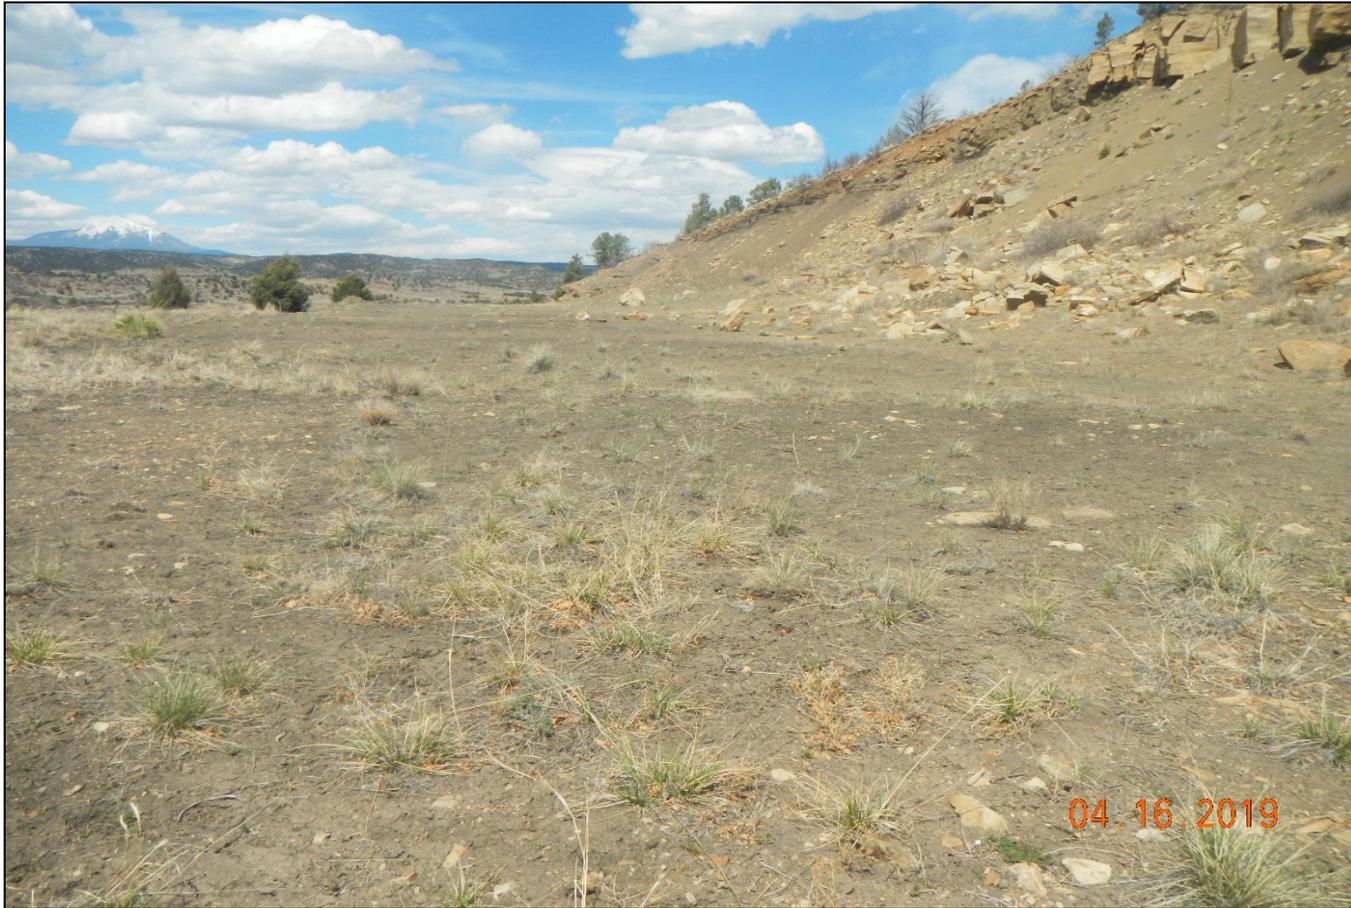
Photo 11. Facing north at the pad.

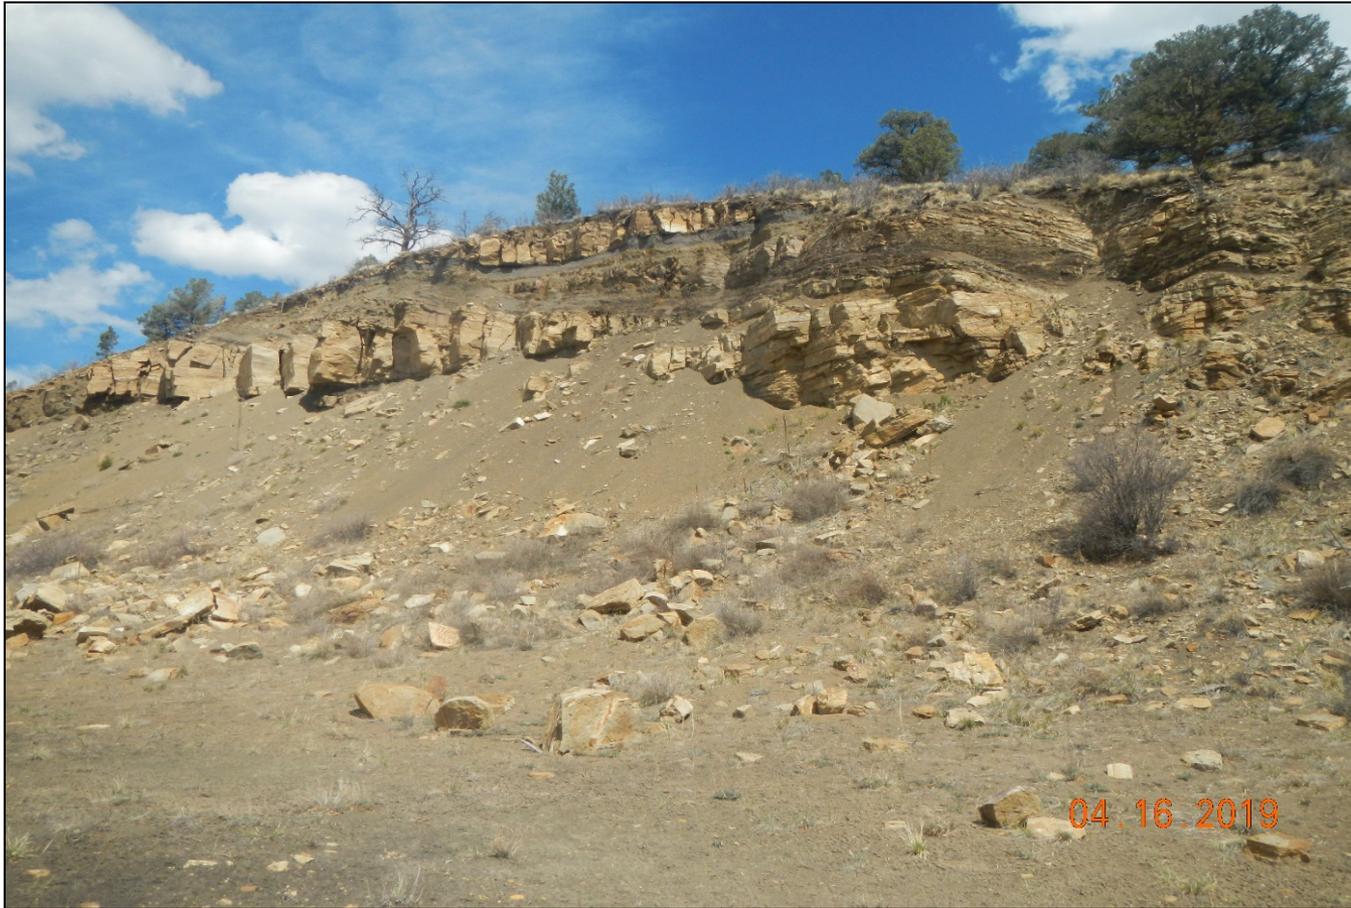
Photo 12. Facing towards the unstable vertical cut slope. Estimated to be 75' high.

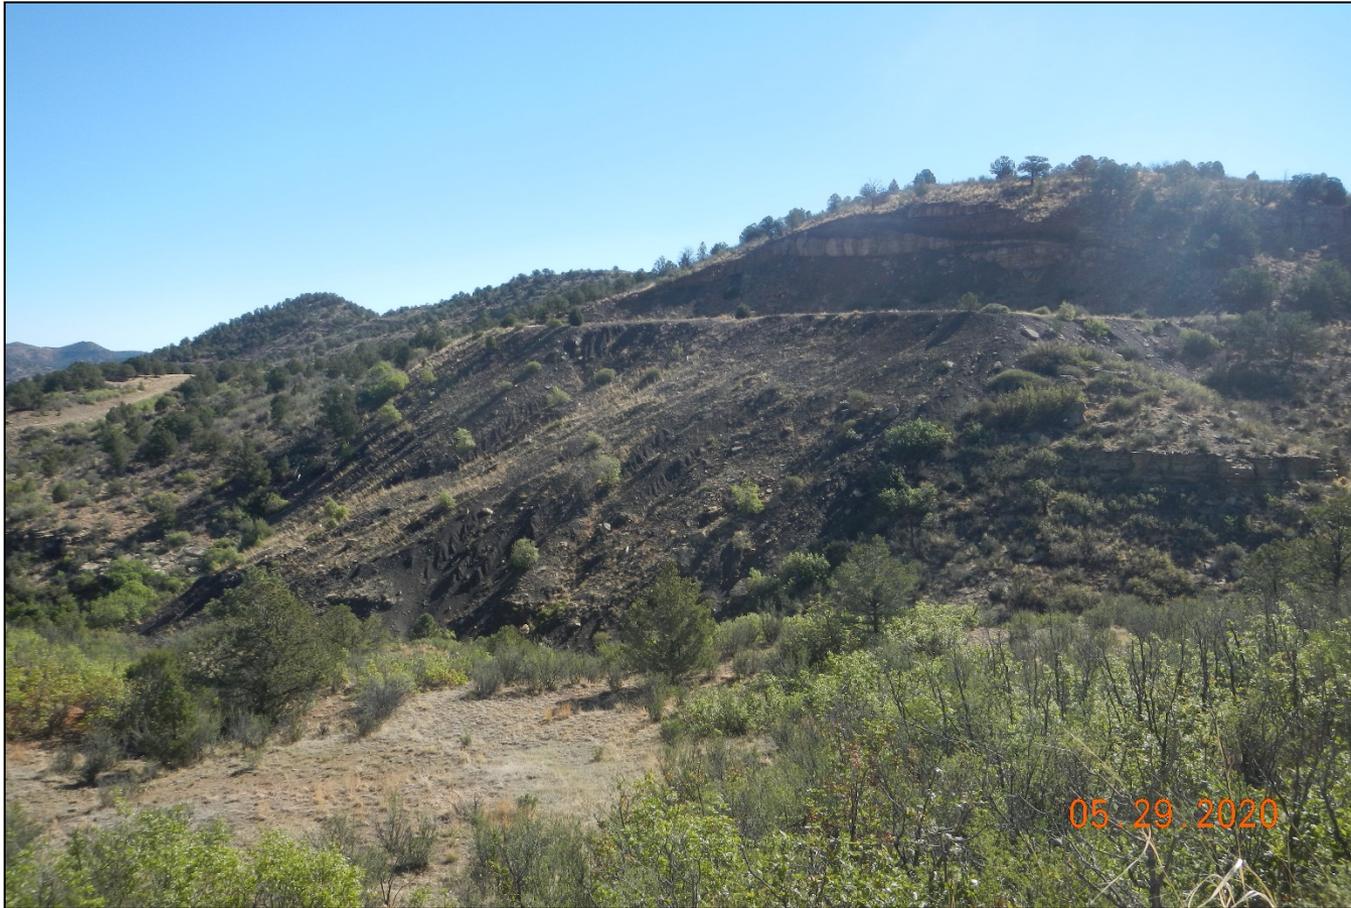
Photo 13. Facing east toward the location from across the canyon. The fill slope is not stabilized and shows signs of erosion. Location not recontoured. Photo taken 5/29/2020.
