Inspection Photos May 18, 2020  
Location Name: Walden Land Treatment Facility ID: 427373

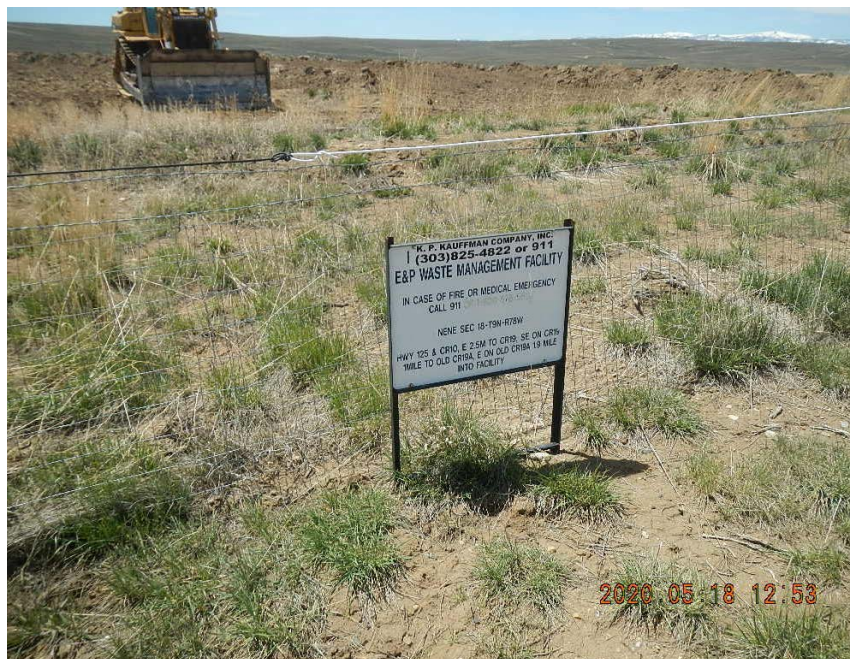
Location Sign.

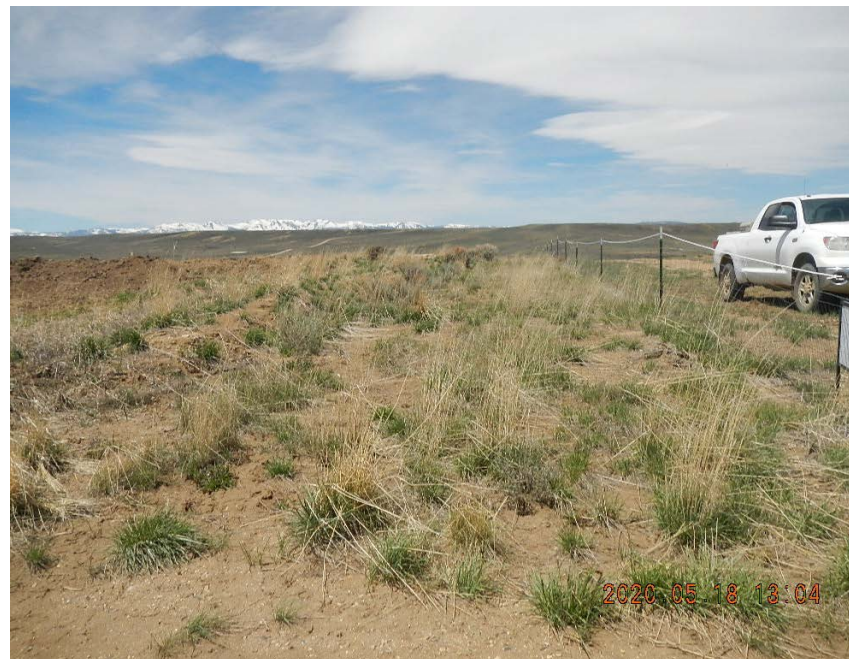
Fire lane on the north side of the CE&P facility.

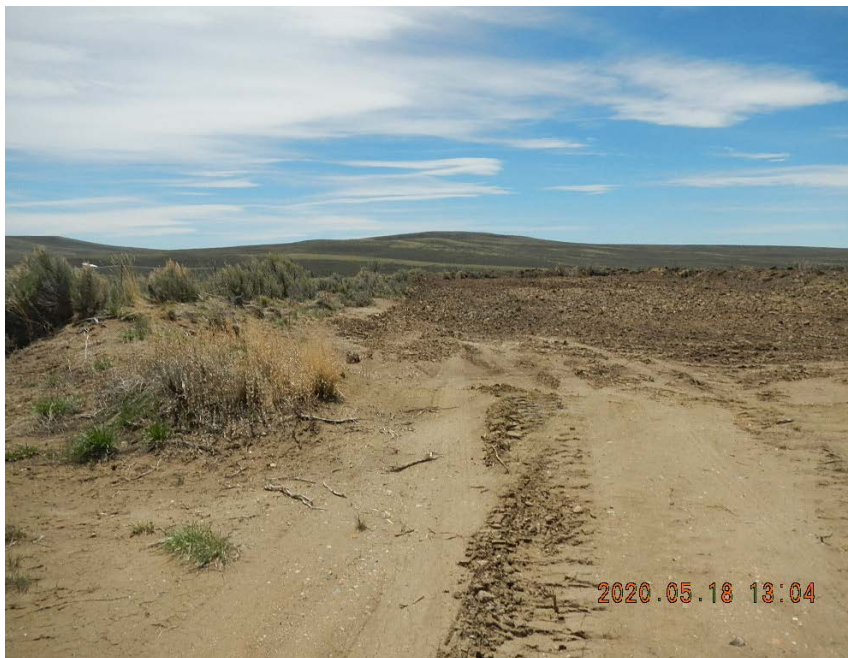
**Entrance into cell 1.**

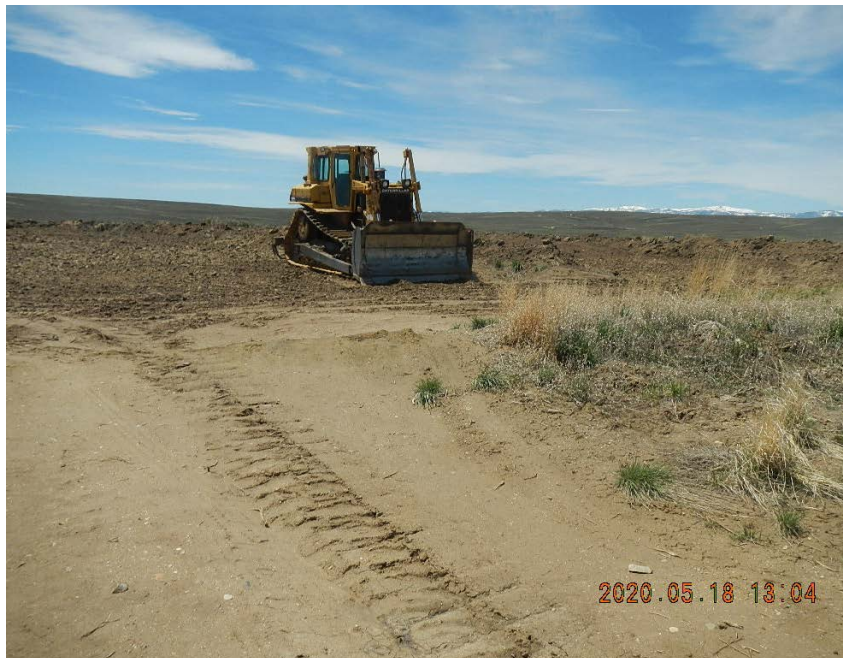
**Dozer in cell 1. All cells recently ripped and turned. Slight hydrocarbon odors noted in soil in cell 1.**

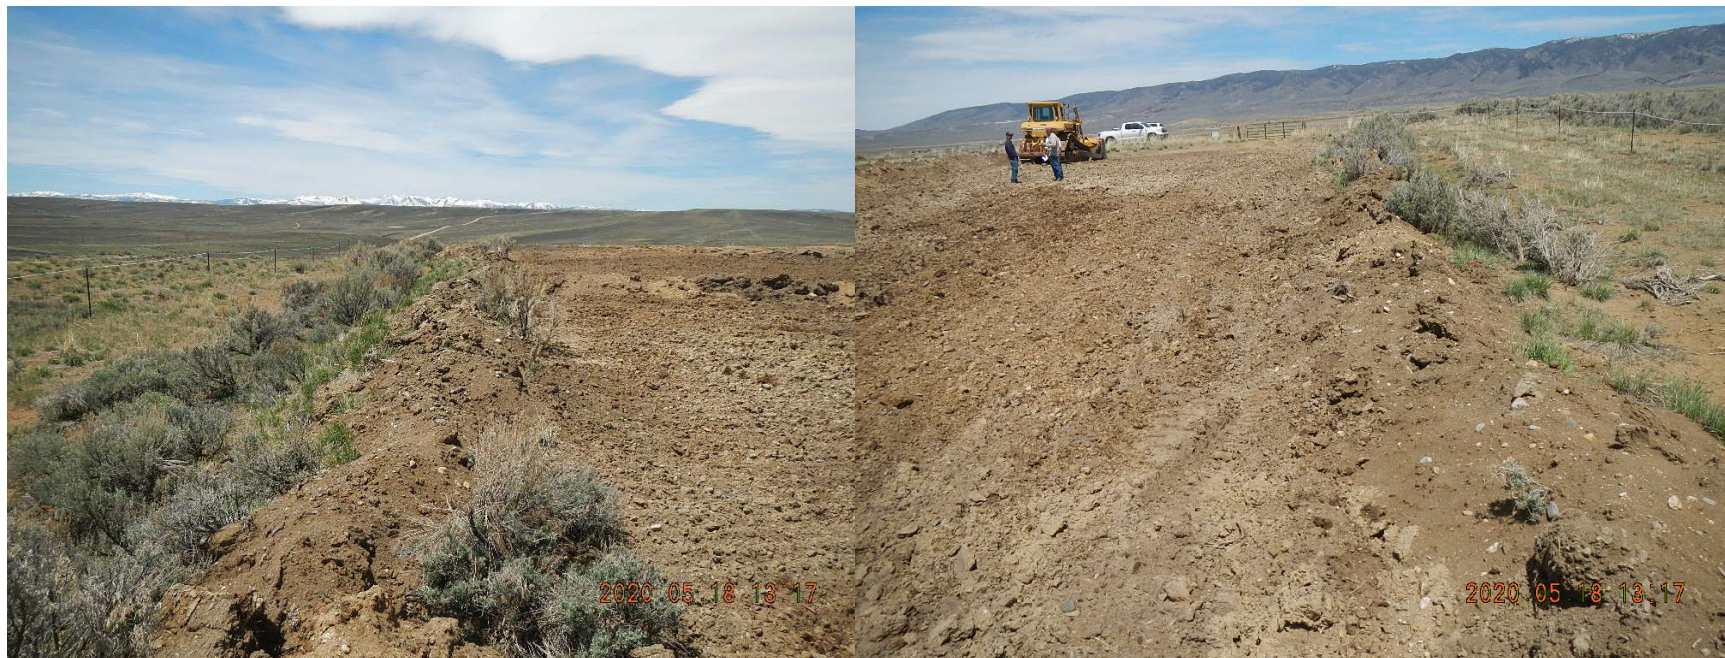
**Standing in the NE Corner looking west.**

**Standing in the NE Corner looking north**

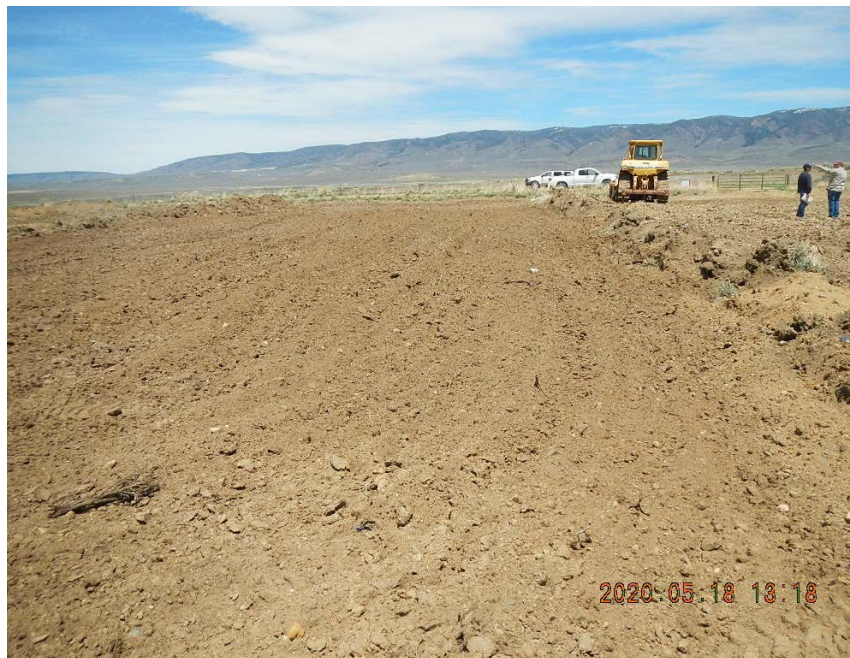
**Cell 2 looking north.**

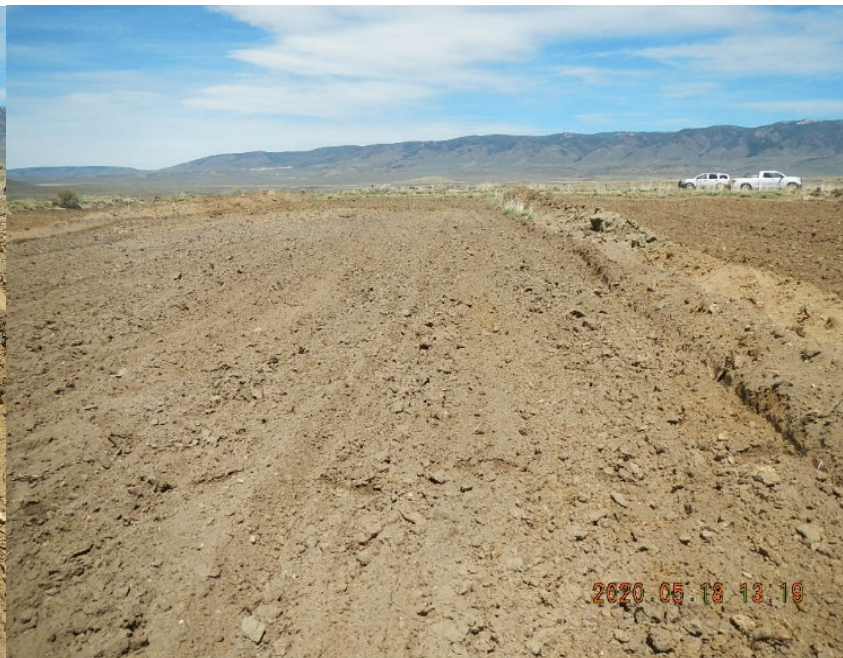
**Cell 3 looking north.**

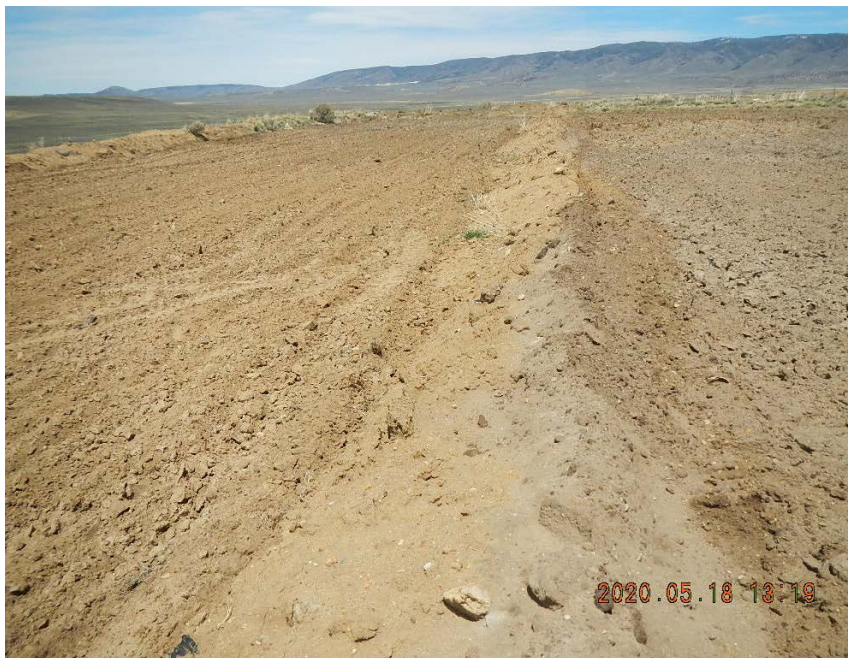
**Cell 4 in left of photo looking north.**

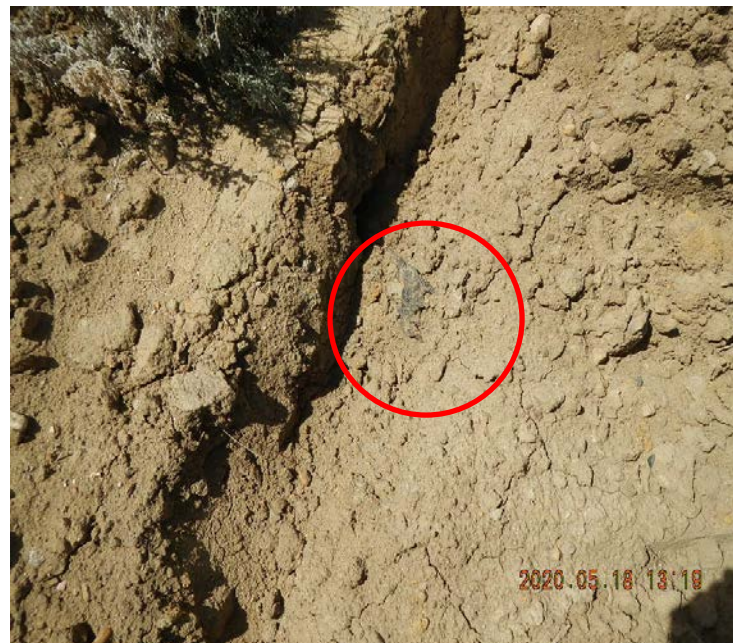
**Plastic liner pieces in cell 4.**

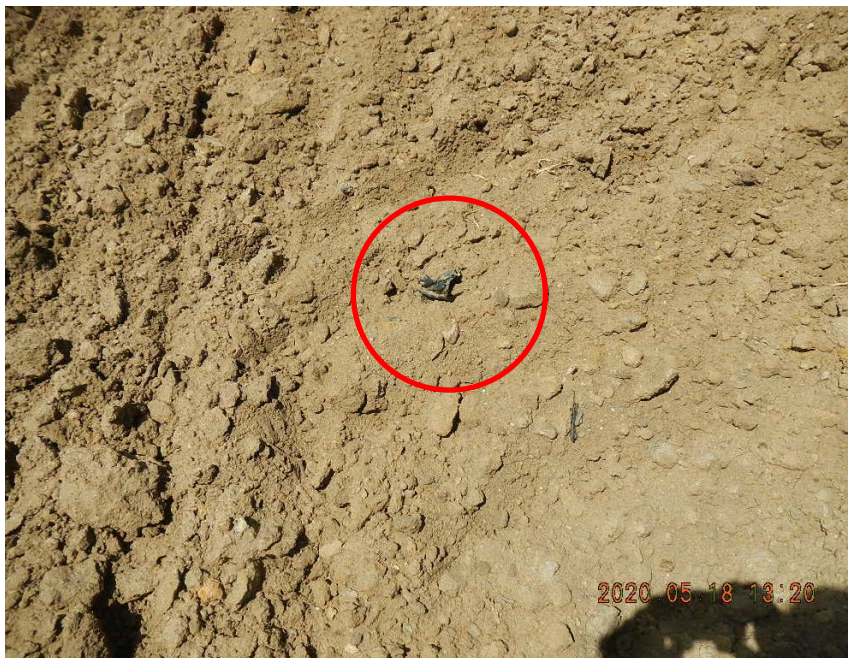
**Pit liner pieces in cell 4.**

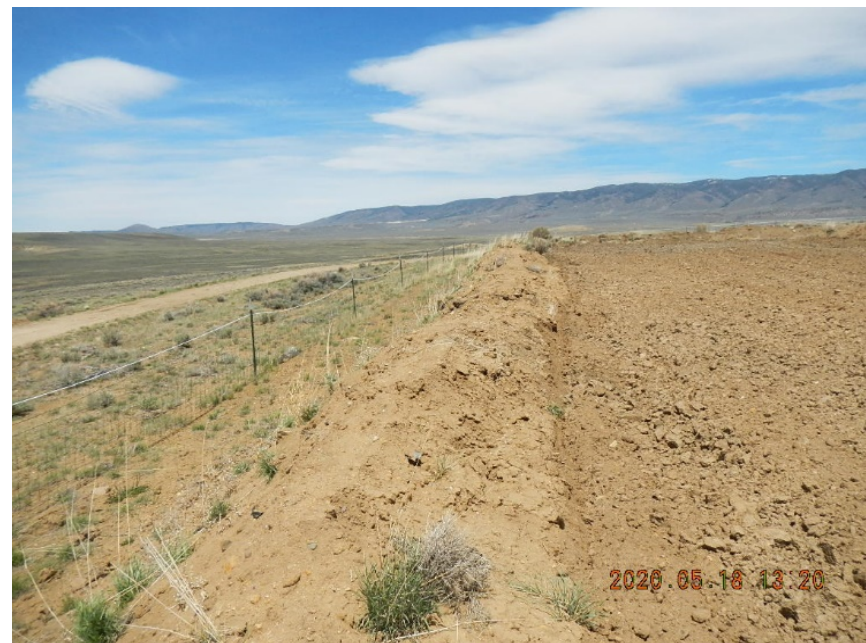
**Berm and fence along west side of cell 4 (looking north).**

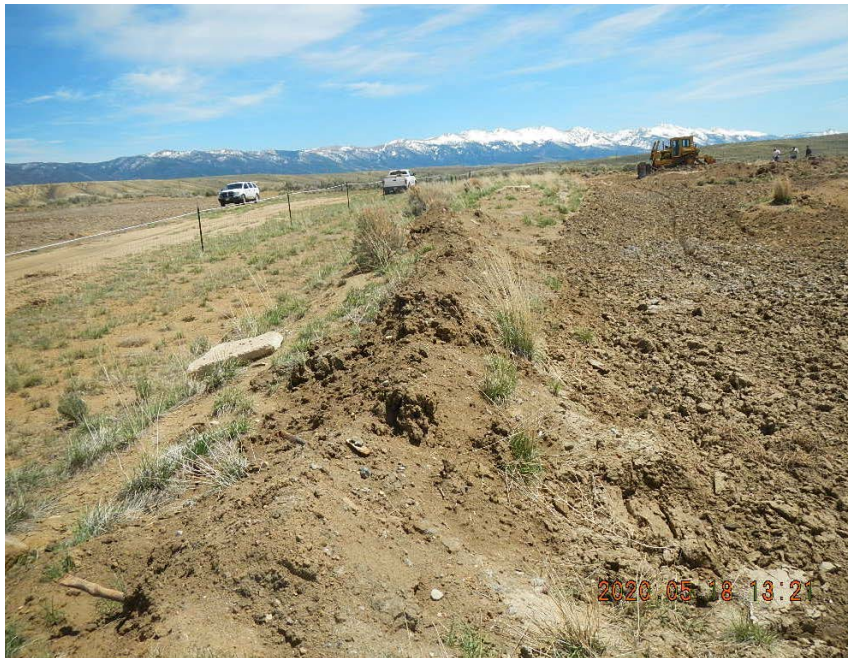
**Berm buffer land, fence, and fire lane along north side of the facility.**

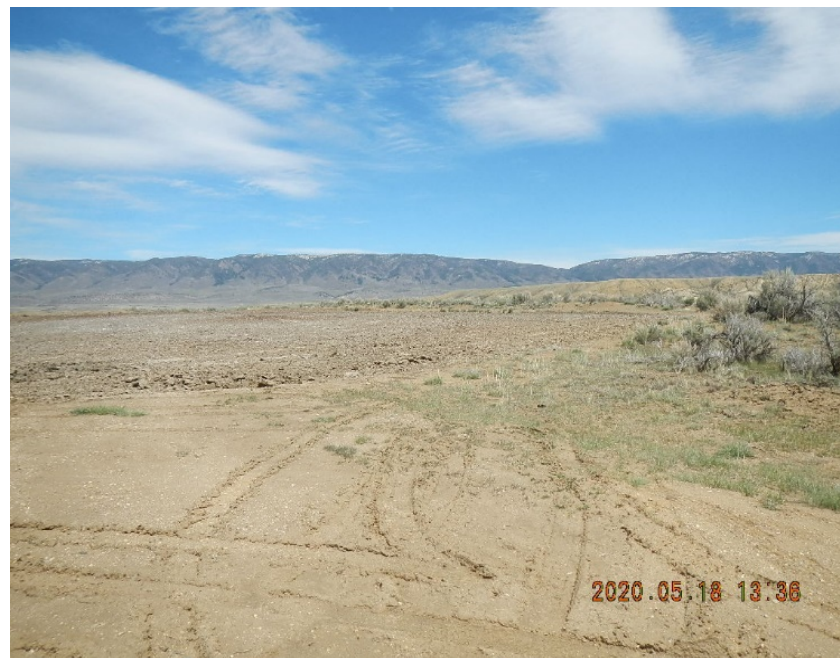
**Drill cutting management area recently ripped, looking north.**

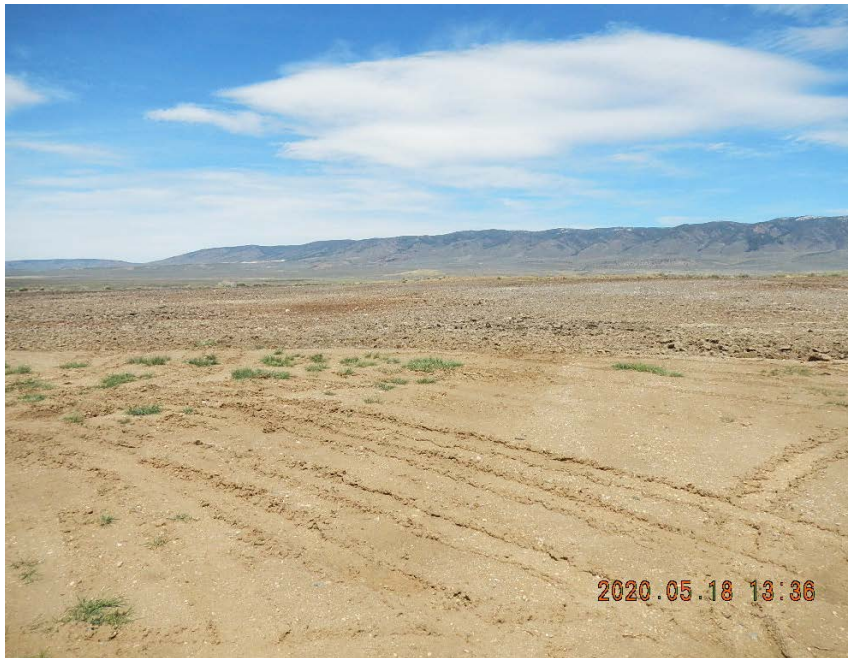
**Drill cutting management area recently ripped, looking north.**

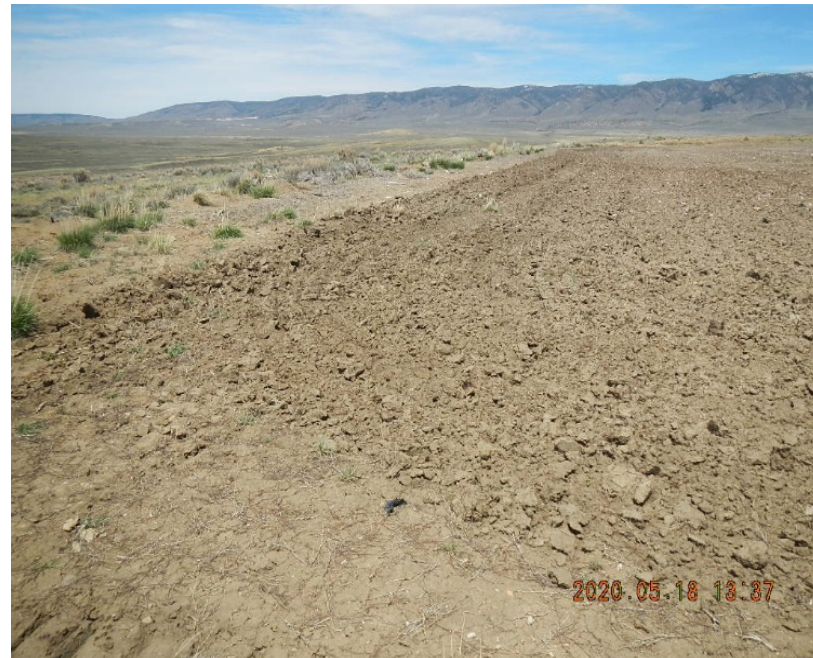
**Western side of drill cutting management area recently ripped, looking north.**

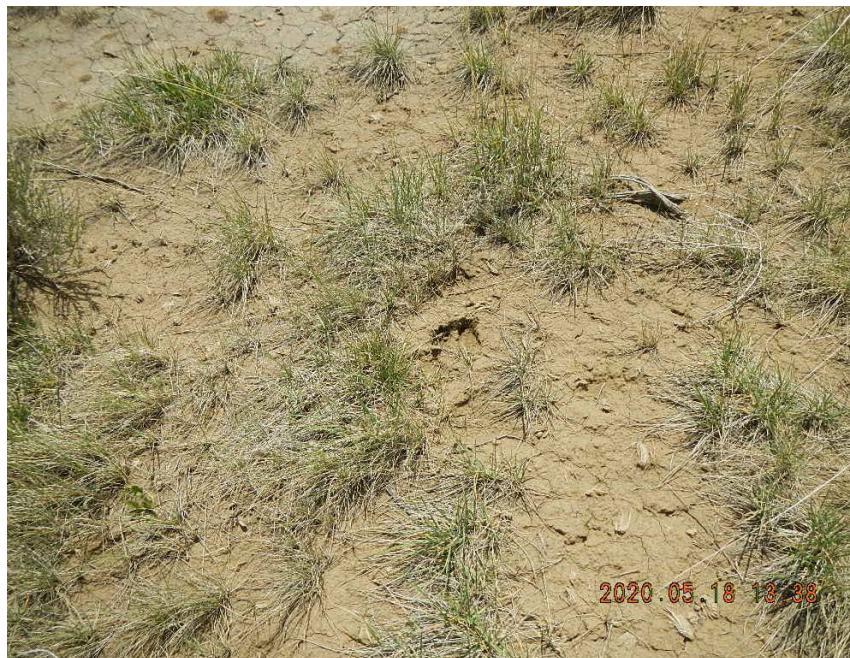
**Evidence of wildlife inside of CE&P Facility.**

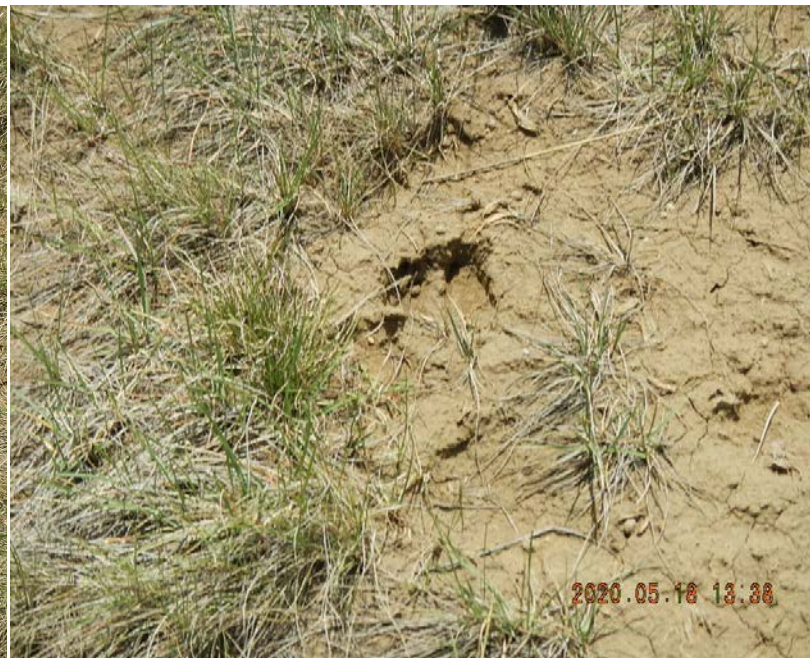
**Evidence of wildlife inside of CE&P Facility.**
