Inspection Photos
Operator: Catamount Energy
API#: 067-05429
Date: 6/3/2020

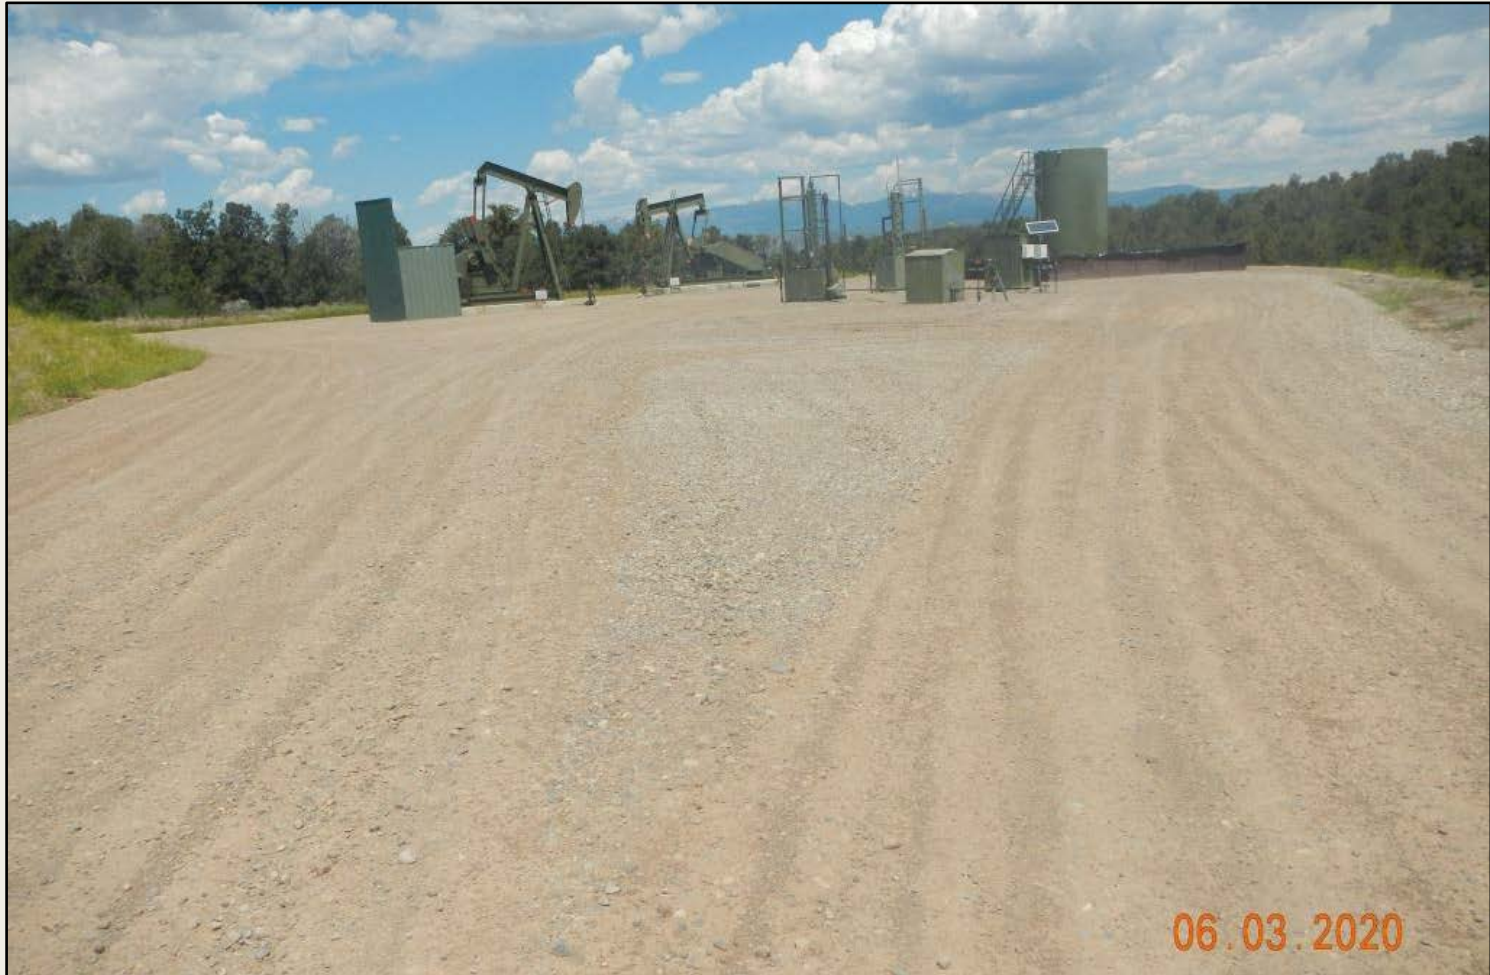
Photo 1. View of the project area from the well pad entrance facing center.

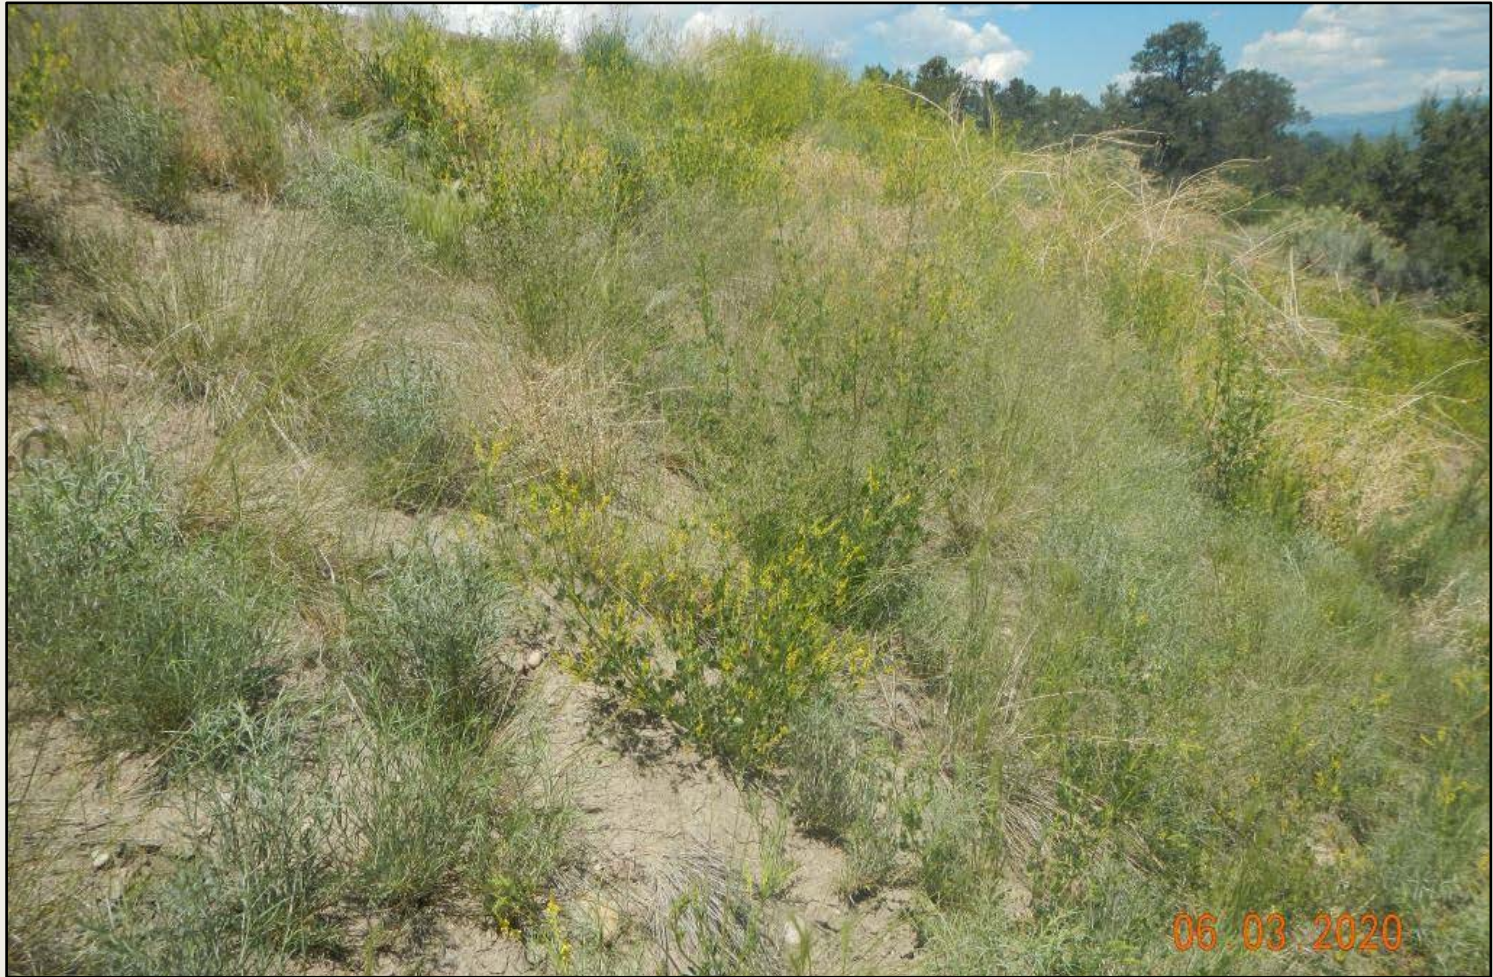
Photo 2. View of the northern fill slope from the northeastern corner facing westward. Revegetation is progressing with western wheatgrass, smooth brome, and rubber rabbitbrush.

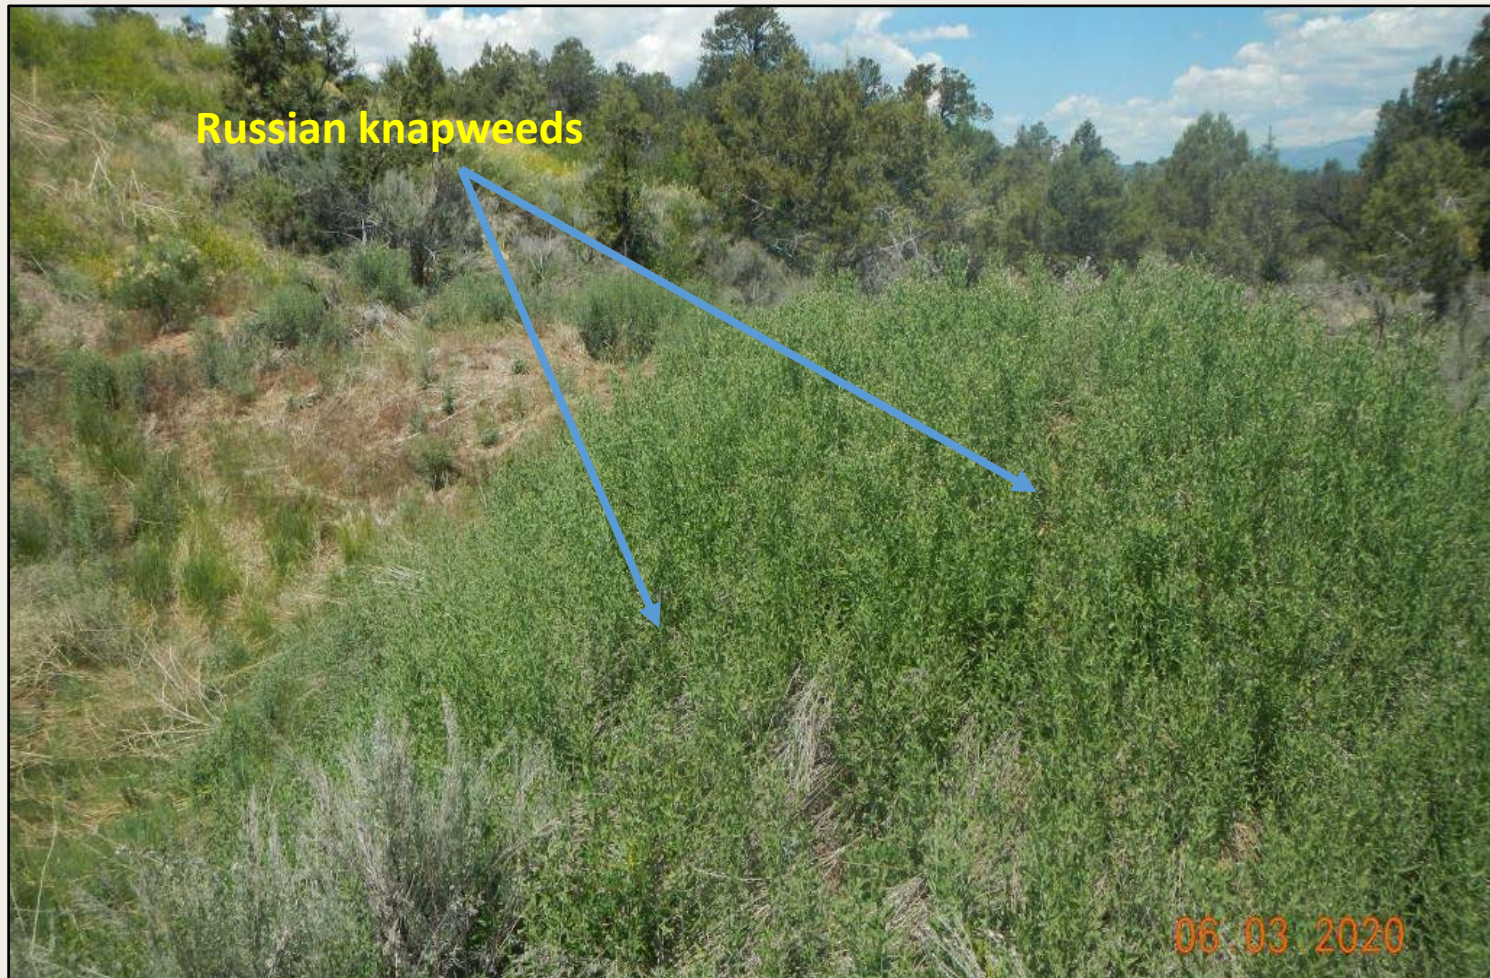
Photos 3. View of dense Russian knapweeds within the northeastern project area. Review of aerial imagery indicates that the bottom of the fill slope is part of the original project area.

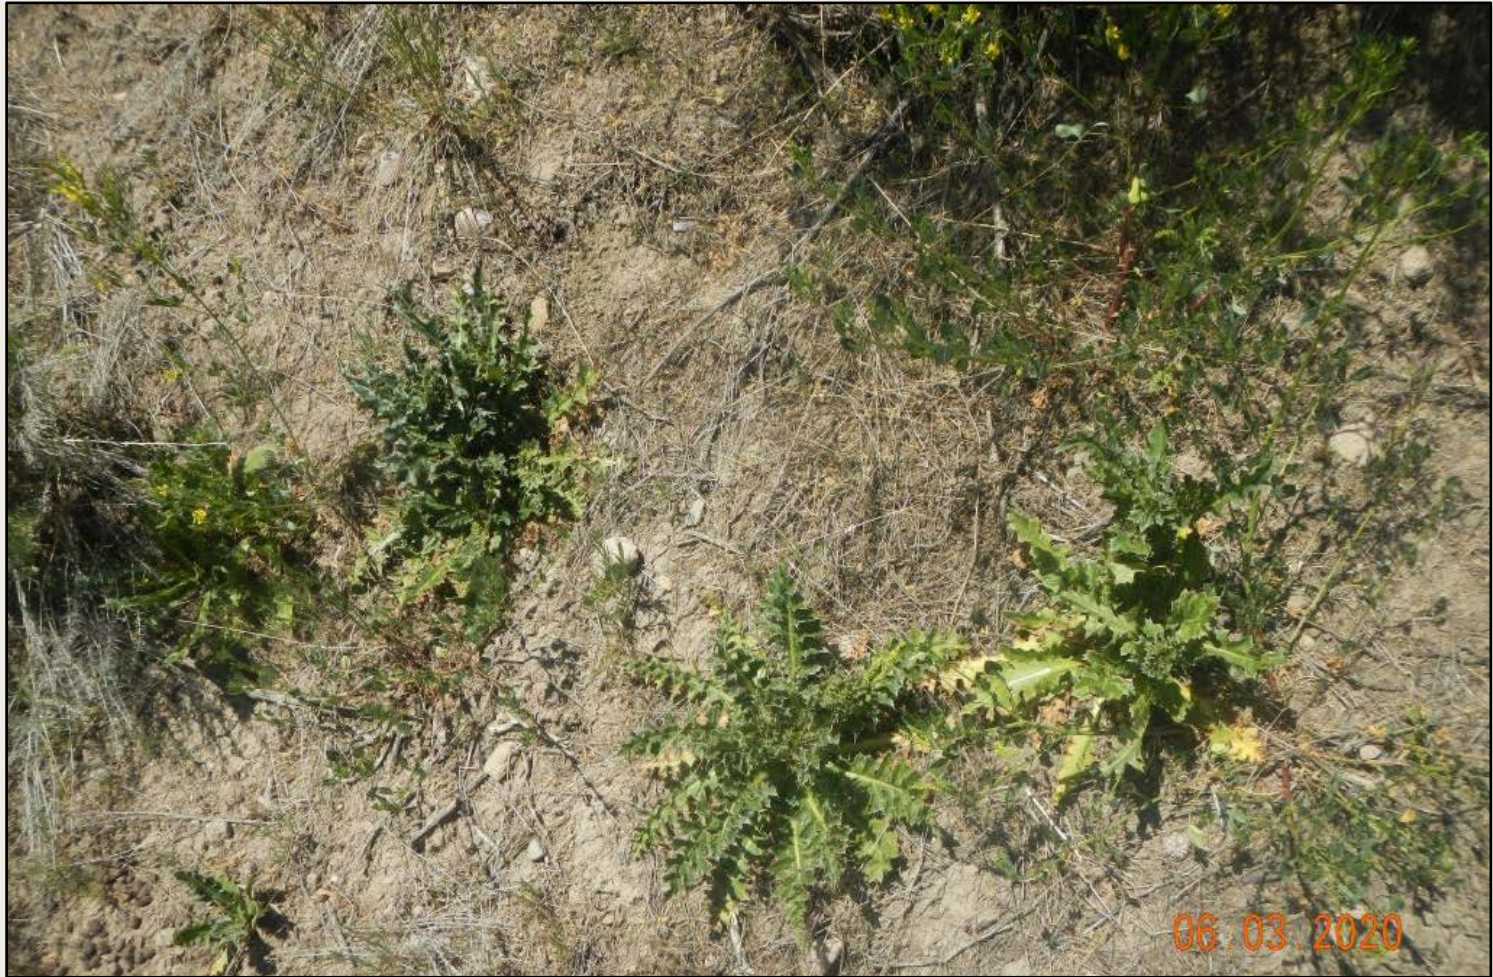
Photos 4. View of musk thistle rosettes within the northeastern project area. Approximately 200 individuals observed.

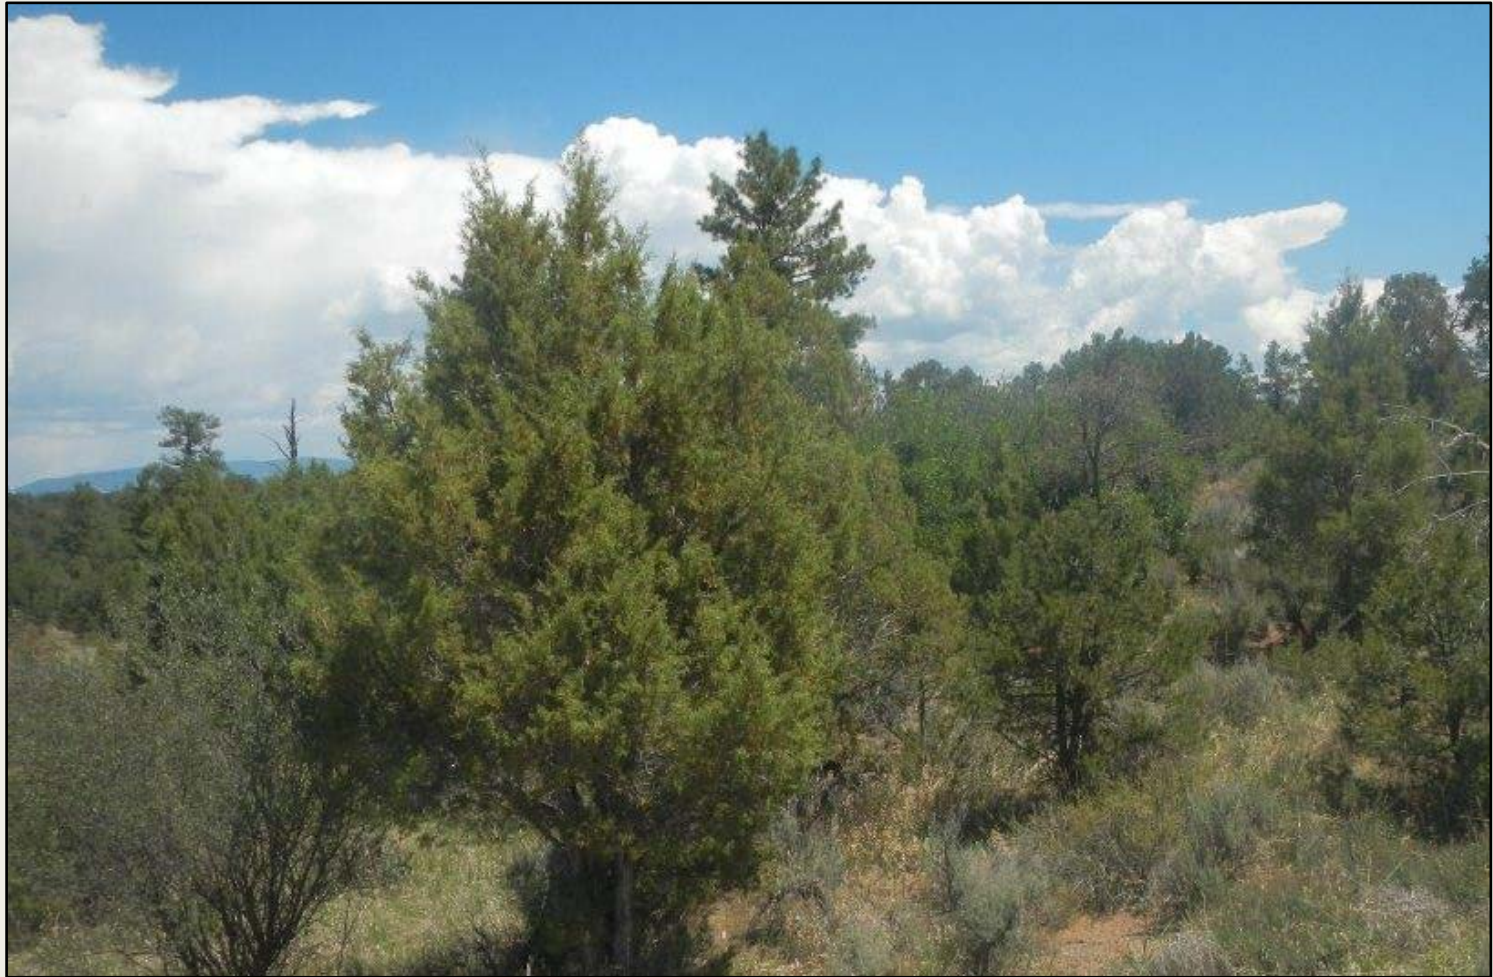
Photo 5. View of reference area comprised of pinyon and juniper woodland with understory of antelope bitterbrush, big sagebrush, James galleta, and penstemon.
