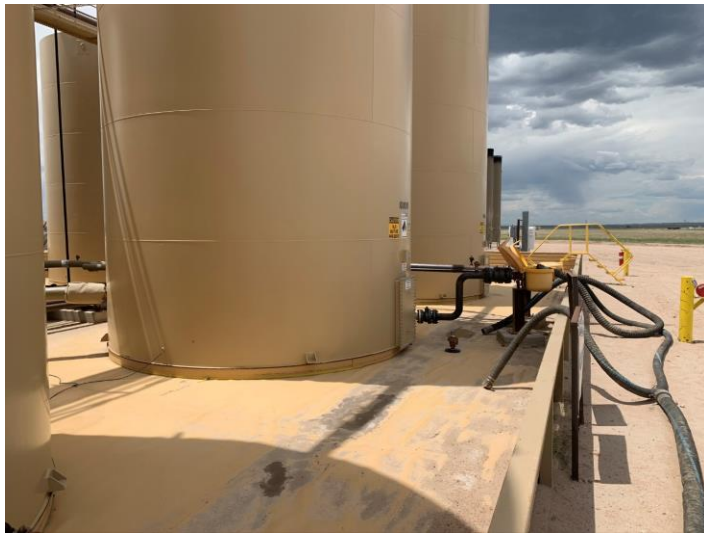
Photo 1 – View toward the west showing load point and secondary containment in vicinity of produced water tanks and load point.

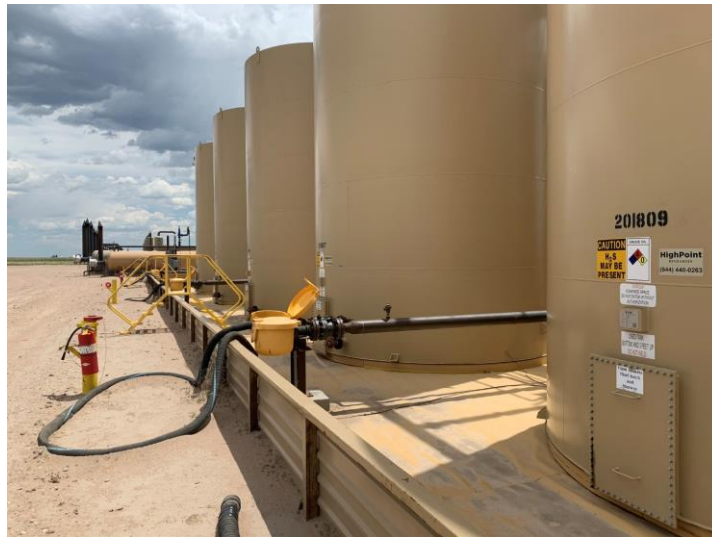
Photo 2 – View toward the east showing load point and secondary containment in vicinity of produced water tanks and load point.

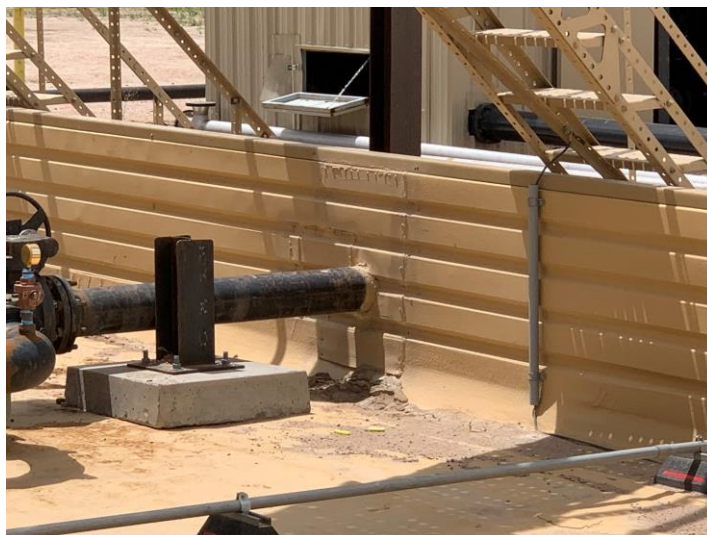
Photo 3 – Repair of secondary containment wall where pipeline breached containment wall. Patch sealed and secured with screws and then the entire repair area recoated with sealant.
