Complaint Photos
Complaint Name: Stewardson
Complaint Doc#: 200448944

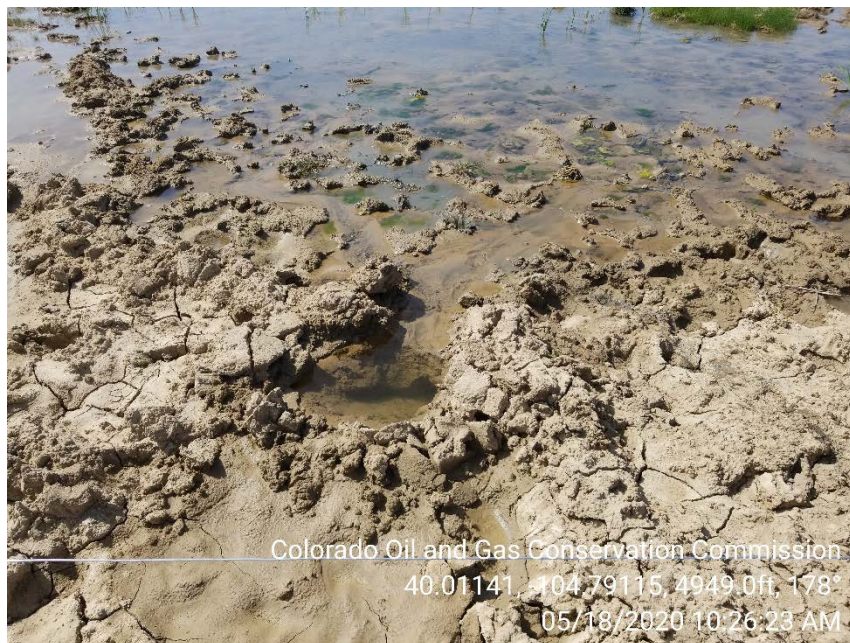
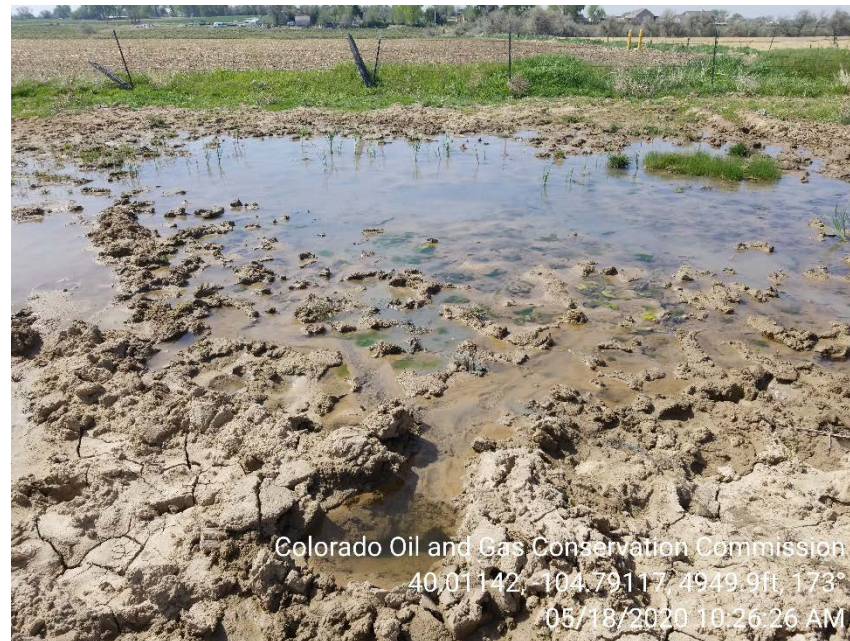
Photo 1 & 2 – Main seep, sample location for Stewardson Field. Seep water was flowing at approximately 2 gallons per minutes. Water was clear of sediment and no sheen was present.

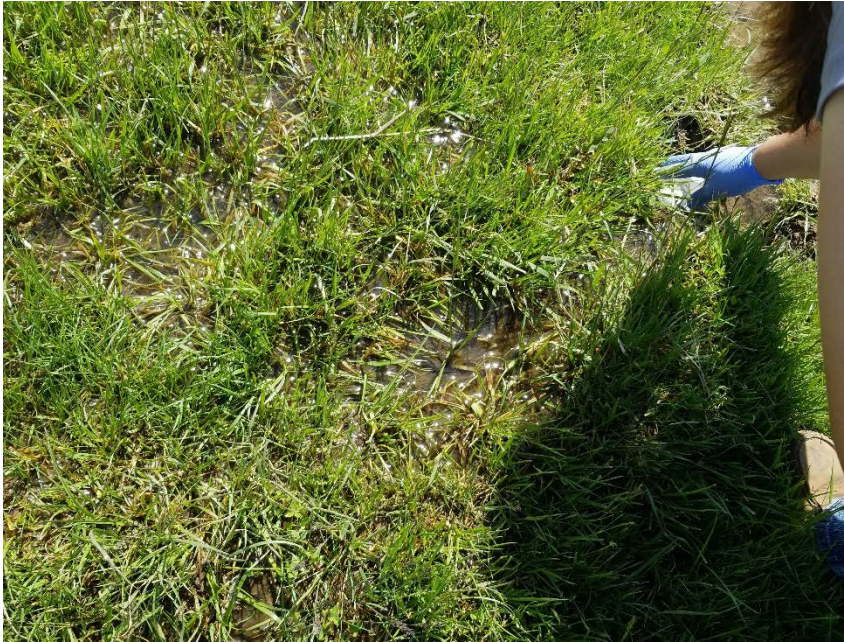
Photo 3 – Irrigation runoff. Background sample location.

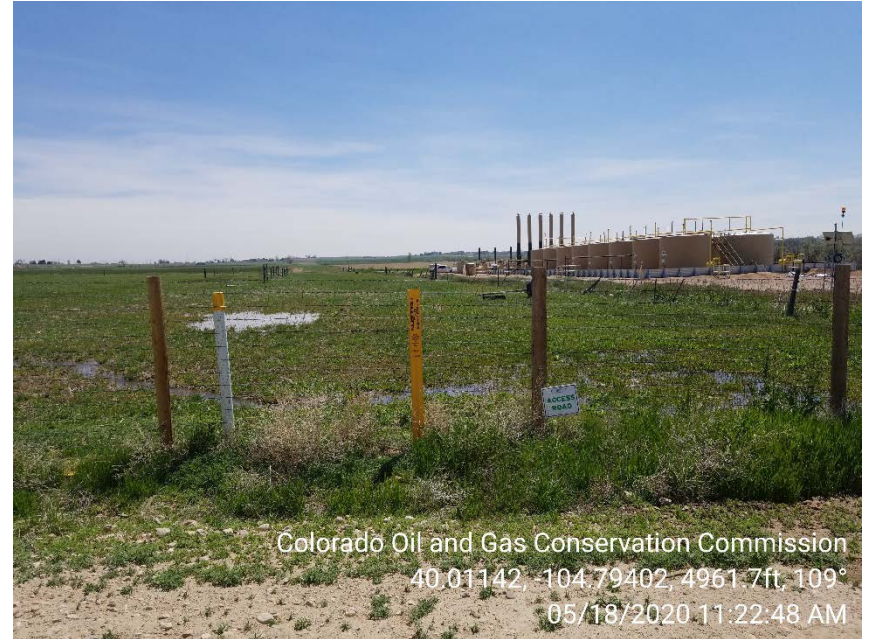
Photo 4 – Irrigation ditch terminus (left), pipeline ROW, and PDC Phelps Pad (background)

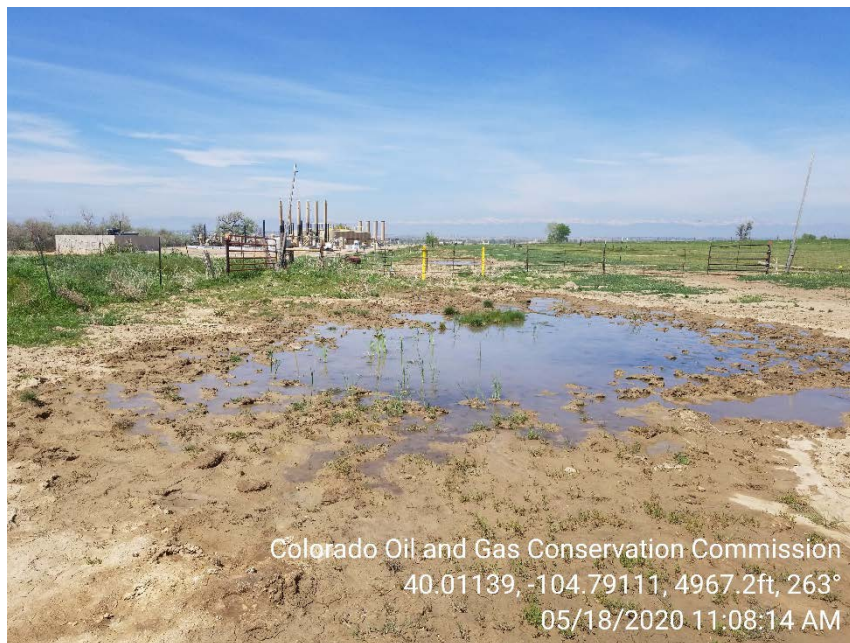
Photo 5 – Main seep (foreground) additional seeps seen in background

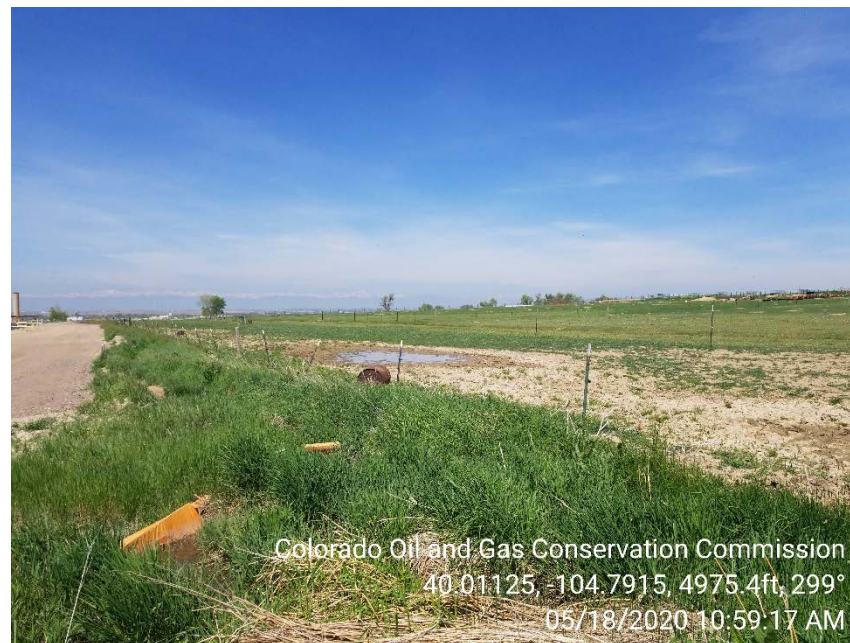
Photo 6 – Additional seeps observed along pipeline ROW

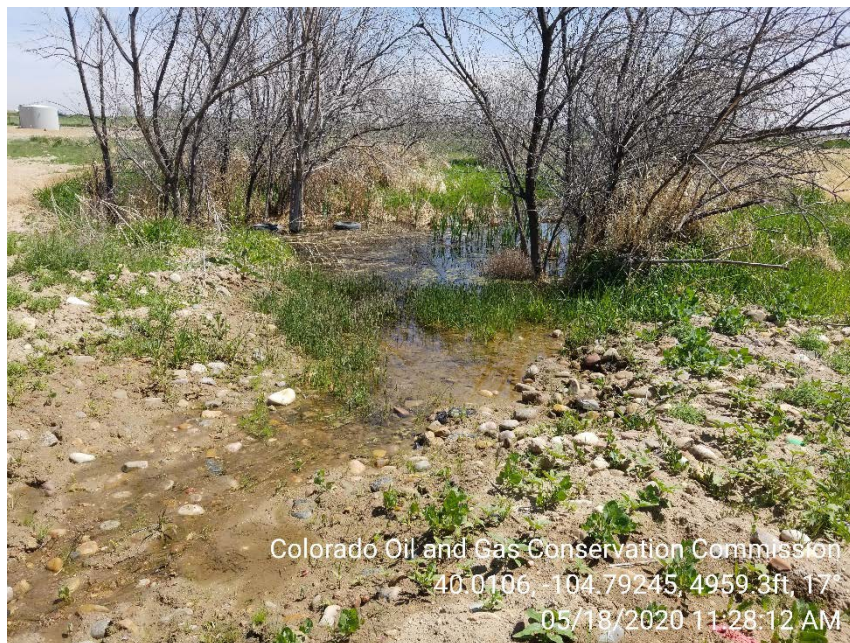
Photo 7 – Sample point for WL, wetlands inside PDC Phelps Pad.

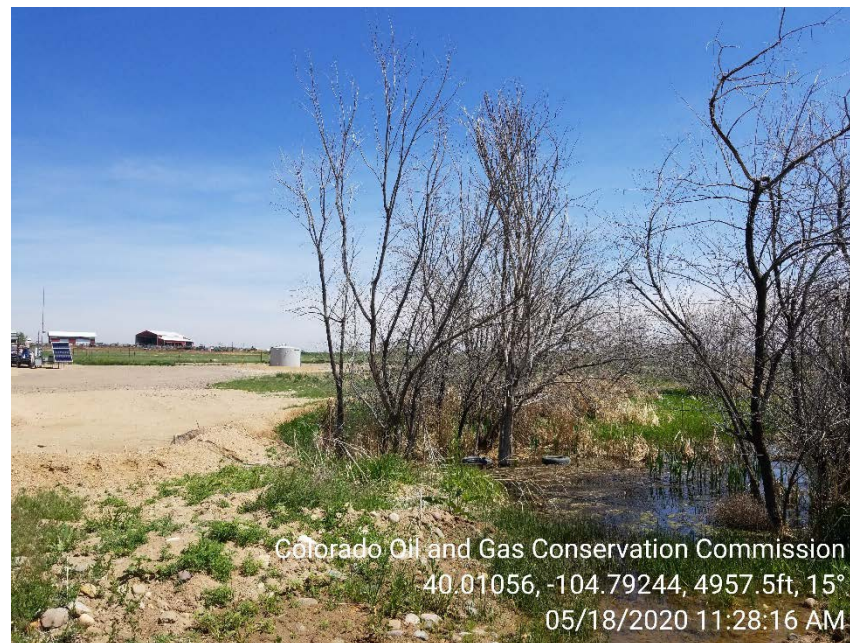
Photo 8 – Looking towards the main seep from the wetlands.

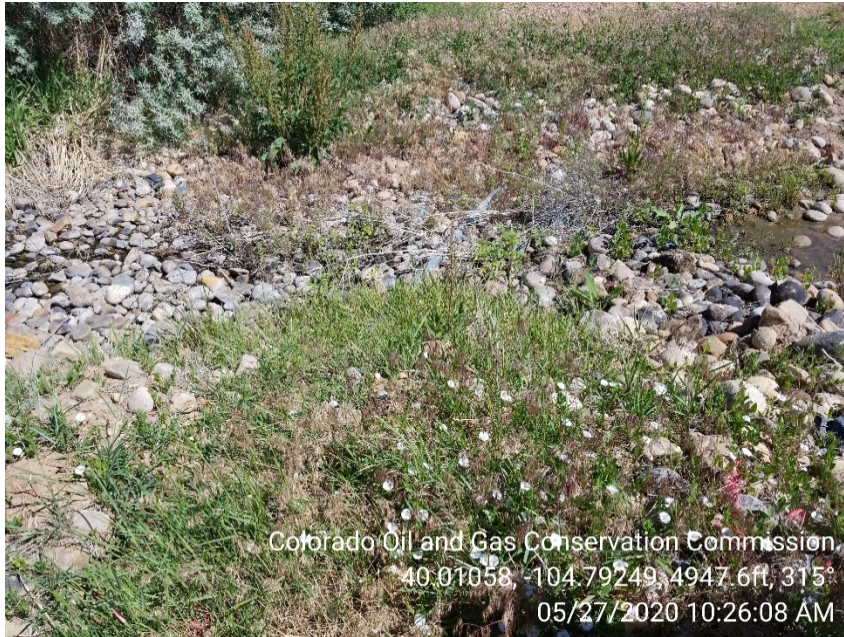
Photo 9 – Wetland disturbance: imported riprap.
Electrical conduit running across wetland.

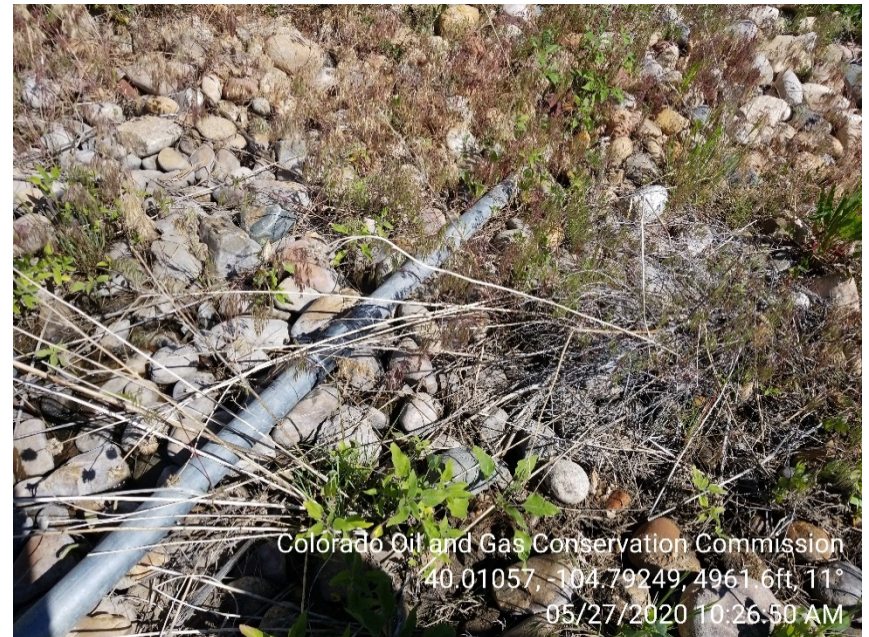
Photo 10 – Wetland disturbance: imported riprap.
Electrical conduit running across wetland.

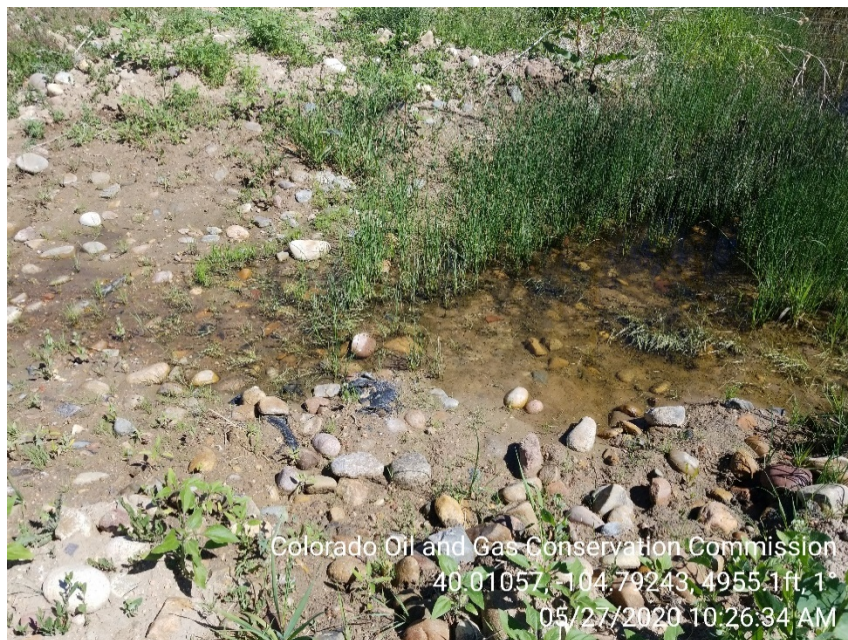
Photo 11 – Wetland disturbance imported riprap, fill, and plastic liner

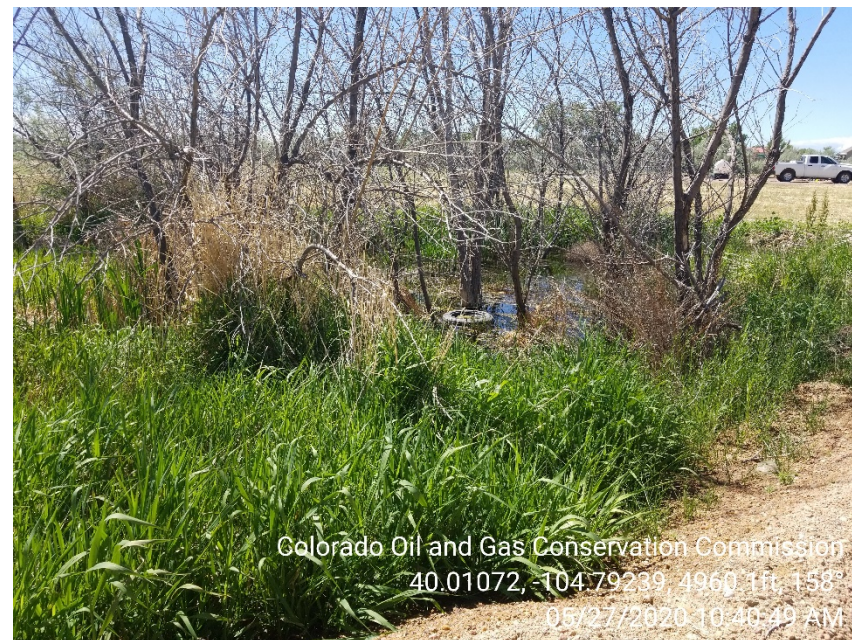
Photo 12 – Wetland disturbance trash and debris in wetland.

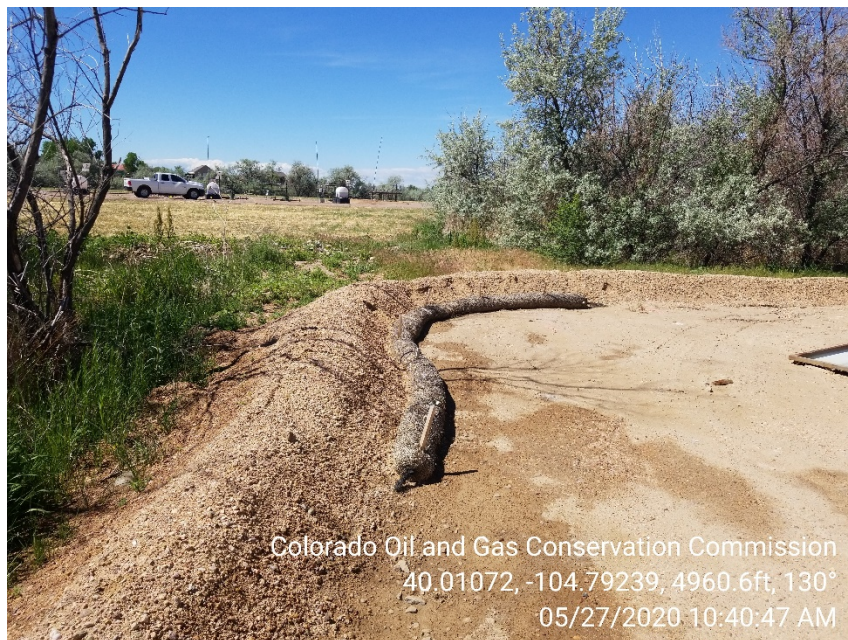
Photo 13 – Wetland disturbance looking south from production pad to wellhead pad

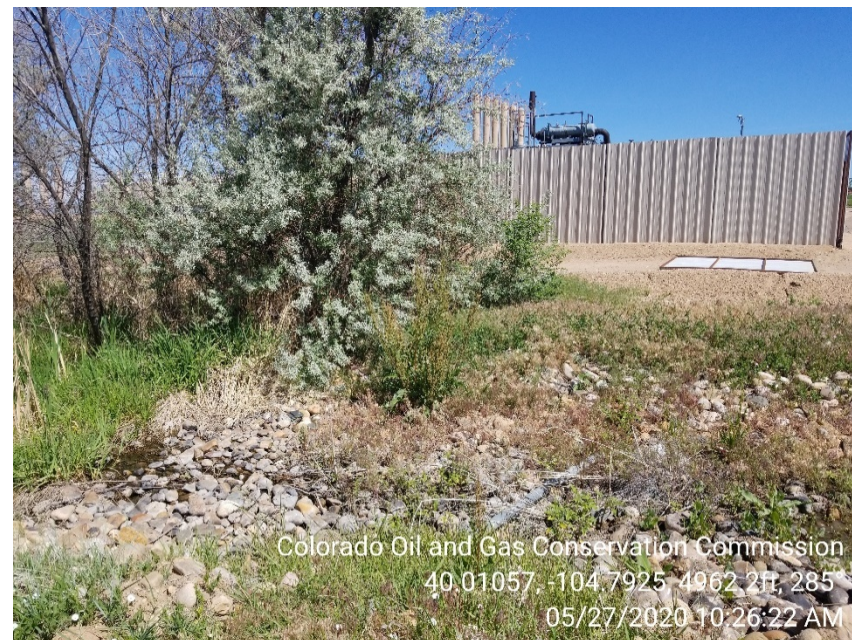
Photo 14 – Wetland disturbance looking north from wellhead pad to production pad

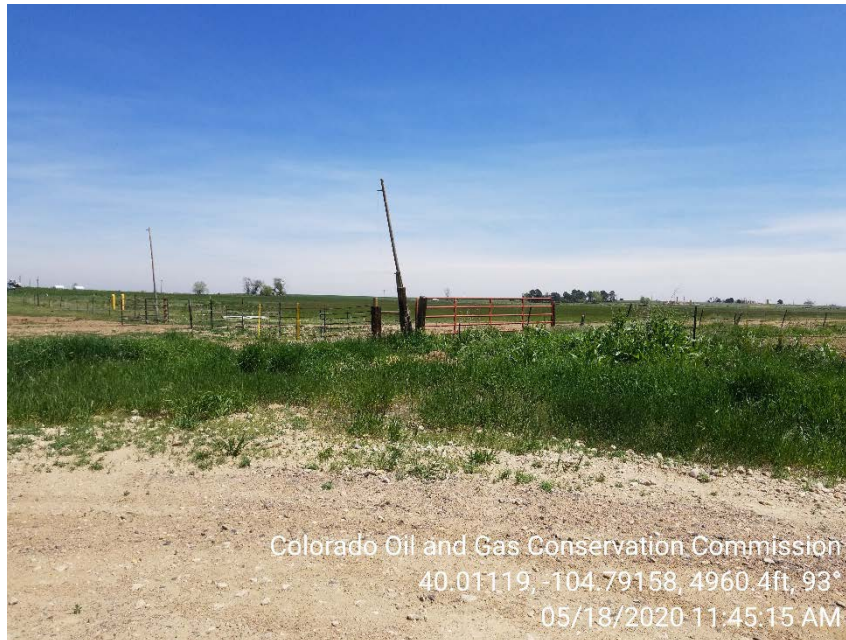
Photo 15 – Looking up-gradient from access road between the wellheads and production facility for the Phelps pad (main seep in background).

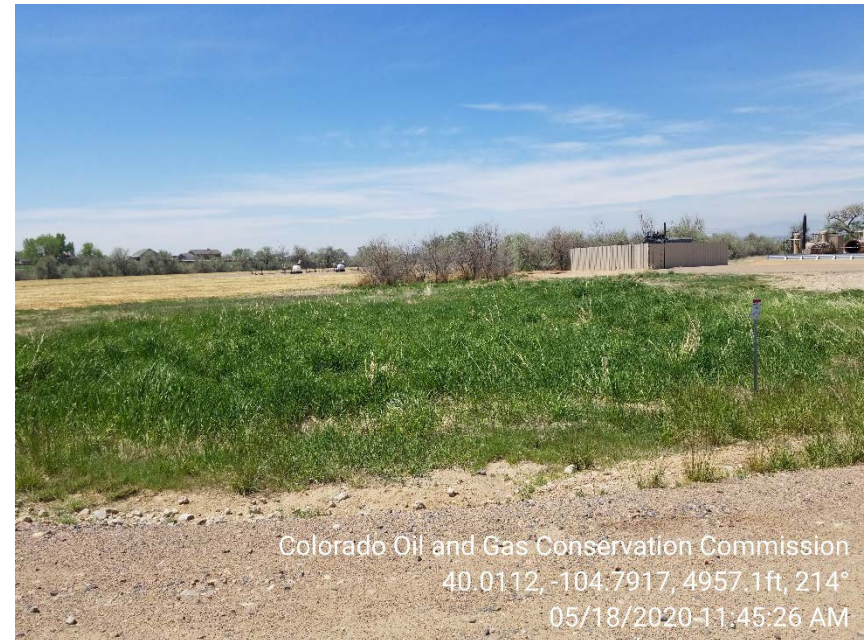
Photo 16 – Looking down-gradient from access road between the wellheads and production facility for the Phelps pad (wellheads and wetlands in background).

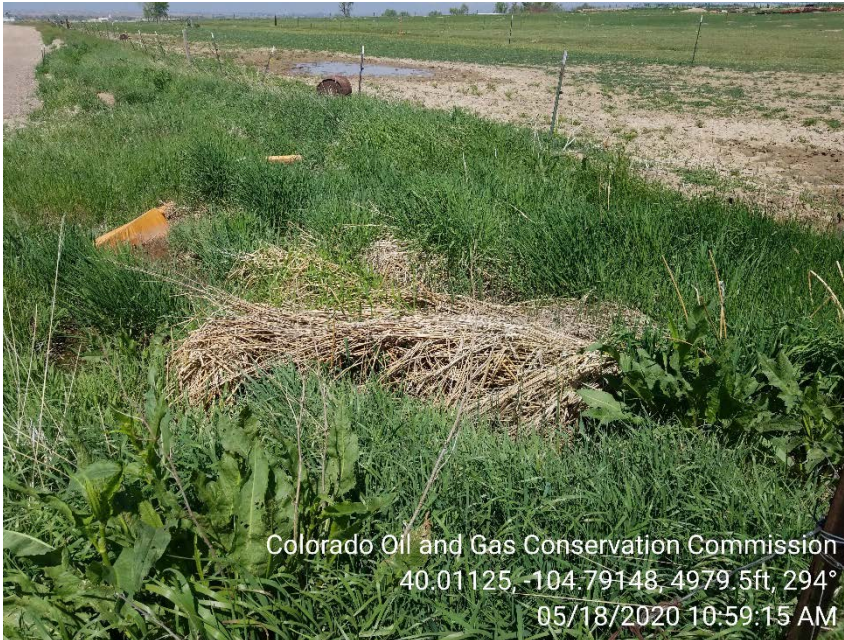
Photo 17 – Non-functional water control devices between seeps and access road for the Phelps pad.

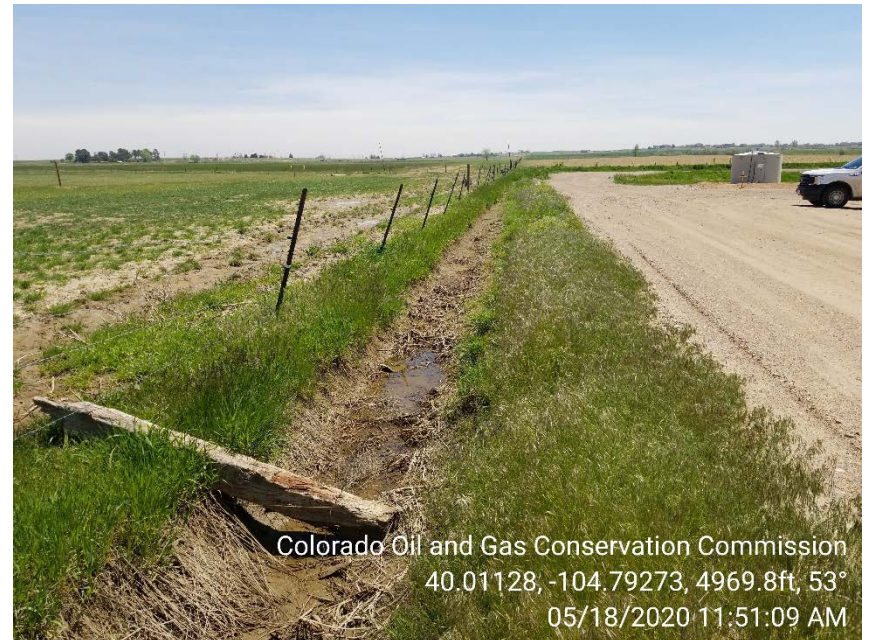
Photo 18 – Diversion ditch on north side of the Phelps Pad.

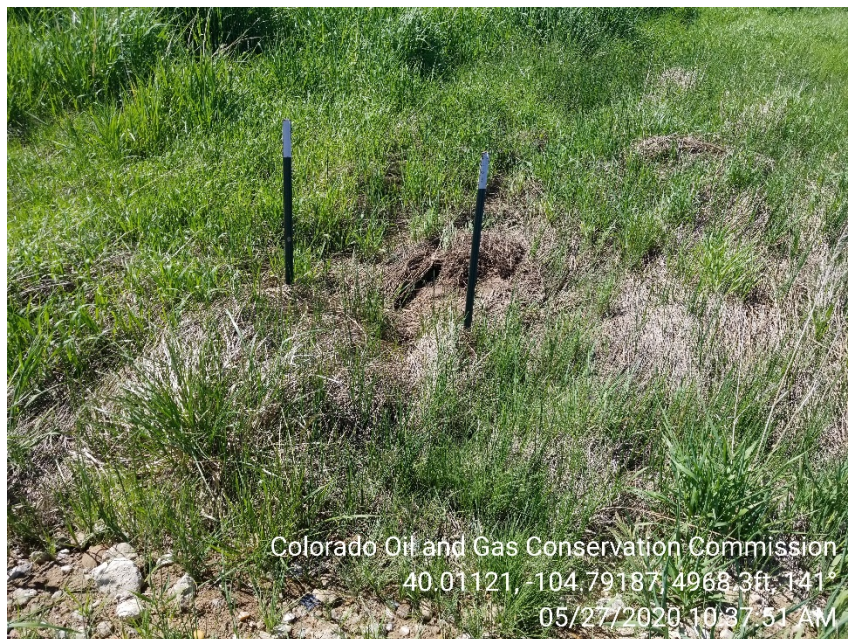
Photo 19 – Culvert under access road. No flow observed.

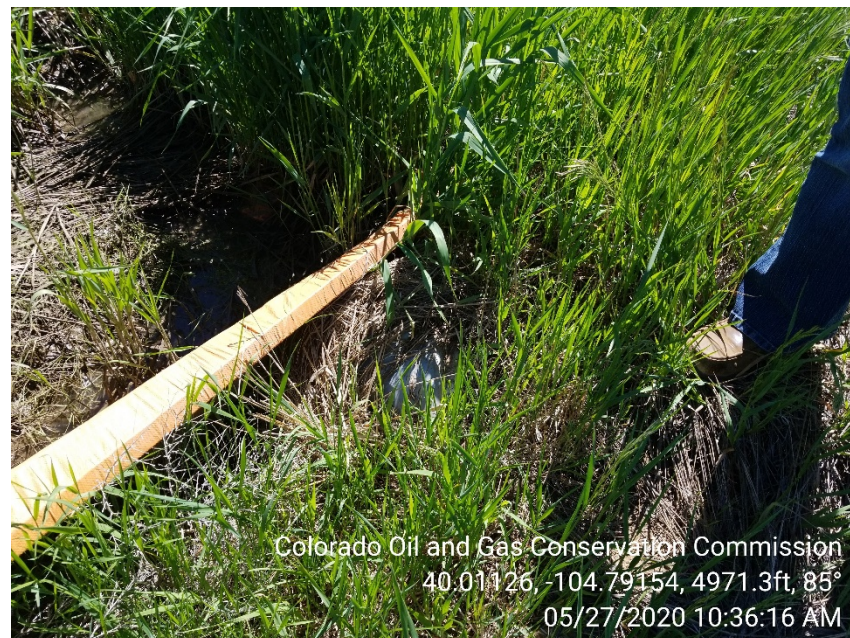
Photo 20 – Culvert under access road. No flow observed.

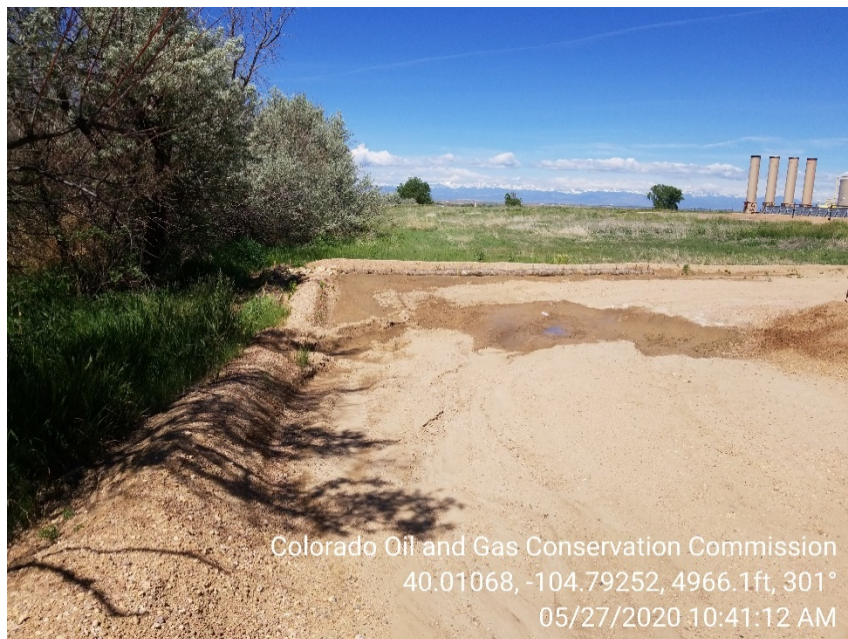
Photo 21 – Low point in production facility pad discharging sediment into wetland.

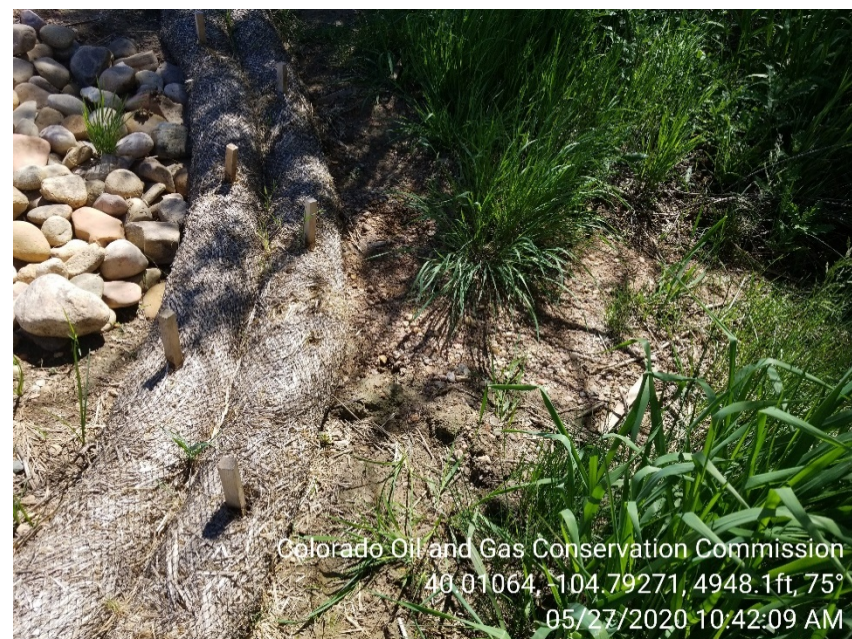
Photo 22 – Low point in production facility pad discharging sediment into wetland.

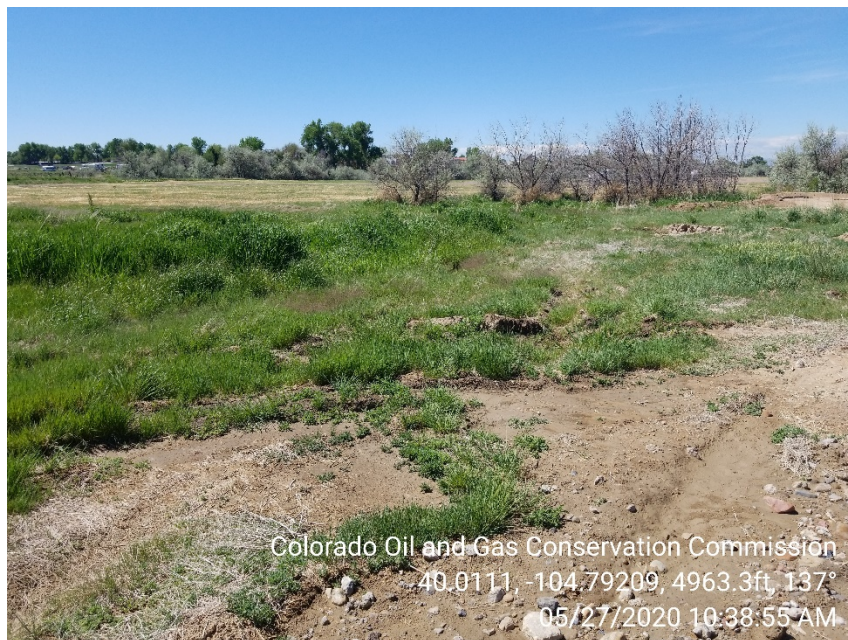
Photo 23 – Vehicle tracks through wetland area.

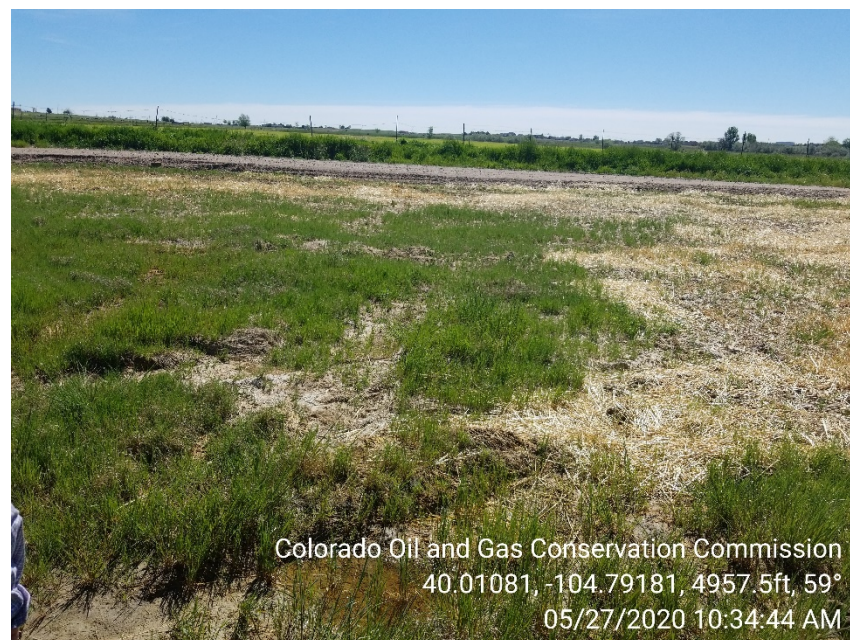
Photo 24 – Vehicle tracks through wetland area.

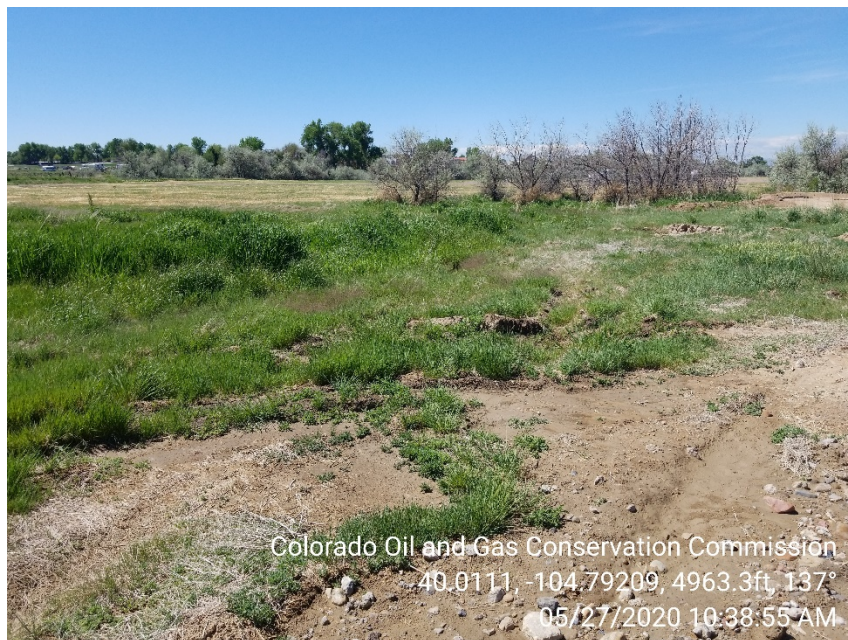
Photo 25 – Vehicle tracks through wetland area.

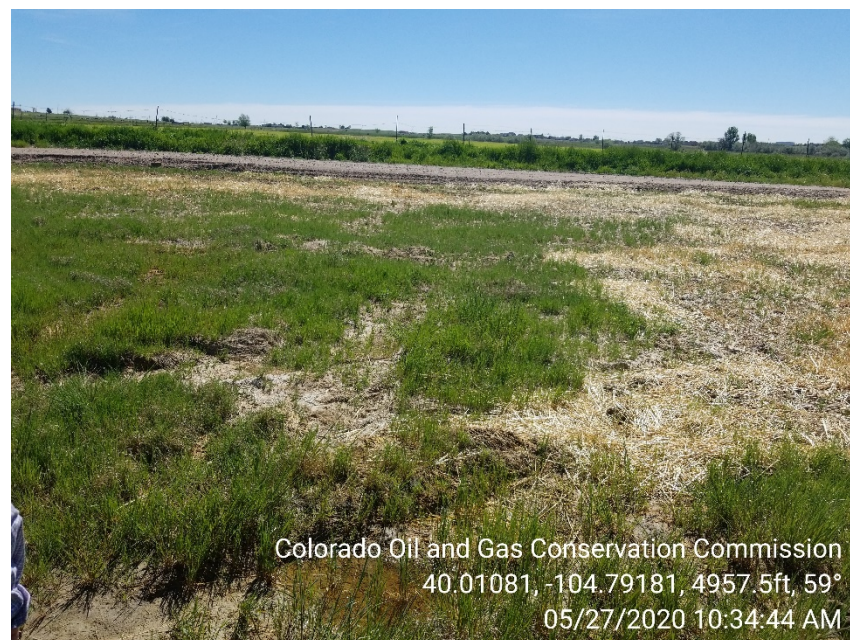
Photo 26 – Vehicle tracks through wetland area.
