Inspection Photos  
Operator Name: CAERUS PICEANCE LLC  
Facility ID: 476728

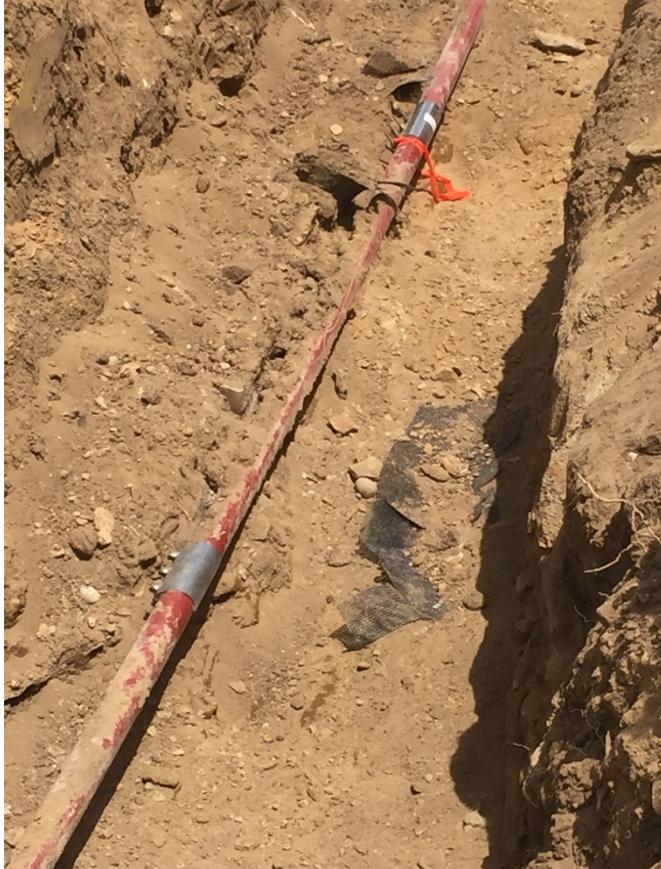
**Produced water gathering flowline with 2 temporary patches installed for pressure test**

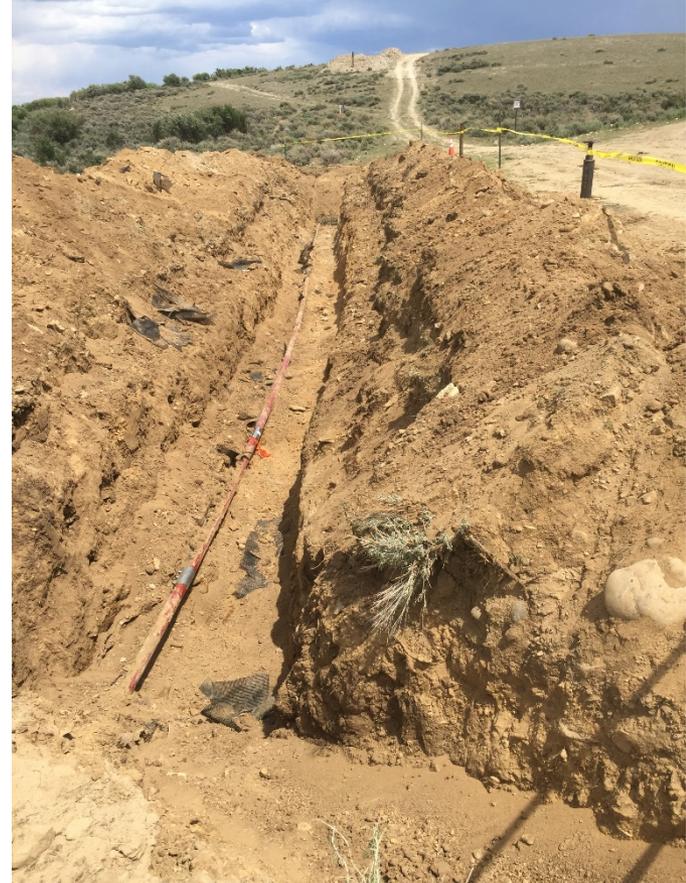
**Excavation area at 1<sup>st</sup> site. 2<sup>nd</sup> site on top of hill**

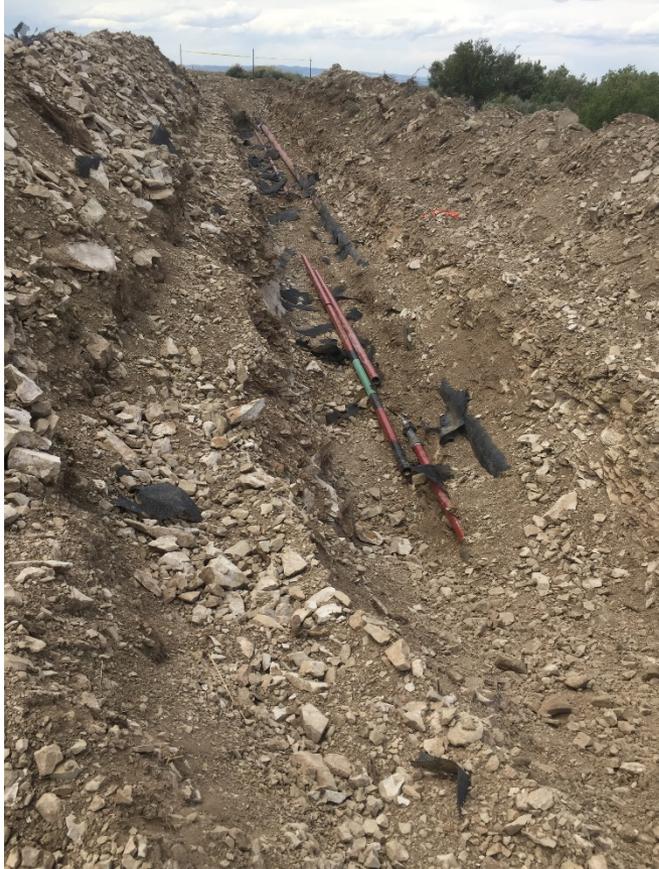
**Produced water gathering flowline with 2 temporary patches installed for pressure test at 2<sup>nd</sup> excavation site**

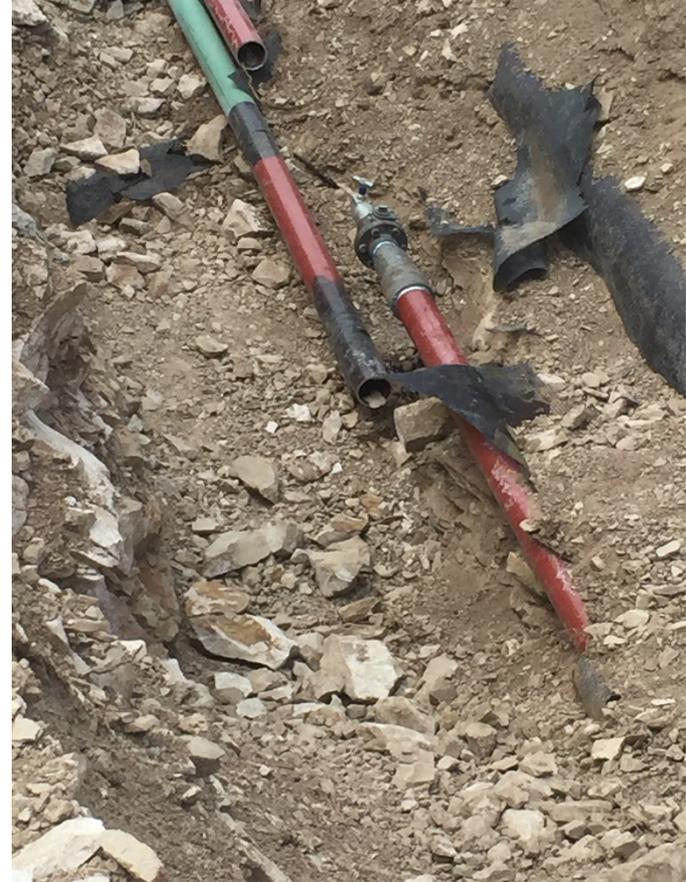
**Flowline cut and future pressure test from here to can, plan forward will be made with results of pressure test**

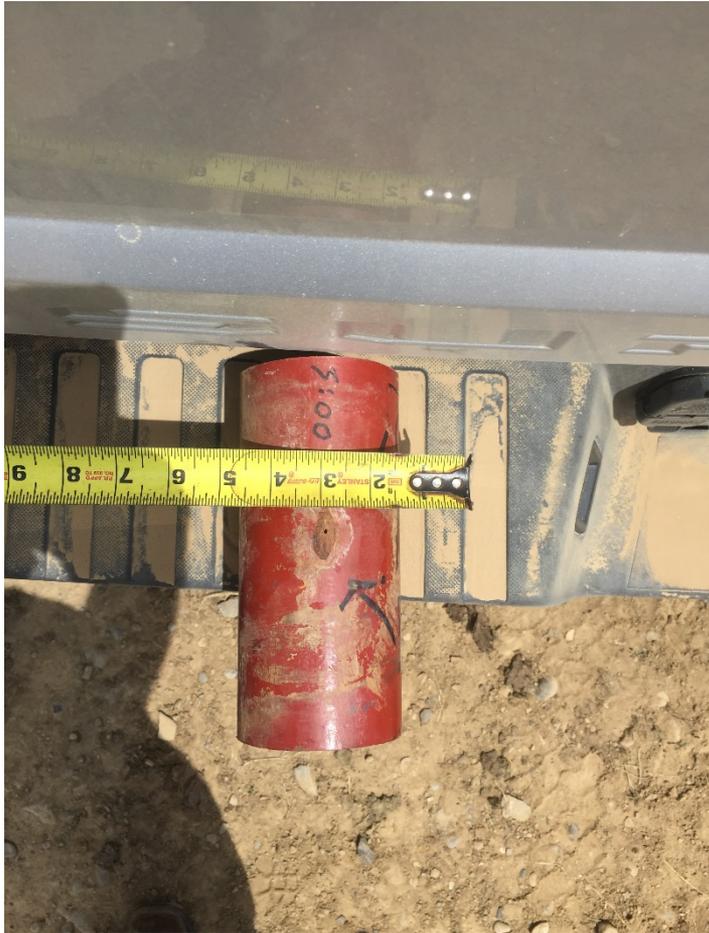
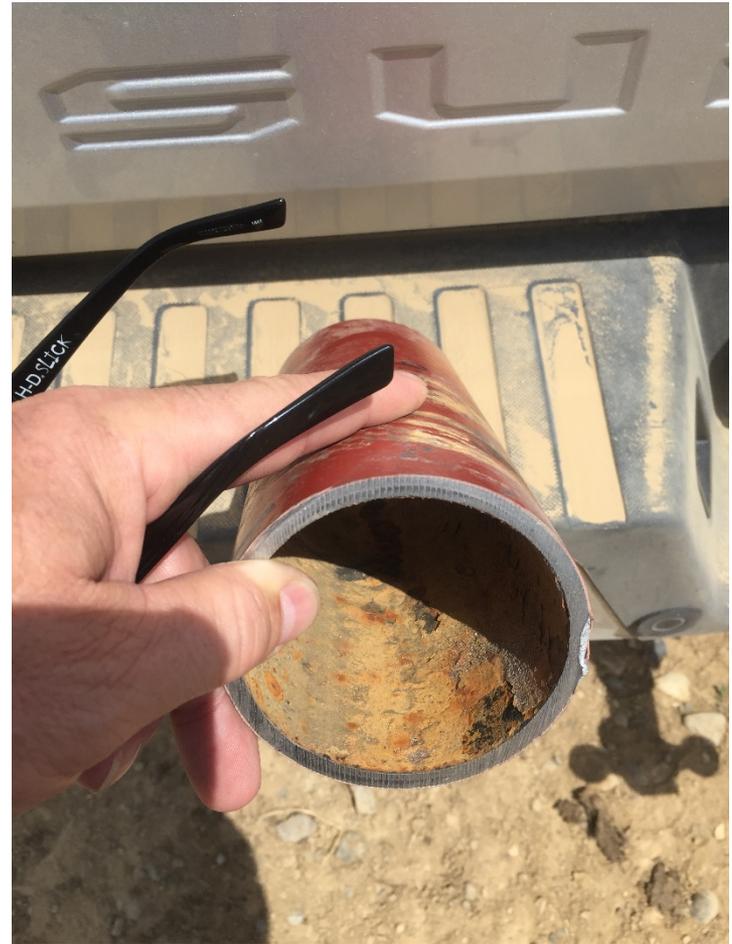
**Pinhole found in flowline in the 3 o'clock position**
