Inspection Photos

Location Name: CAERUS PICEANCE LLC DRY FORK FEDERAL-68S98W /11SESW

Location ID: 323897

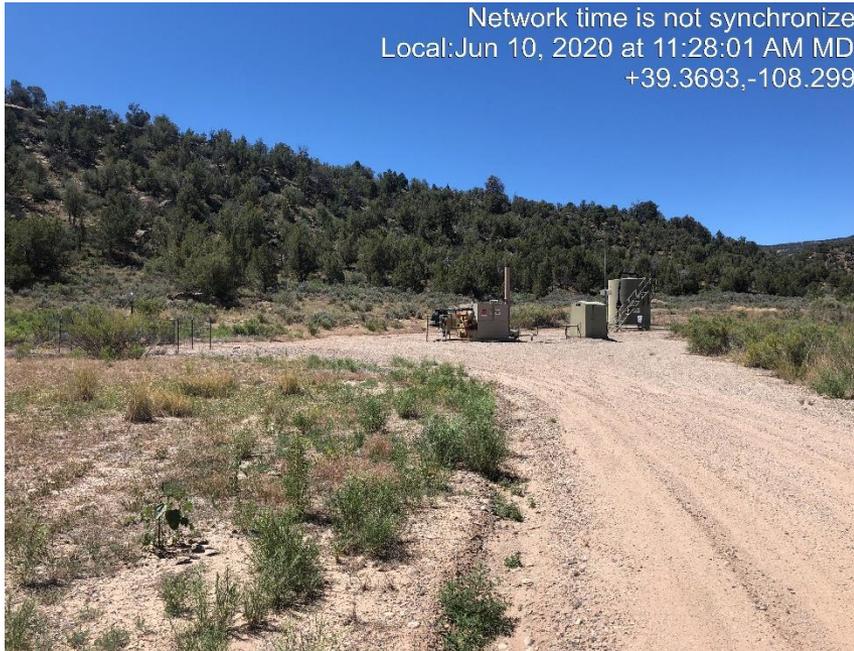
Photo #1339 from entrance to location

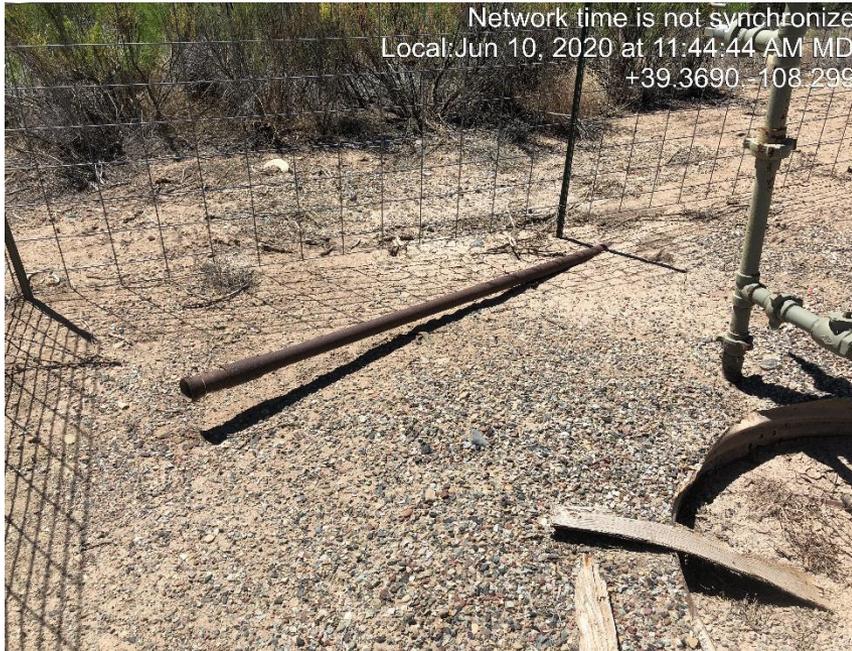
Photo #1340 Unused pipe by wellhead.
