# Inspection Photos

API: 05-055-06072

Operator: OXY USA INC

Inspection Date: 6/9/2020

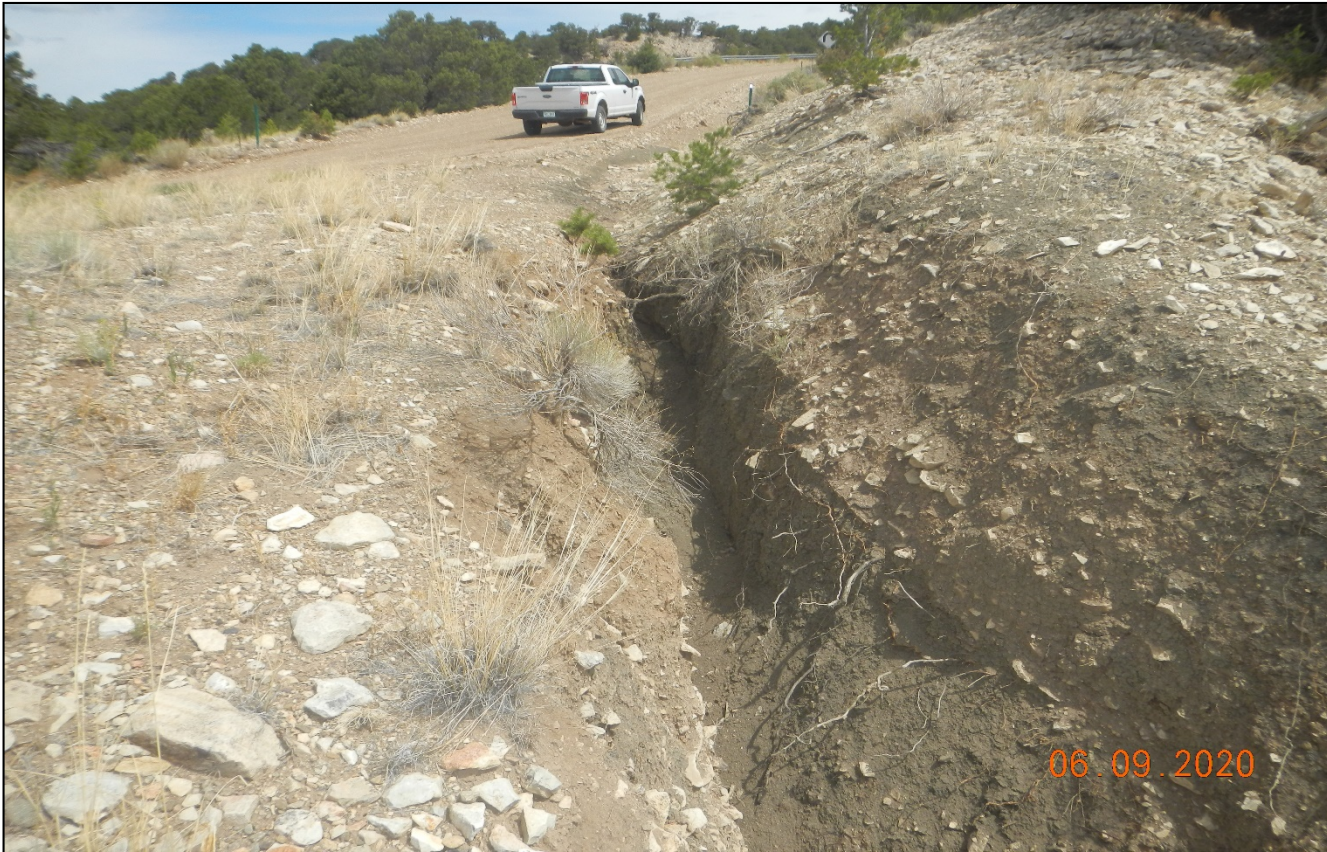
**Photo 1.** Facing north toward the access road. There is erosion occurring caused by stormwater directed off the road at Lat/Long:37.71484,-105.23178.

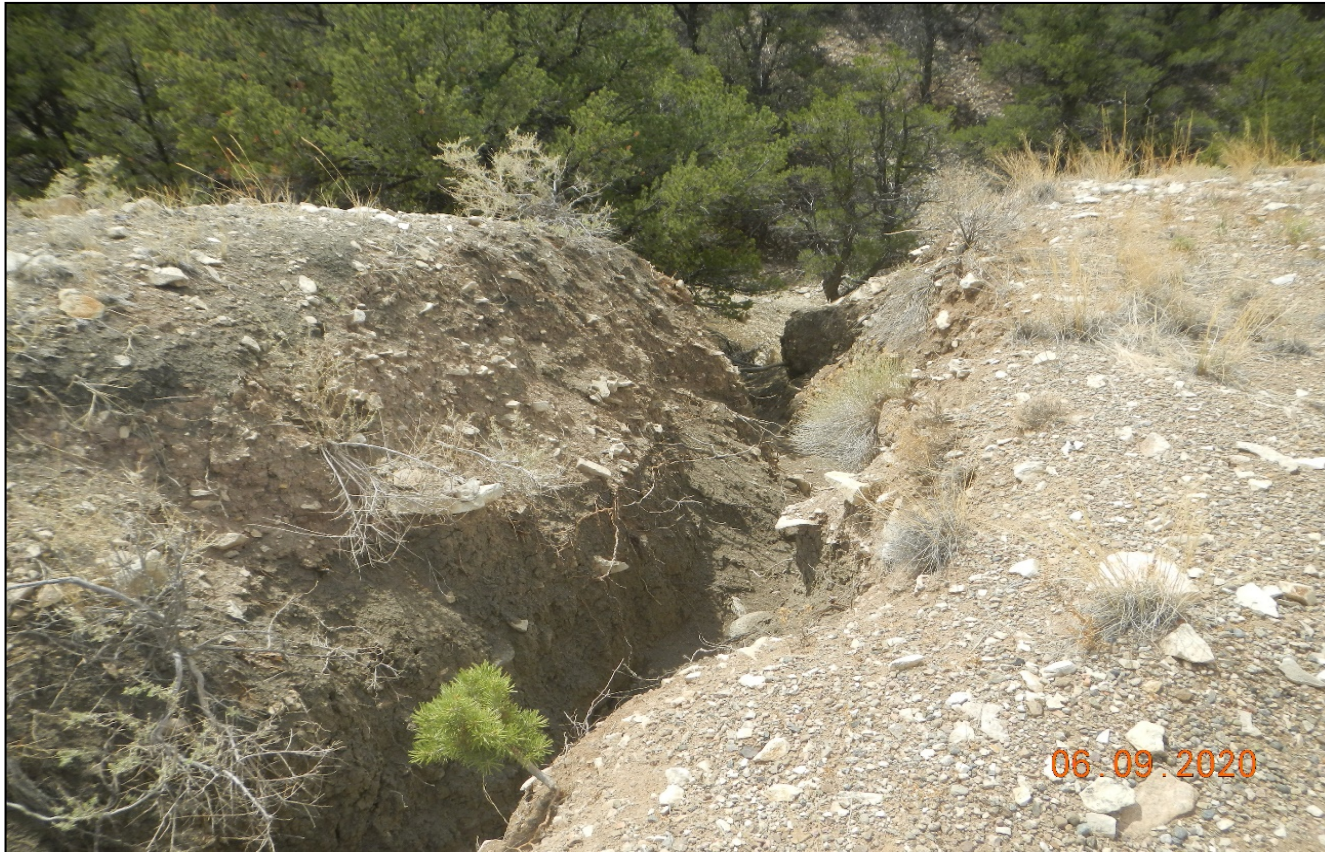
**Photo 2.** Facing south toward erosion which is occurring from stormwater runoff shown in previous photo at Lat/Long:37.71484,-105.23178.

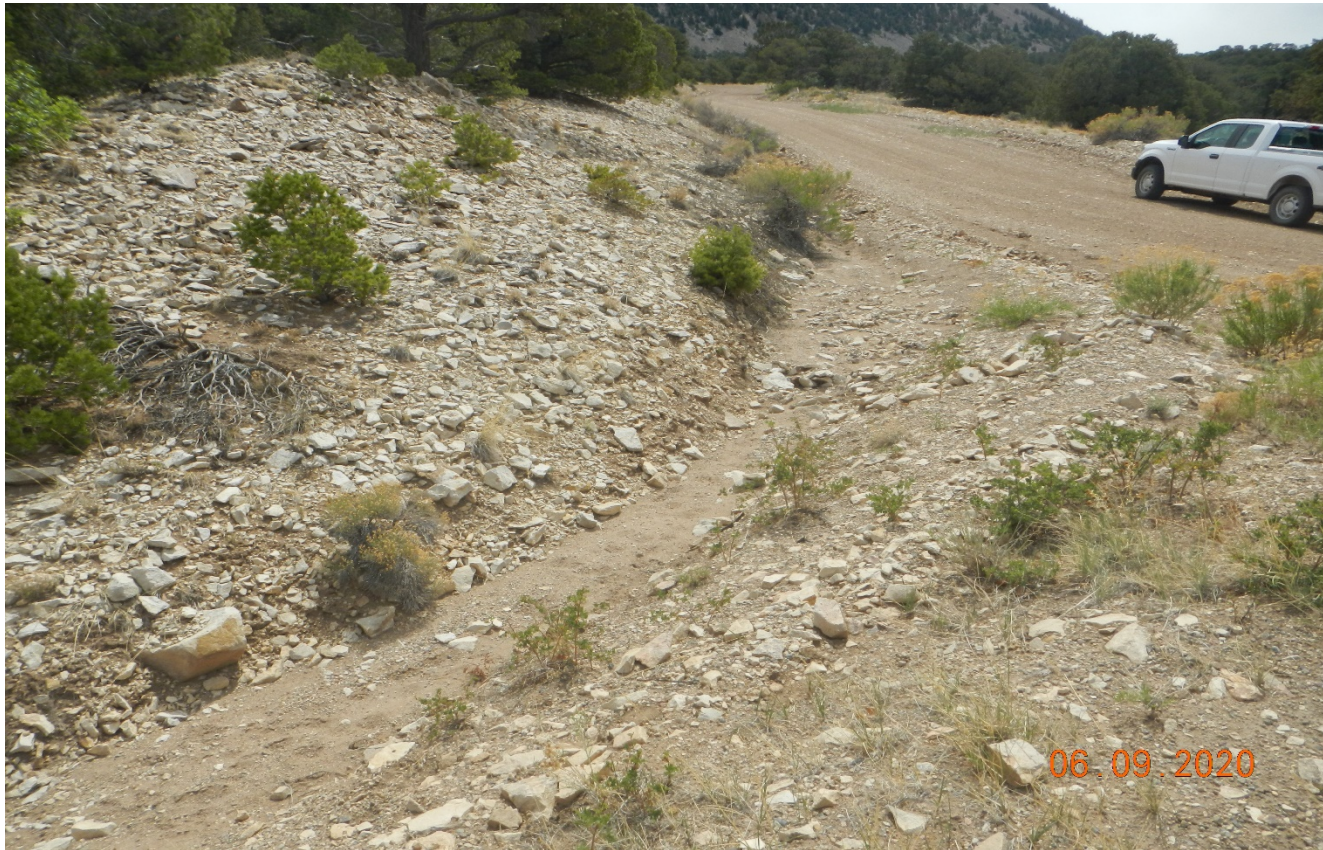
**Photo 3.** Facing east on the next switchback of the road. Stormwater is directed off the road which is causing erosion shown in the next photo at Lat/Long:37.71576,-105.23161.

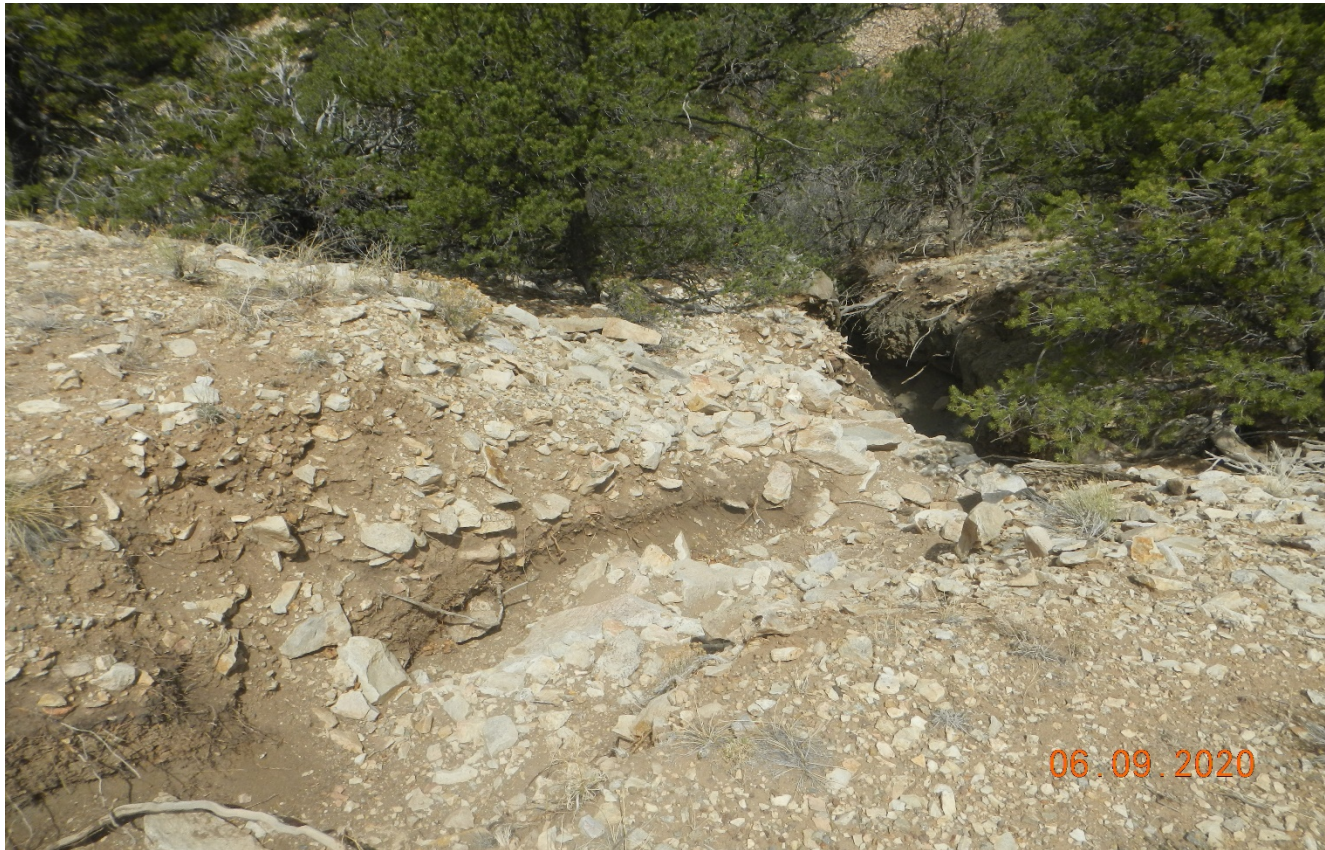
**Photo 4.** Facing nothwest toward erosion which is occurring from stormwater runoff shown in previous photo at Lat/Long:37.71484,-105.23178.

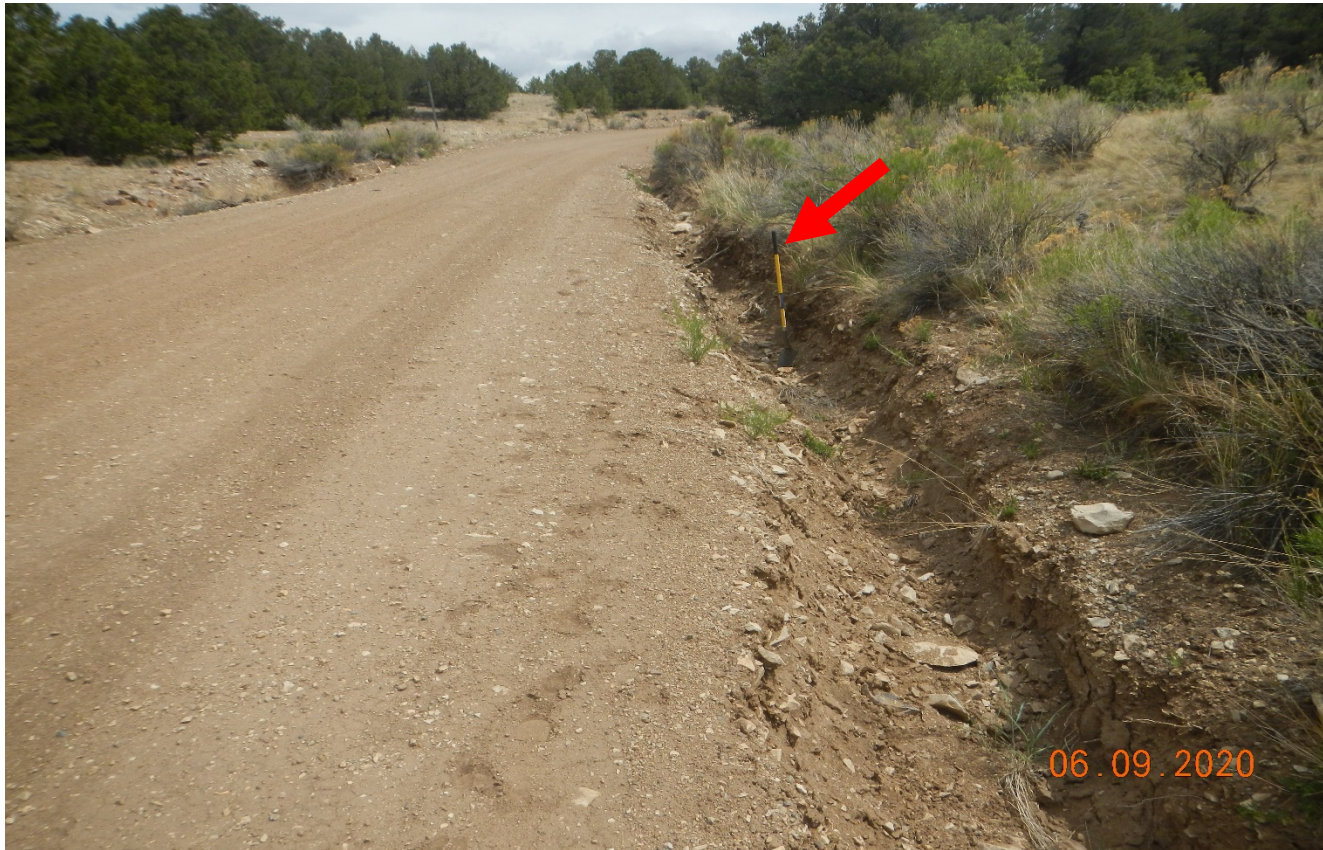
**Photo 5.** There is erosion occurring along the main access road at Lat/Long:37.71665,-105.22713. Red arrow points to 4.5 ft. shovel to depth of erosion.

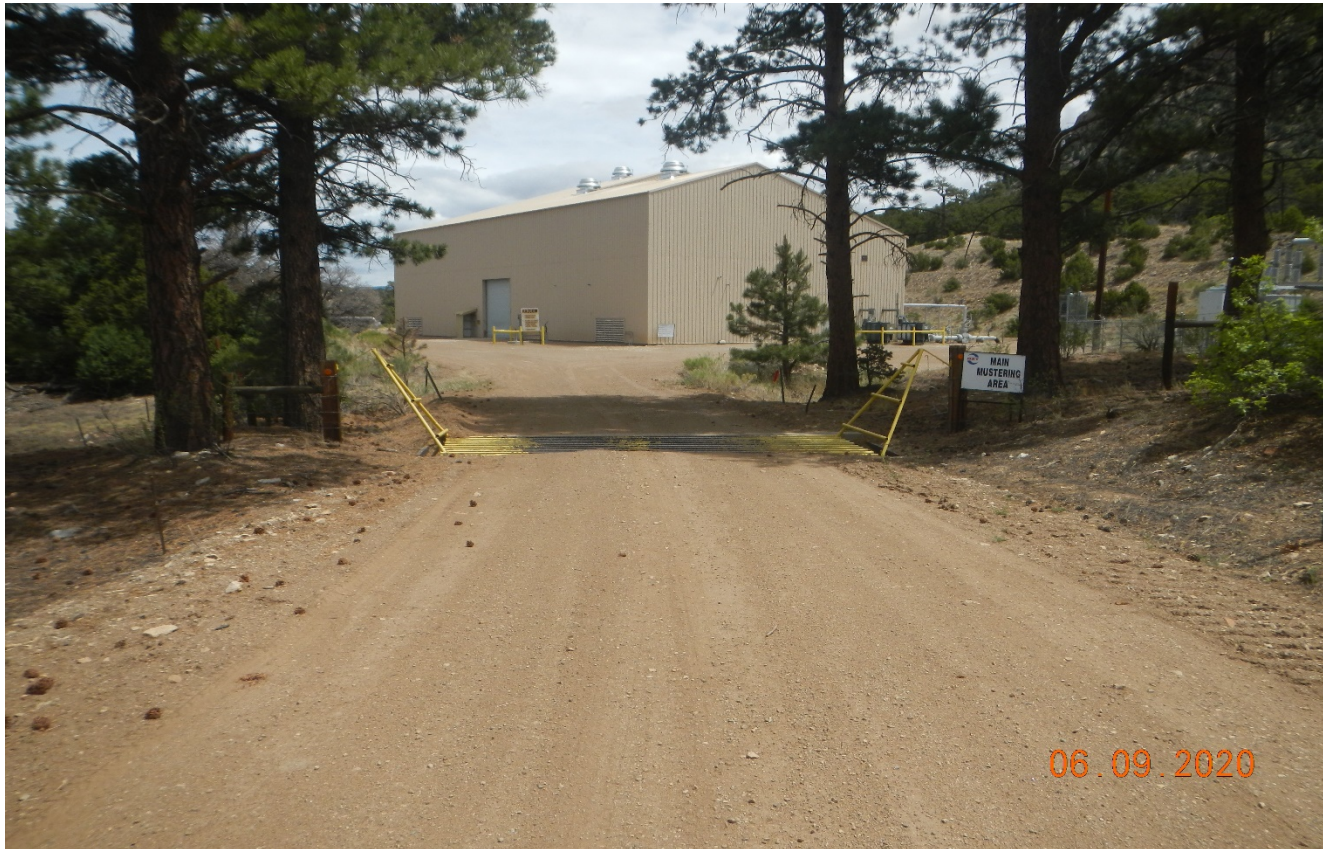
**Photo 6.** Facing northeast toward the compressor station.

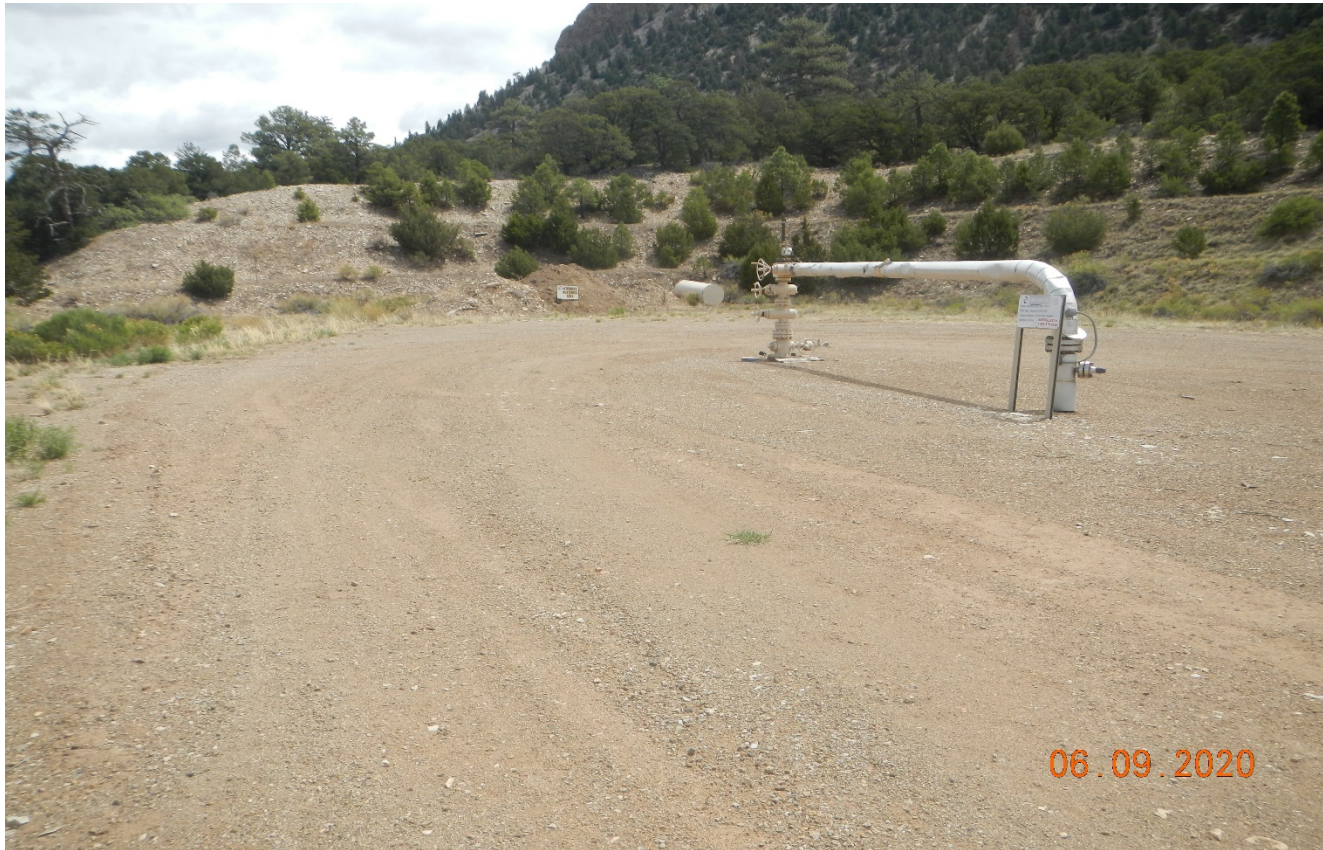
**Photo 7.** Facing northeast toward the SMU 4-4 well. Sign is posted at the wellhead.

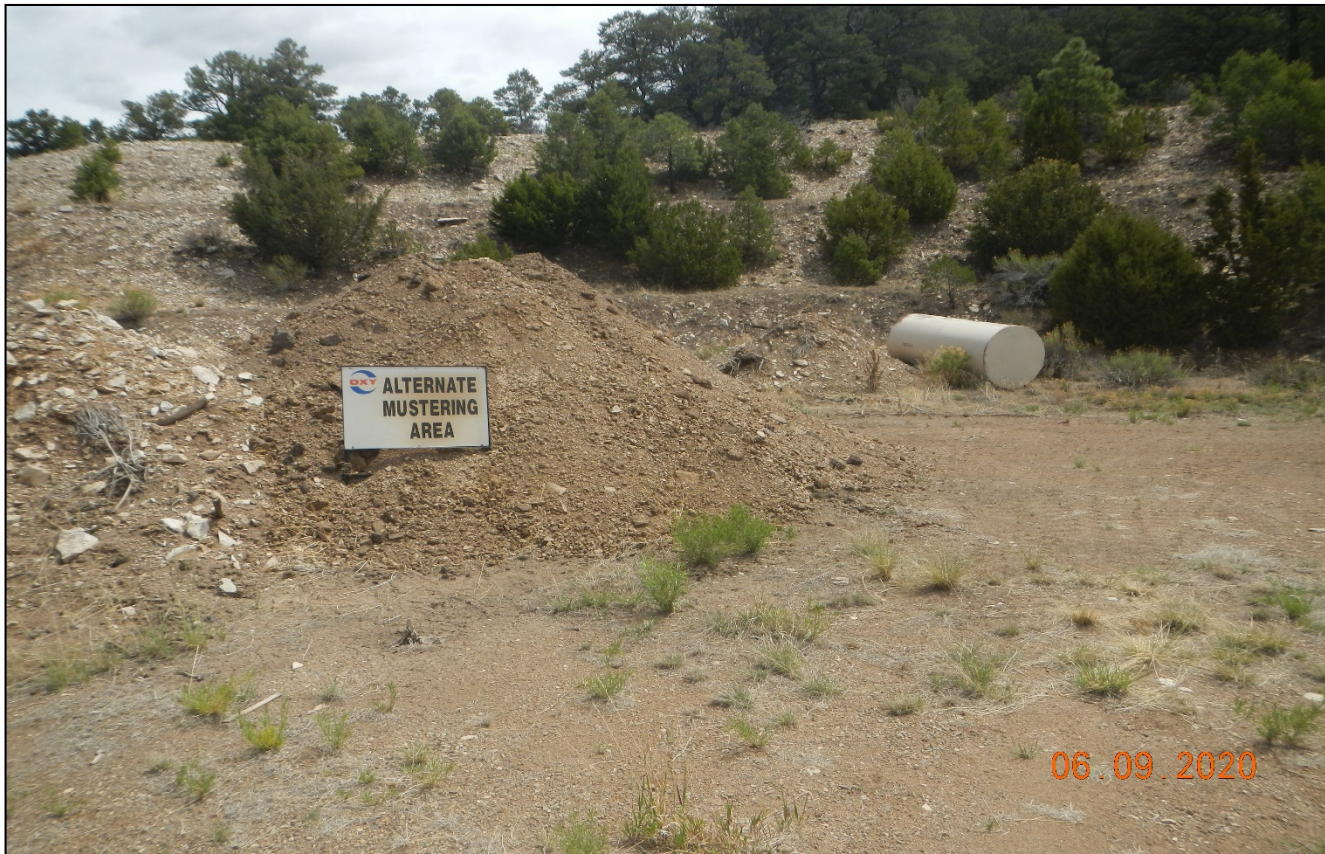
**Photo 8.** There is a pile of soil and an unused tank stored at the northeast side of the location.

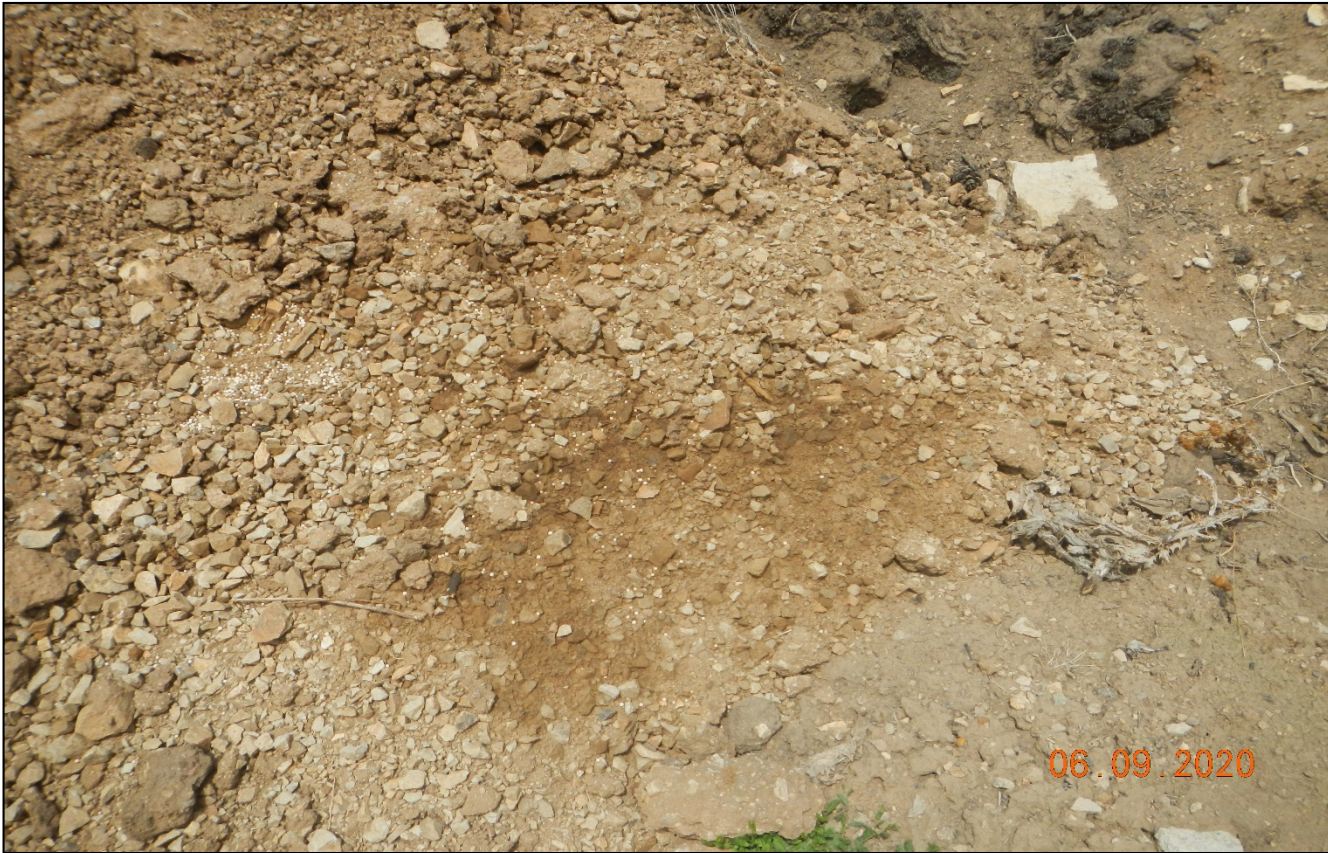
**Photo 9.** There is oil stained soils in the soil pile at the northeast side of the location. The soil had an oil odor.

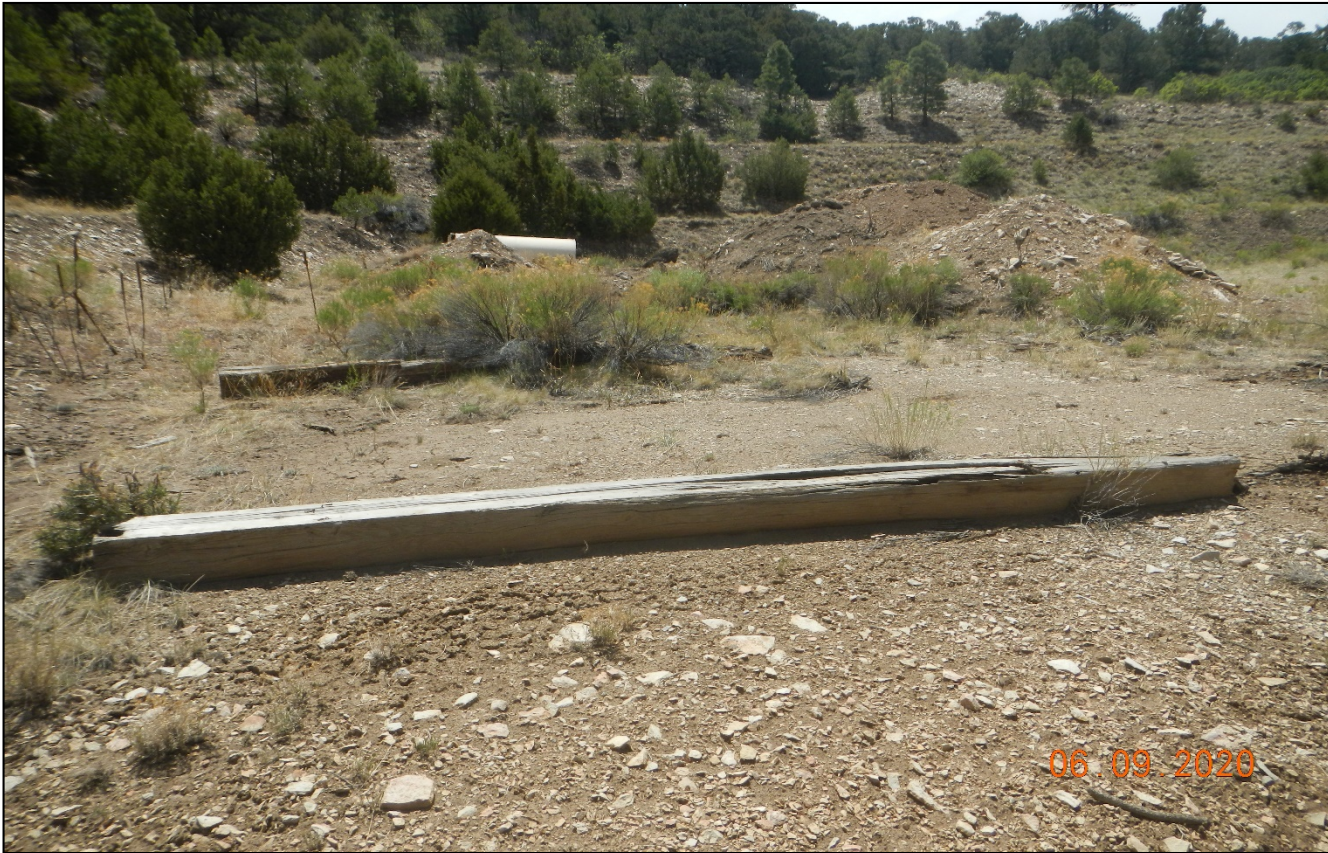
**Photo 10.** There is degraded wood timbers that need to be removed.

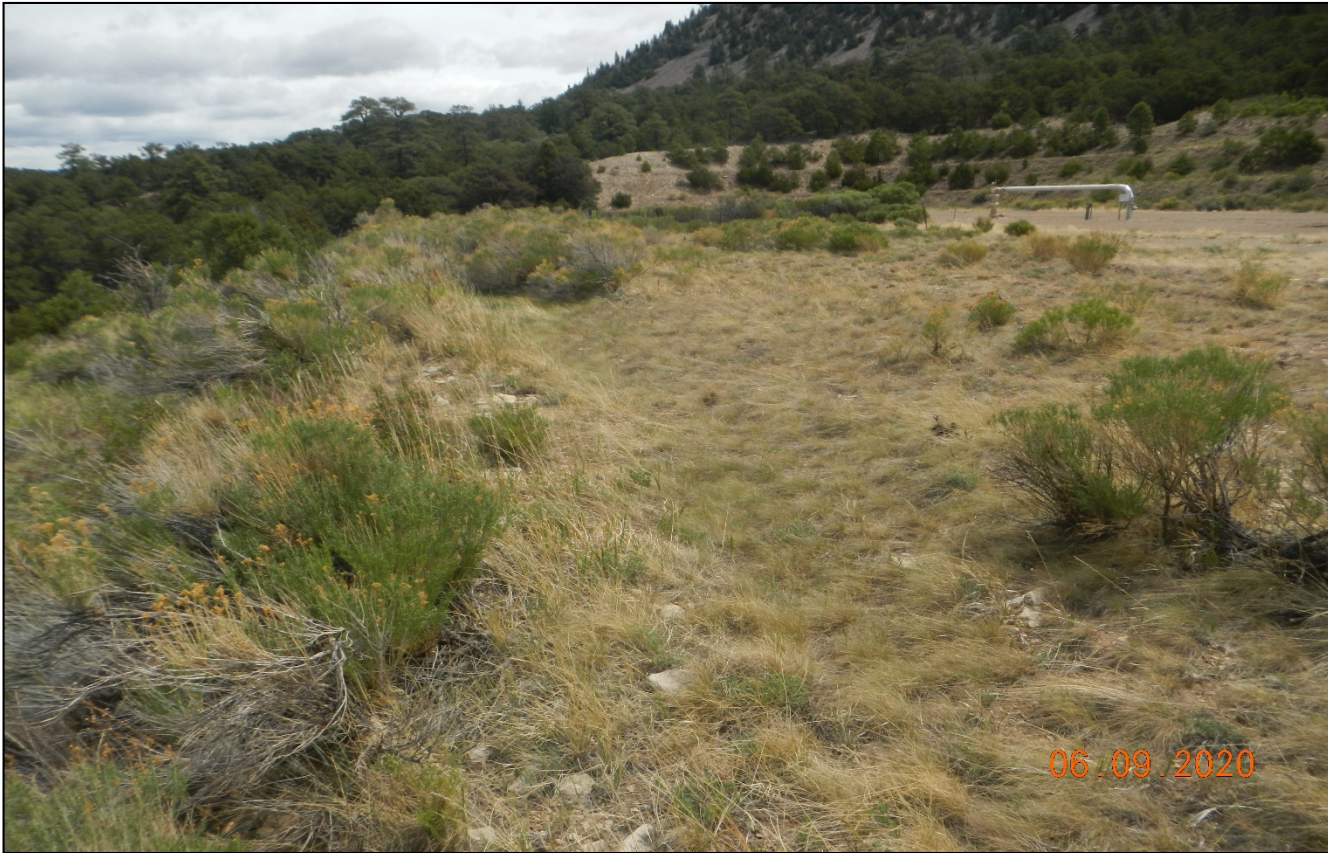
**Photo 11.** Facing northeast toward the fill slope of the location. The vegetation is well established in the interim reclamation area.
