# Inspection Photos

API: 05-055-06314

Operator: OXY USA INC

Inspection Date: 6/9/2020

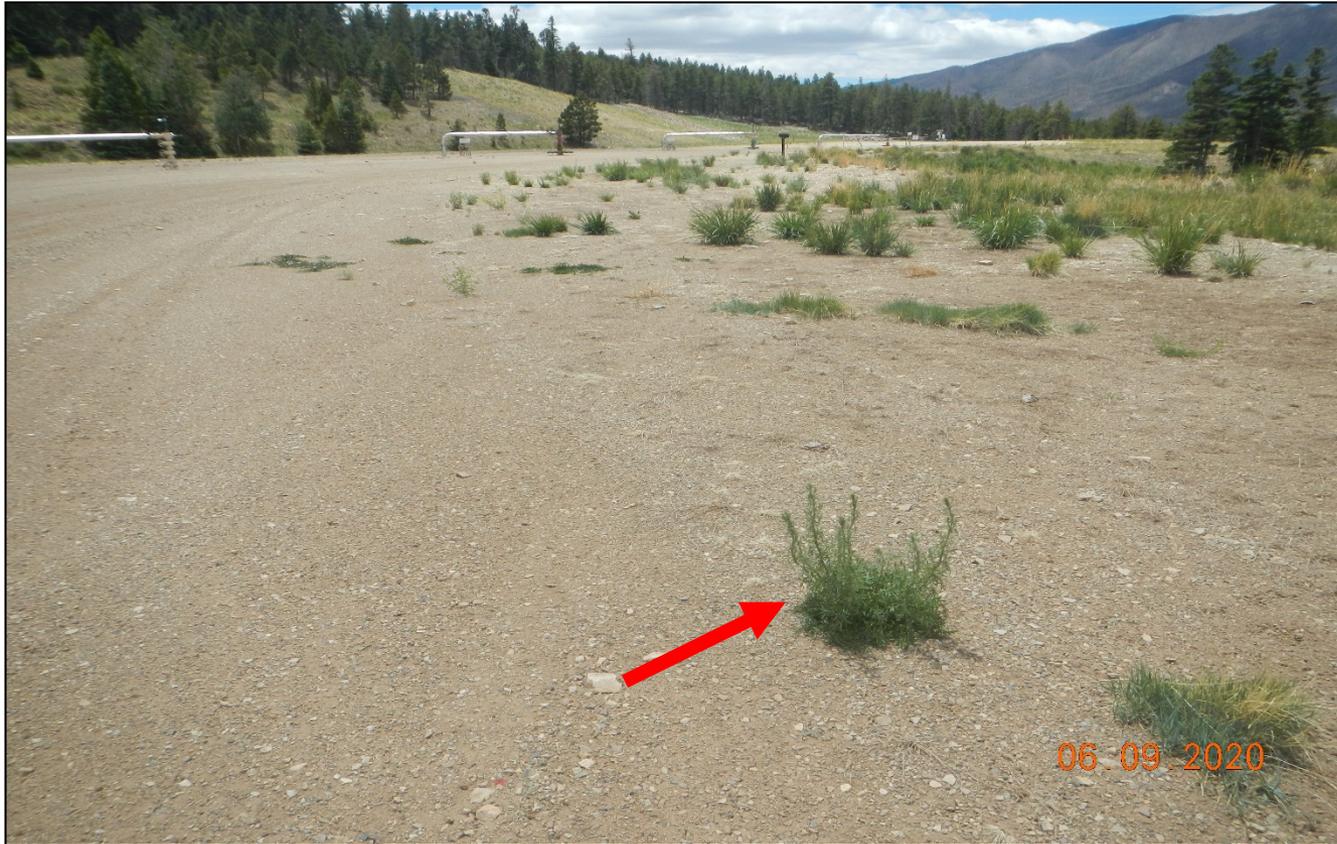
**Photo 4.** Facing southwest toward the location. Red arrow points to Diffuse knapweed List B noxious weed which needs to be controlled.

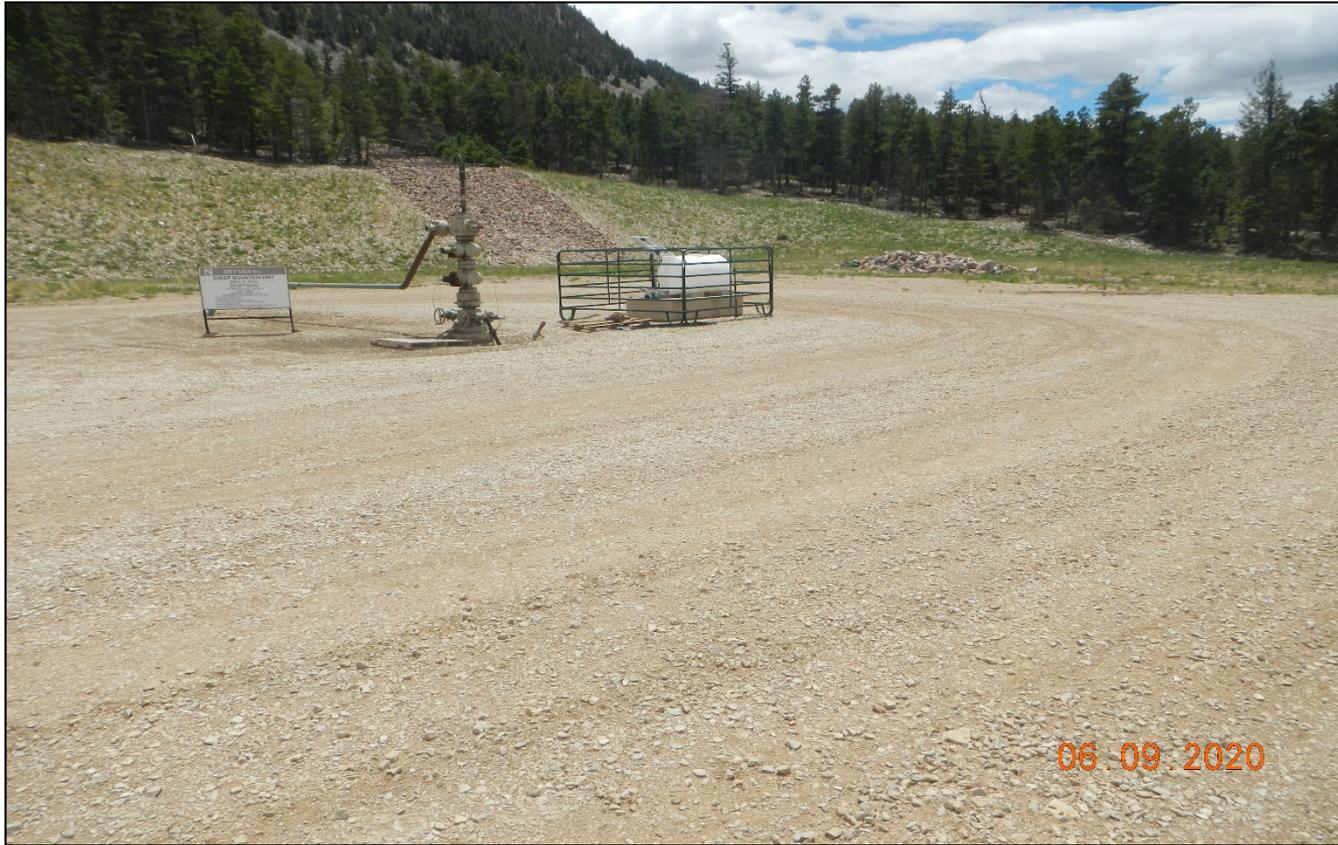
**Photo 2.** Facing southeast toward the SMU 4-23 well.

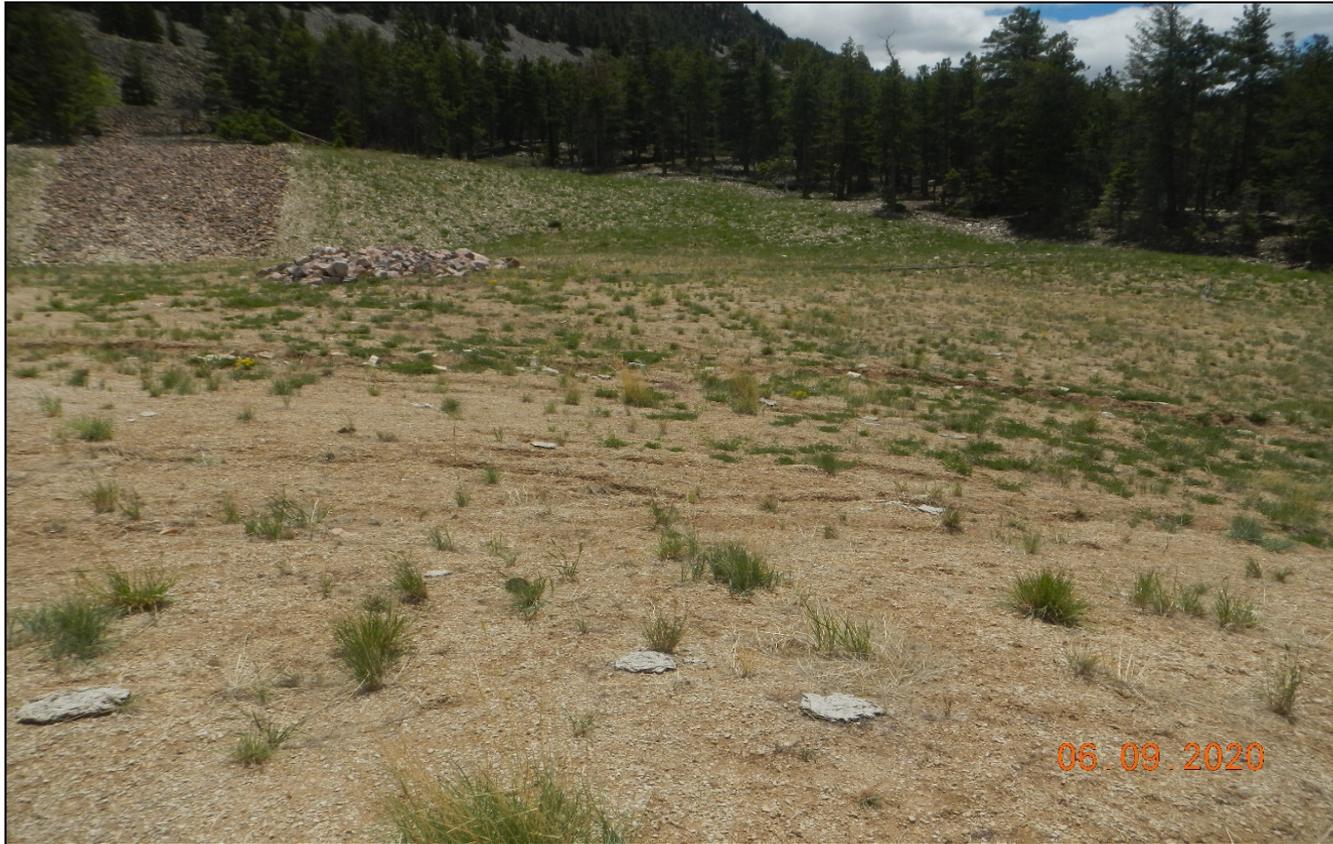
**Photo 3.** Facing southeast toward the interim reclamation area. Vegetation has not adequately reestablished and there are signs of erosion.

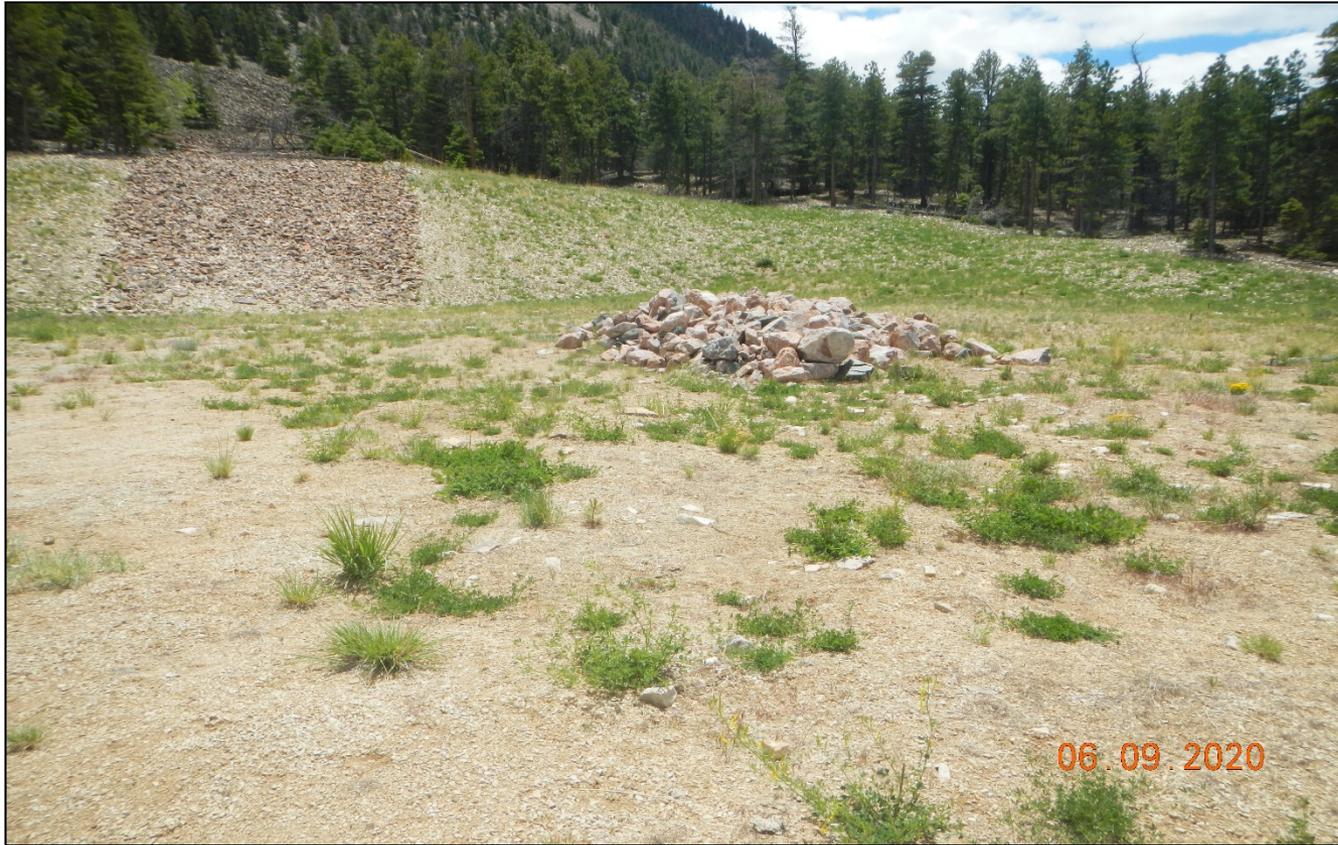
**Photo 4.** There is a pile of rock at the south side of the location that needs to be removed.

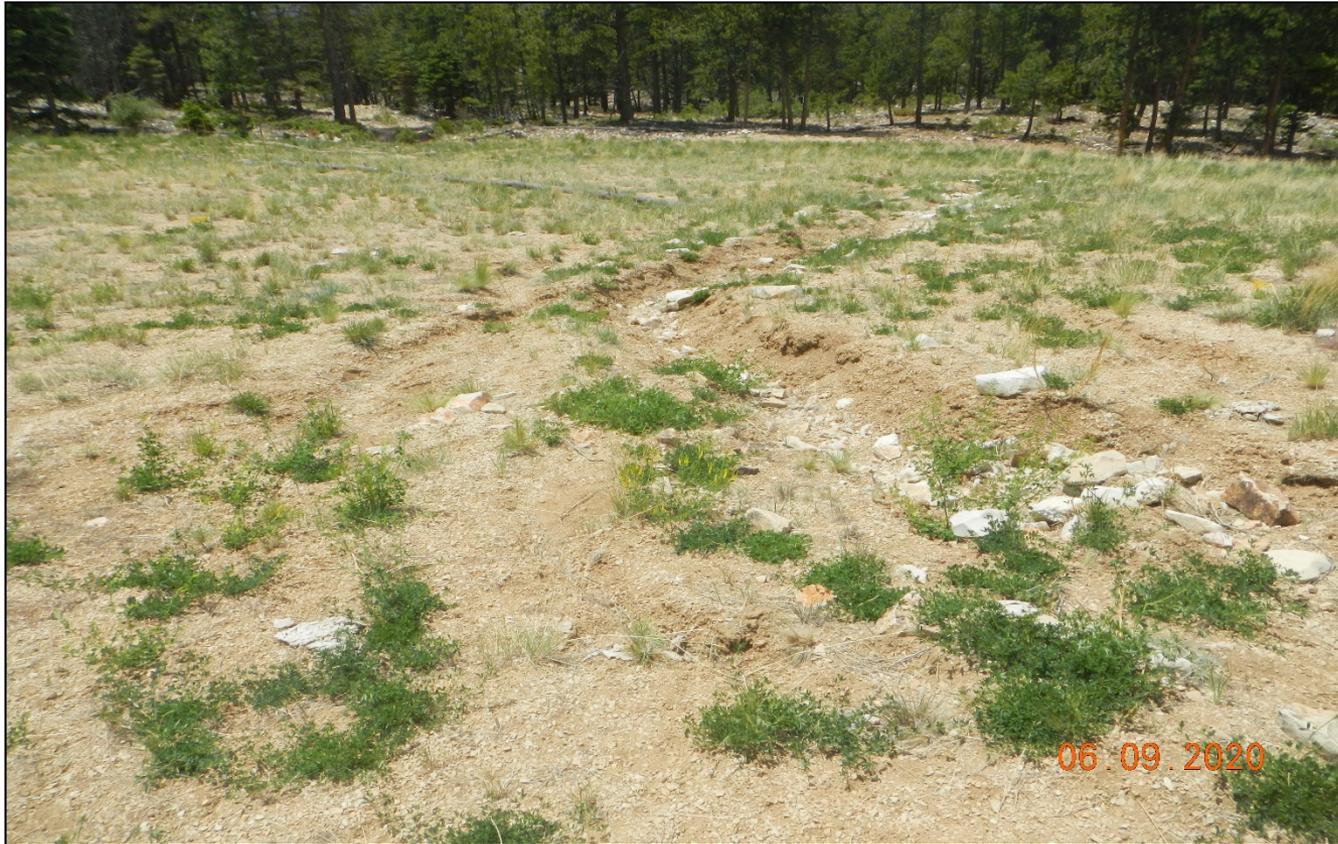
**Photo 5.** There is erosion channels at the reclaimed area at the south side of the location. There are signs that the check dams and wattles have failed.

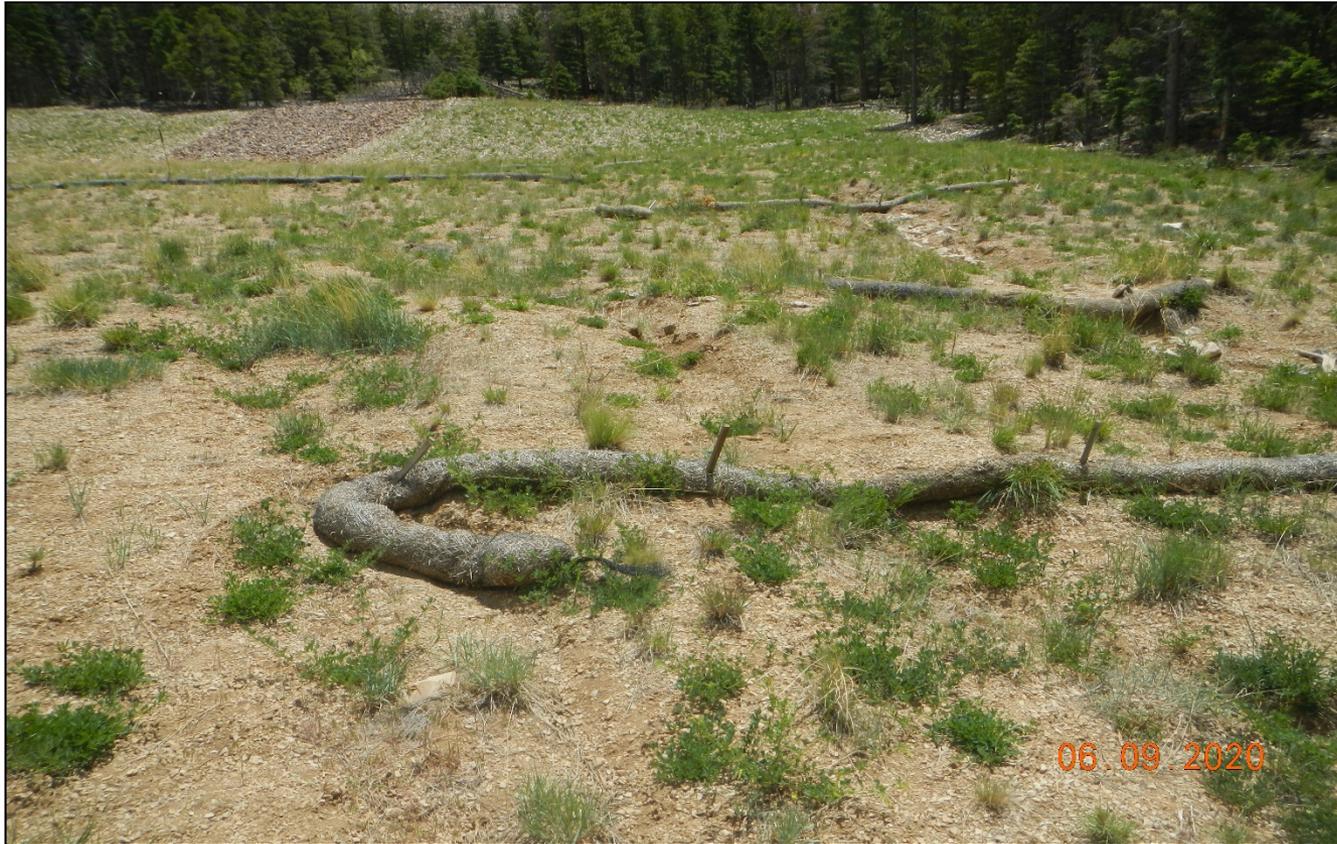
**Photo 6.** The wattles at the south side of the location are filled in with sediment and displaced. The BMP's have not been repaired since the previous inspection.

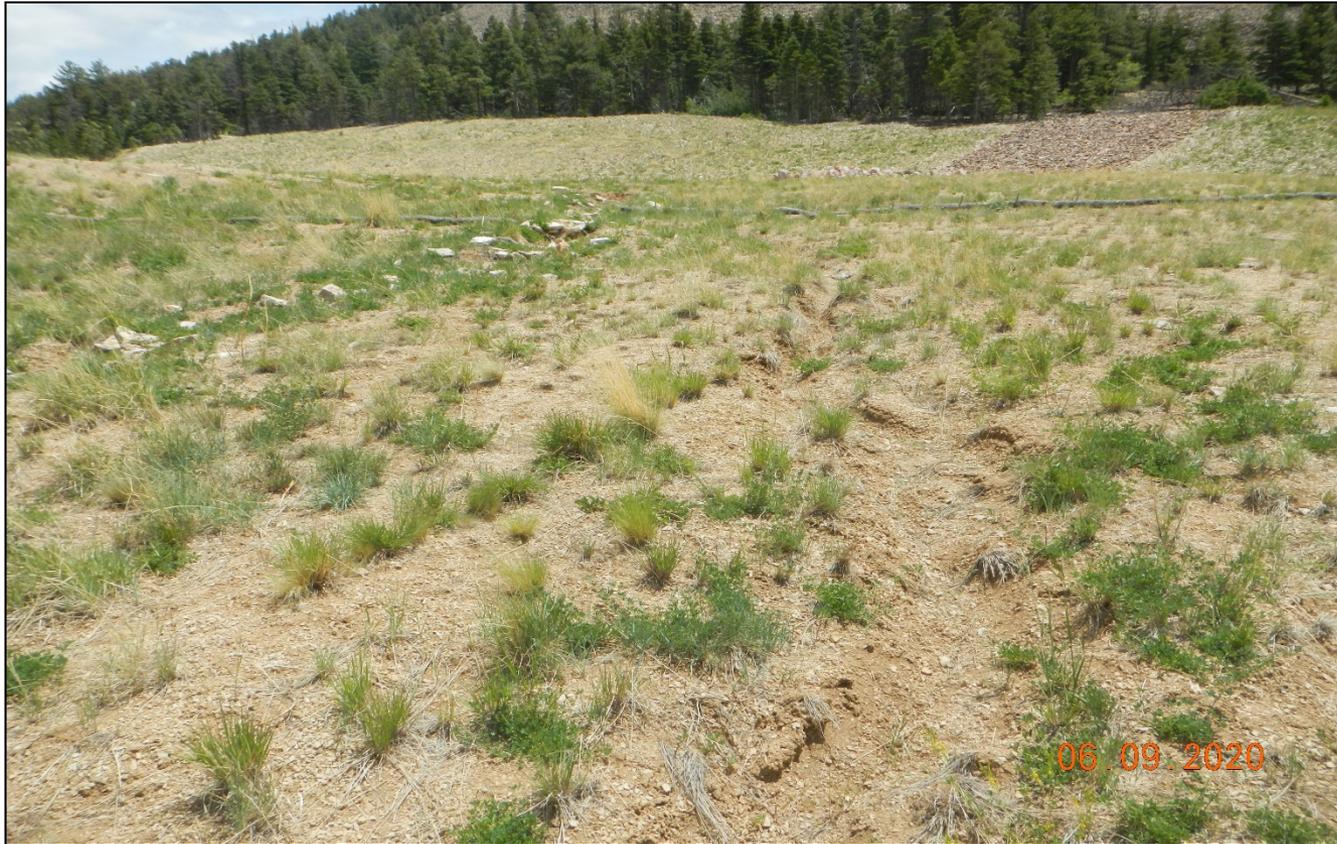
**Photo 7.** Facing east toward the interim reclamation area. Vegetation has not adequately reestablished and there are signs of erosion.

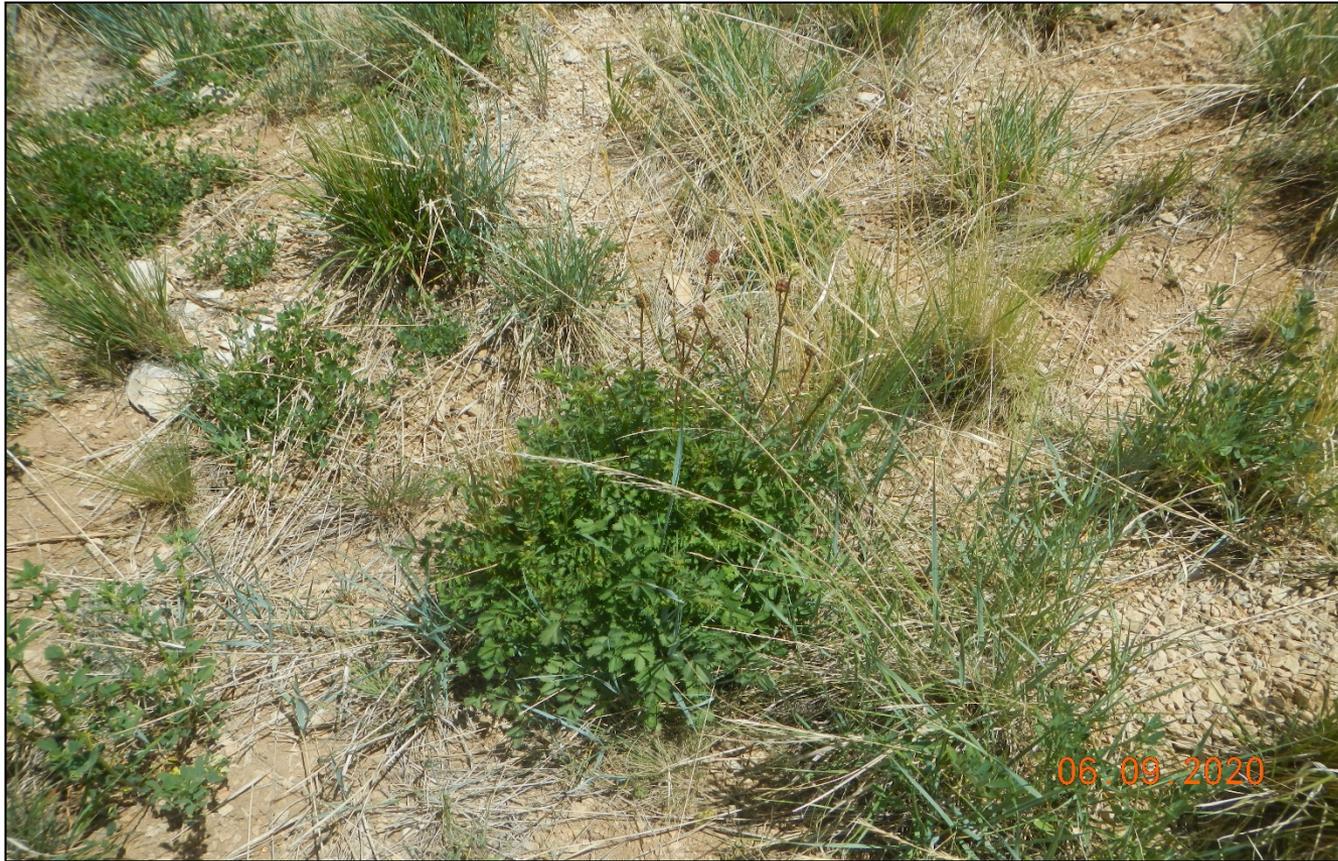
**Photo 8.** There are numerous non native Small burnet (*Sanguisorba minor*) plants growing in the interim reclamation area. The plants are not reflective of reference area vegetation and not a desired landowner specie. The plants must be eradicated.

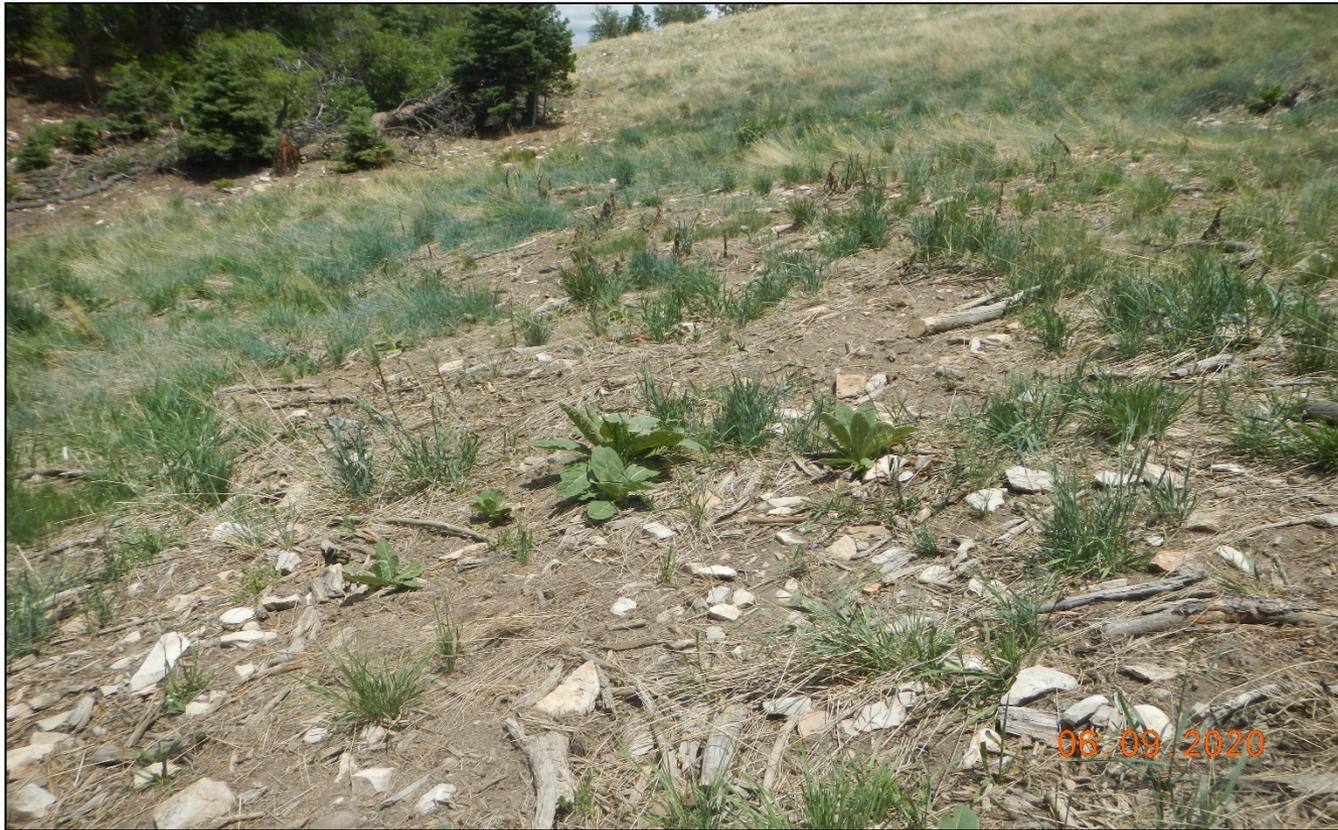
**Photo 9.** There is noxious weeds (Mullein) beginning to establish at the west side of the fill slope which needs to be controlled.
