Inspection Photos
Operator: BP America
API#: 067-06819
Date: 6/11/2020

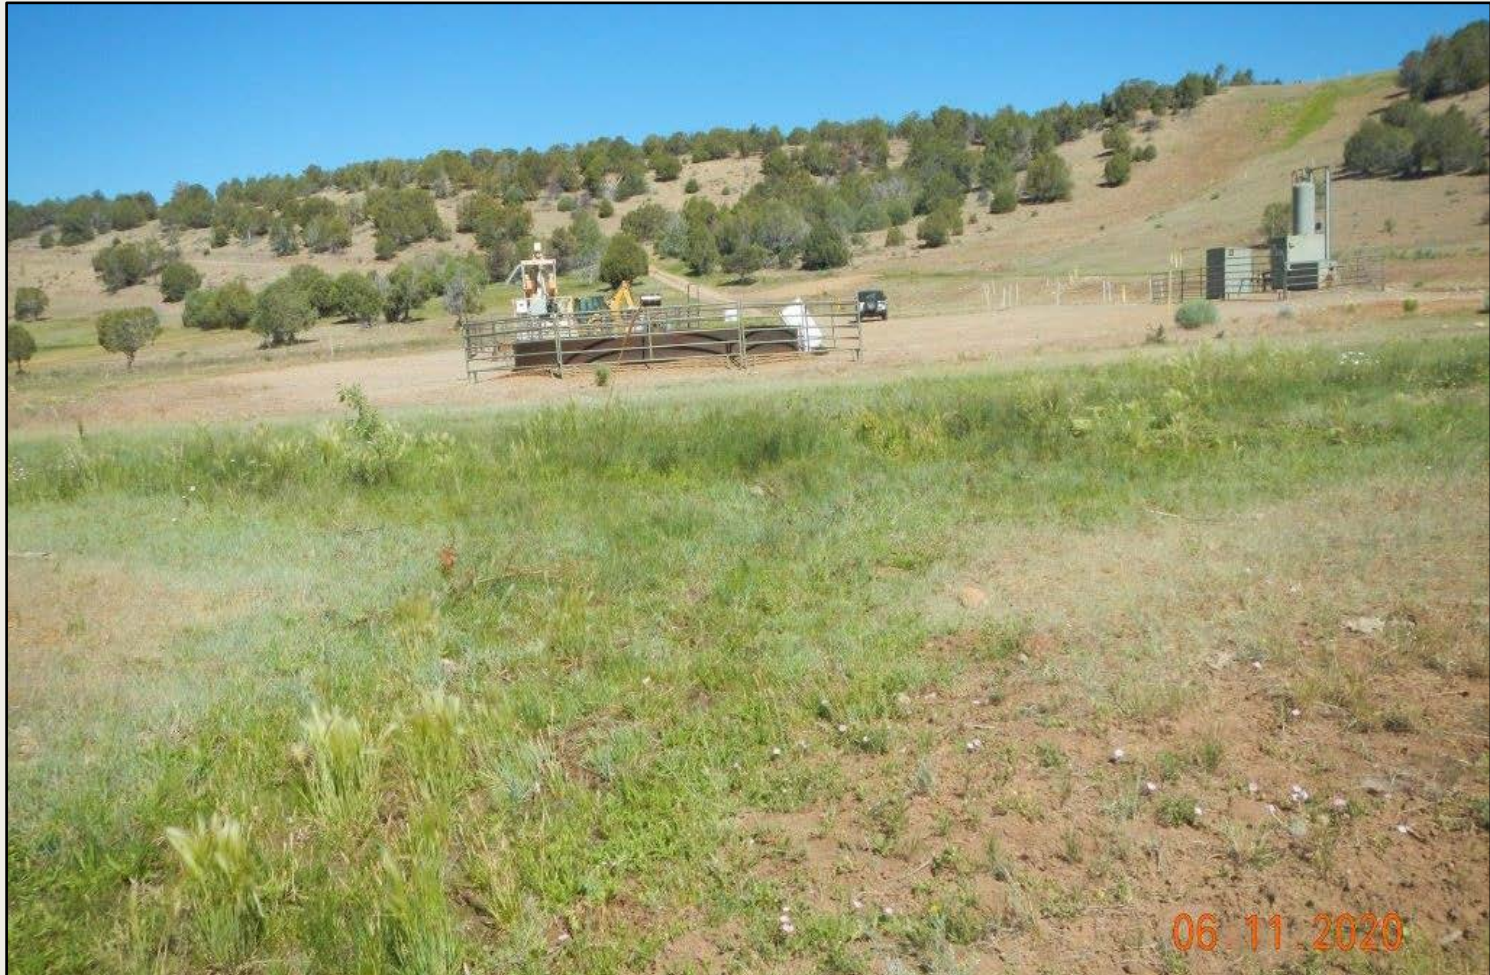
Photo 1. View of the project area from the southeastern corner facing center.

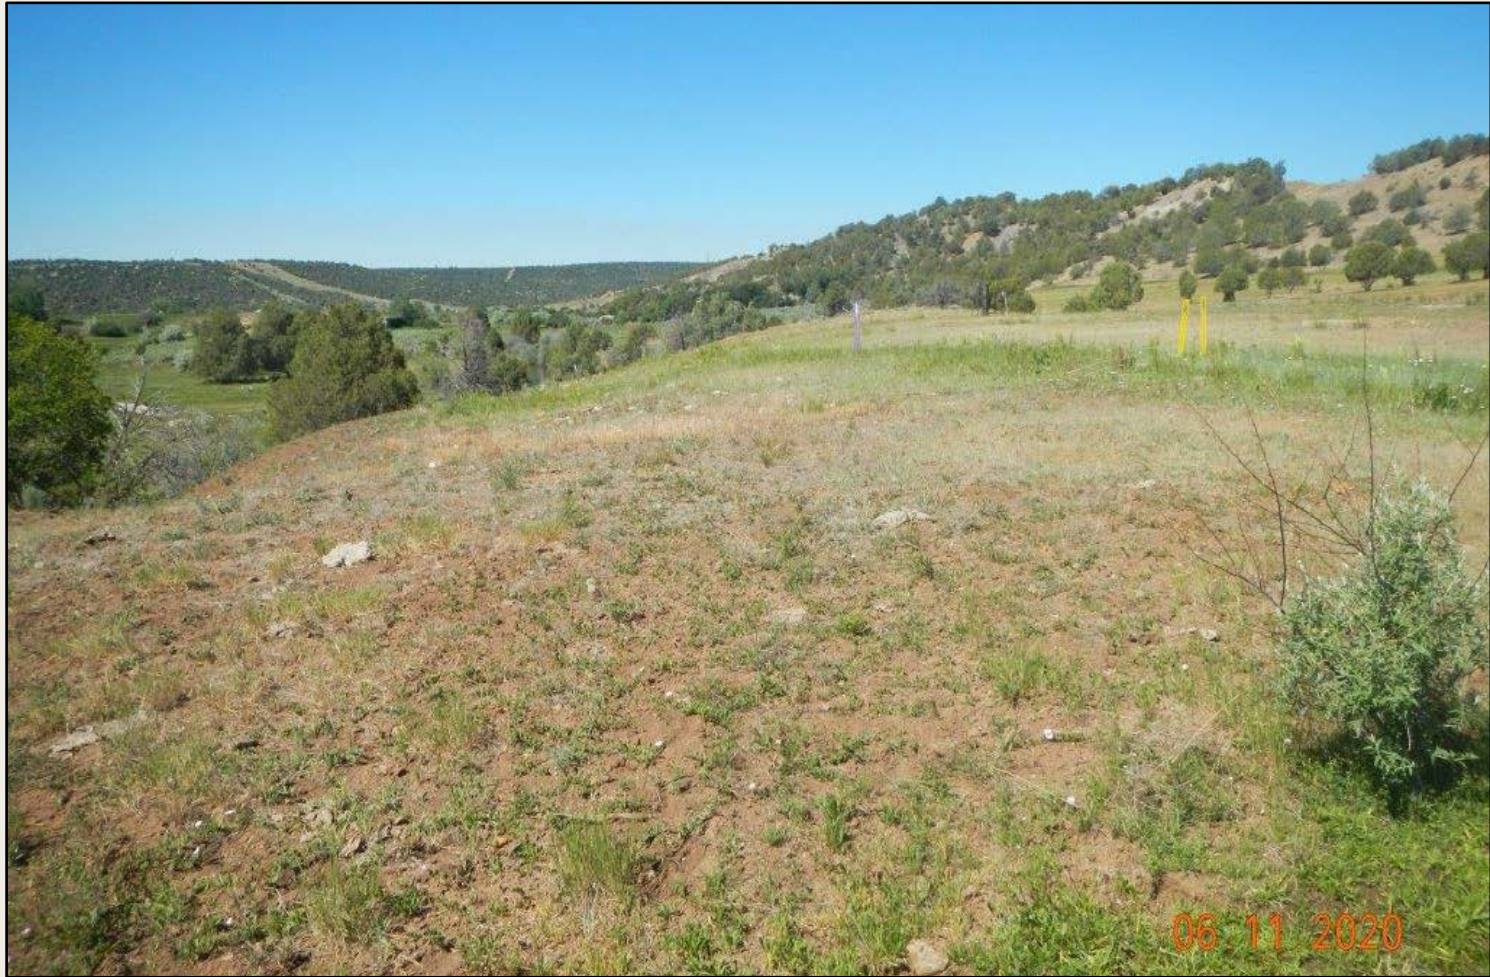
Photo 2. View of the southern fill slope from the southeastern corner facing westward. Revegetation is progressing in a grazed condition with grasses such as western wheatgrass and smooth brome.

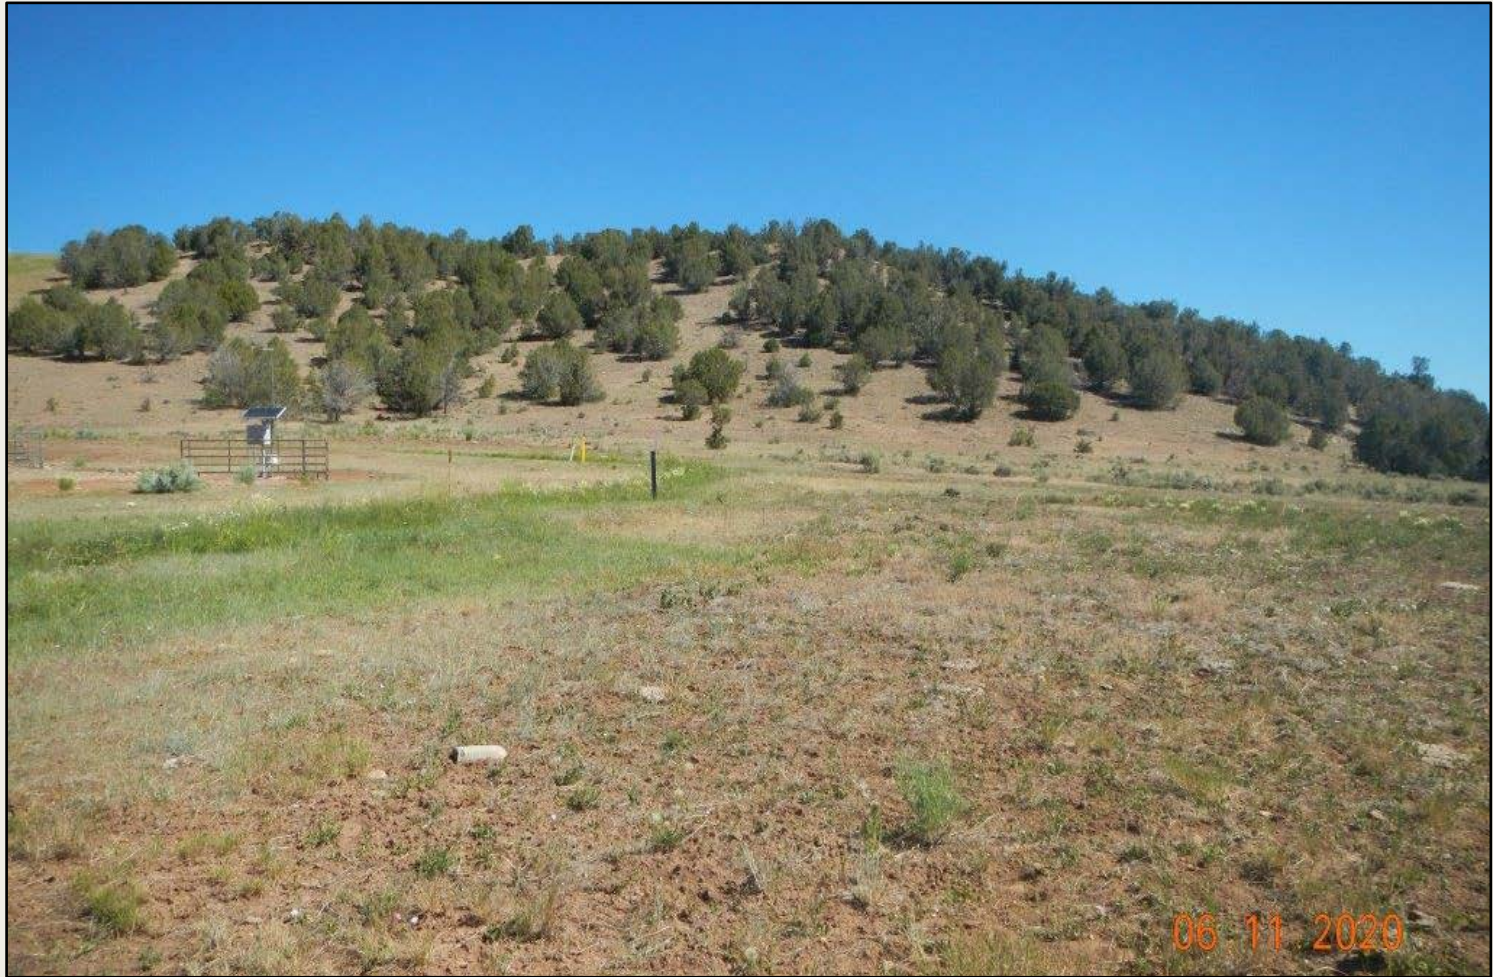
Photo 3. View of the eastern project area from the southeastern corner facing northward.

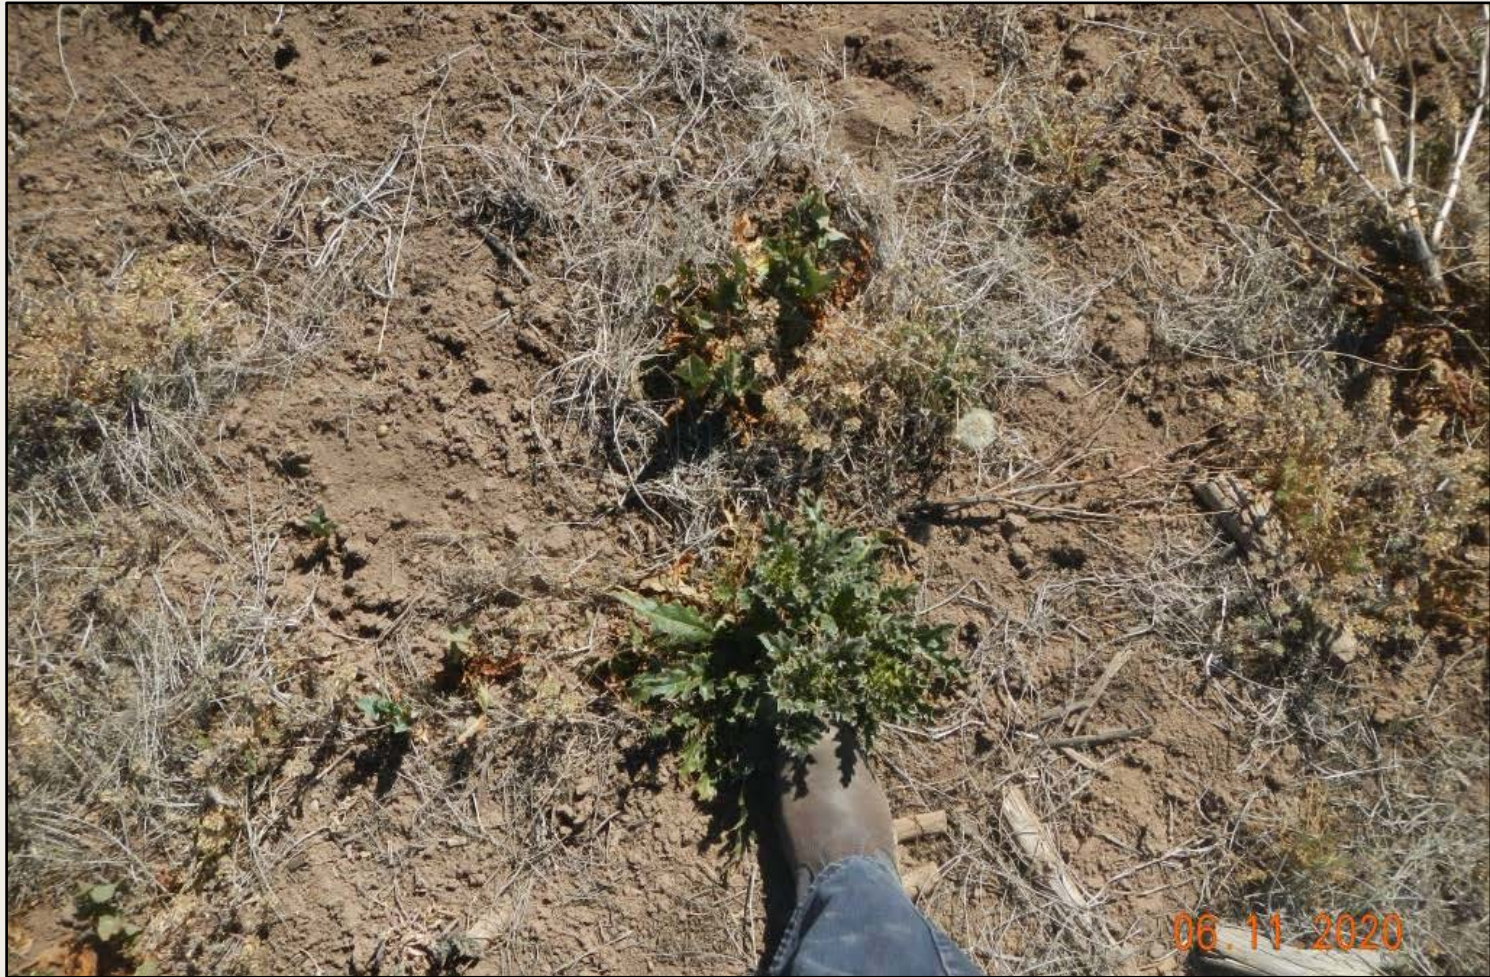
Photo 4. View of musk thistles within the project area, approximately 200 individuals observed.

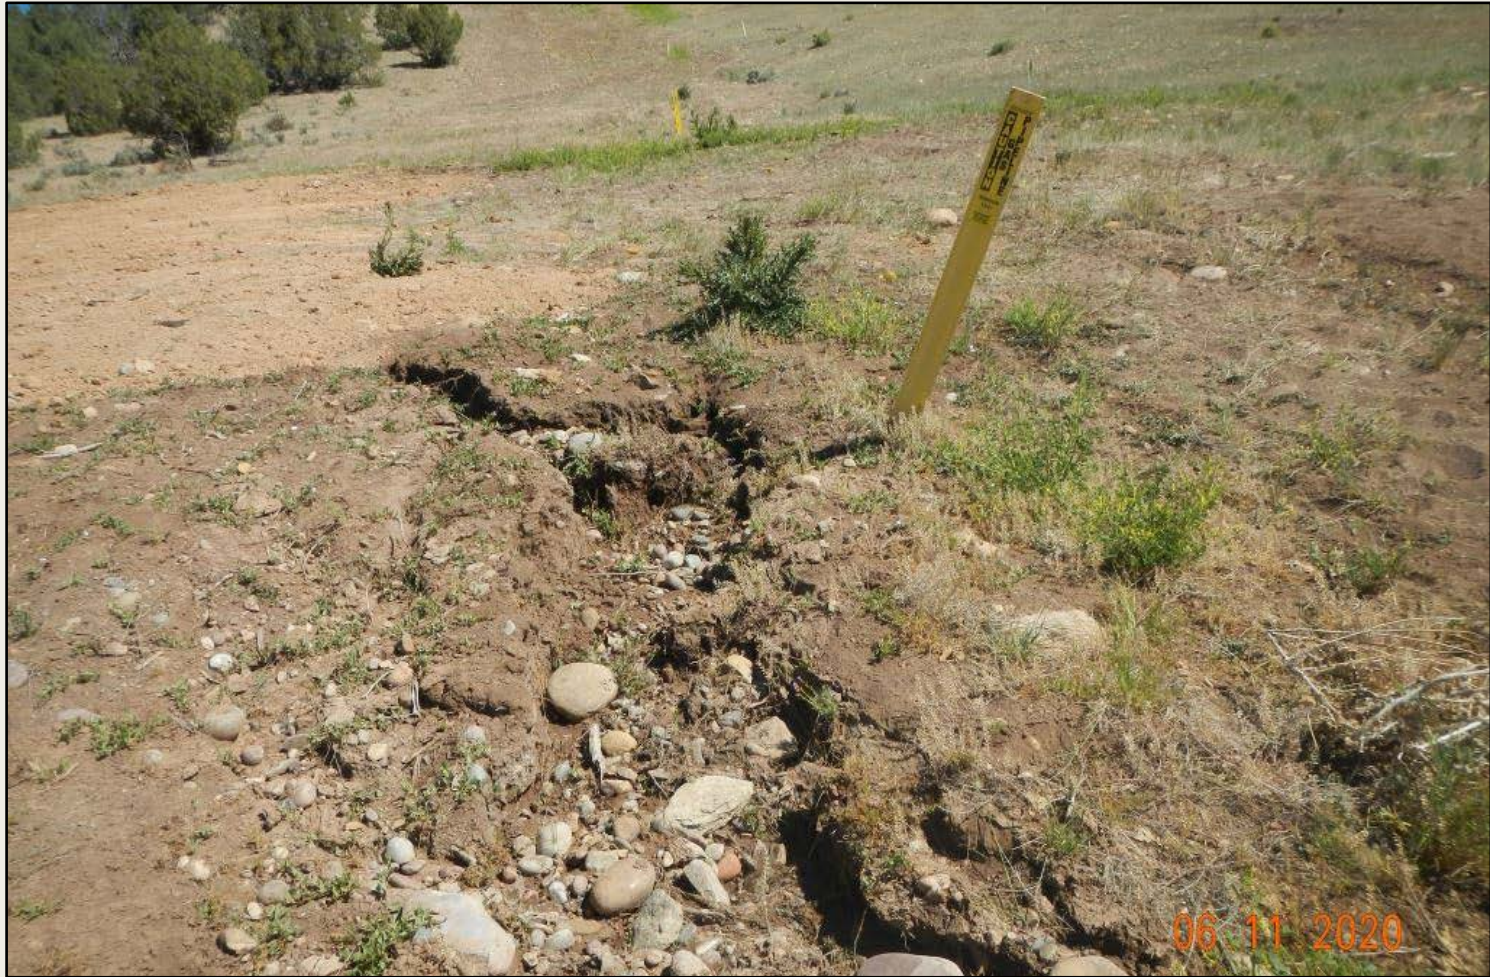
Photo 5. View of erosional channel approximately 1.5 feet wide and 8 inches deep, near the well pad entrance.

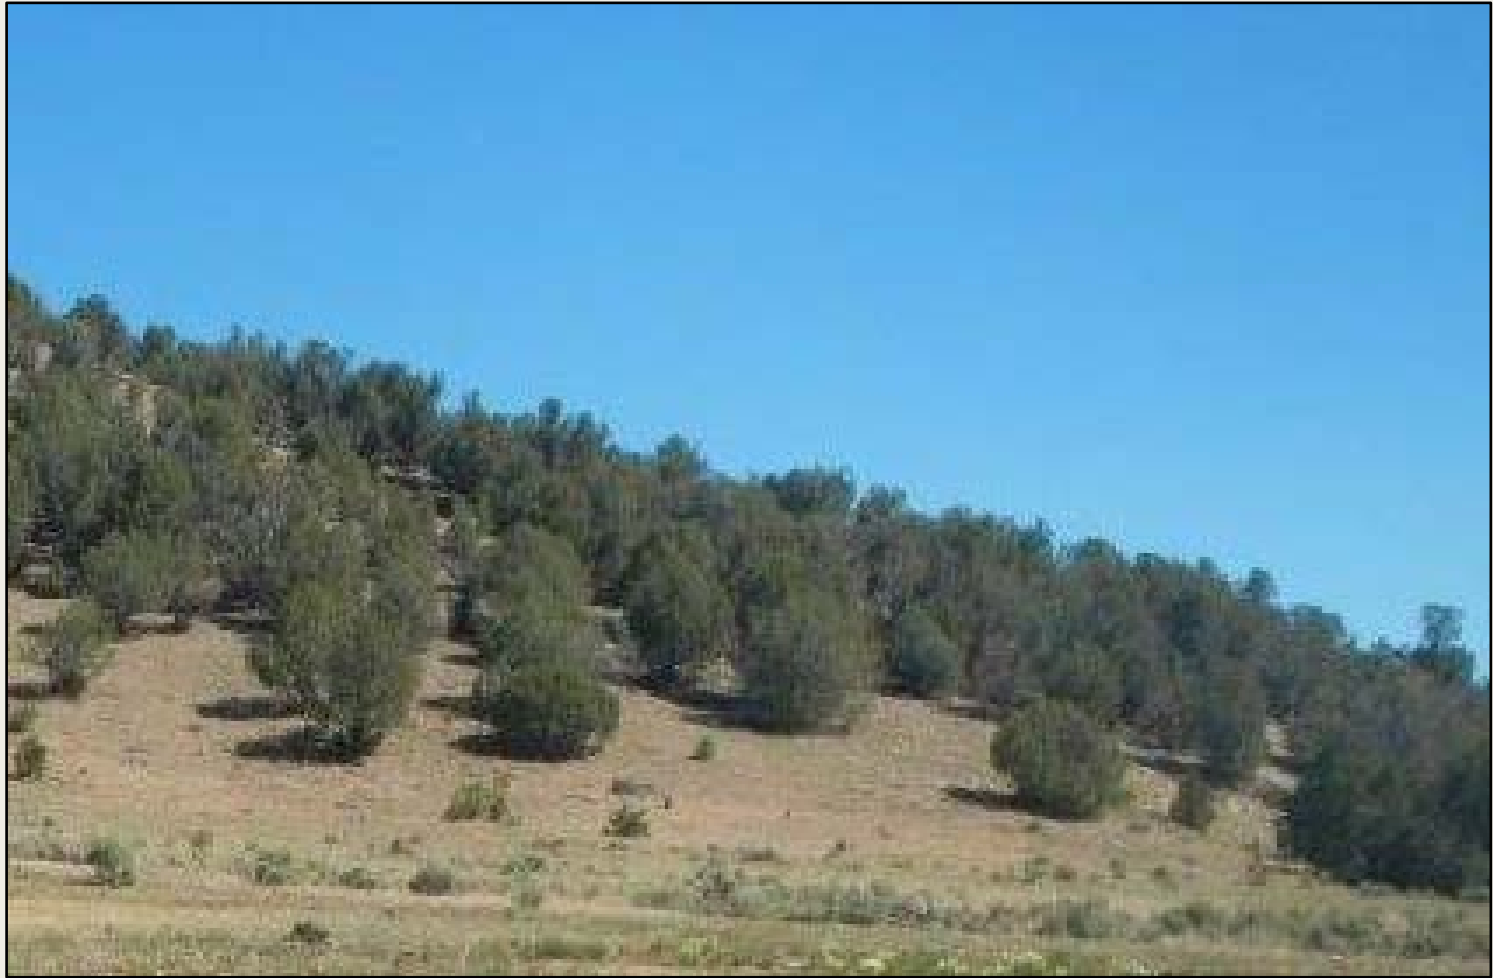
Photo 6. View of reference area comprised of open pinyon juniper woodland with understory of sagebrush, western wheatgrass, and snakeweed.
