Inspection Photos
Operator: BP America
API#: 067-08262
Date: 6/11/2020

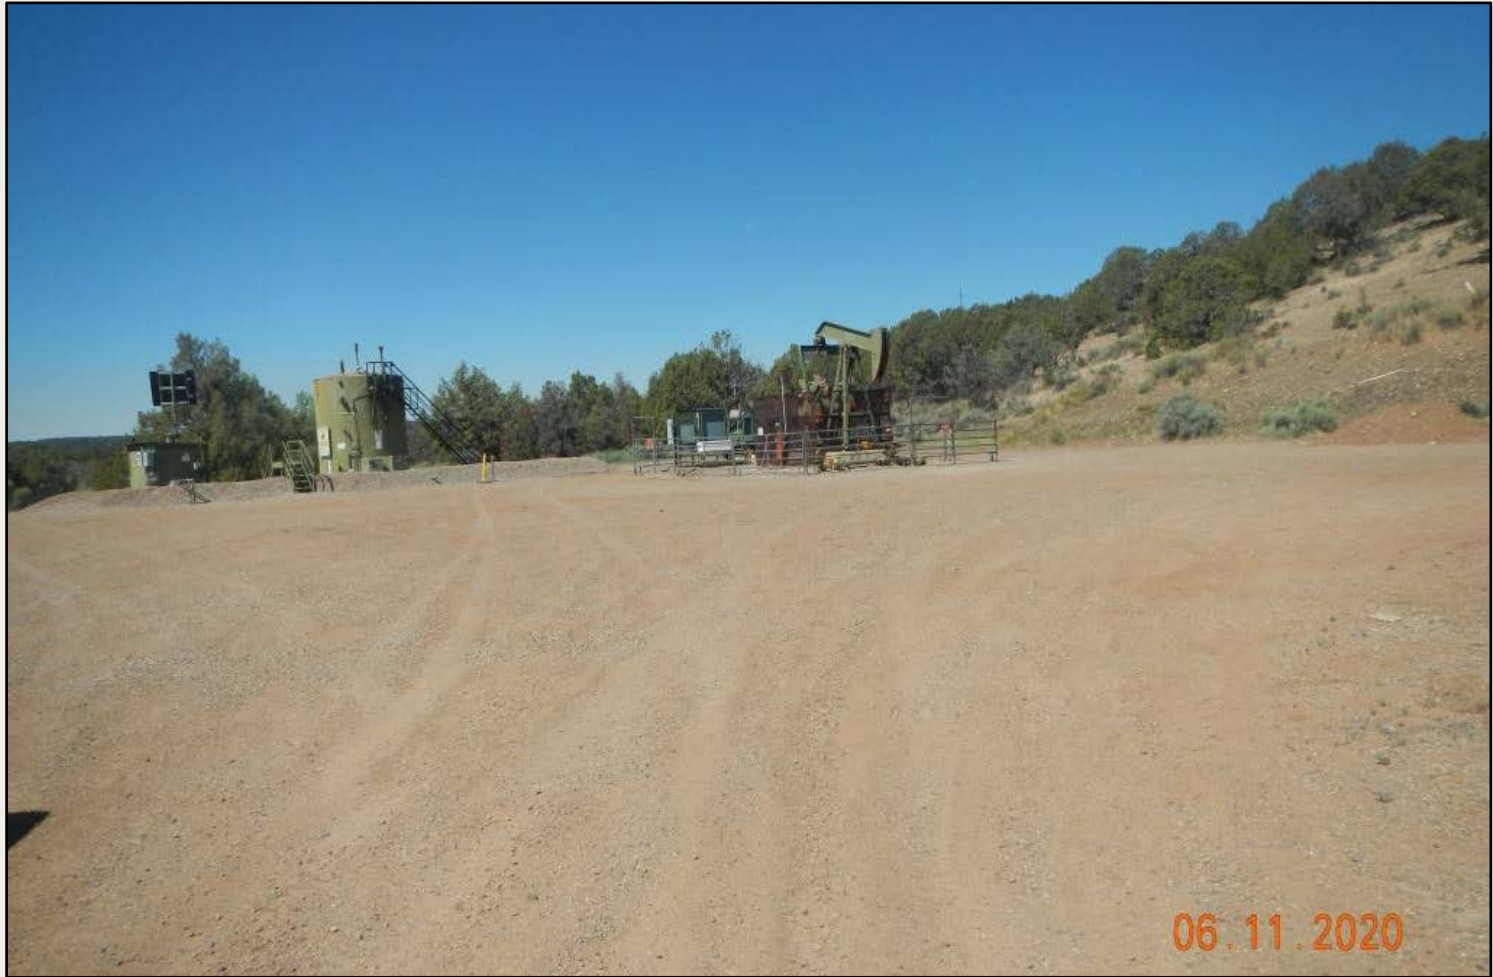
Photo 1. View of the project area from the northeastern corner facing center.

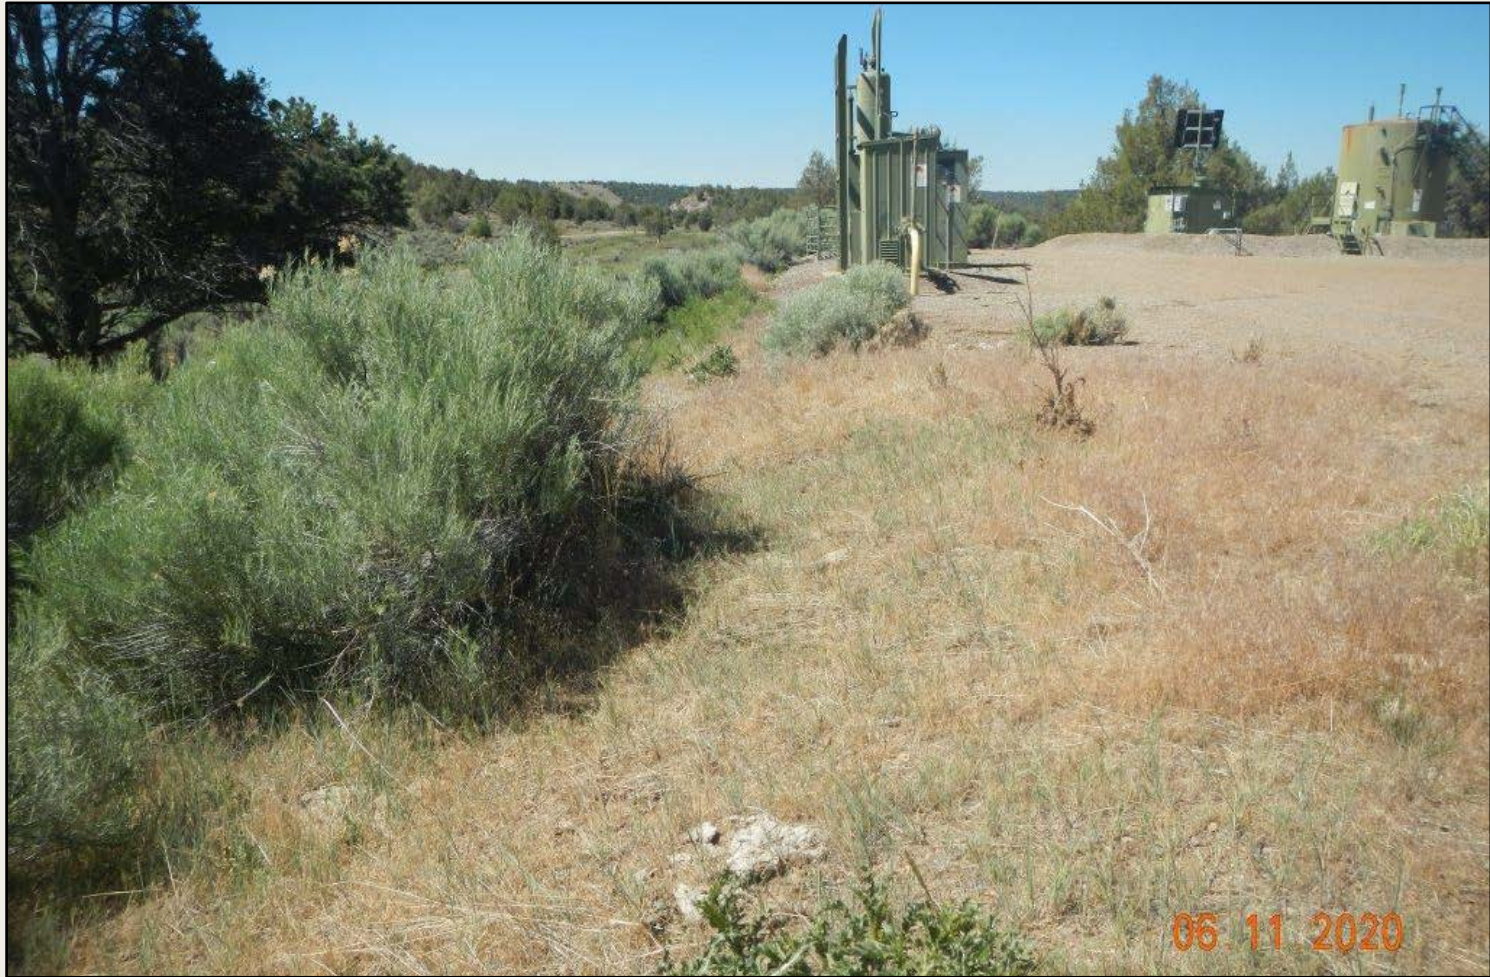
Photo 2. View of the southeastern fill slope from the eastern corner facing southward. Revegetation is progressing with western wheatgrass, crested wheatgrass, and rubber rabbitbrush.

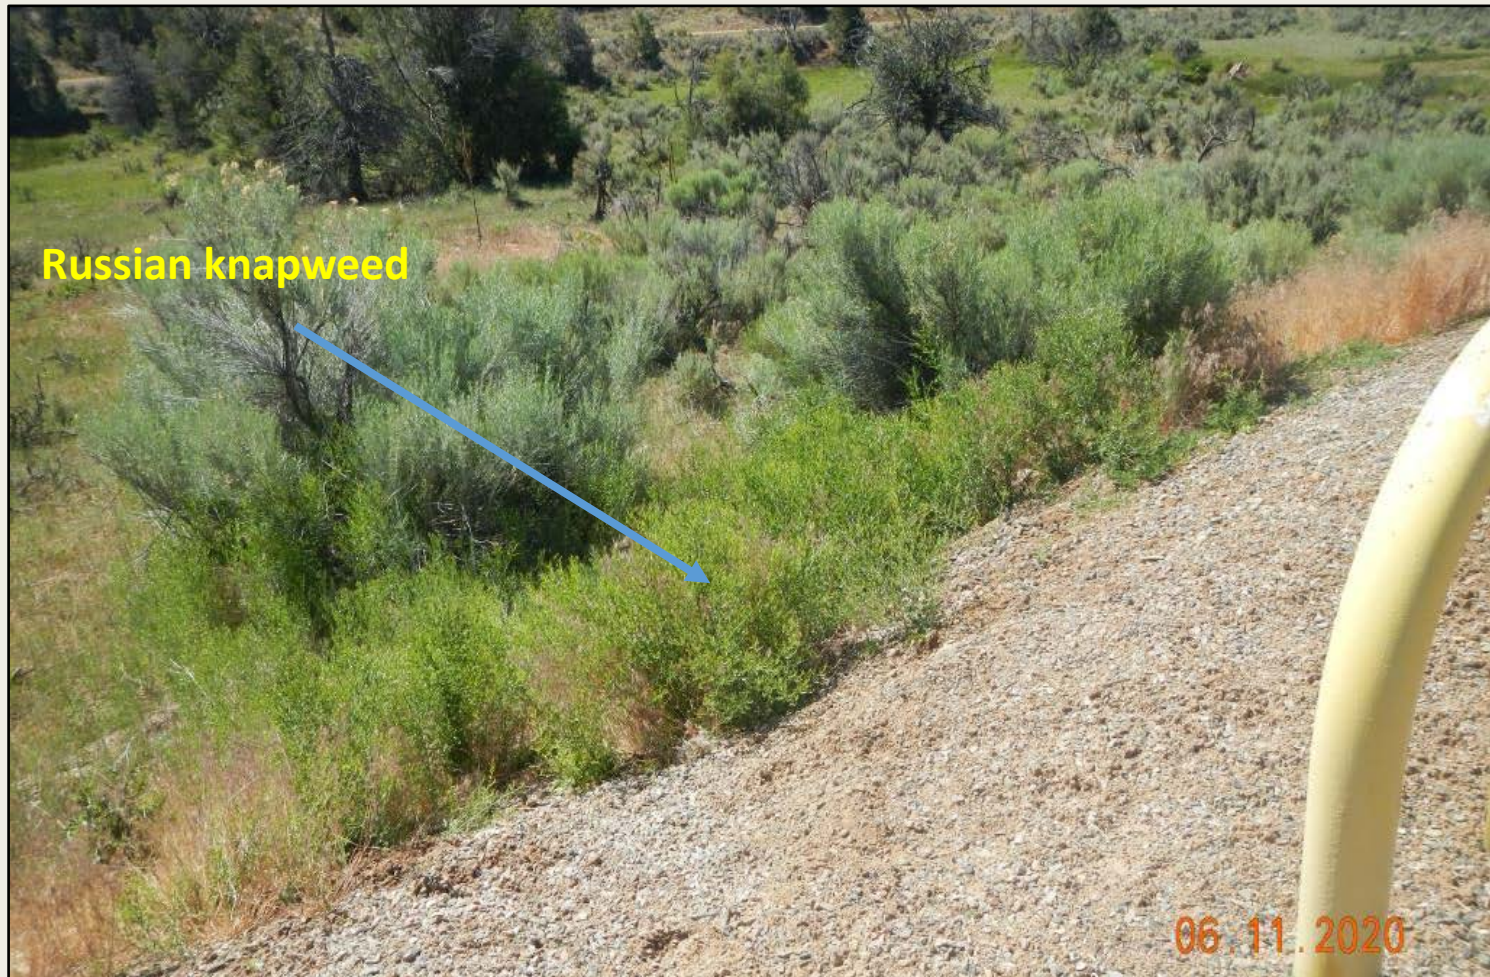
Photo 3. View of Russian knapweeds within the southeastern project area. Approximately 500 individuals observed.

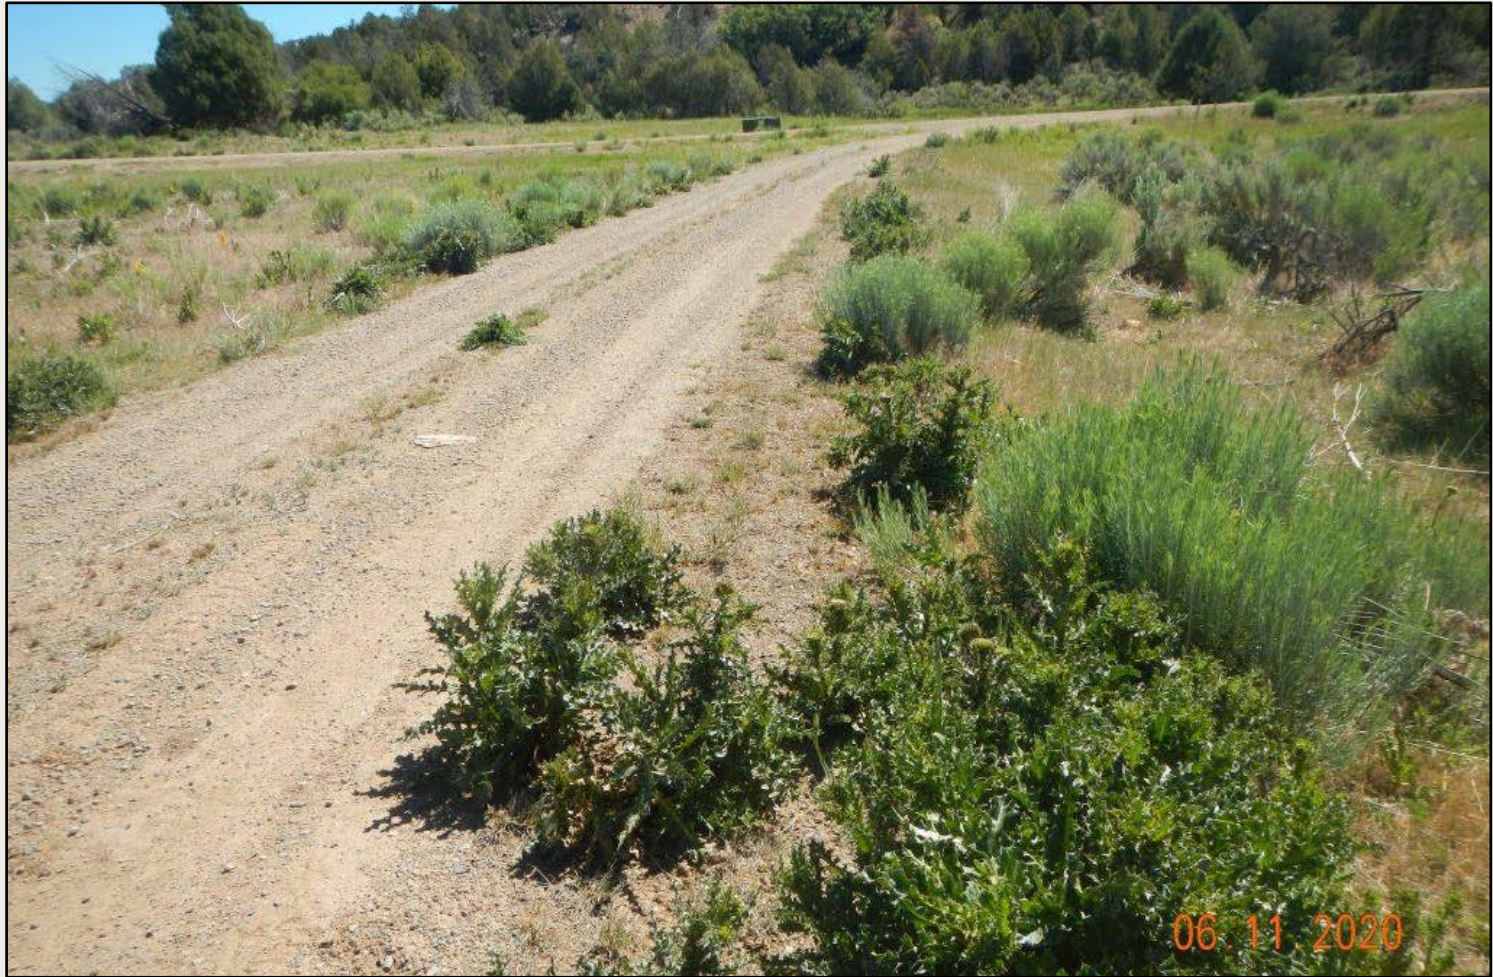
Photo 4. View of musk thistles along the access road, approximately 200 individuals observed.

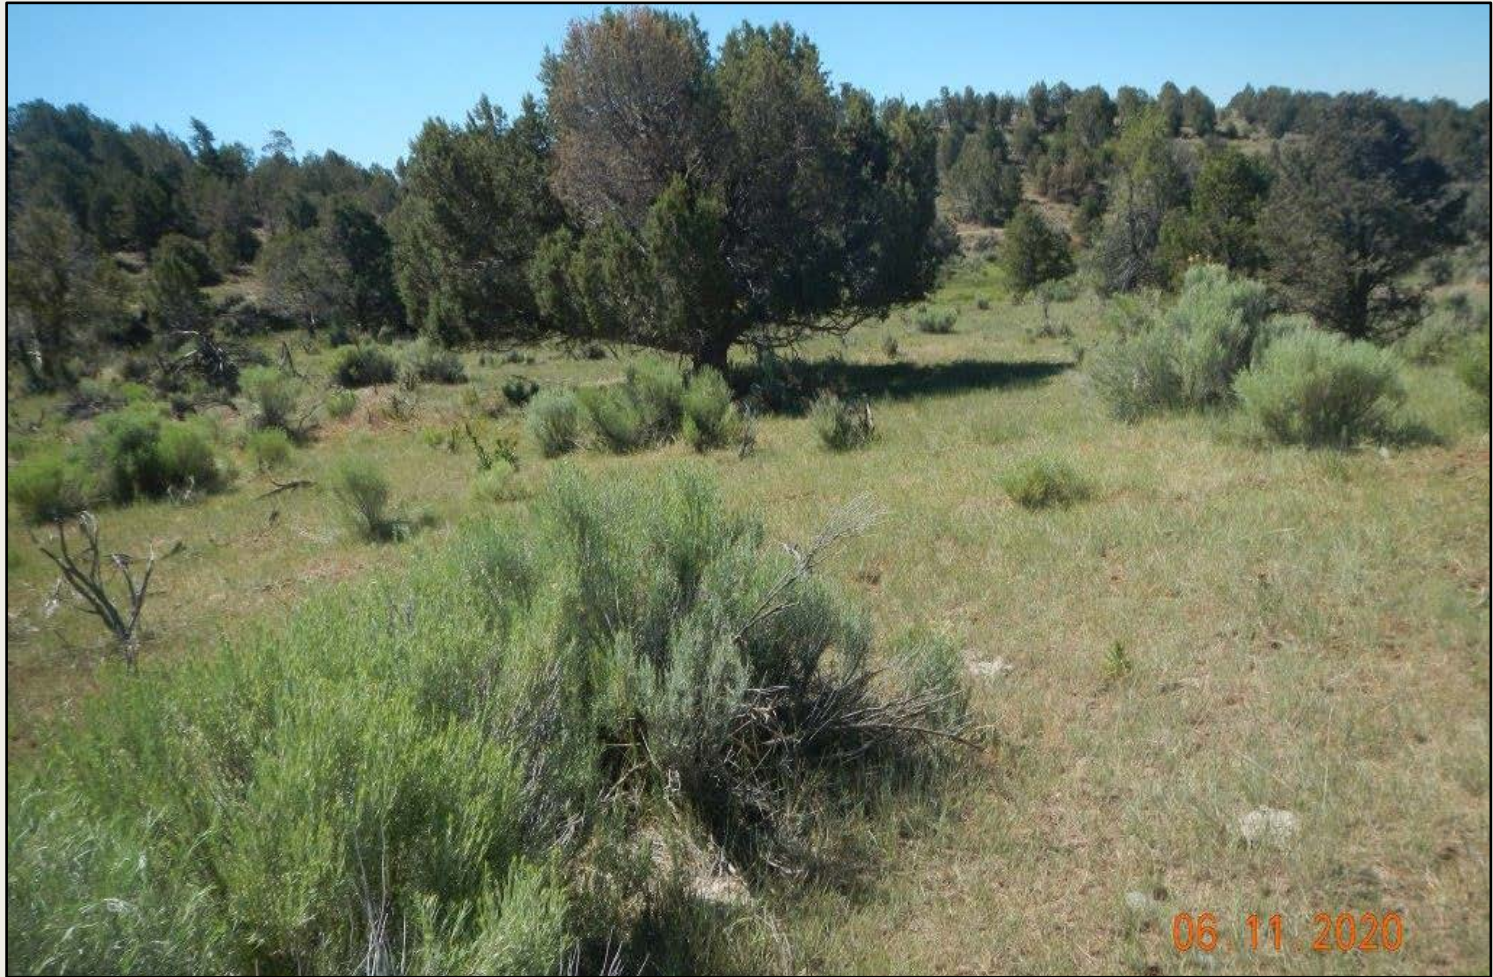
Photo 5. View of reference area comprised of pinyon and juniper woodland with understory of western wheatgrass, big sagebrush, rubber rabbitbrush.
