# Inspection Photos

API: 05-055-06105

Operator: OXY USA INC

Inspection Date: 6/9/2020

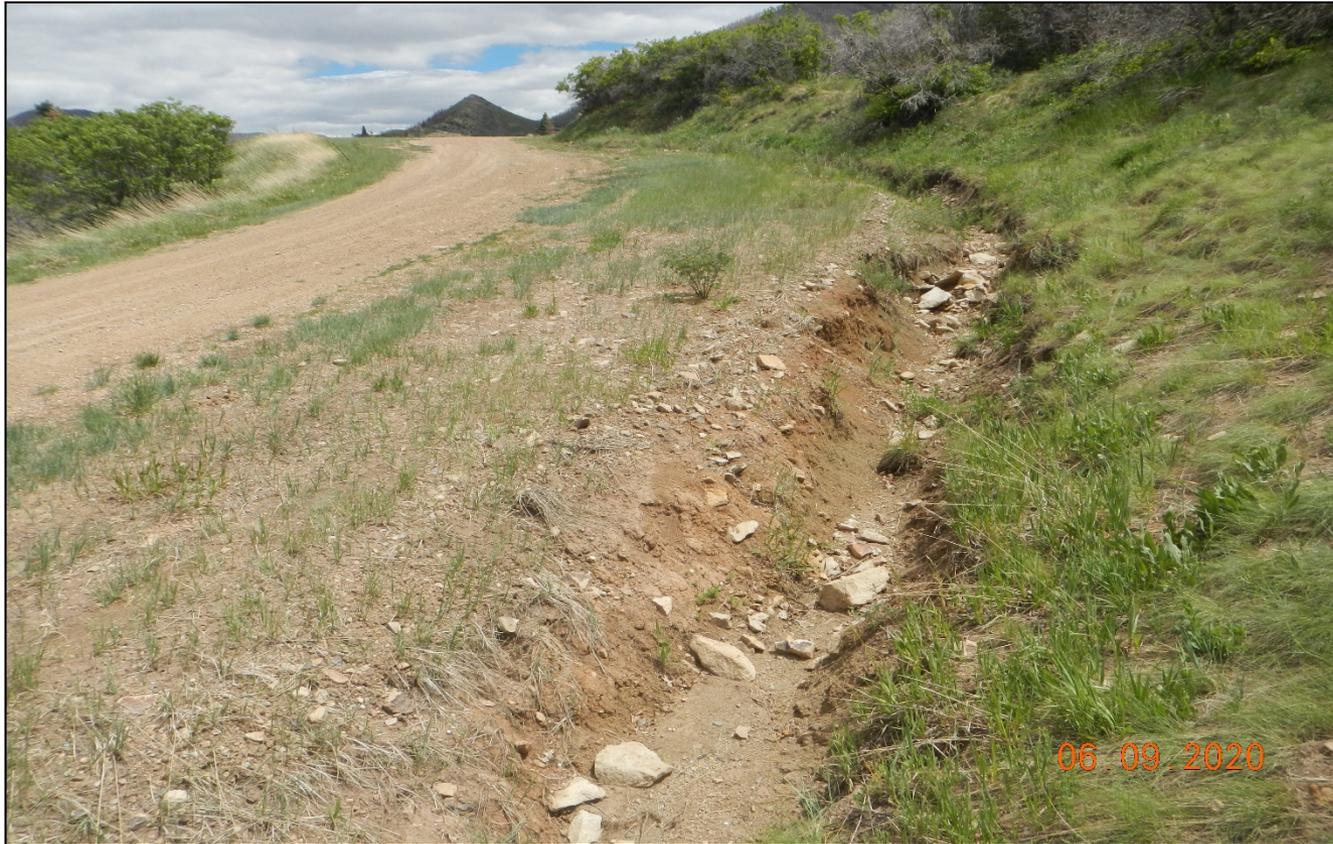
**Photo 1.** Facing southeast ascending the hill toward the location. There is erosion occurring along the road. BMP's are needed in this area along the road to prevent further erosion.

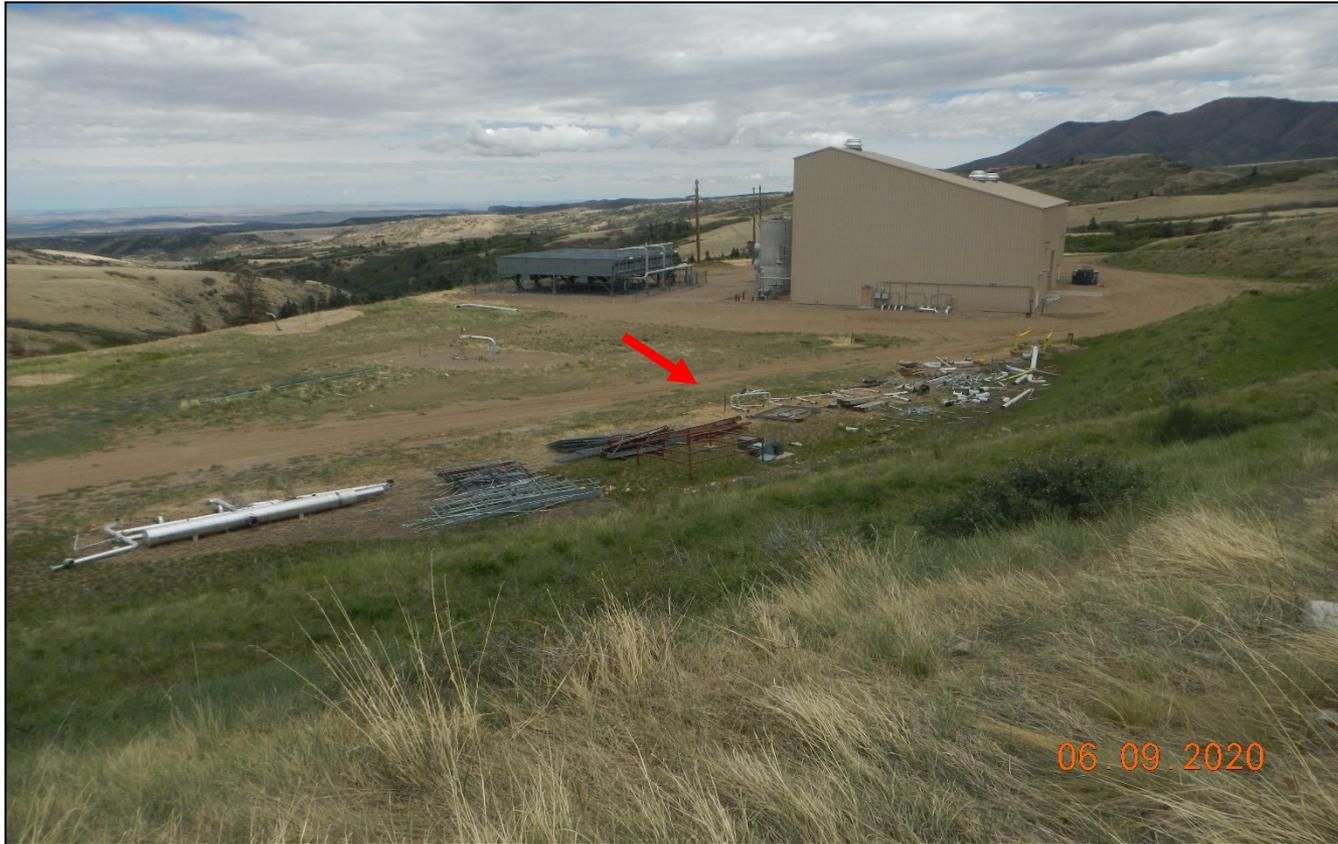
**Photo 2.** Facing east overlooking the location. There is unused equipment being stored at the location shown by red arrow.

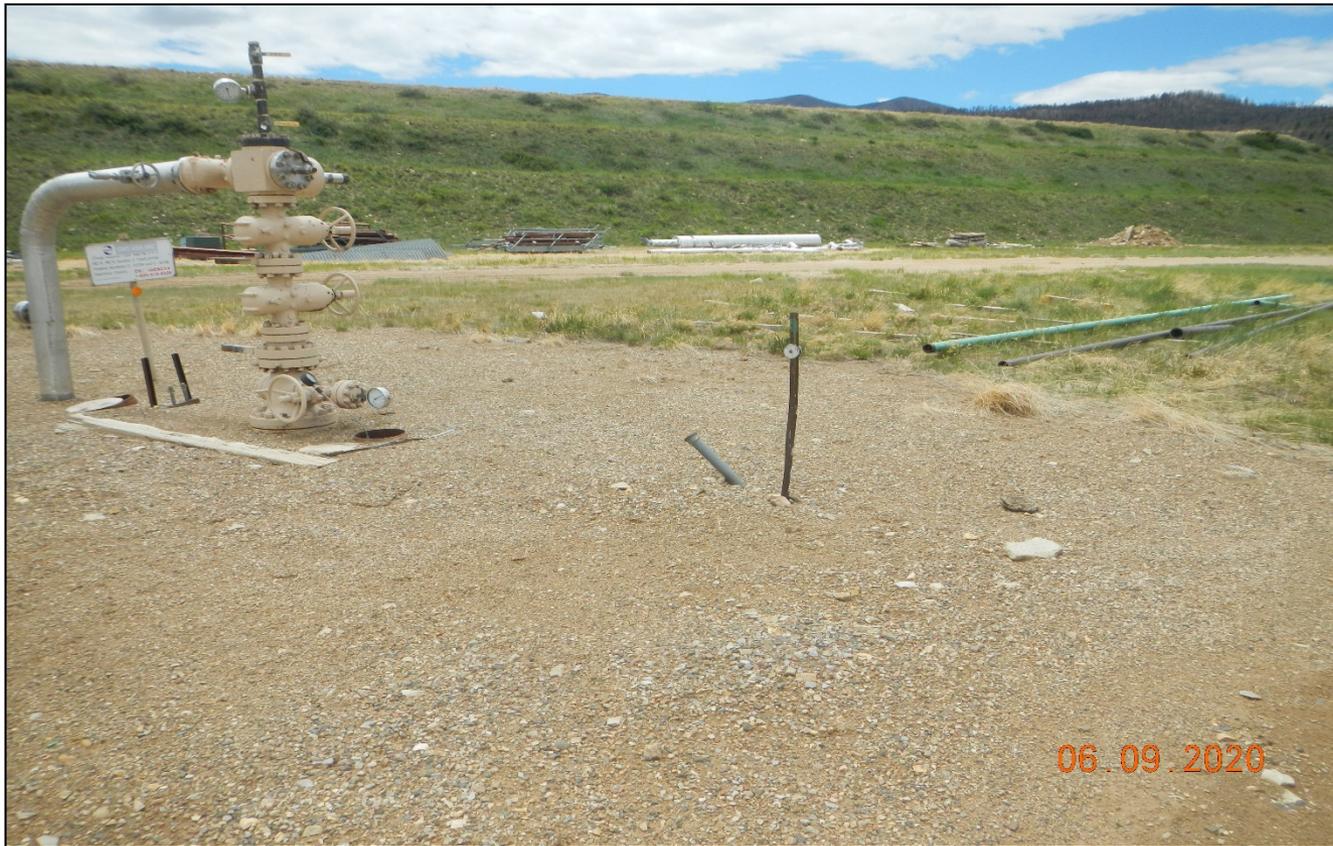
**Photo 3.** Facing toward the well. Sign is posted at the wellhead.

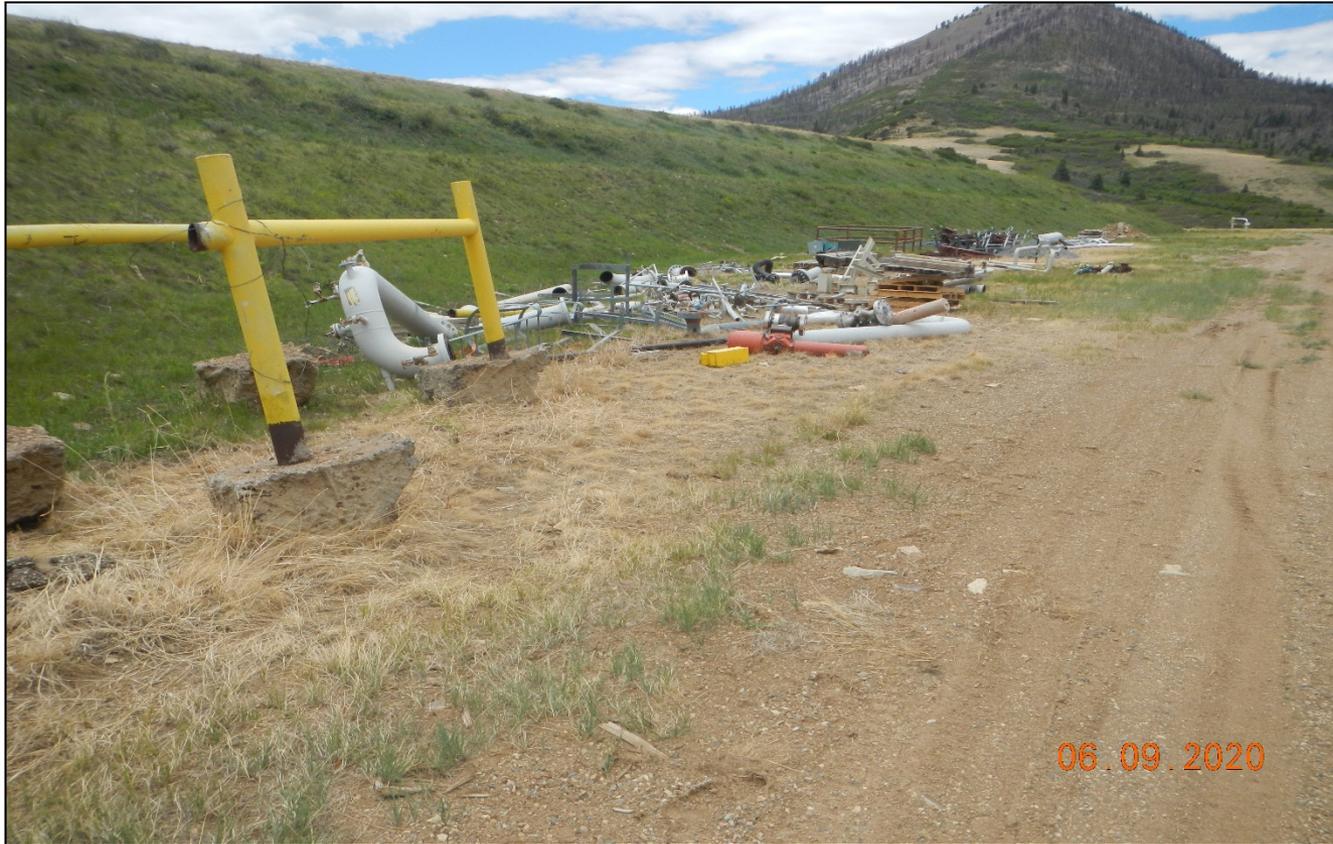
**Photo 4.** Facing northwest at the location. There is various unused equipment stored in this area. Since last year during inspection. The amount of unused equipment has increased in this area.
