Inspection Photos
Location Name: Robert G Berge #2 Flowline Release
Spill ID 476918

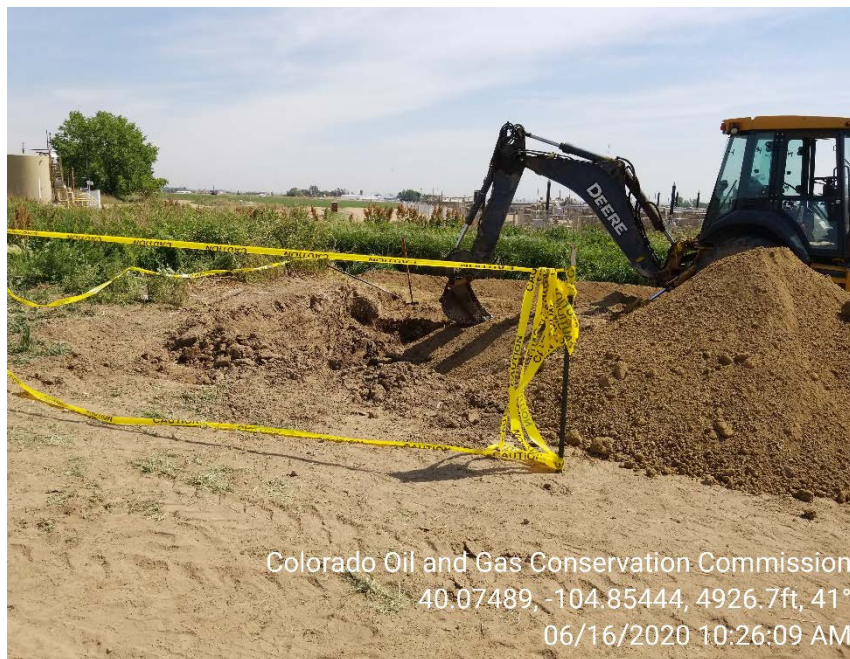
Photo 1 – Spill location adjacent to irrigation ditch

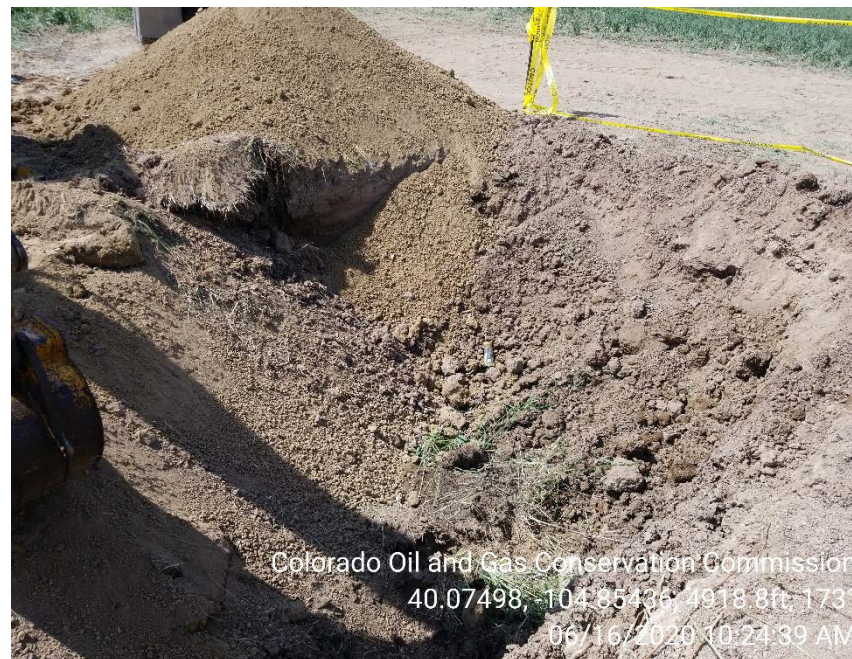
Photo 2 – Partially backfilled spill excavation

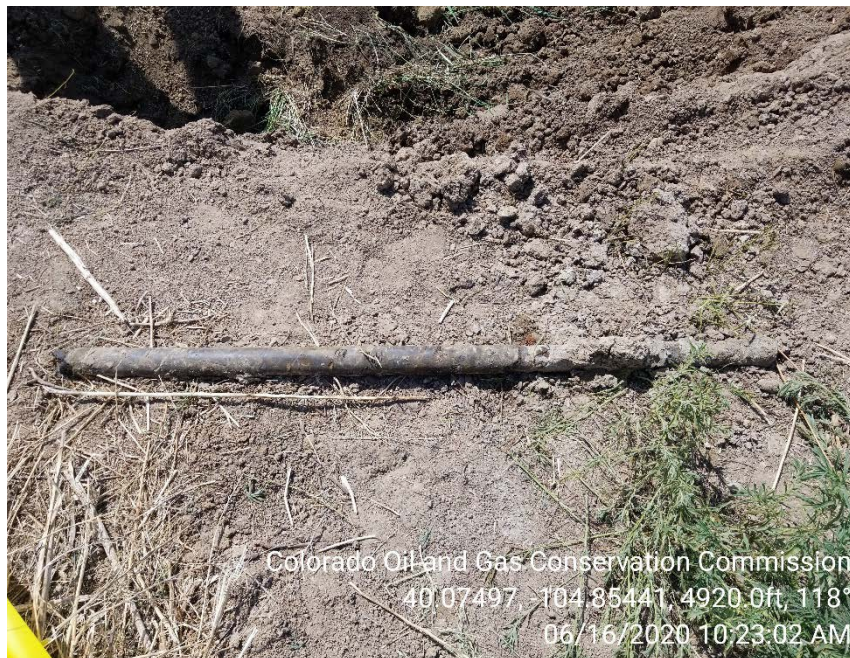
Photo 3 – Corrosion visible on piece of flowline removed from the excavation

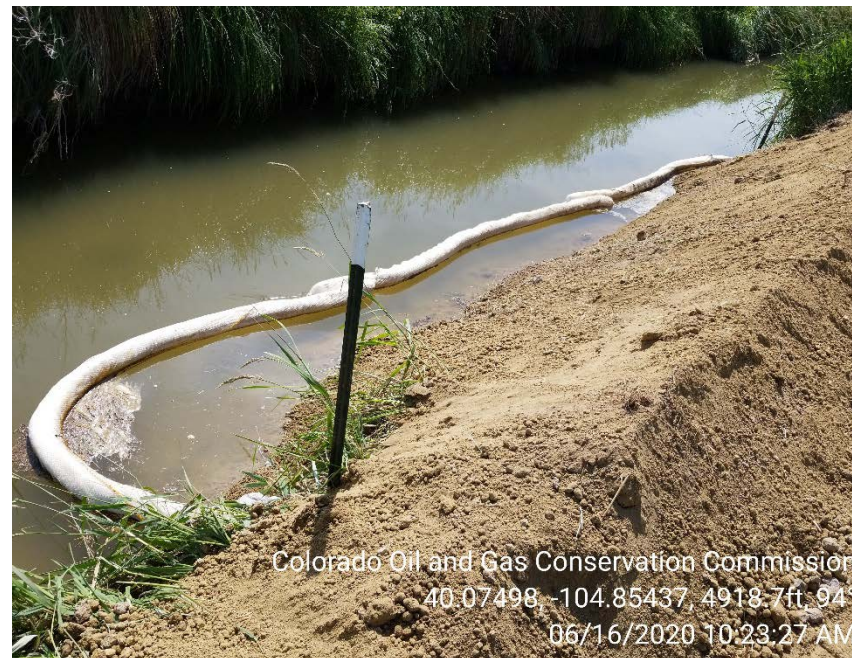
Photo 4 – Soil berm constructed between spill excavation and irrigation ditch. Boom deployed to help mitigate the additional spread of hydrocarbon fluid into irrigation canal

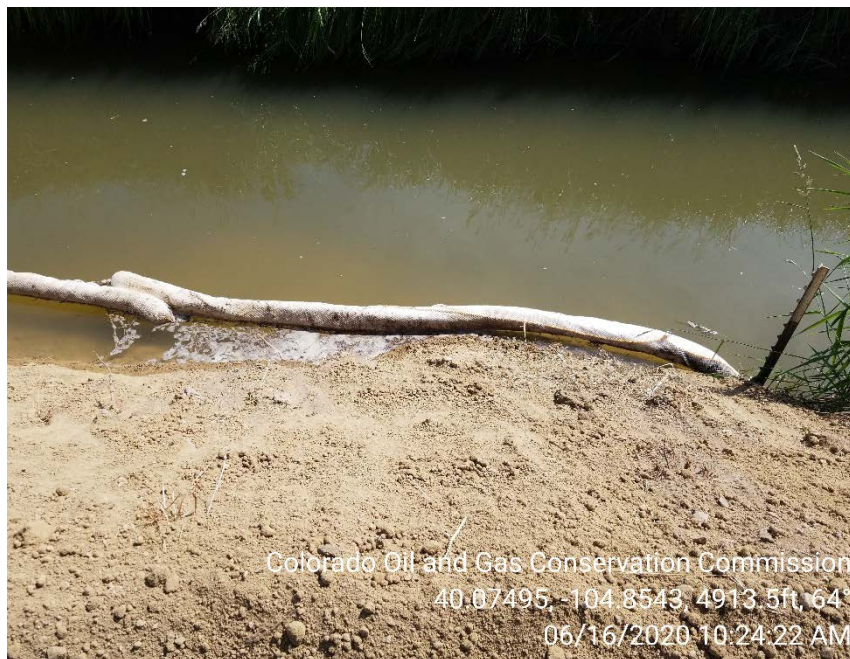
Photo 5 – Sheen noted on water adjacent to spill location

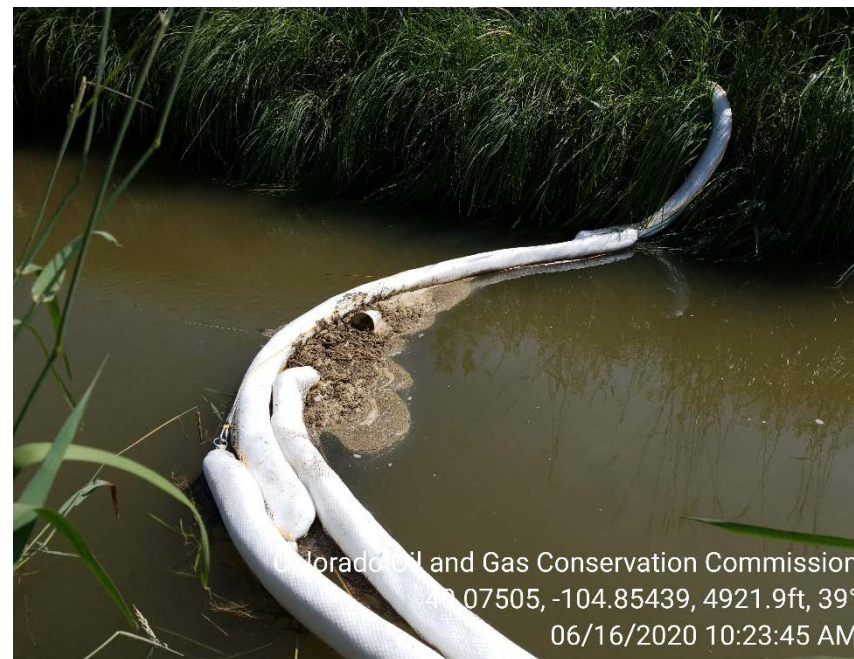
Photo 6 – Berm placed in irrigation ditch downstream of spill; sheen noted on water caught by boom
