Inspection Photos
Operator: BP America
API: 067-08955
Date: 6/16/2020

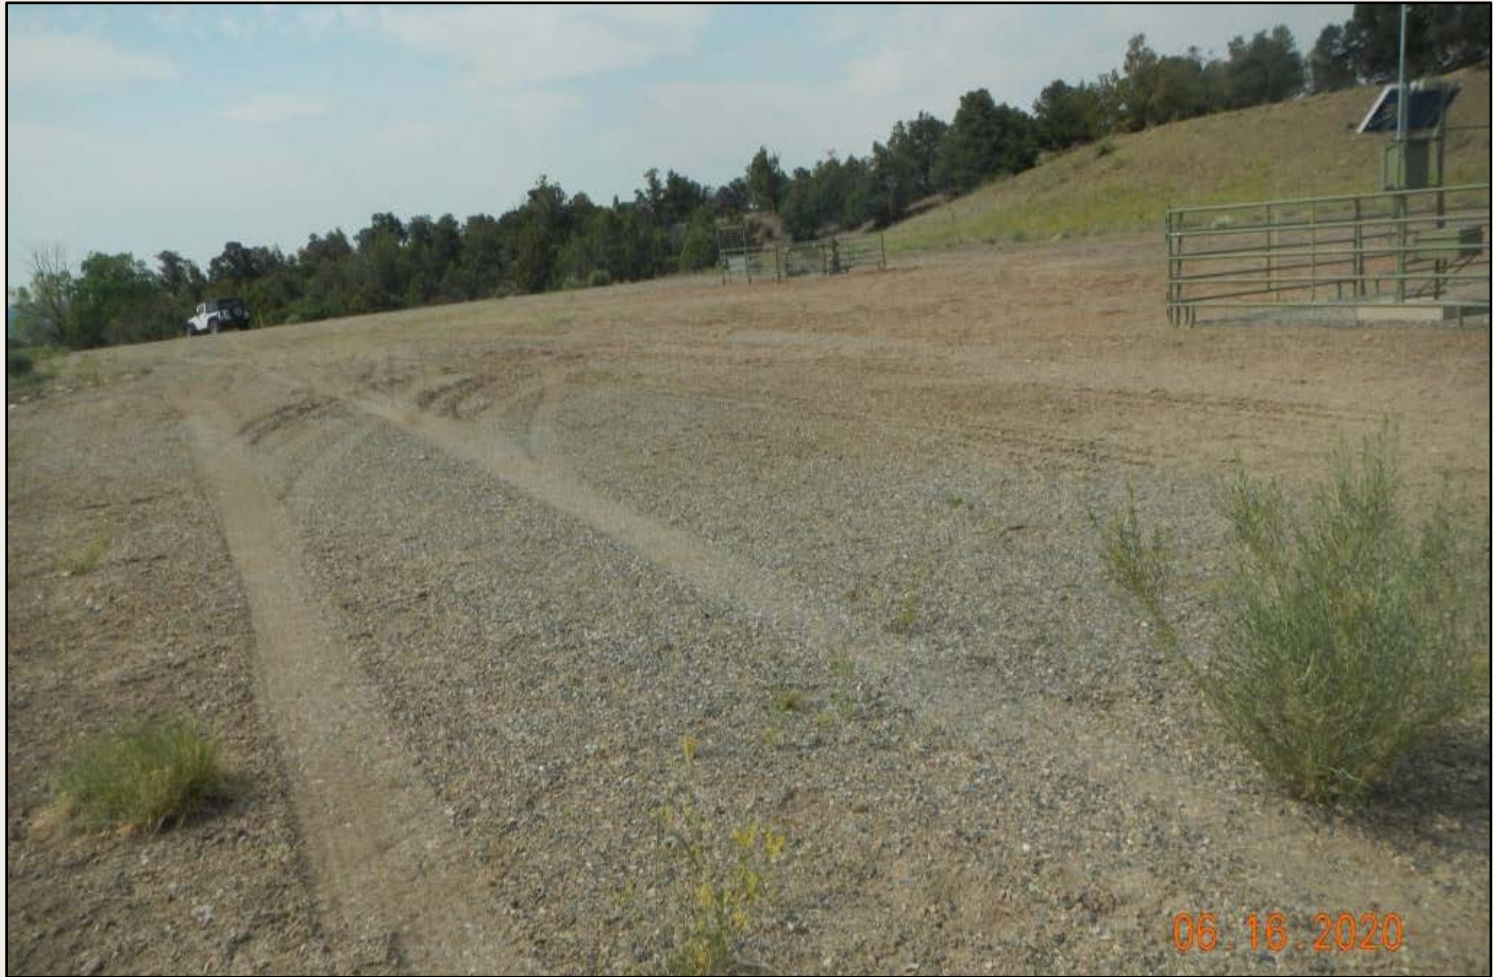
Photo 1. View of the project area from the northeastern corner facing center.

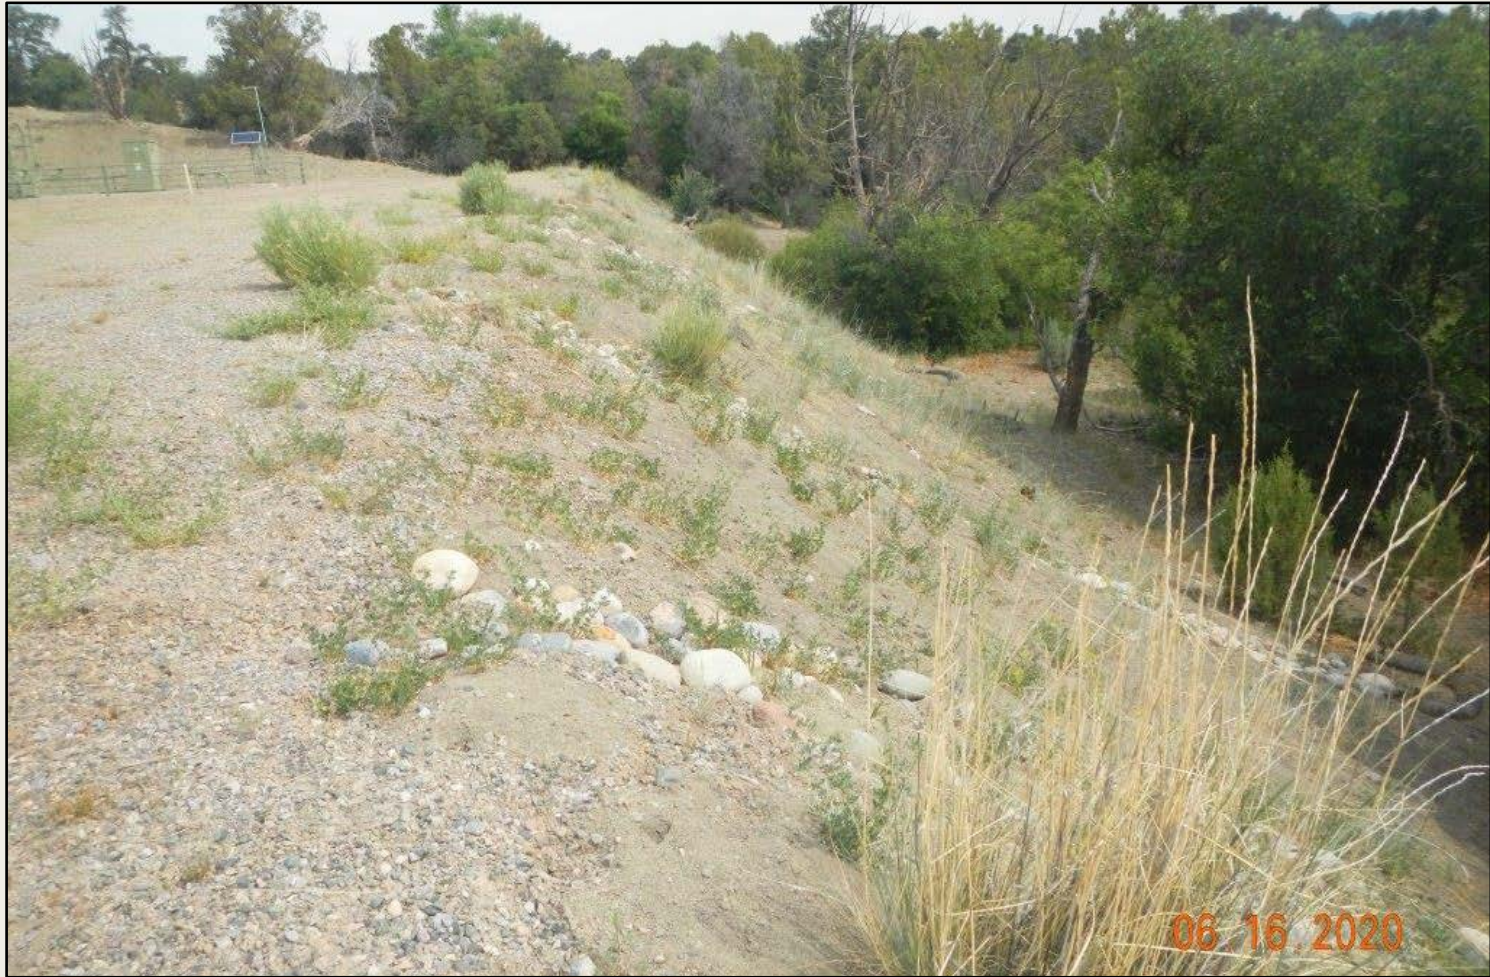
Photo 2. View of the eastern project area from the southeastern corner facing northward. Revegetation is progressing in portions but remains sparse in other portions. Slopes are not yet stabilized with desirable vegetation. Species observed include: western wheatgrass, intermediate wheatgrass, and smooth brome.

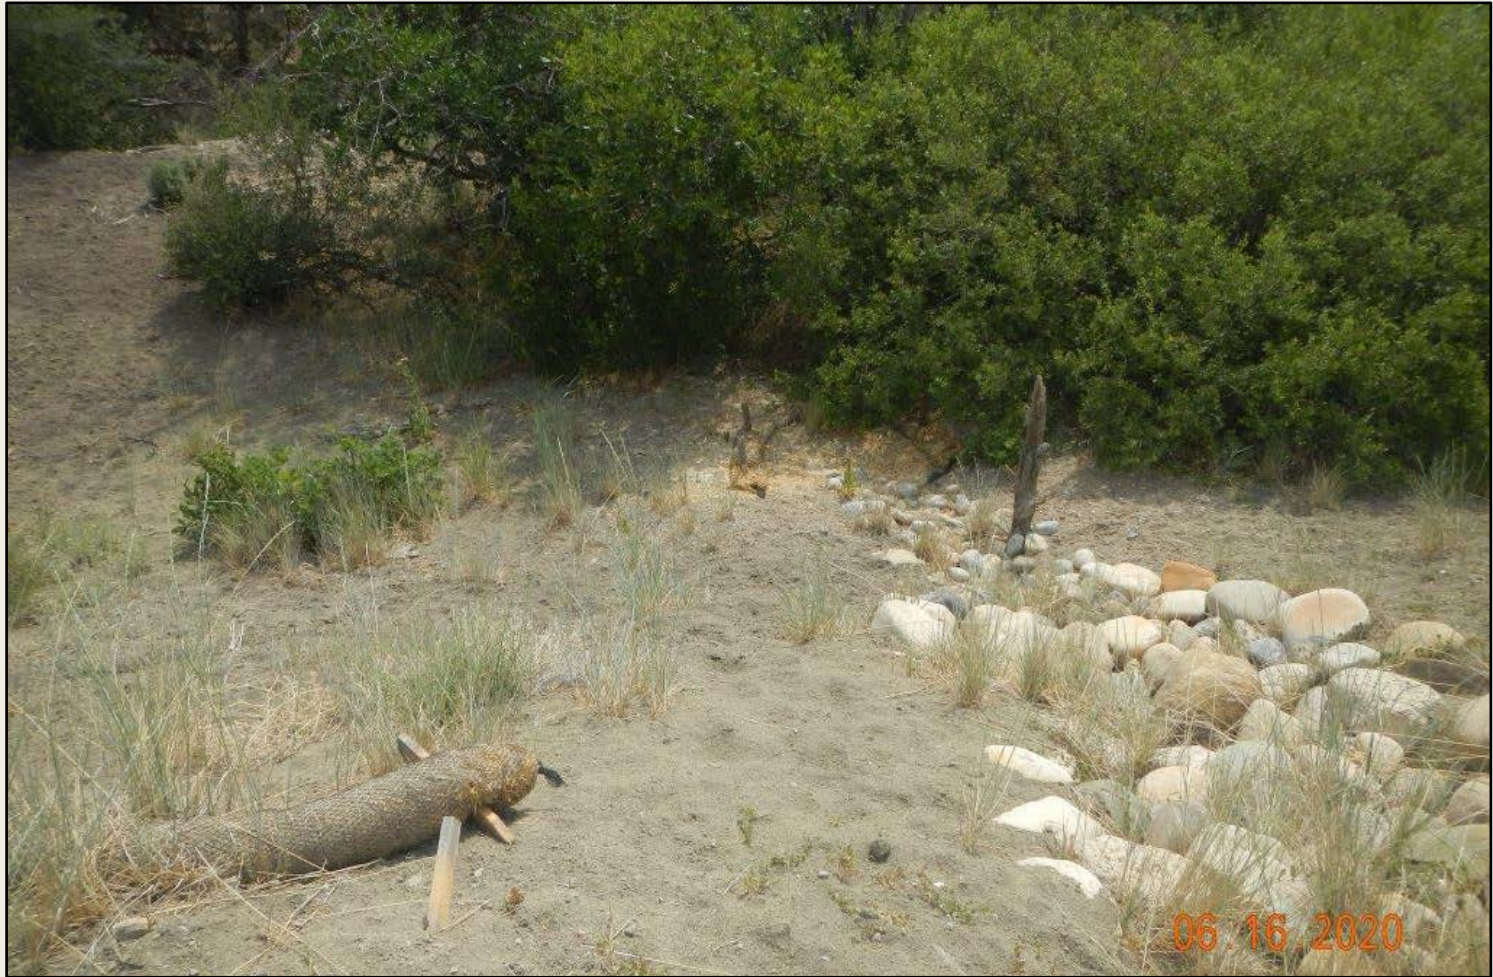
Photo 3. View of BMPs within the eastern project area that need maintenance. Wattles are no longer staked and filled with sediment, cobble run-down is filling with sediment.

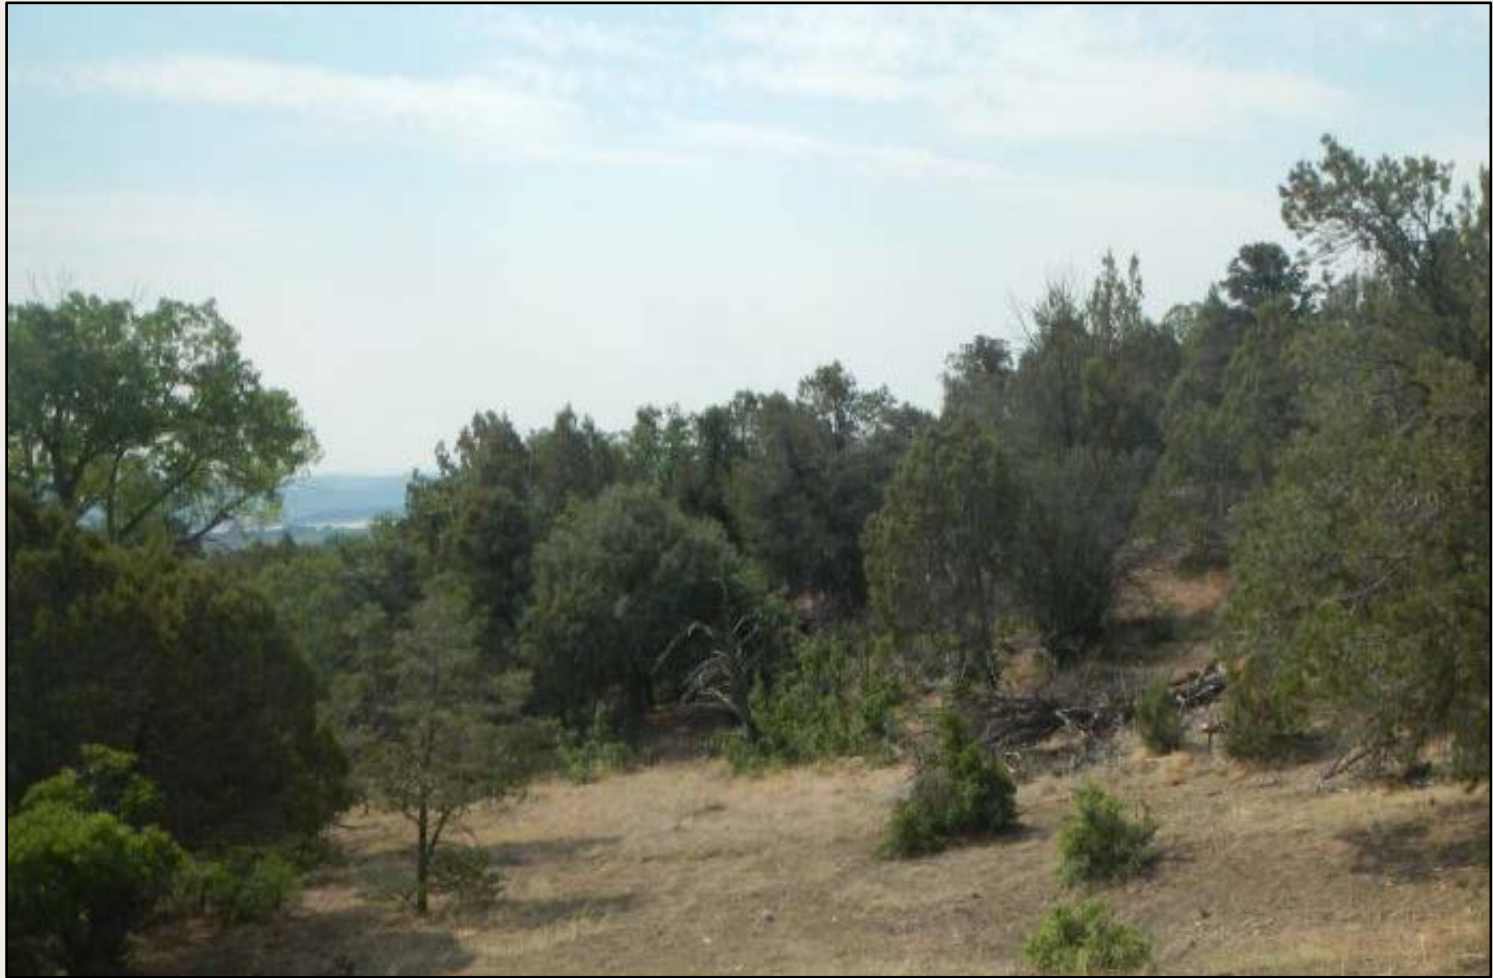
Photo 4. View of the reference area, comprised of pinyon and juniper woodland with understory of grasses and forbs such as western wheatgrass, blue grama, prickly pear, as well as shrubby gambel oak.
