Inspection Photos
Operator: BP America
API: 067-06639
Date: 6/16/2020

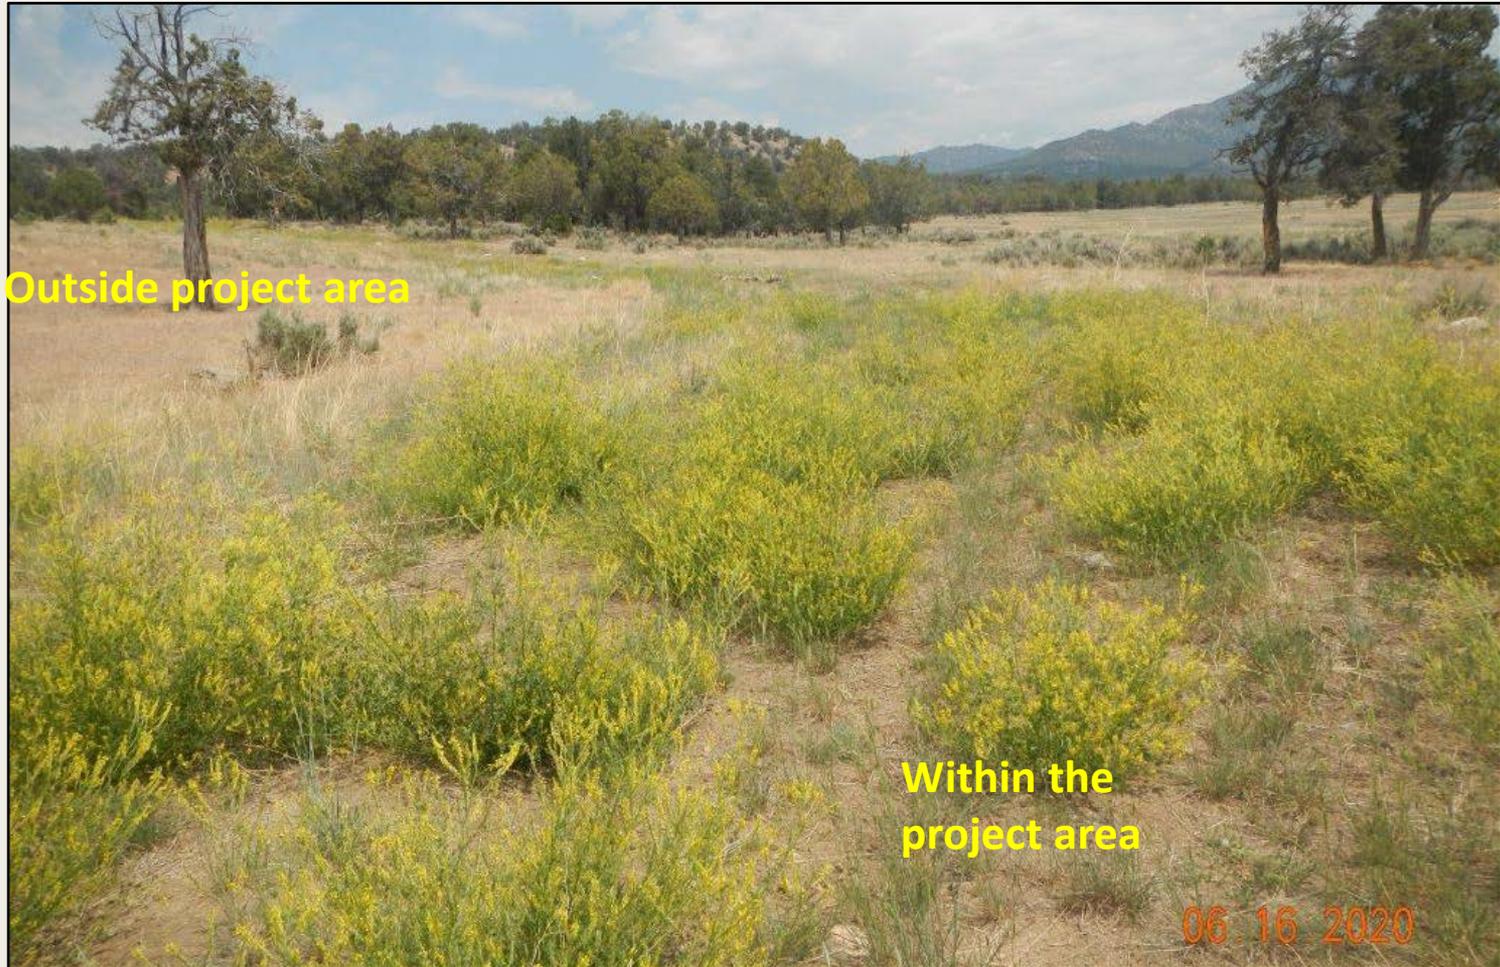
Photo 1. View of the reclaimed access road from the beginning of access, facing north, toward the project area. Reclamation appears to be progressing, with perennial grasses becoming established.

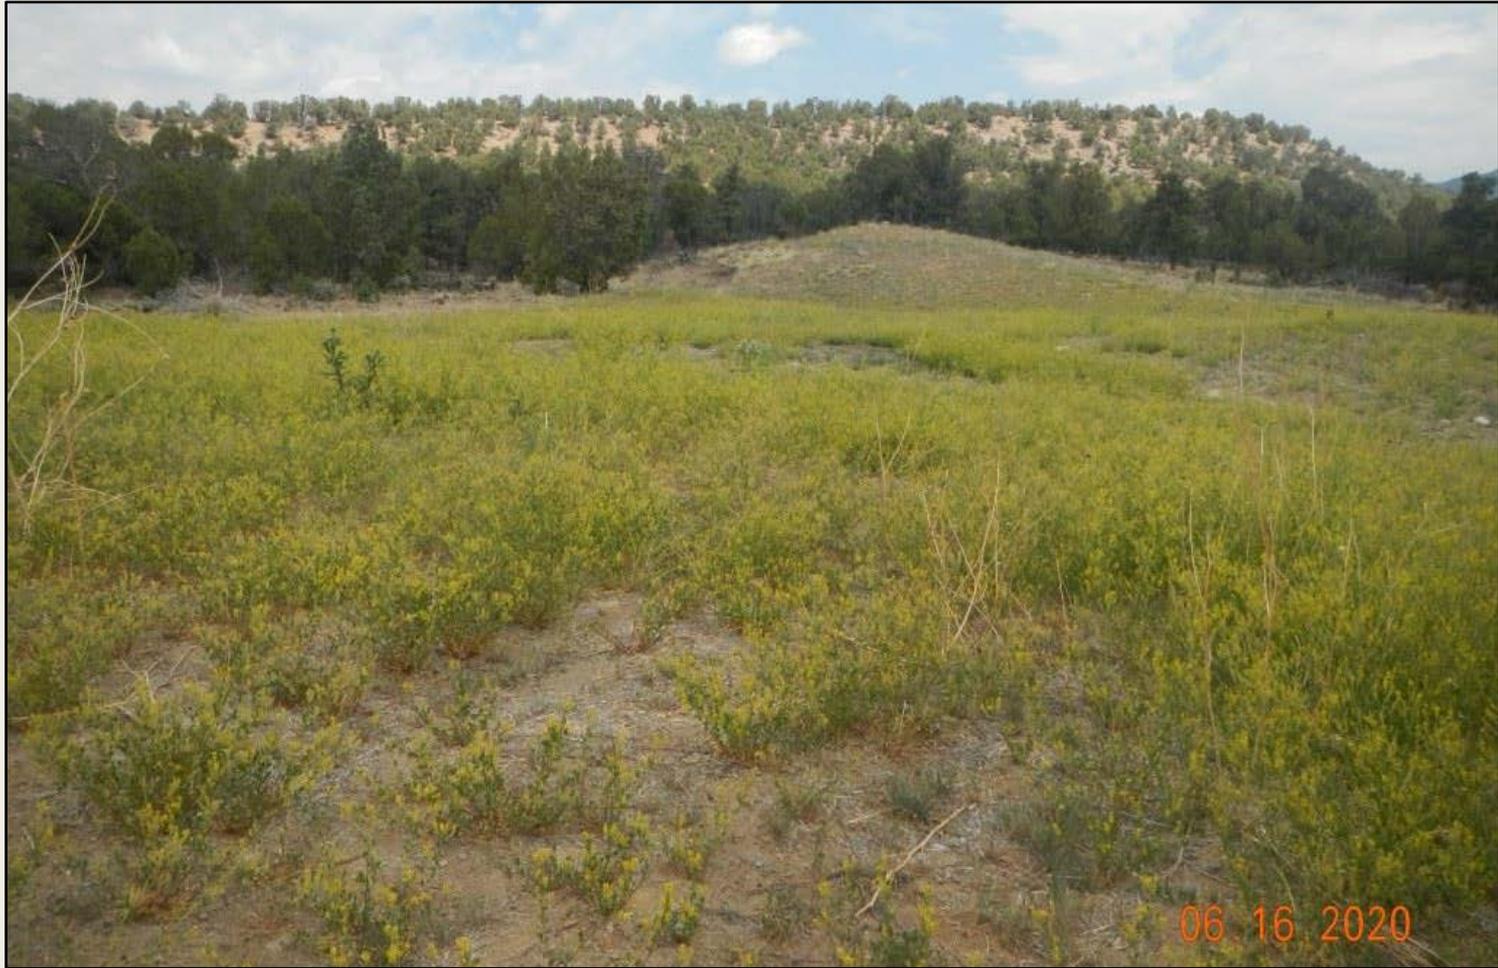
Photo 2. View of the western well pad from the southwestern corner facing northward. Revegetation is progressing in an early seral condition. Continued monitoring is needed to ensure successful establishment.

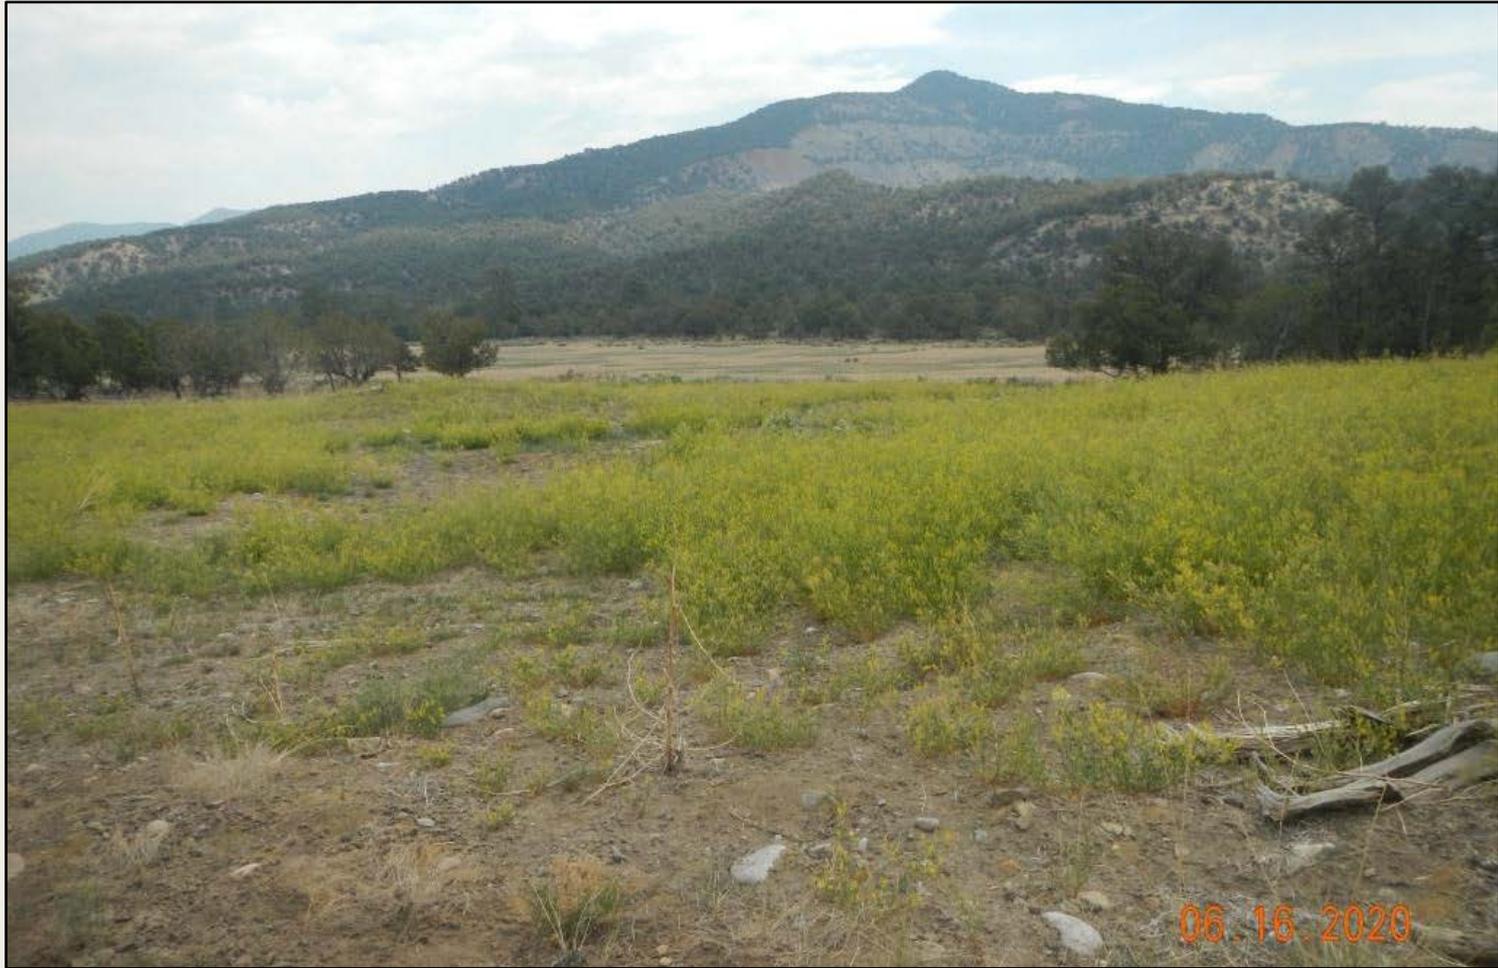
Photo 3. View of the reclaimed project area from the southwestern edge facing center. Drainage patterns are recontoured within the project area, and appear to be functioning at this time.

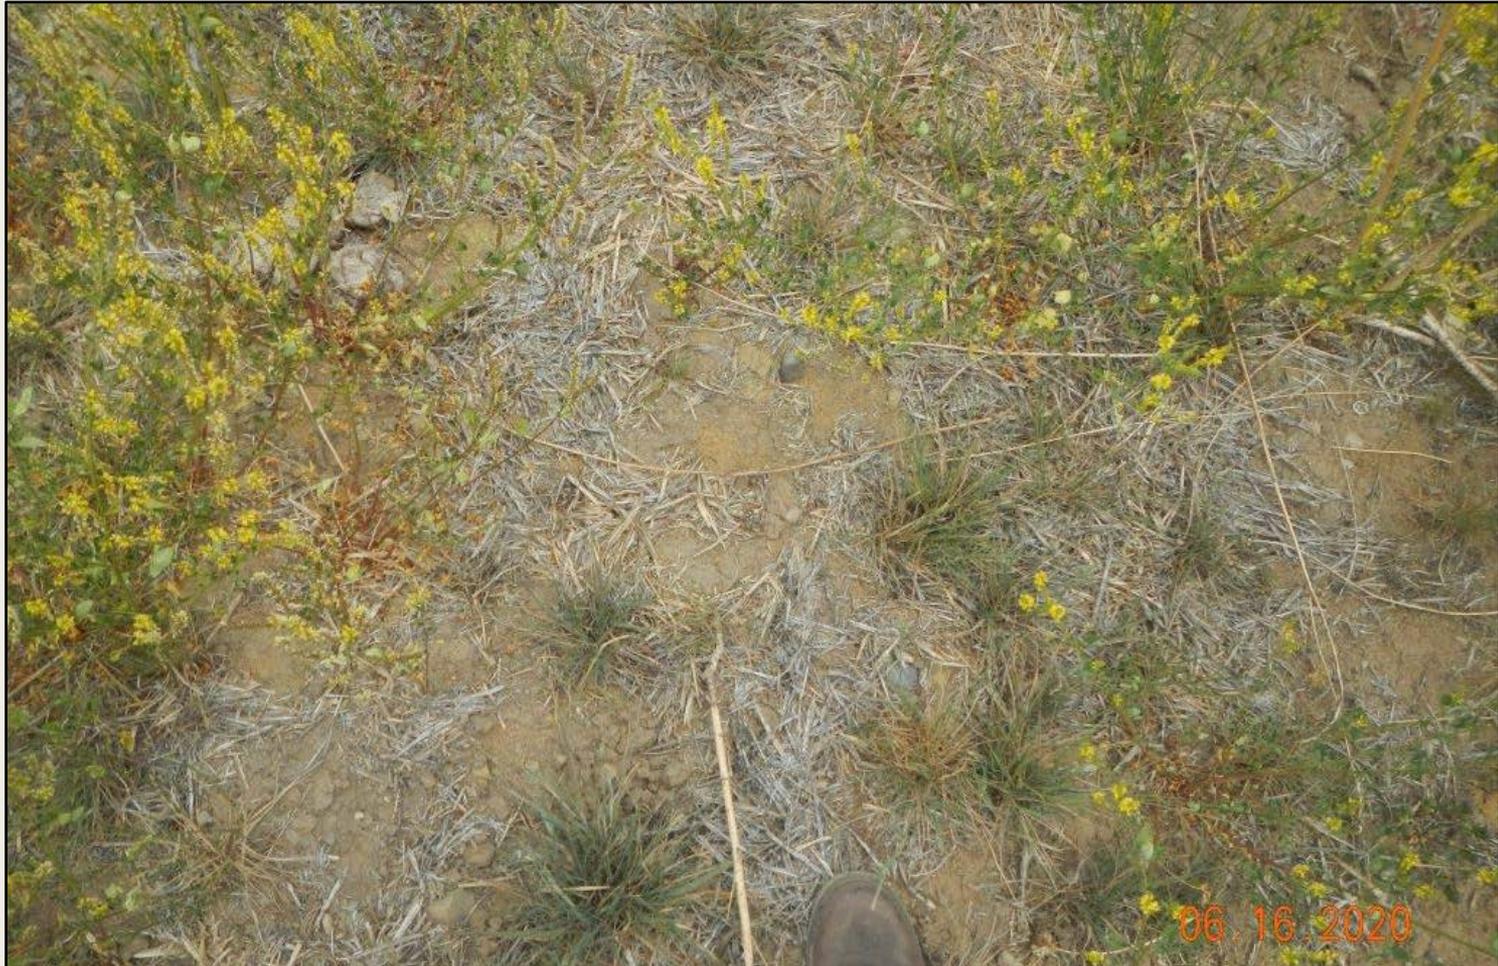
Photo 4. Birdseye view of young perennial grasses, straw mulch, and yellow sweet clover. Native forbs such as sagebrush also observed. Typical of revegetation condition within the project area.

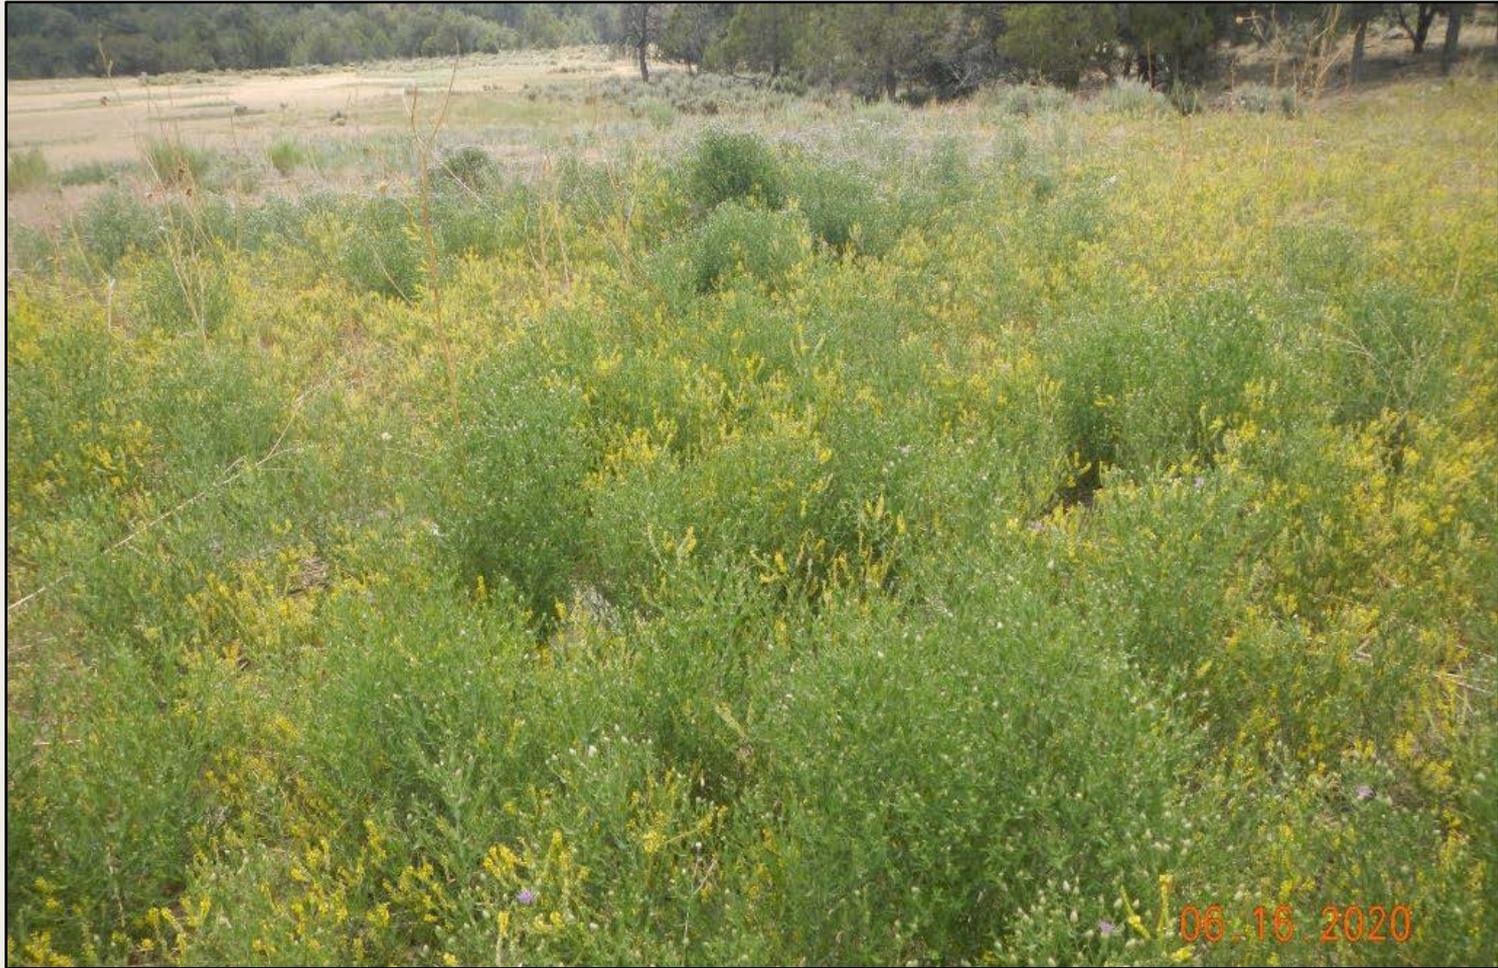
Photo 5. View of dense Russian knapweeds within the eastern project area. Knapweed infestation needs to be controlled as it is threatening desirable revegetation.

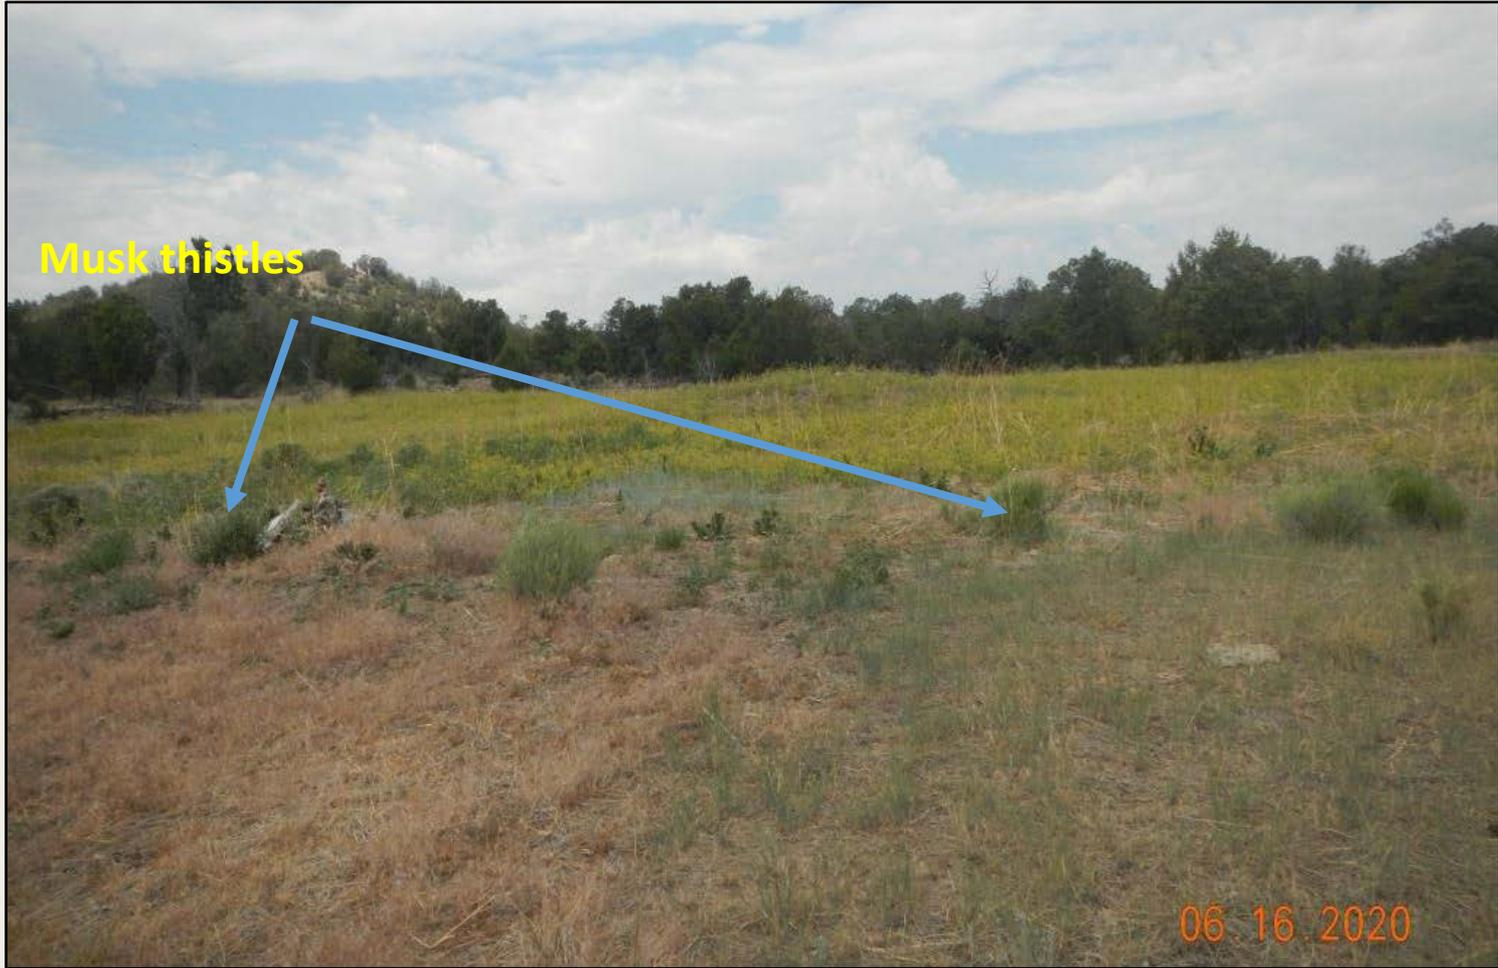
Photo 6. View of musk thistles within the western project area. Approximately 75 individuals observed.

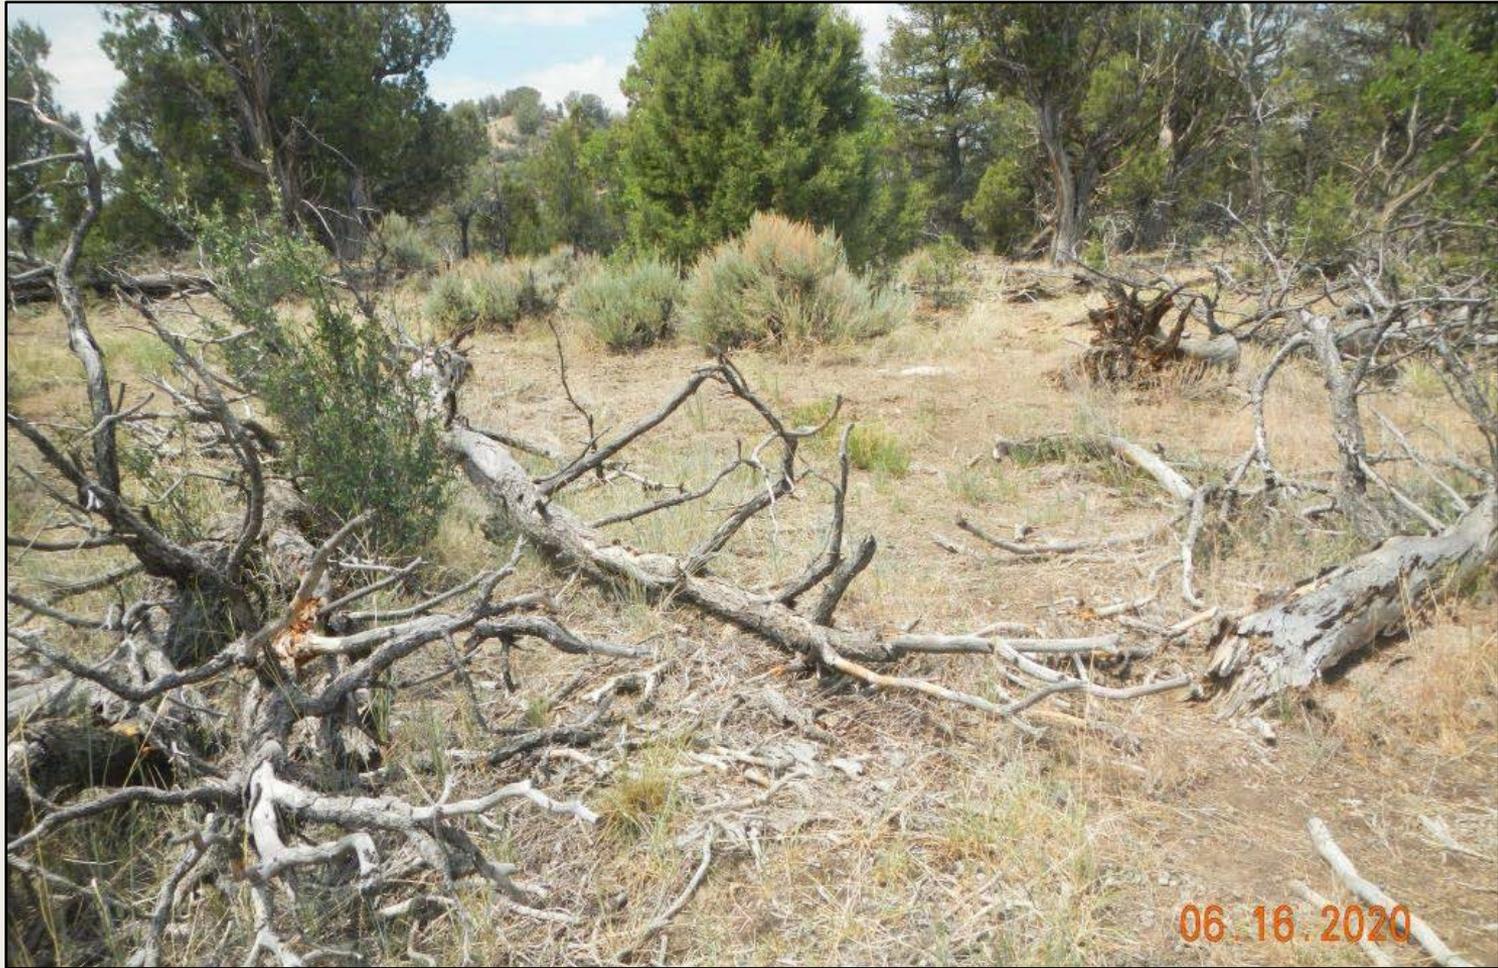
Photo 7. View of the reference area, comprised of pinyon and juniper woodland with understory of sagebrush, antelope bitterbrush, Indian ricegrass, prickly pear, penstemon, etc.
