Inspection Photos  
Operator: BP America  
API: 067-06921  
Date: 6/19/2020

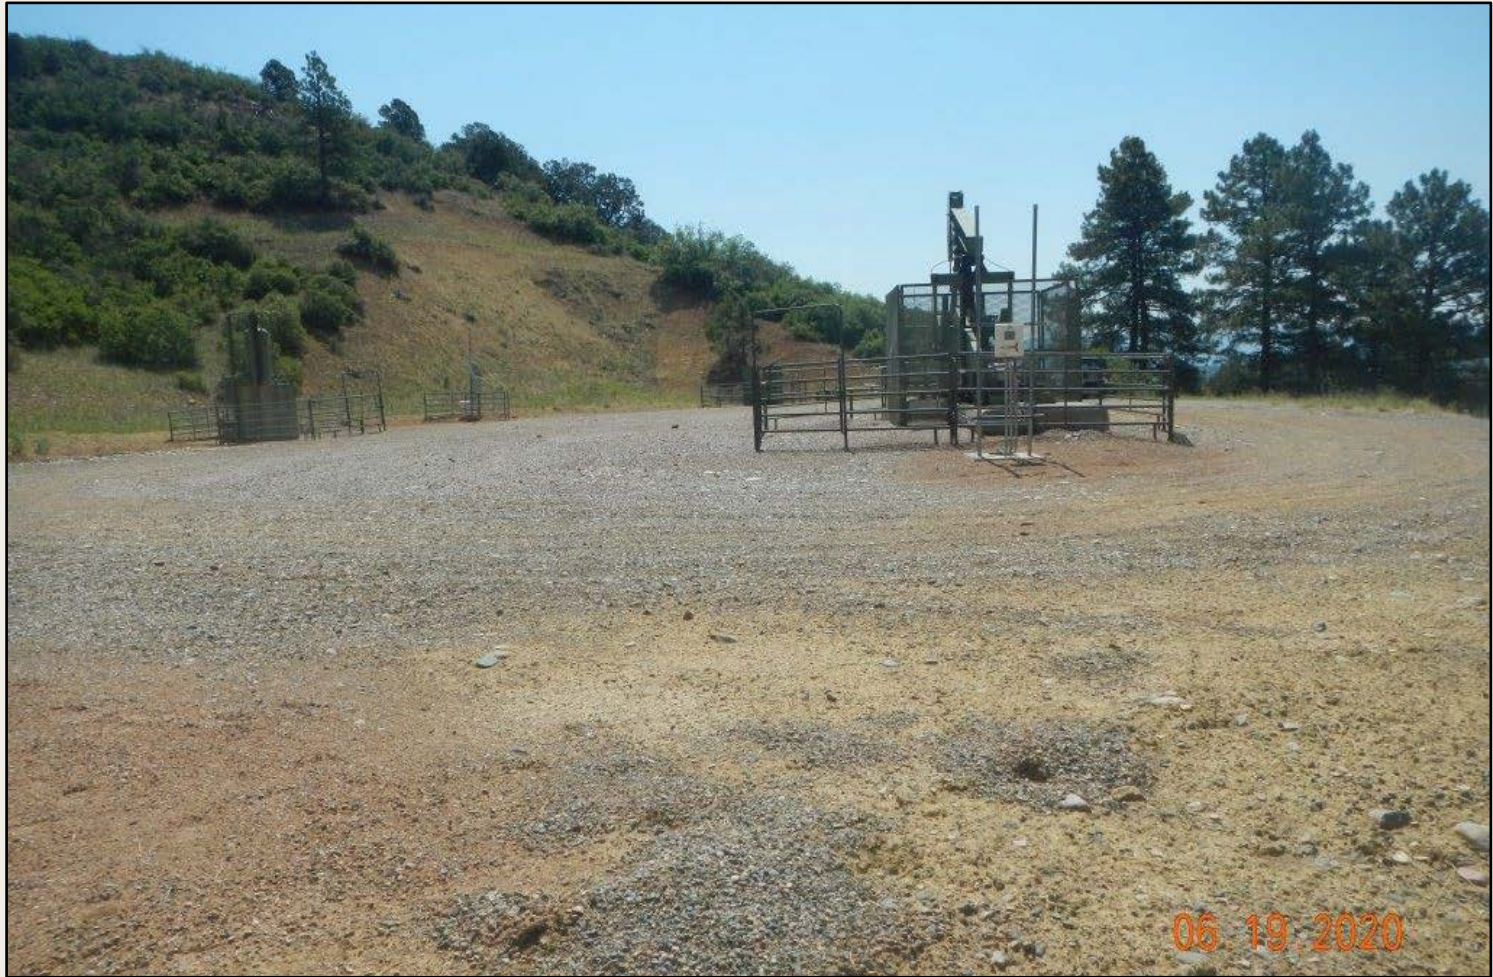
Photo 1. View of the project area from the northwestern corner facing center.

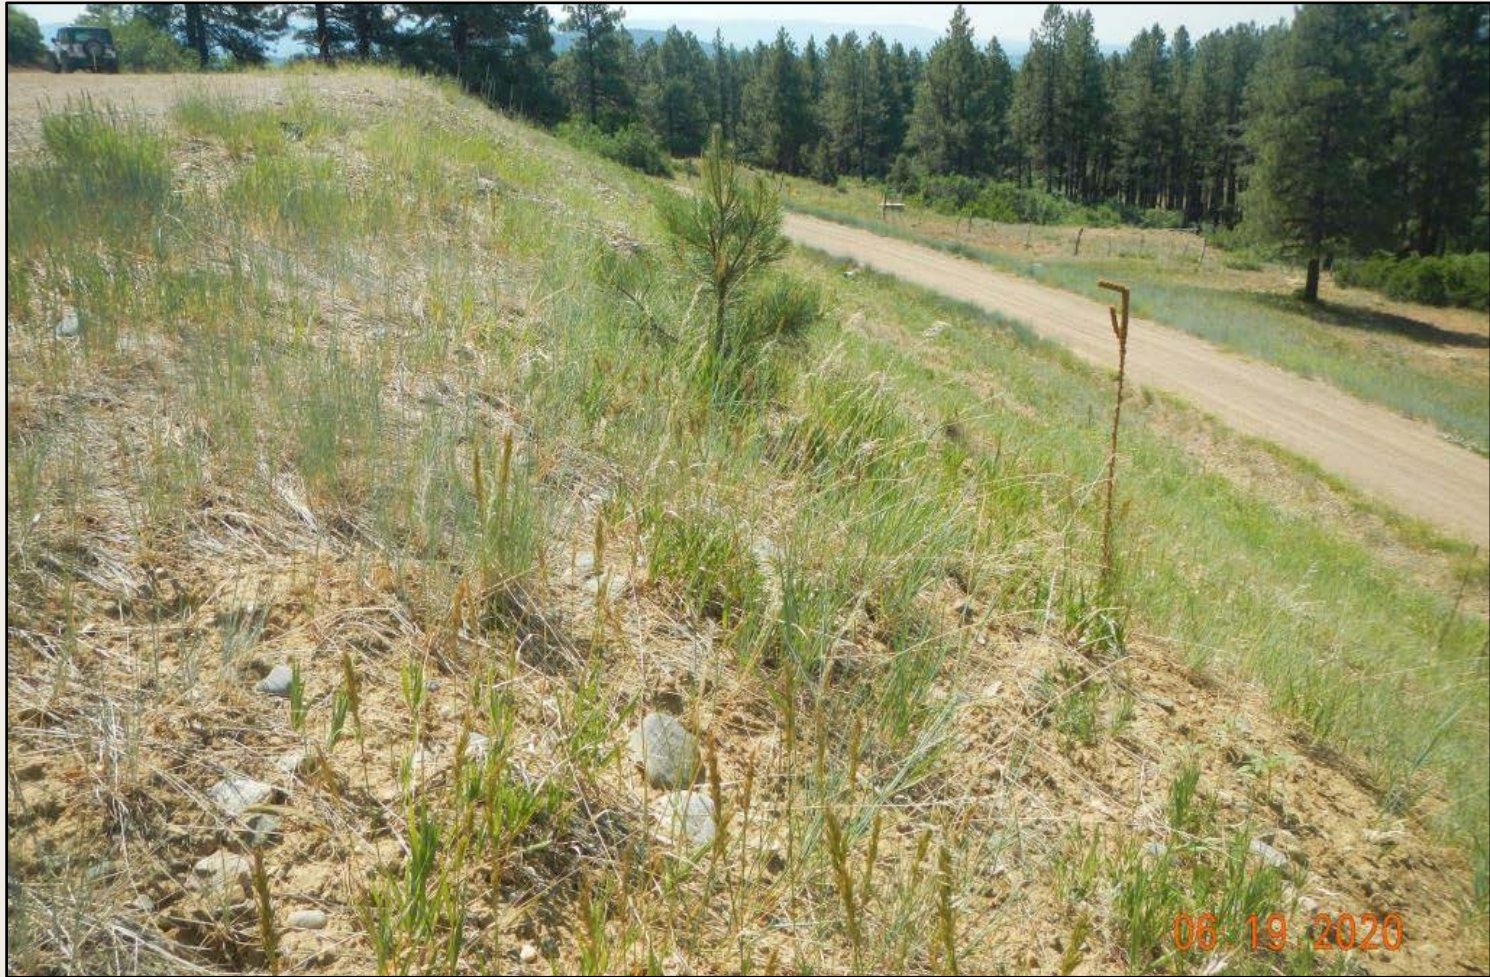
Photo 2. View of the western fill slope from the northwestern corner facing southward. Revegetation is progressing, largely with smooth brome and western wheatgrass.

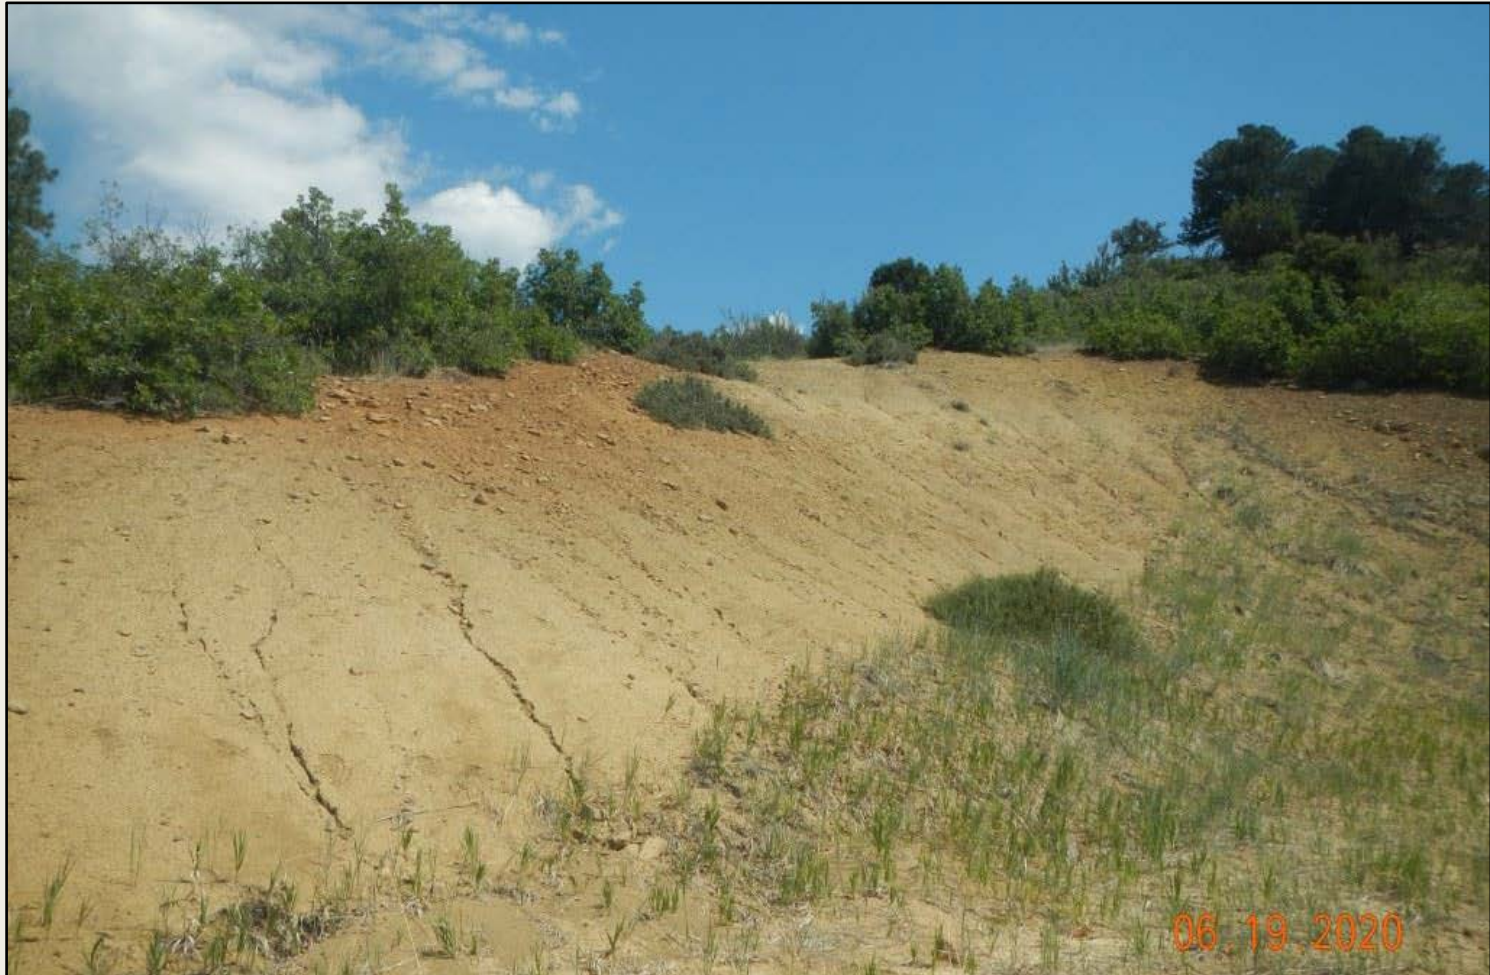
Photo 3. View of bare soils in the northern cut-slope facing eastward. Bare soils in the northern project area need stabilization.

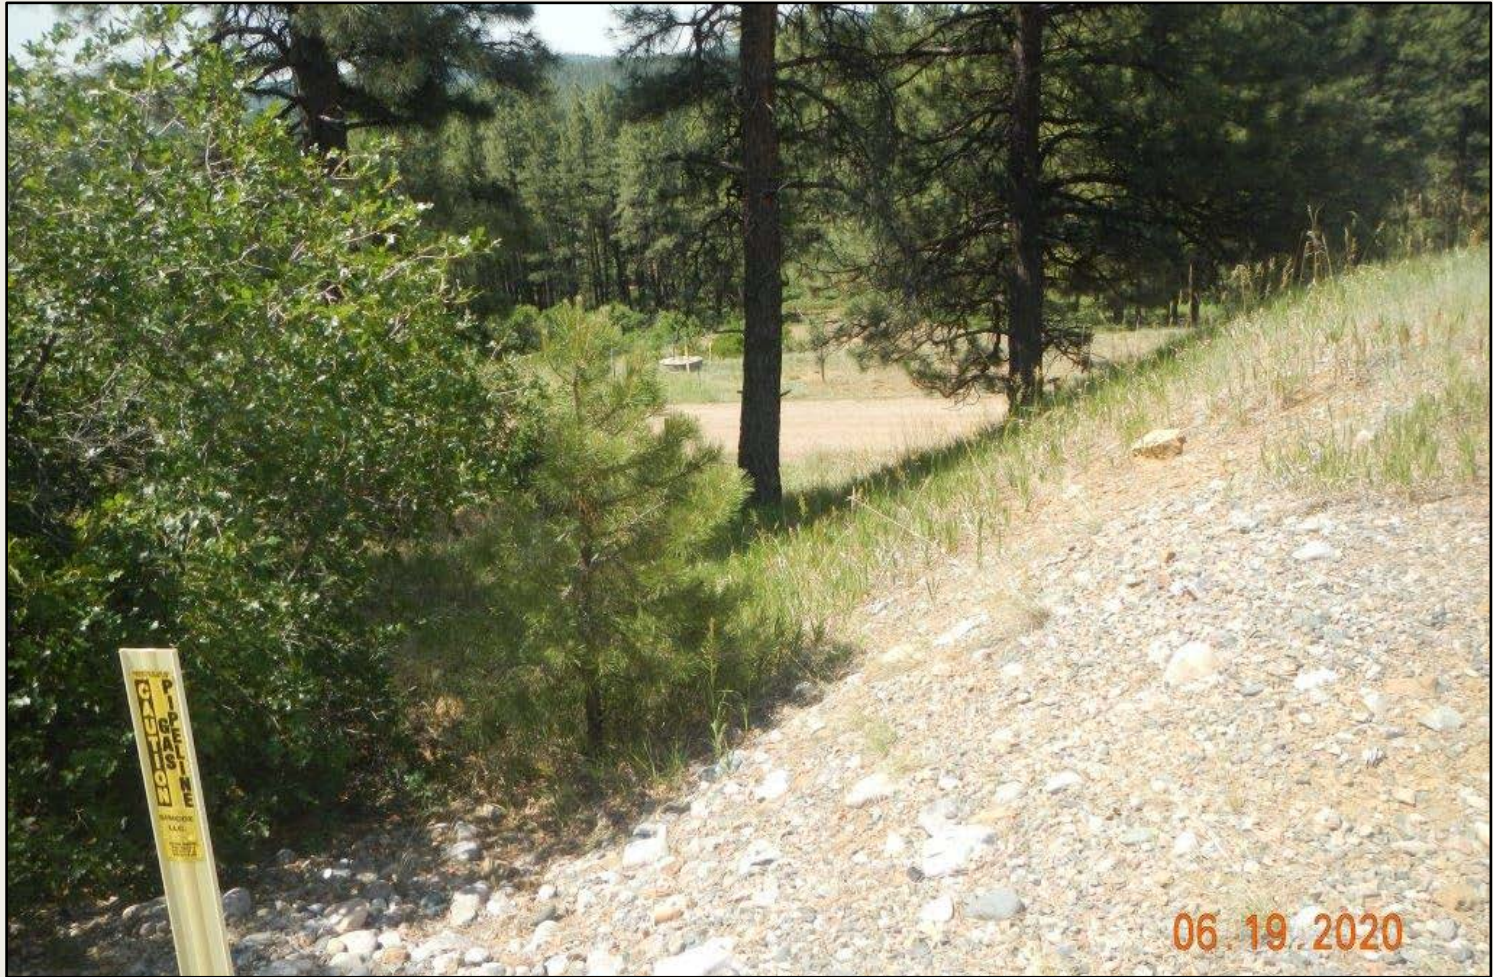
Photo 4. View of the southern project area from the well pad entrance facing westward.

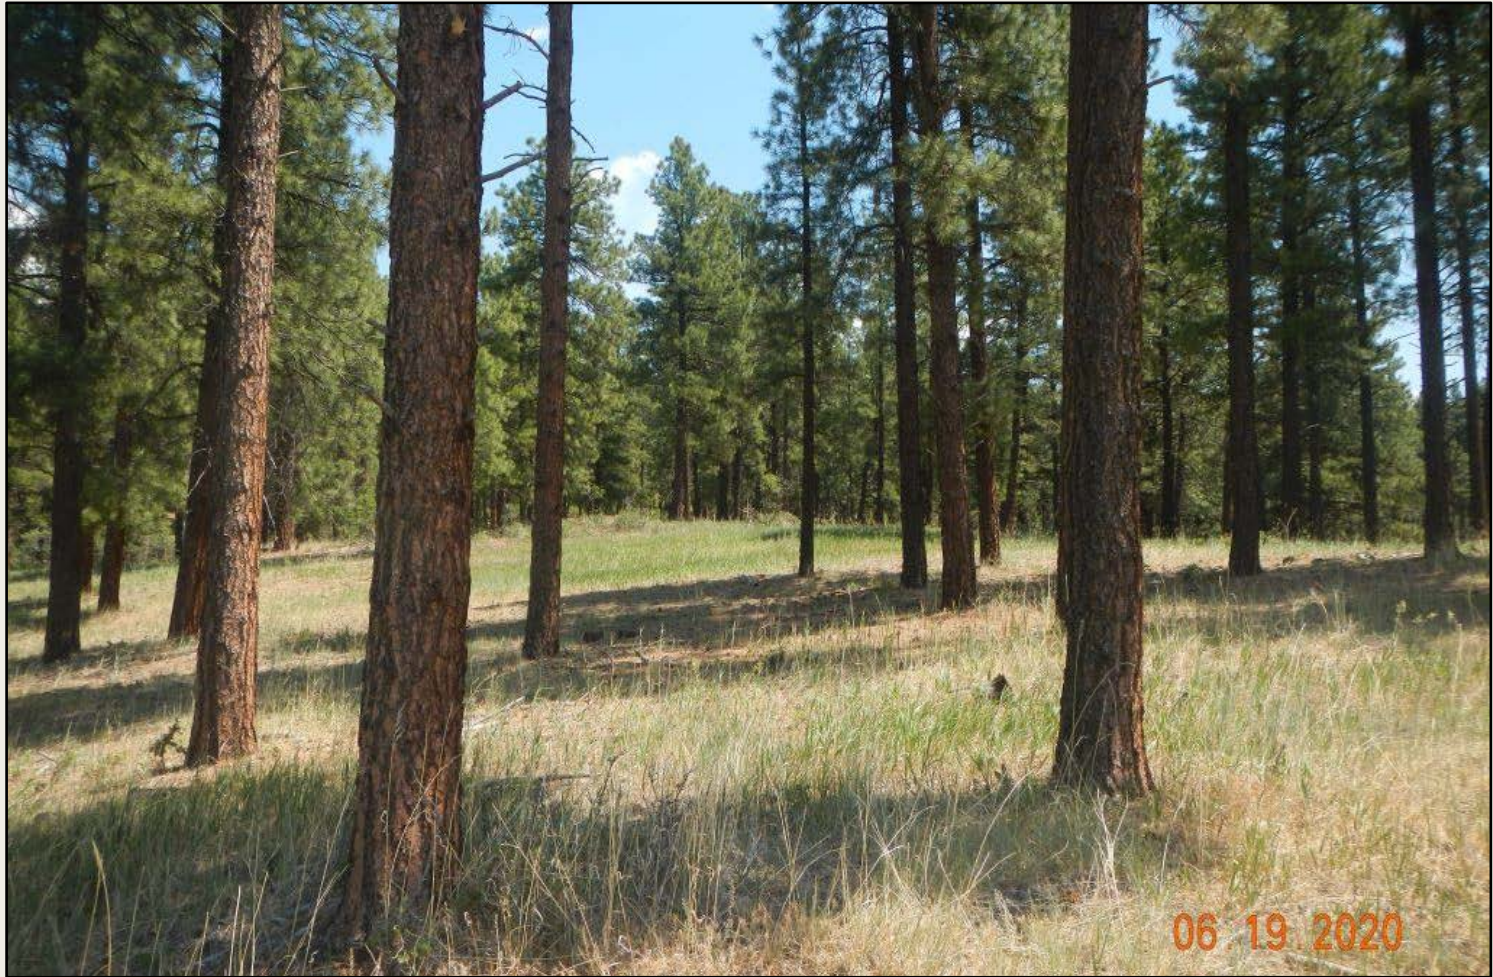
Photo 5. View of the reference area, comprised of ponderosa pine woodland with a grassy understory of smooth brome and western wheatgrass, as well as gambel oaks.
