# Inspection Photos

API: 05-009-06585

Operator: SOVEREIGN OPERATING COMPANY

Inspection Date: 6/22/2020

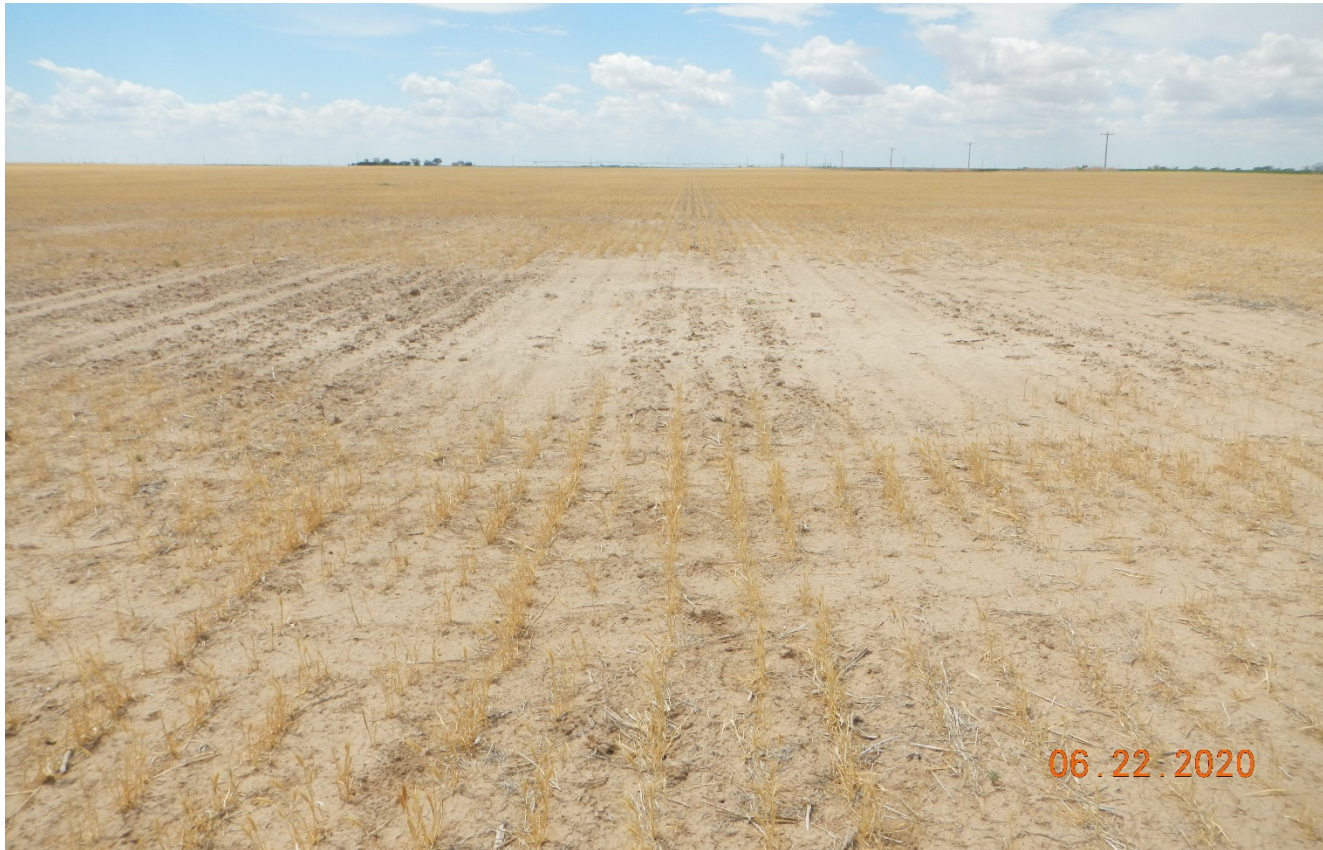
**Photo 1.** Facing south toward the wellsite. The area of the wellsite does not have crop growth.

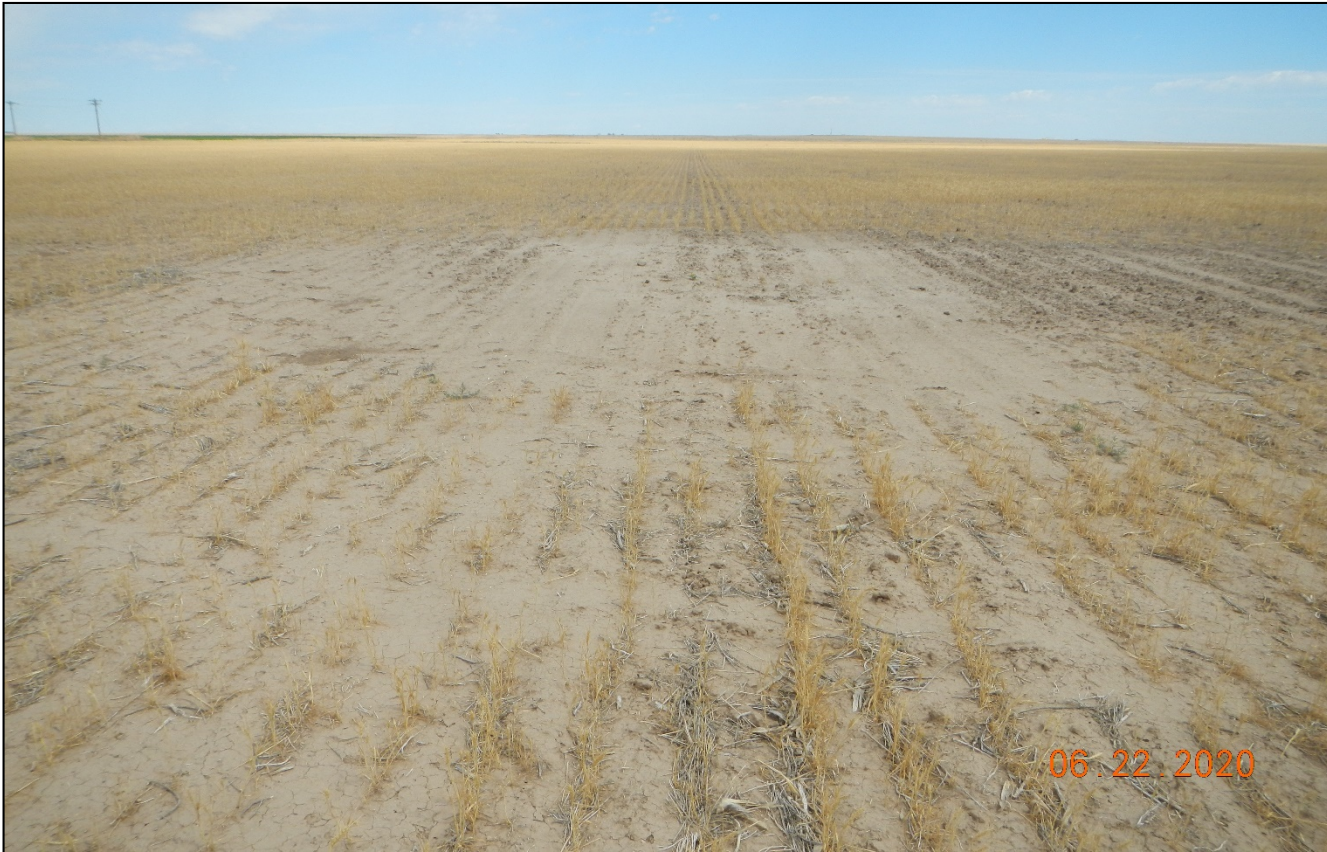
**Photo 2.** Facing north at the wellsite. This area is approximately 50 ft. x 50 ft. which does not have adequate crop growth.

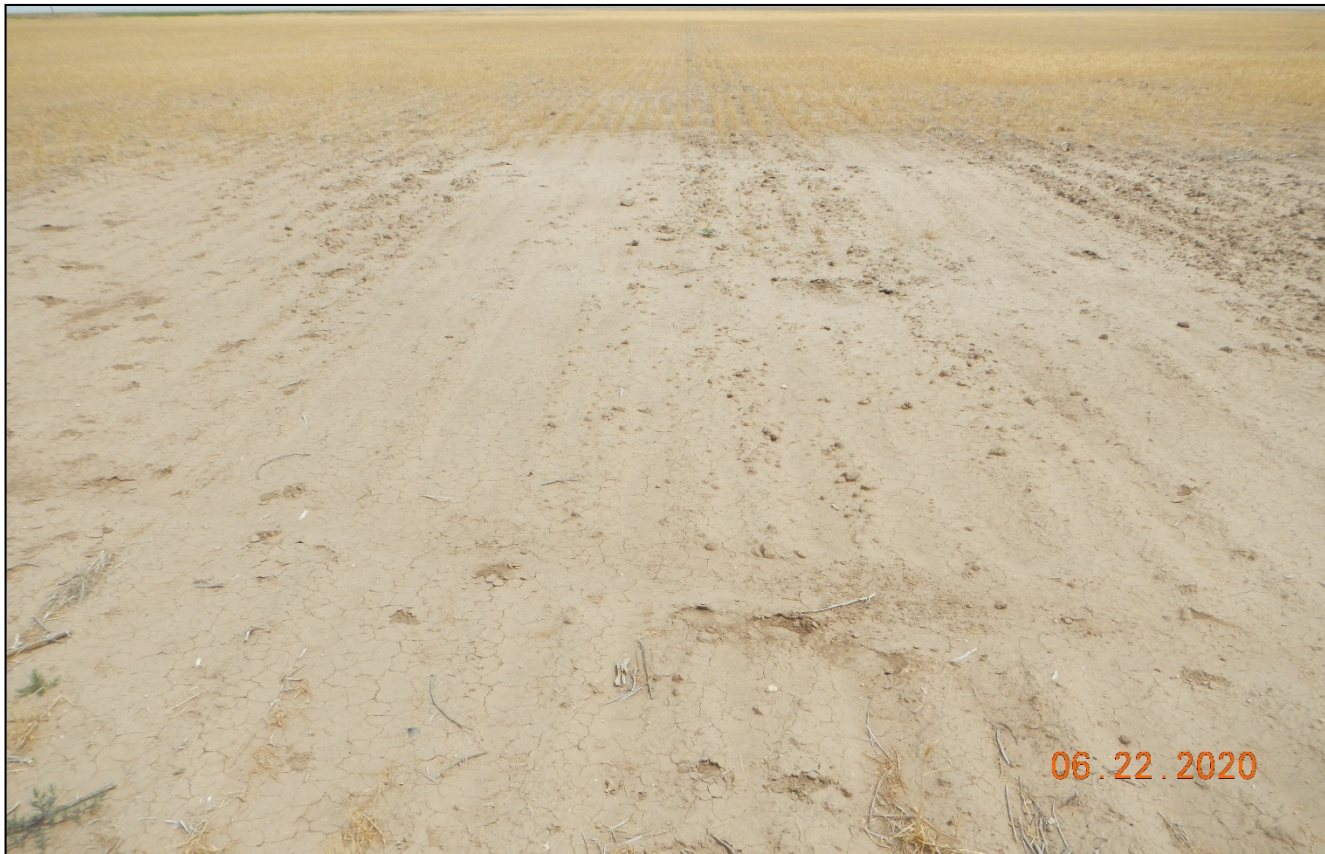
**Photo 3.** The soils are bare of crop growth.

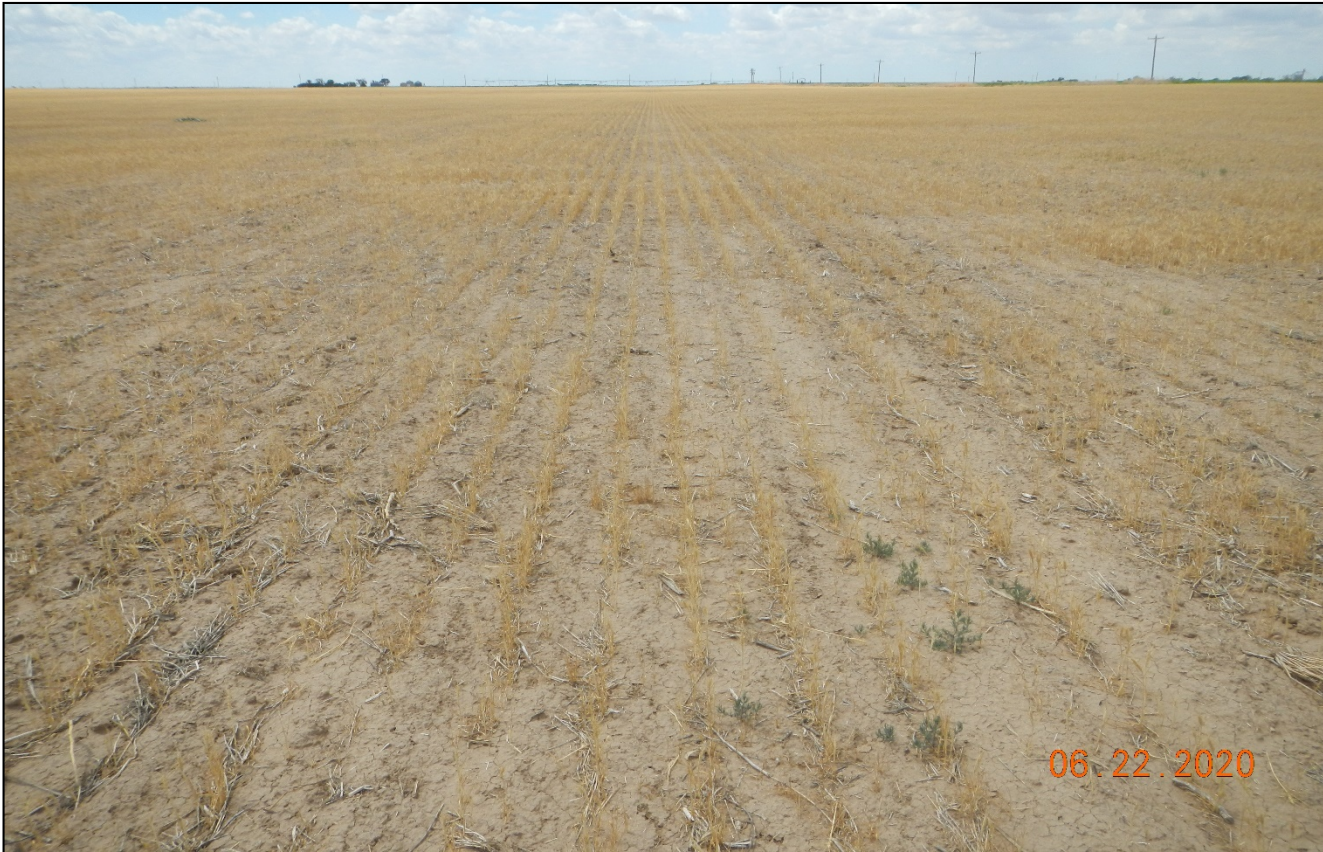
**Photo 4.** Facing south toward the surrounding crop field which has uniform crop growth.
