Inspection Photos  
Operator: BP America  
API: 067-07777  
Date: 6/24/2020

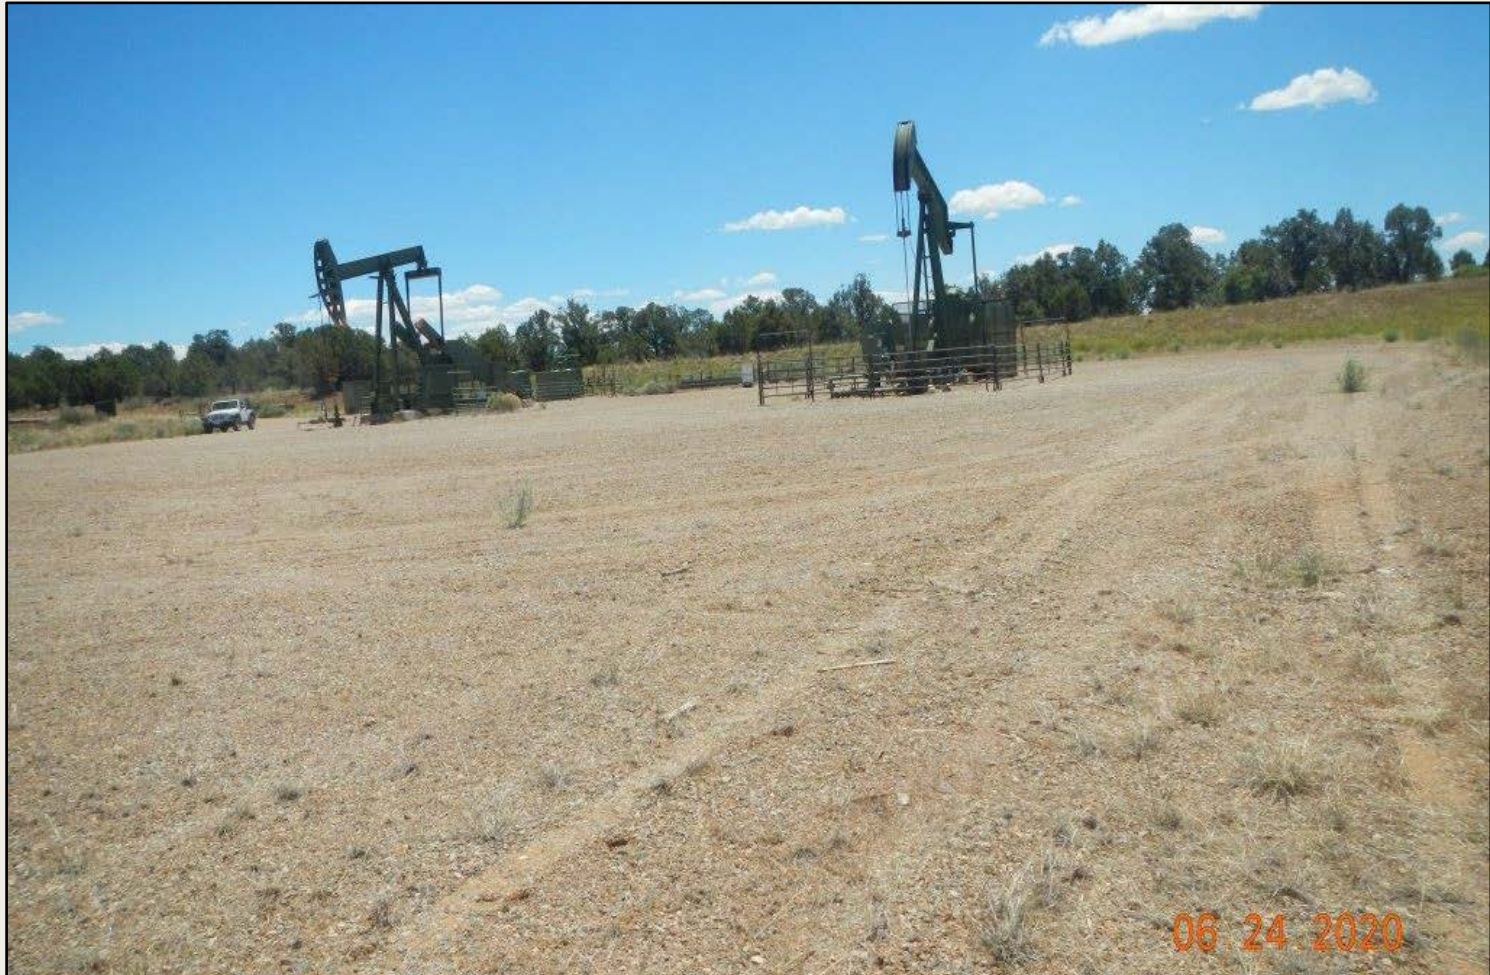
Photo 1. View of the project area from the northwestern corner facing center.

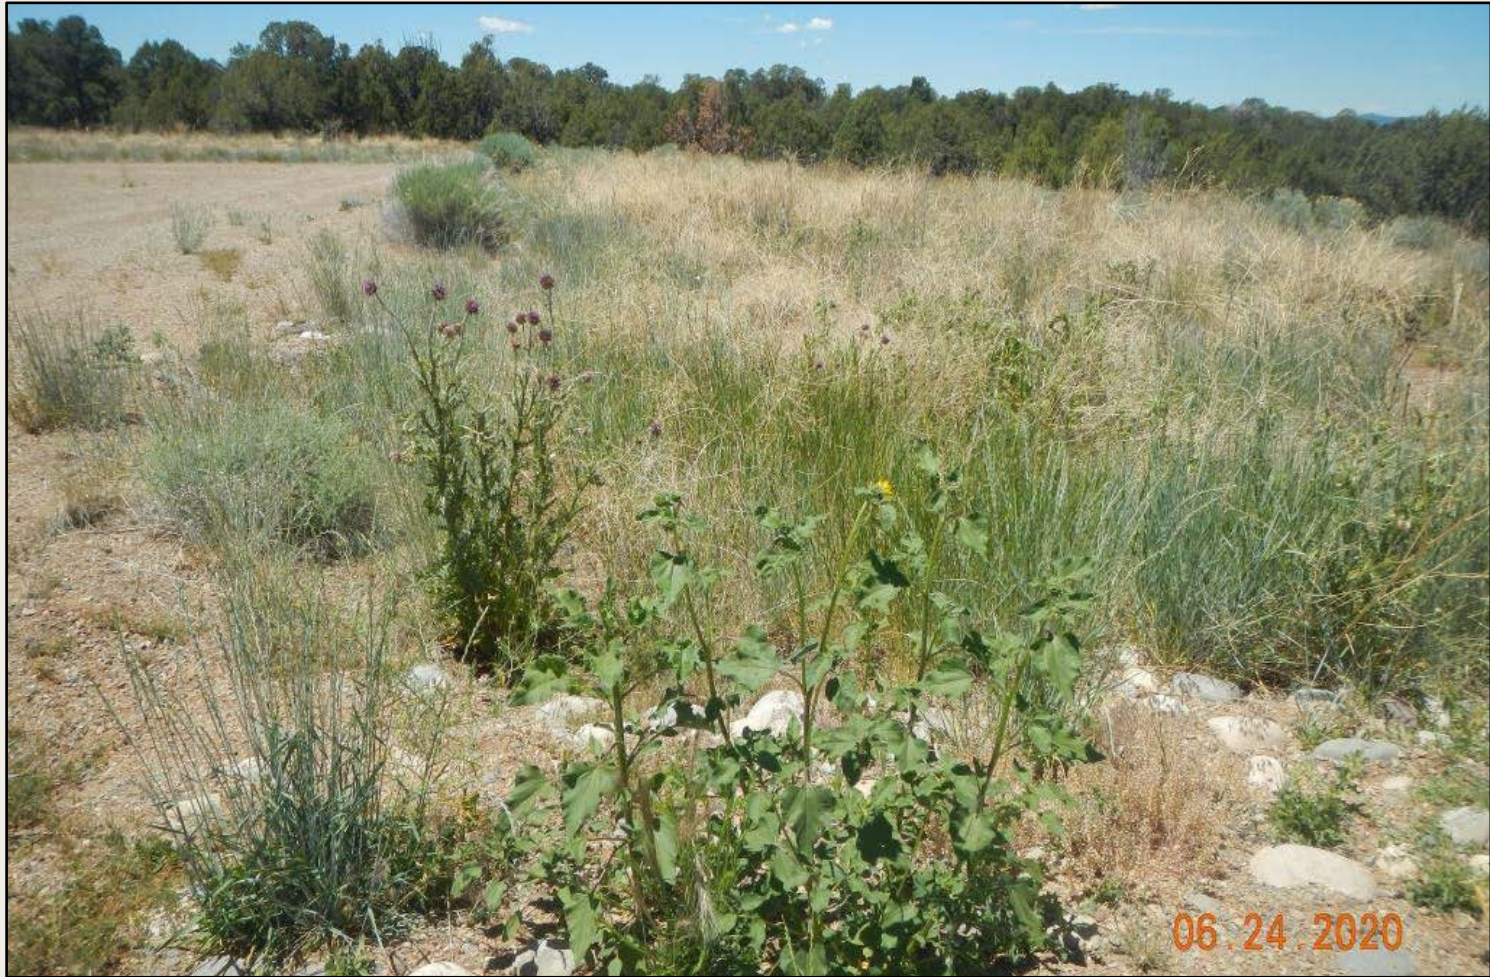
Photo 2. View of the northern fill slope from the northeastern corner facing westward. Revegetation is largely progressing within the interim reclamation areas, largely with western wheatgrass, smooth brome, and crested wheatgrass. Although, hundreds of musk thistles observed. Many appear to be recently treated, but many untreated individuals observed.

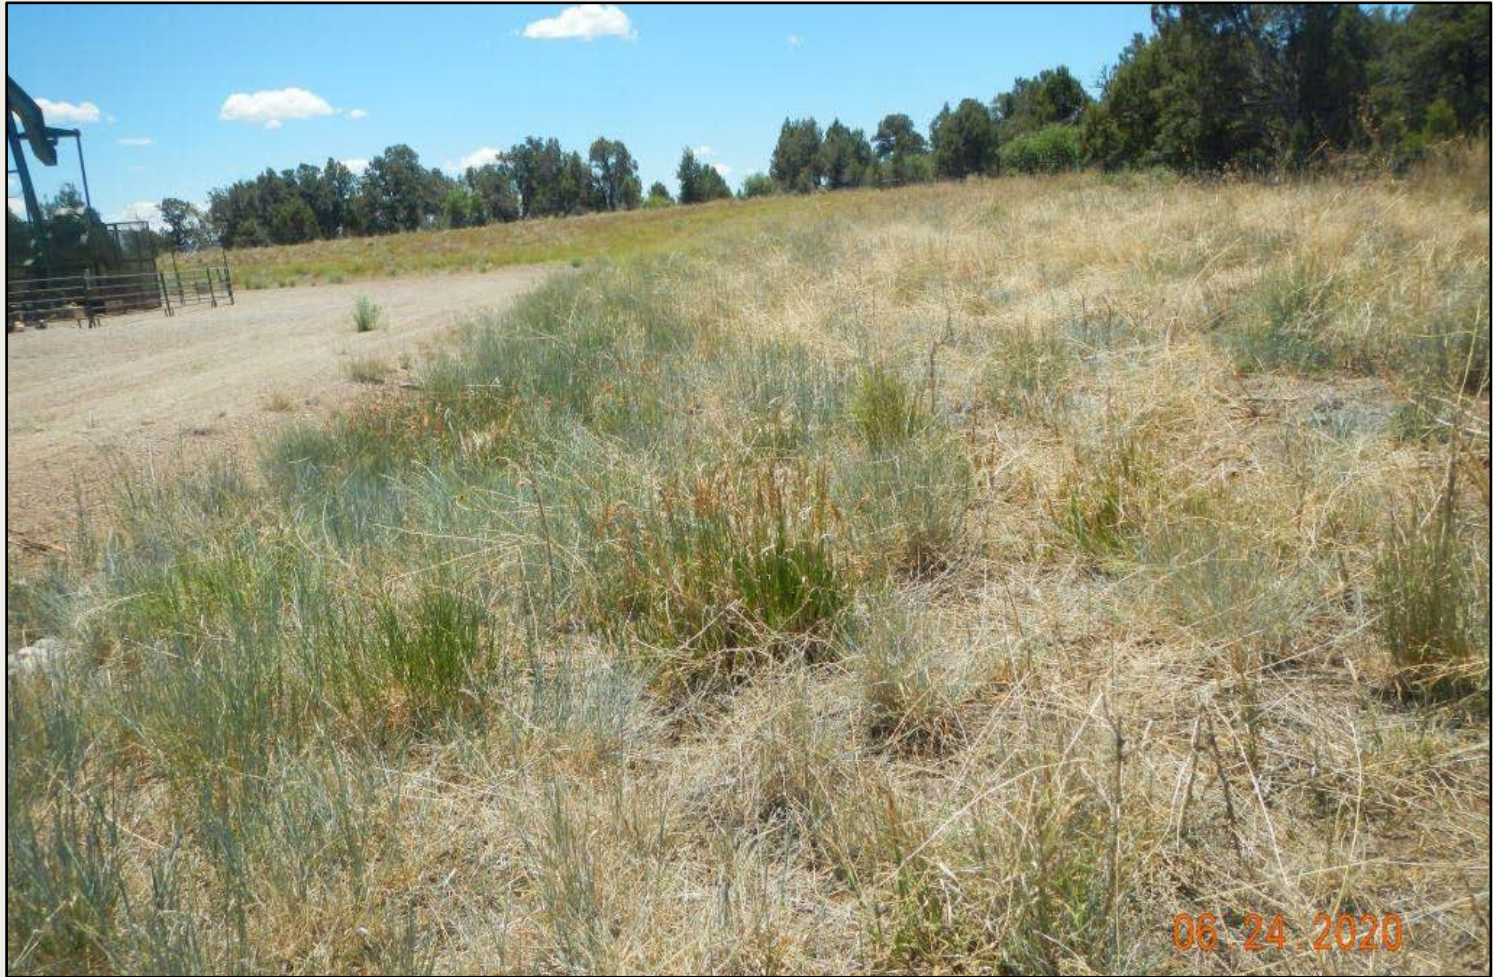
Photo 3. View of the eastern project area facing southward.

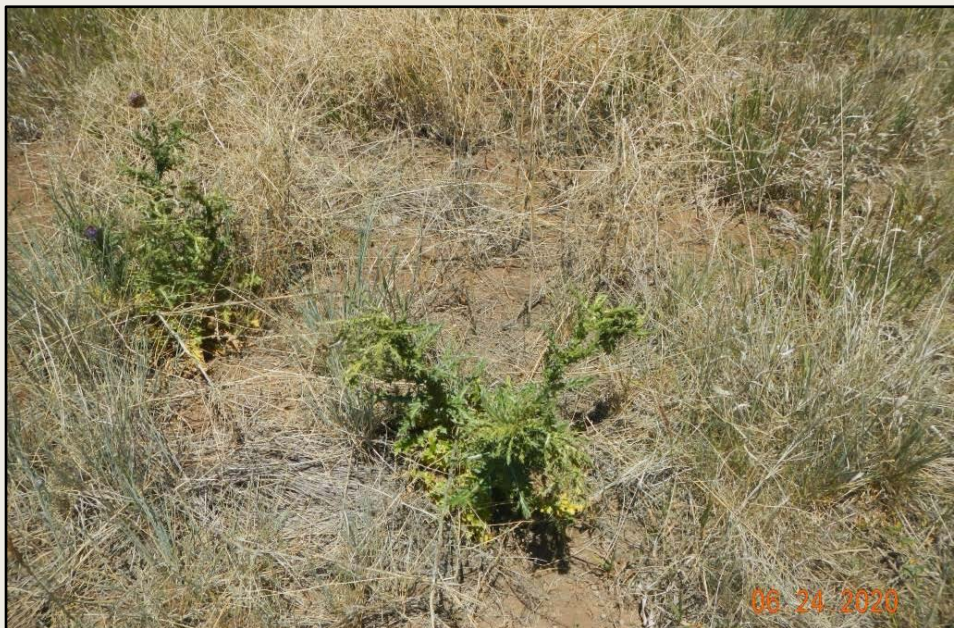
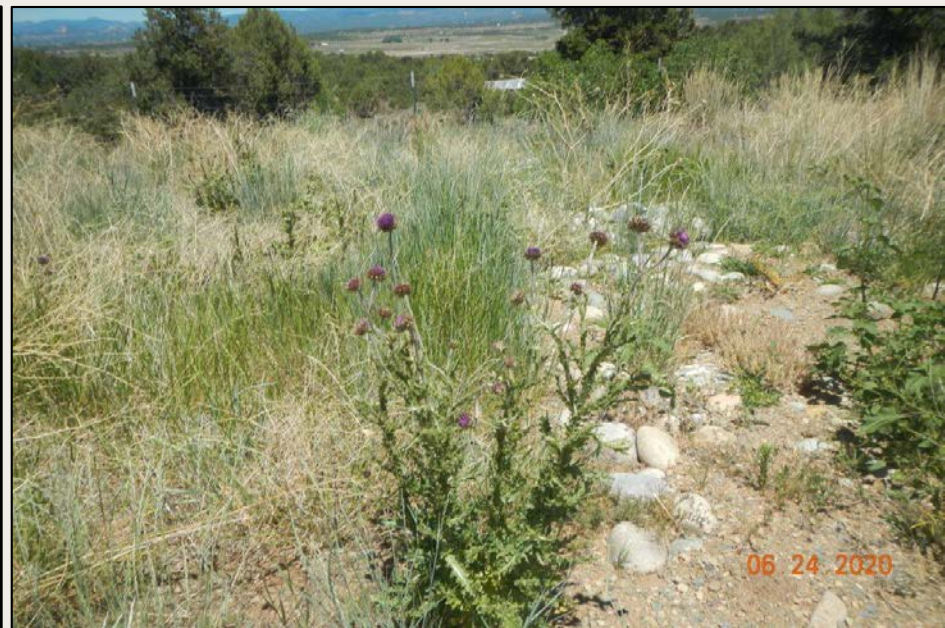
Photos 4/5. View of musk thistles within the project area, many appear to be chemically treated (left photo) and many remain untreated (right photo)

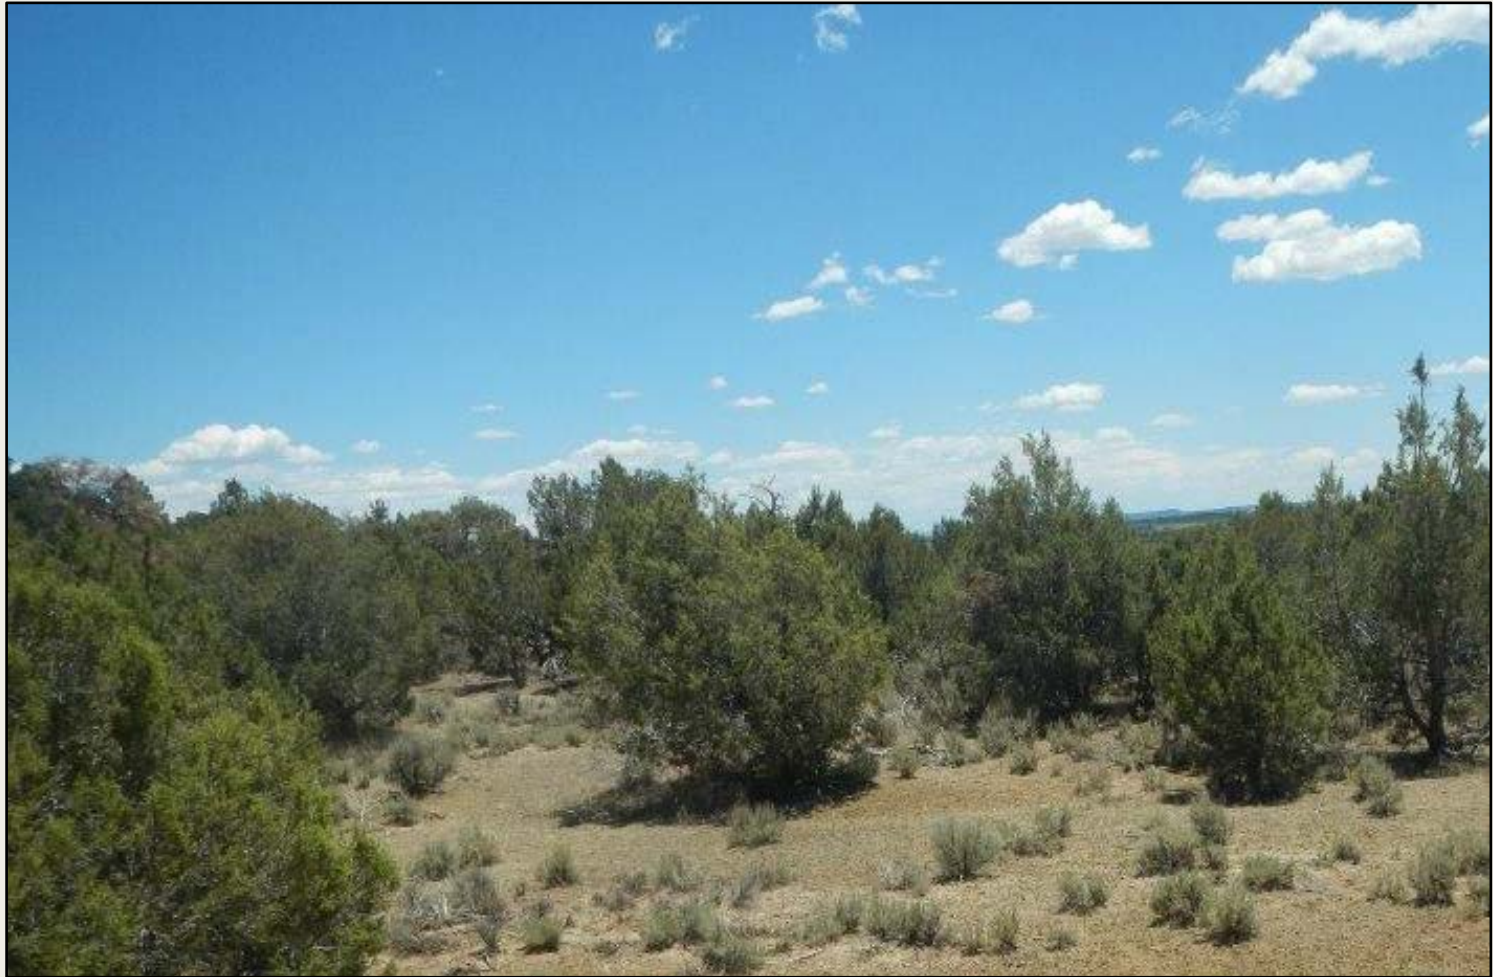
Photo 4. View of the reference area, comprised of pinyon juniper woodland with sagebrush and blue grama understory.
