Inspection Photos  
Operator: BP America  
API: 067-07713  
Date: 6/24/2020

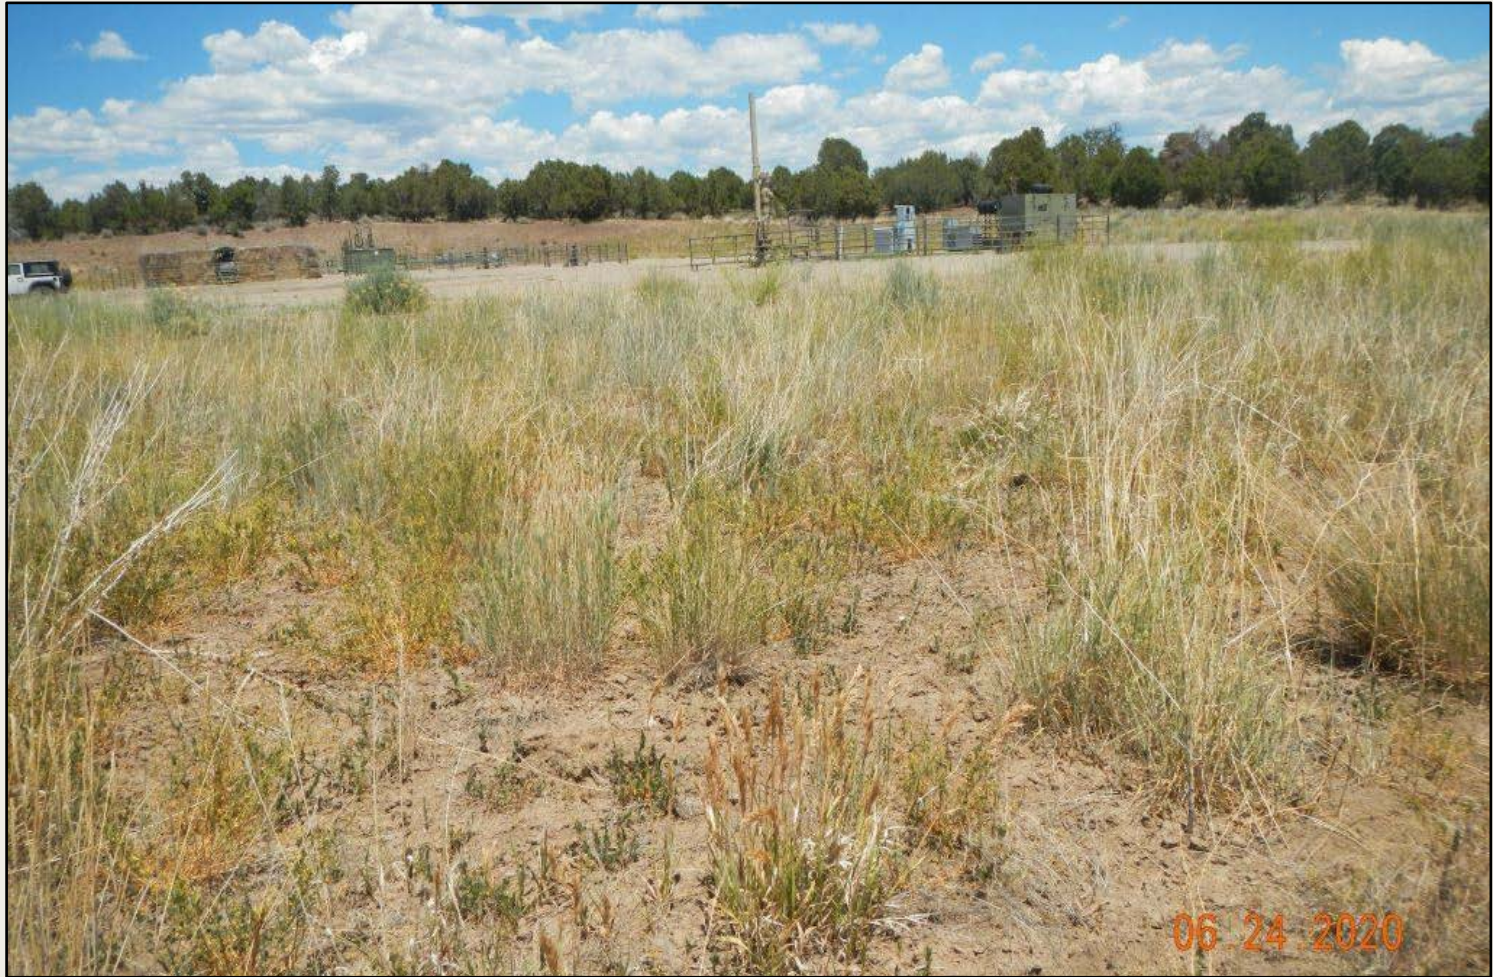
Photo 1. View of the project area from the southwestern corner facing center.

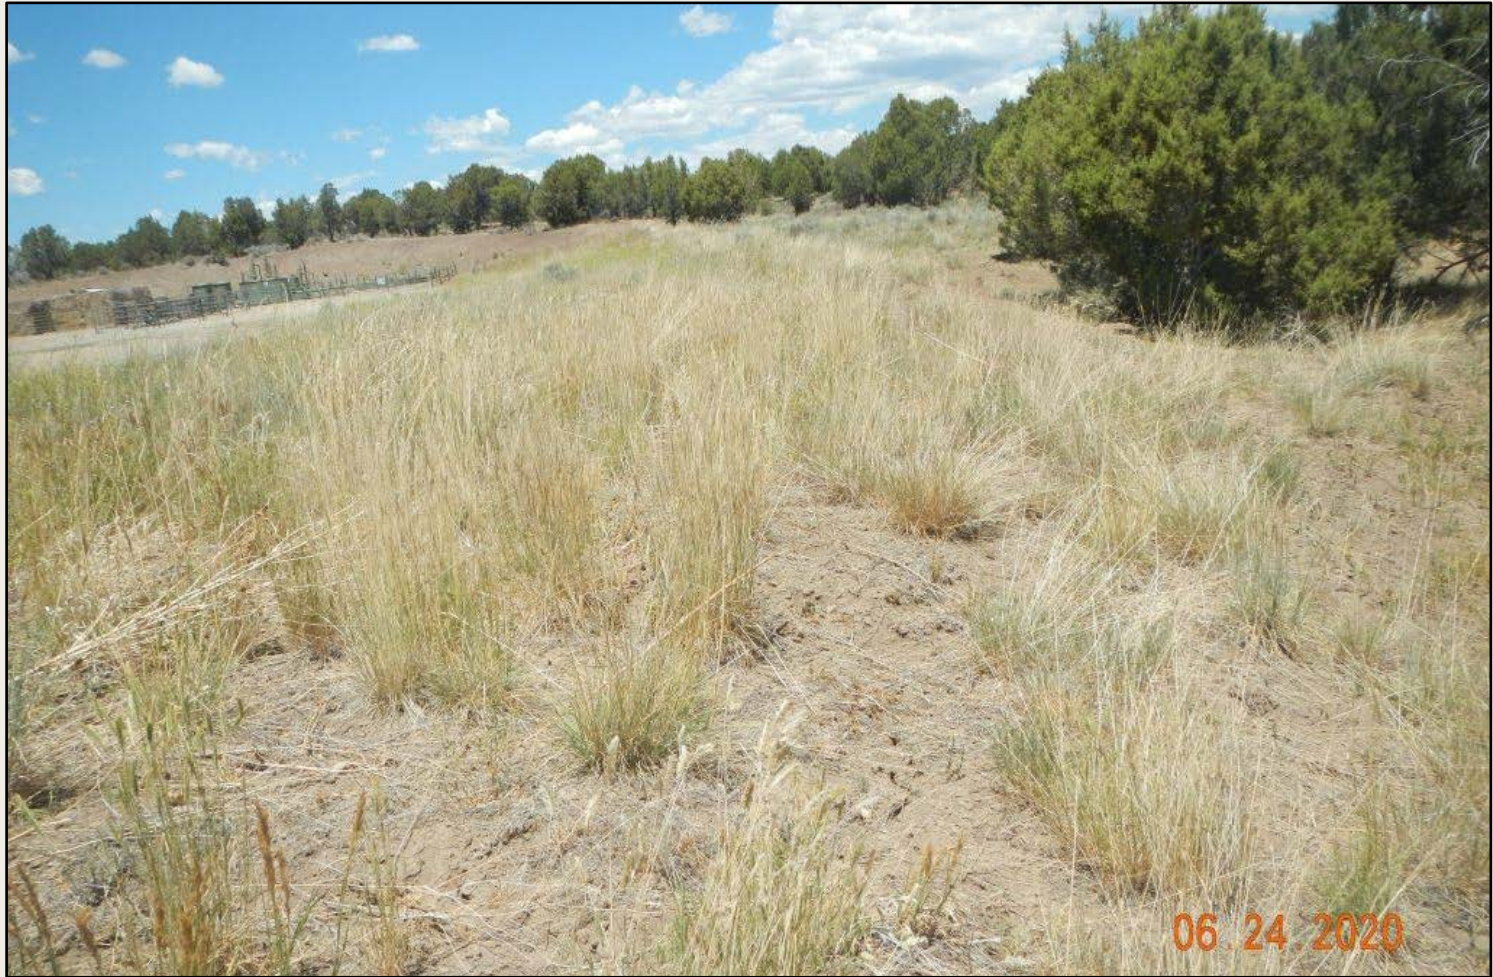
Photo 2. View of the eastern fill slope from the southeastern corner facing northward. Revegetation is largely progressing within the interim reclamation areas, largely with western wheatgrass, smooth brome, and crested wheatgrass.

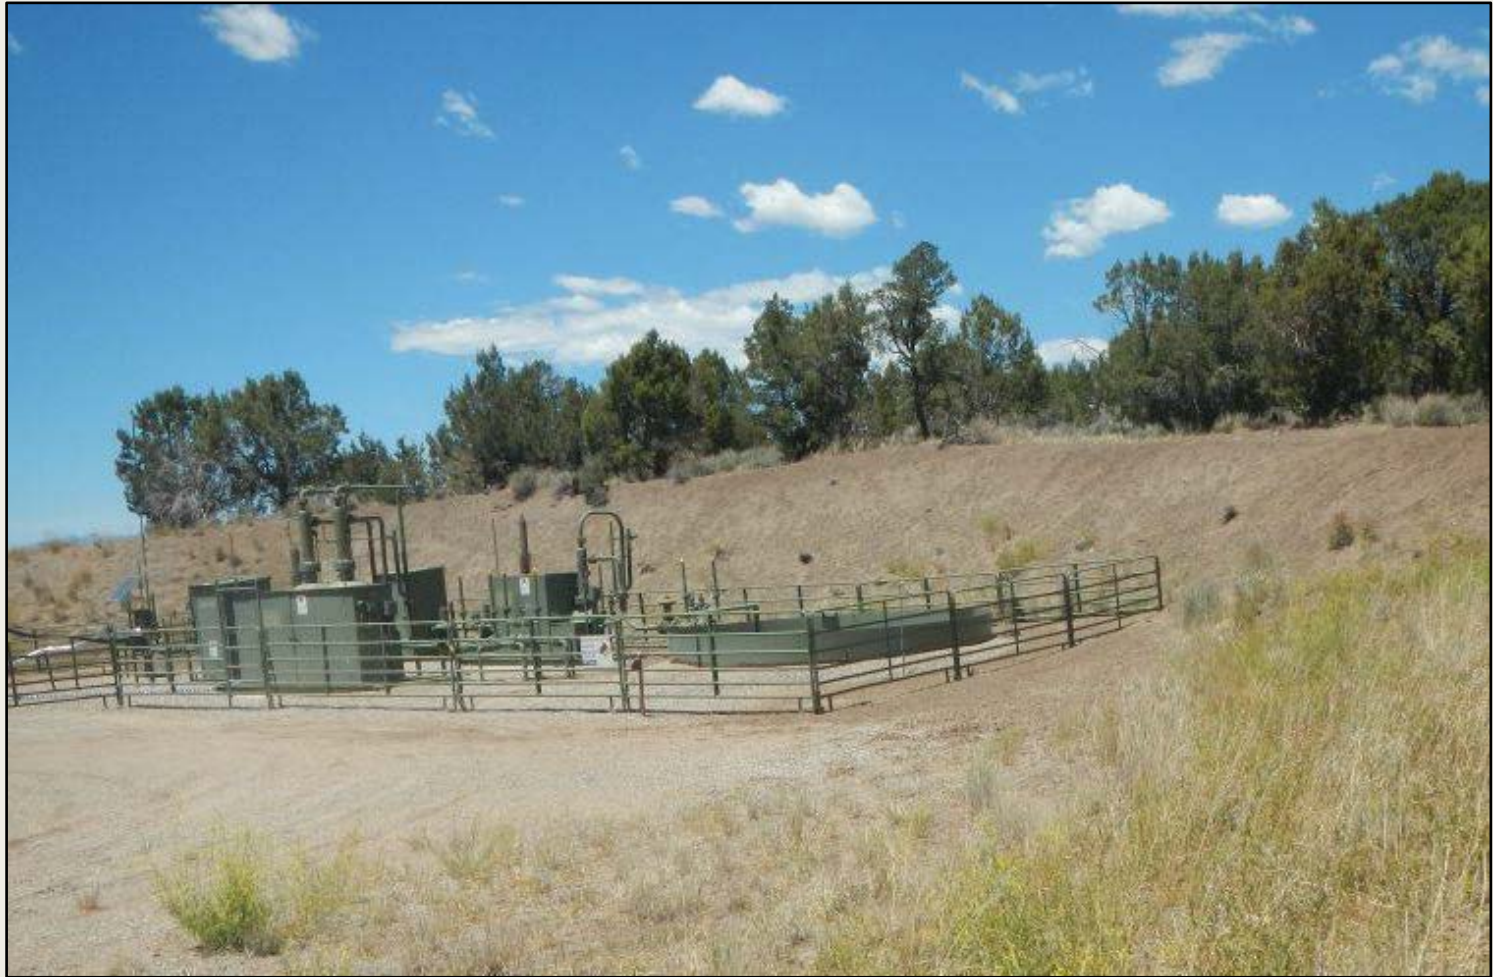
Photo 3. View of the northern cut-slope facing northward. Little vegetation is present on slope. Stabilization measures are needed.
