Interim Reclamation Inspection

Operator: NOBLE ENERGY INC - #100322

Location ID's: 329335 and 319297

Inspection Document #: 697501670

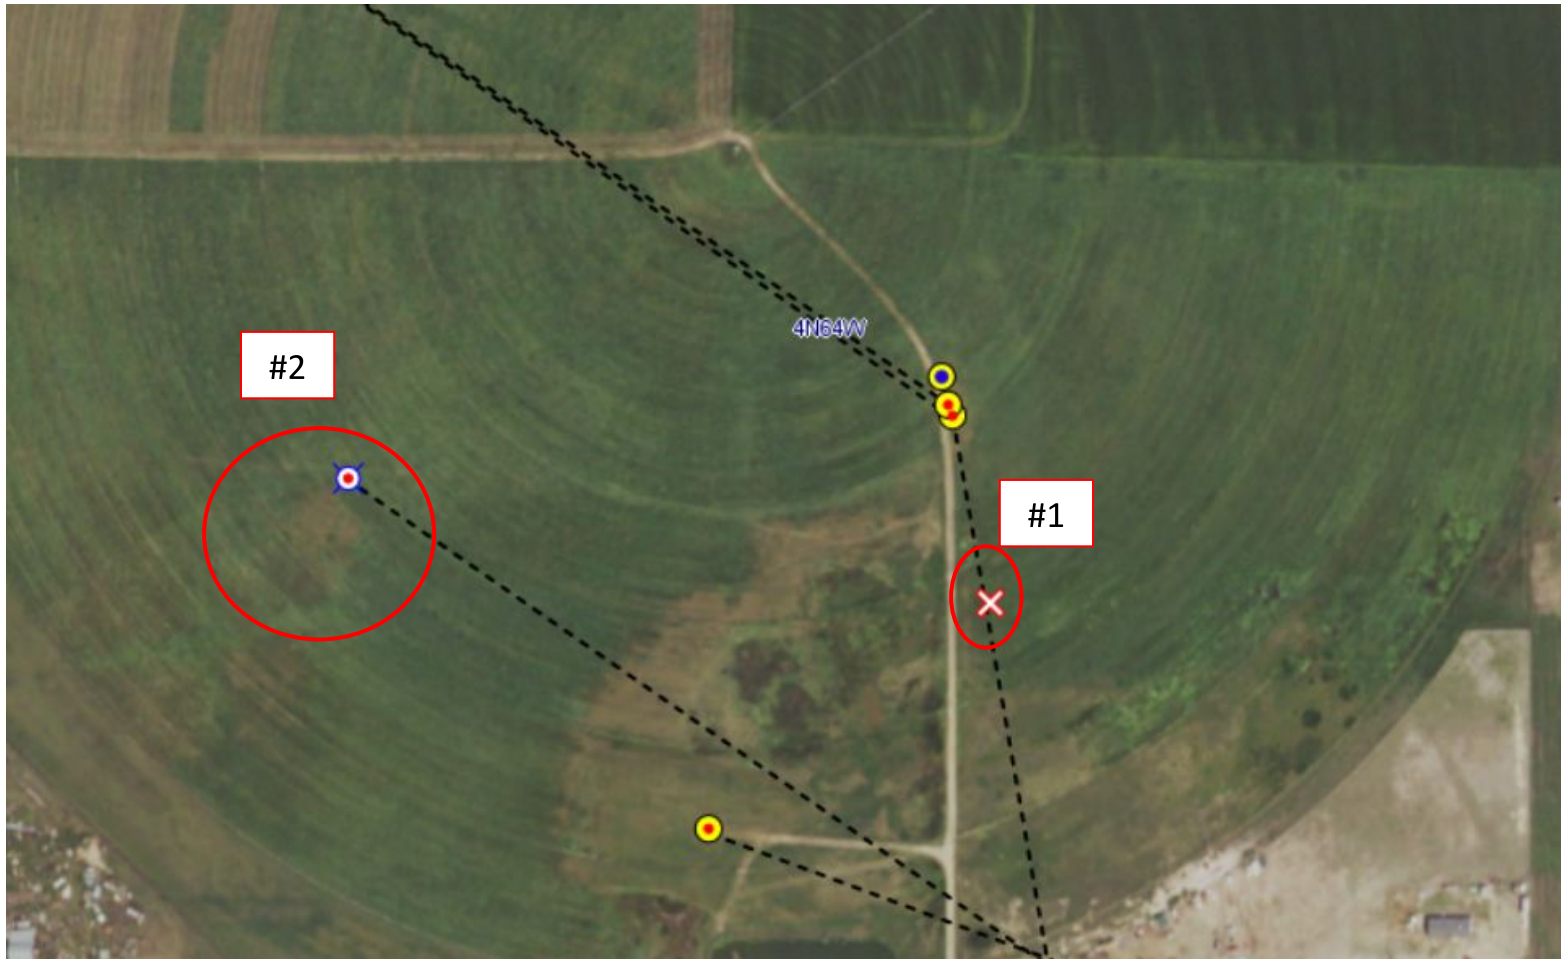
Photo 1. Aerial imagery taken in 2017. This complaint is in regards to two issues (red circles).

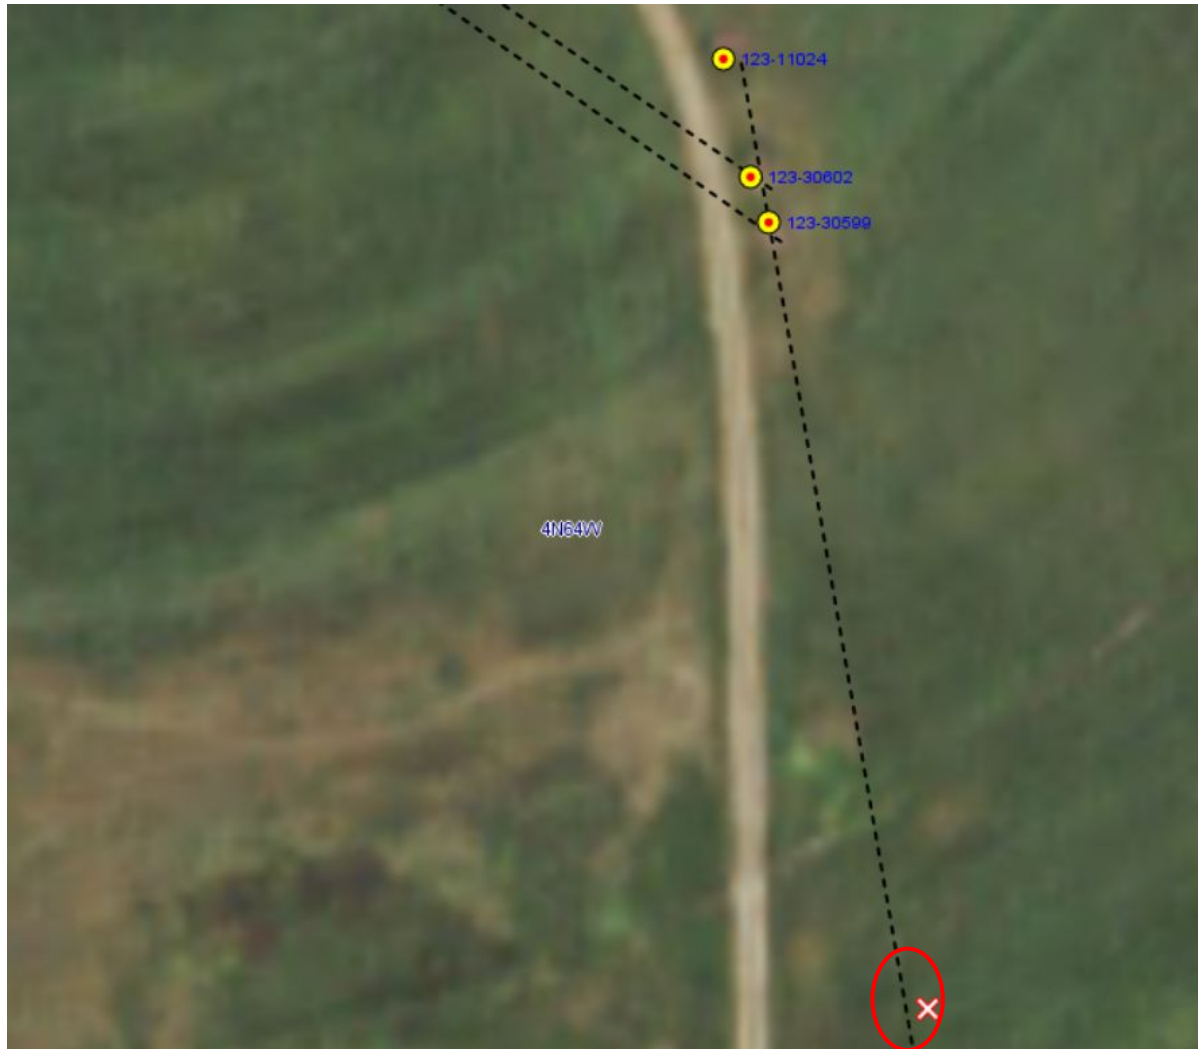
Photo 2. Aerial imagery taken in 2017. Aerial imagery of a subsidence area (red x) that appears to be associated with the flowline (black-dashed line= Active (inferred)) for well 123-11024. Subsidence is located at the approximate Lat/Long coordinates: 40.321403, -104.539956.

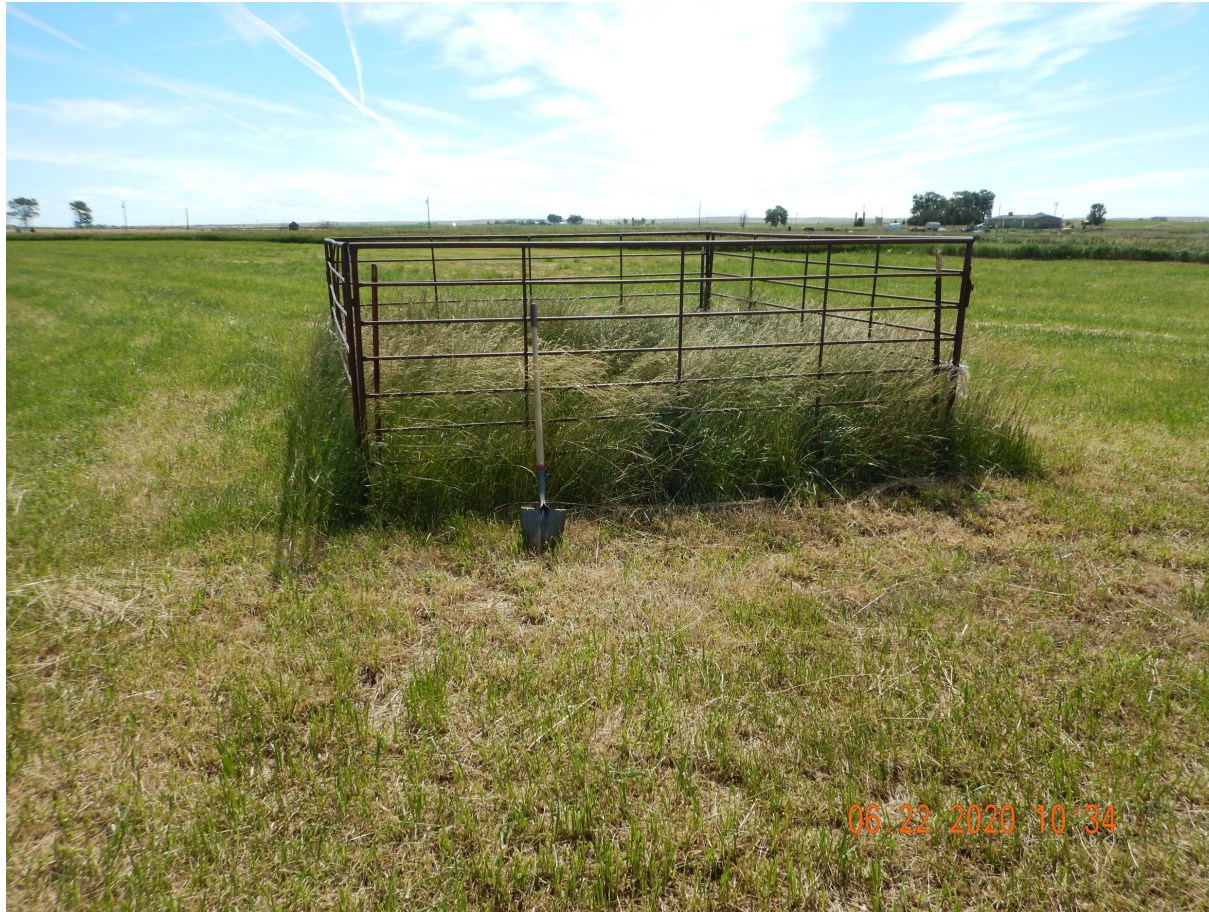
Photo 3. Photo taken from the subsidence area, facing East. Photo illustrates fencing that has been put in place by the surface owner to mitigate any safety hazards with livestock and farming equipment.

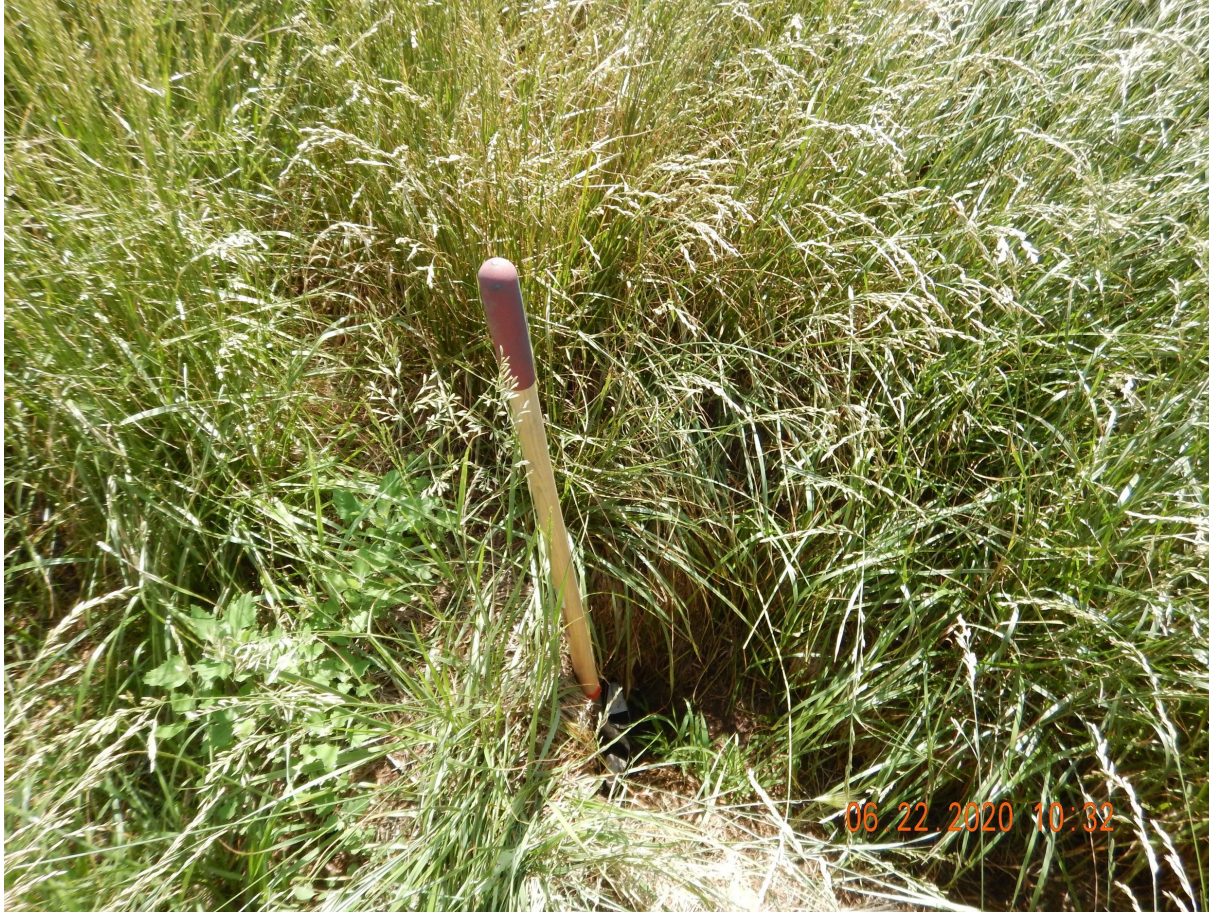
Photo 4. Photo taken from the area of subsidence. Photo illustrates a standard shovel placed into the subsidence which is ~3 feet deep.

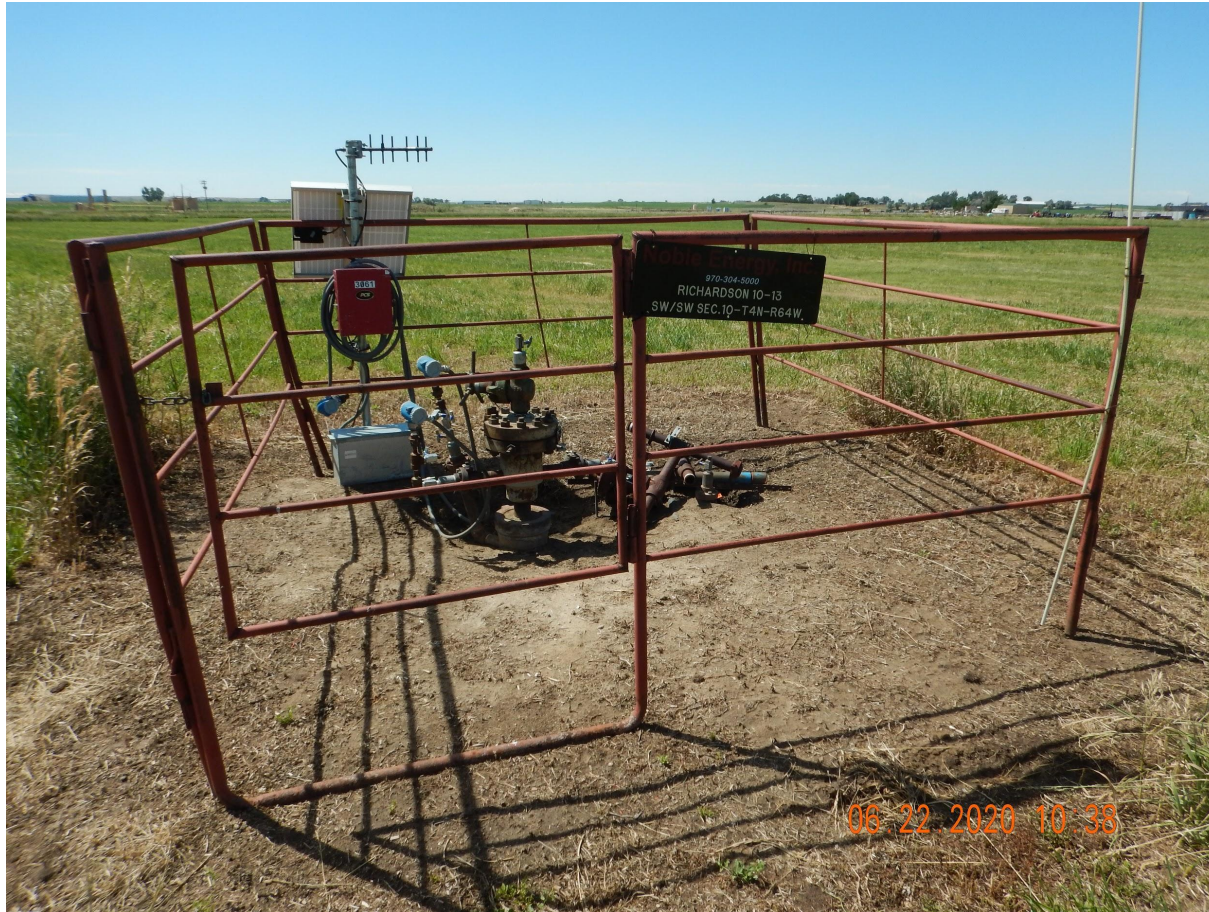
Photo 5. Photo taken from the well location, facing South. Photo illustrates the well is temporarily abandoned. Complainant thought the well was plugged but not abandoned.

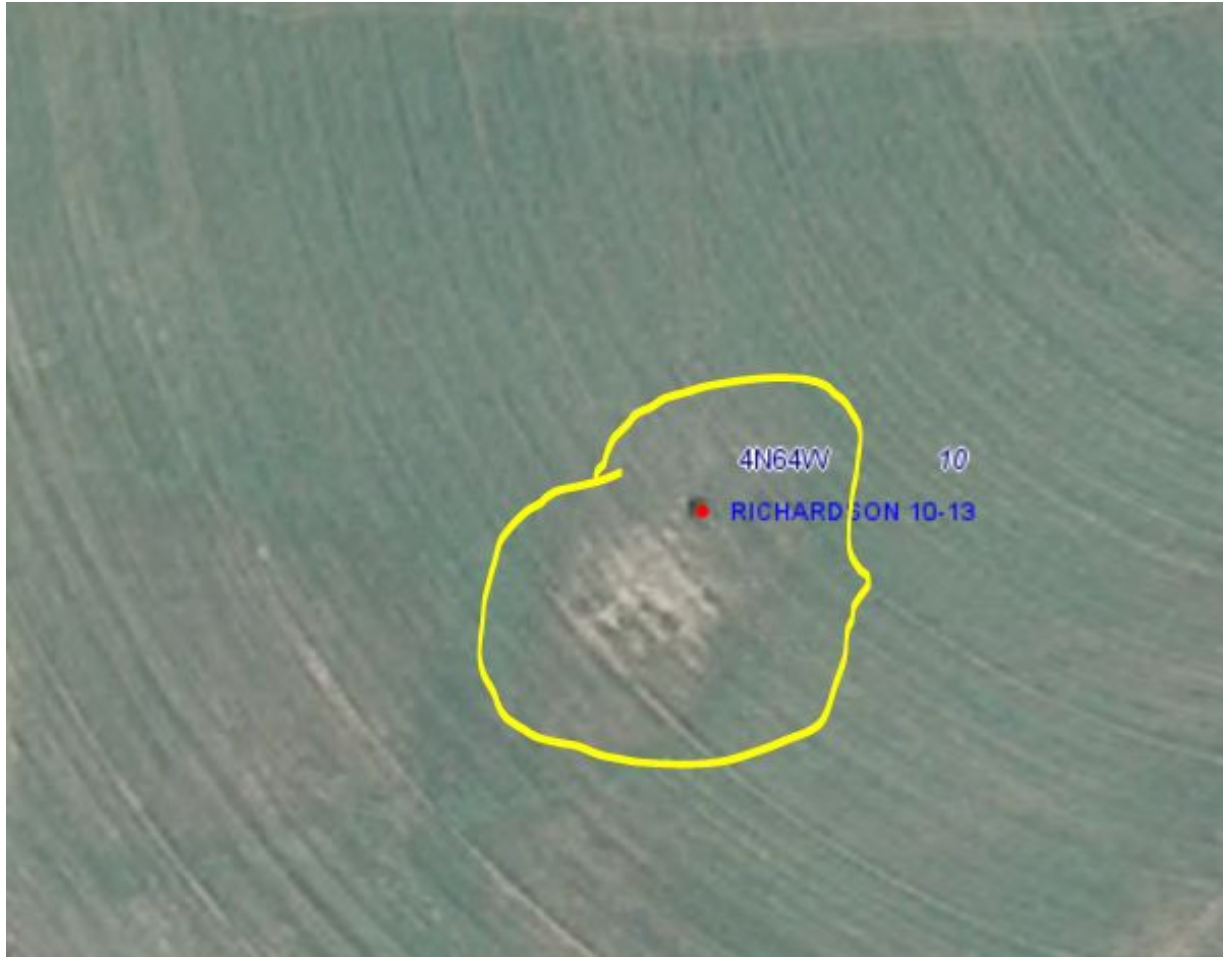
Photo 6. Aerial imagery taken in 2011. Aerial imagery shows a disturbance area around the wellhead that is not reflective of reference area vegetation.

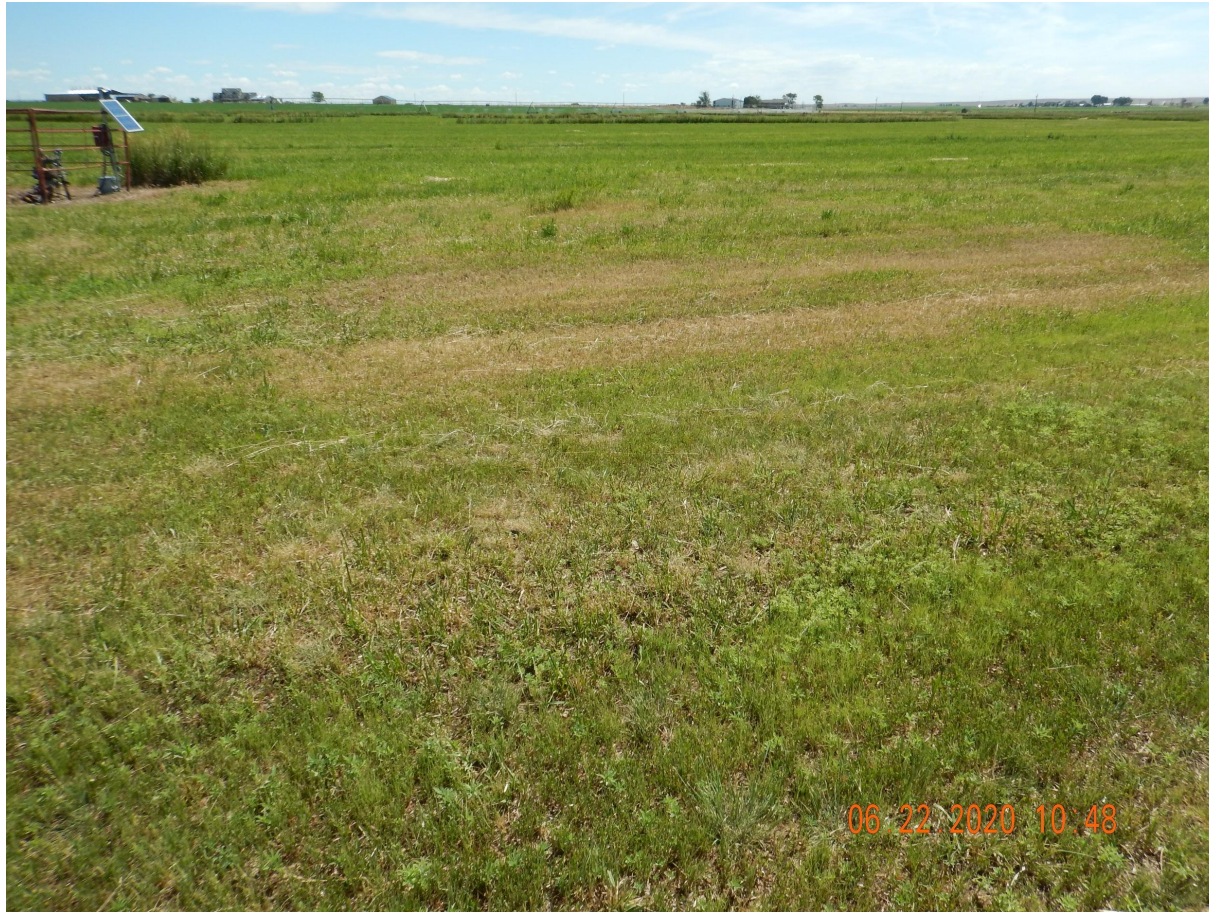
Photo 7. Photo taken adjacent to the well location, facing Southeast. Photo illustrates a disturbance area that has not been properly contoured and is not reflective of reference area vegetation. This was part of a previous complaint from 2019 that has not been addressed. This field has already been mowed so the vegetation issue is hard to observe. Refer to Photos 8-11 taken in May 2019 that better illustrate the vegetation issue.

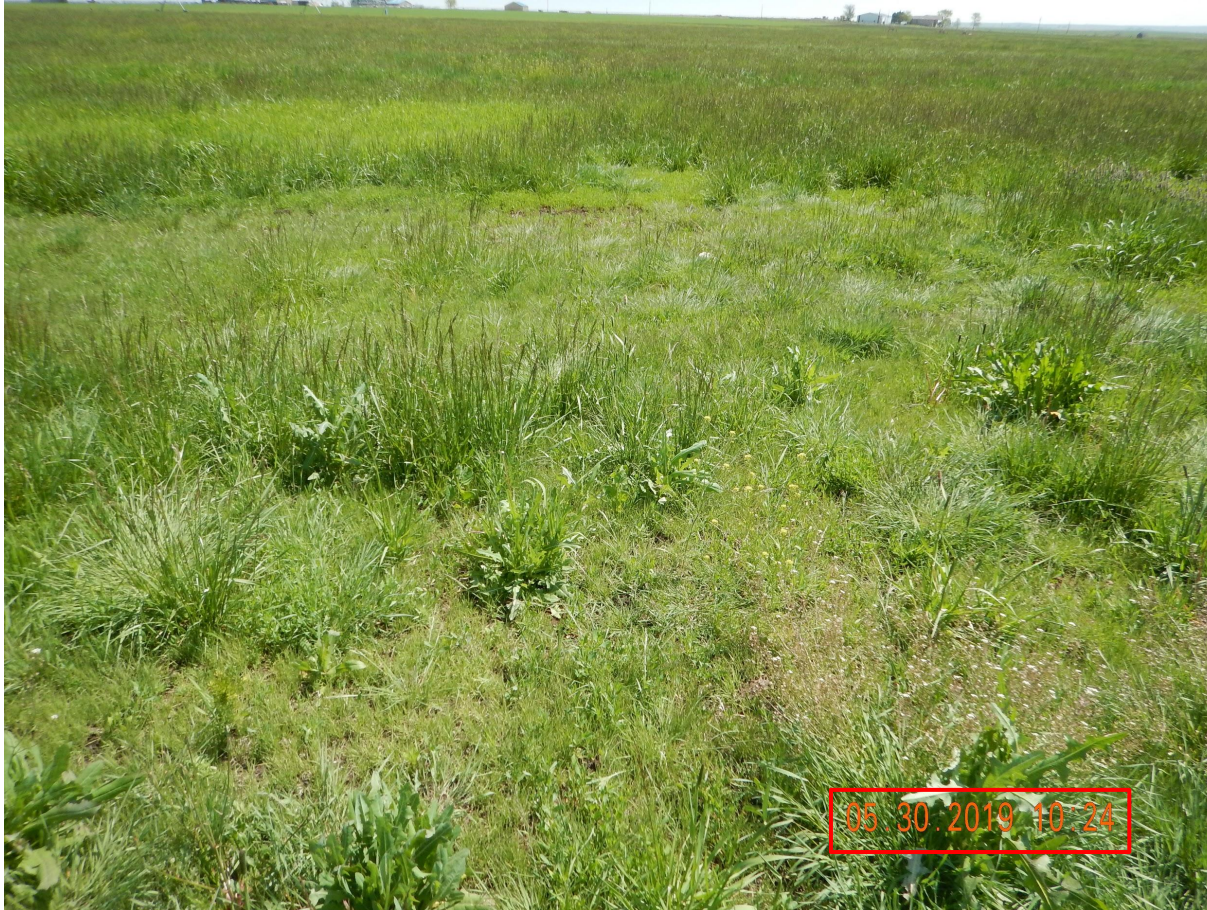
Photo 8. Photo taken adjacent to the well location on 5/30/2019, facing South. Photo illustrates a disturbance that is not reflective of reference area vegetation. Uniform establishment of reference area perennial species has not been achieved.

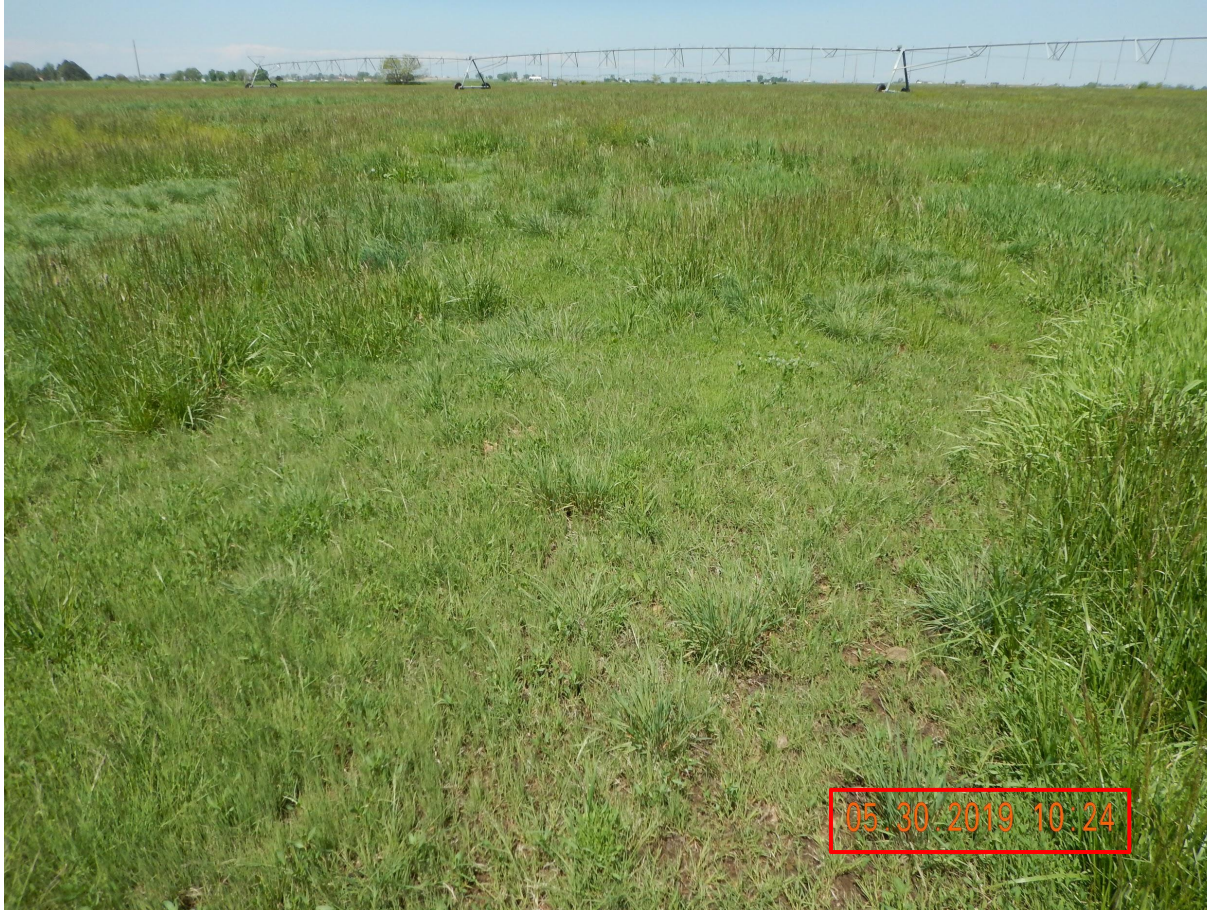
Photo 9. Photo taken adjacent to the well location on 5/30/2019, facing West. See comments under Photo 8.

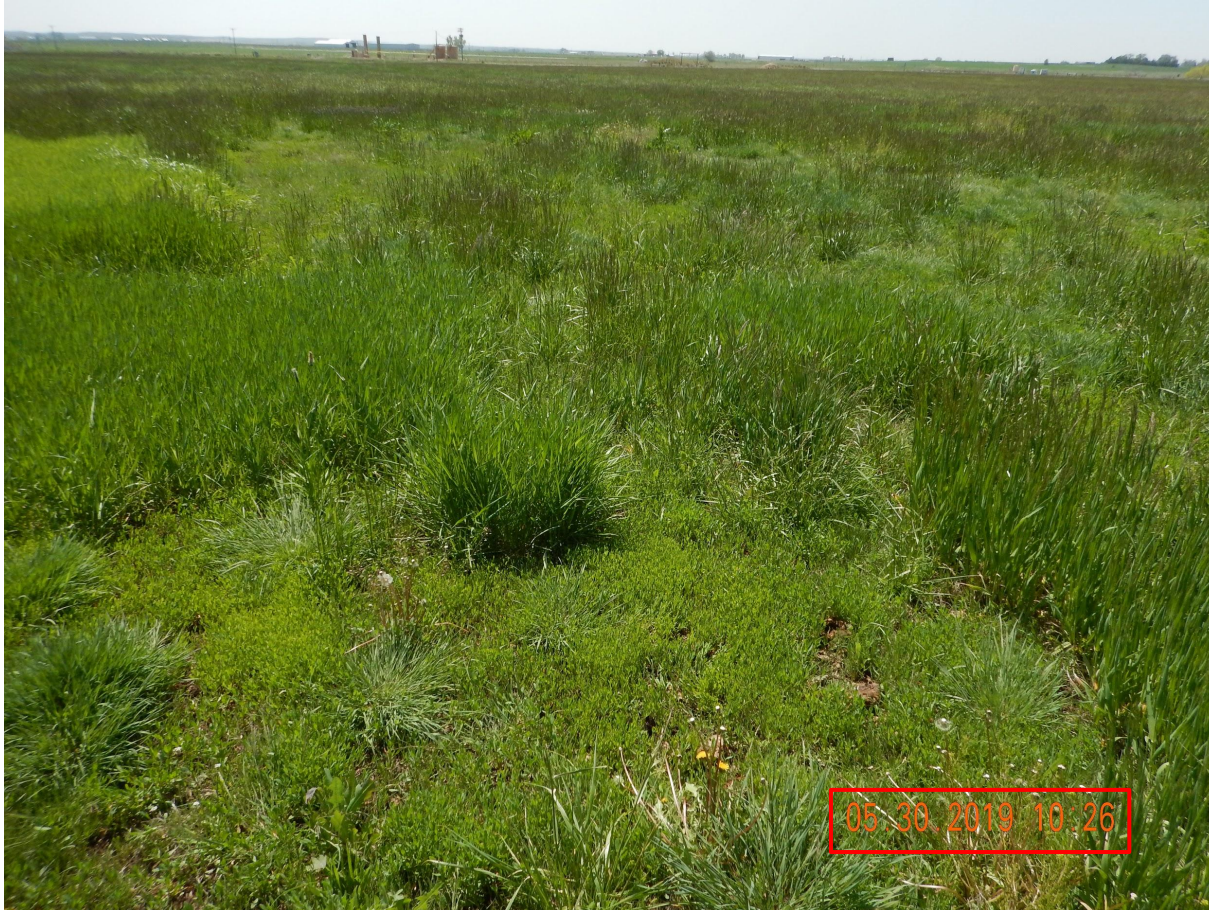
Photo 10. Photo taken adjacent to the well location on 5/30/2019, facing East. See comments under Photo 8.

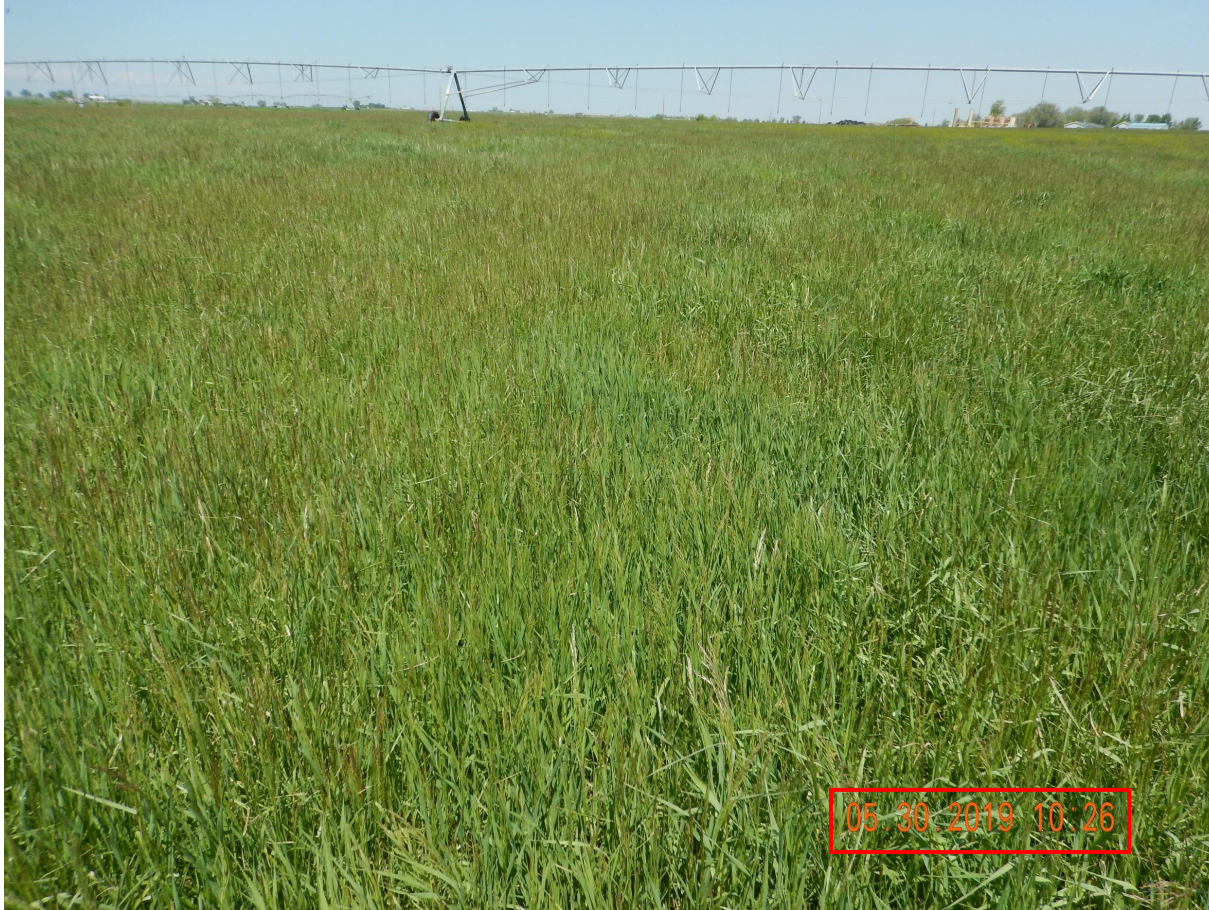
Photo 11. Reference photo taken west of the well location on 5/30/2019, facing West. See comments under Photo 8.
