Interim Reclamation Inspection

June 22, 2020

Operator: NOBLE ENERGY INC - #100322

Location ID's: 329335 and 319297

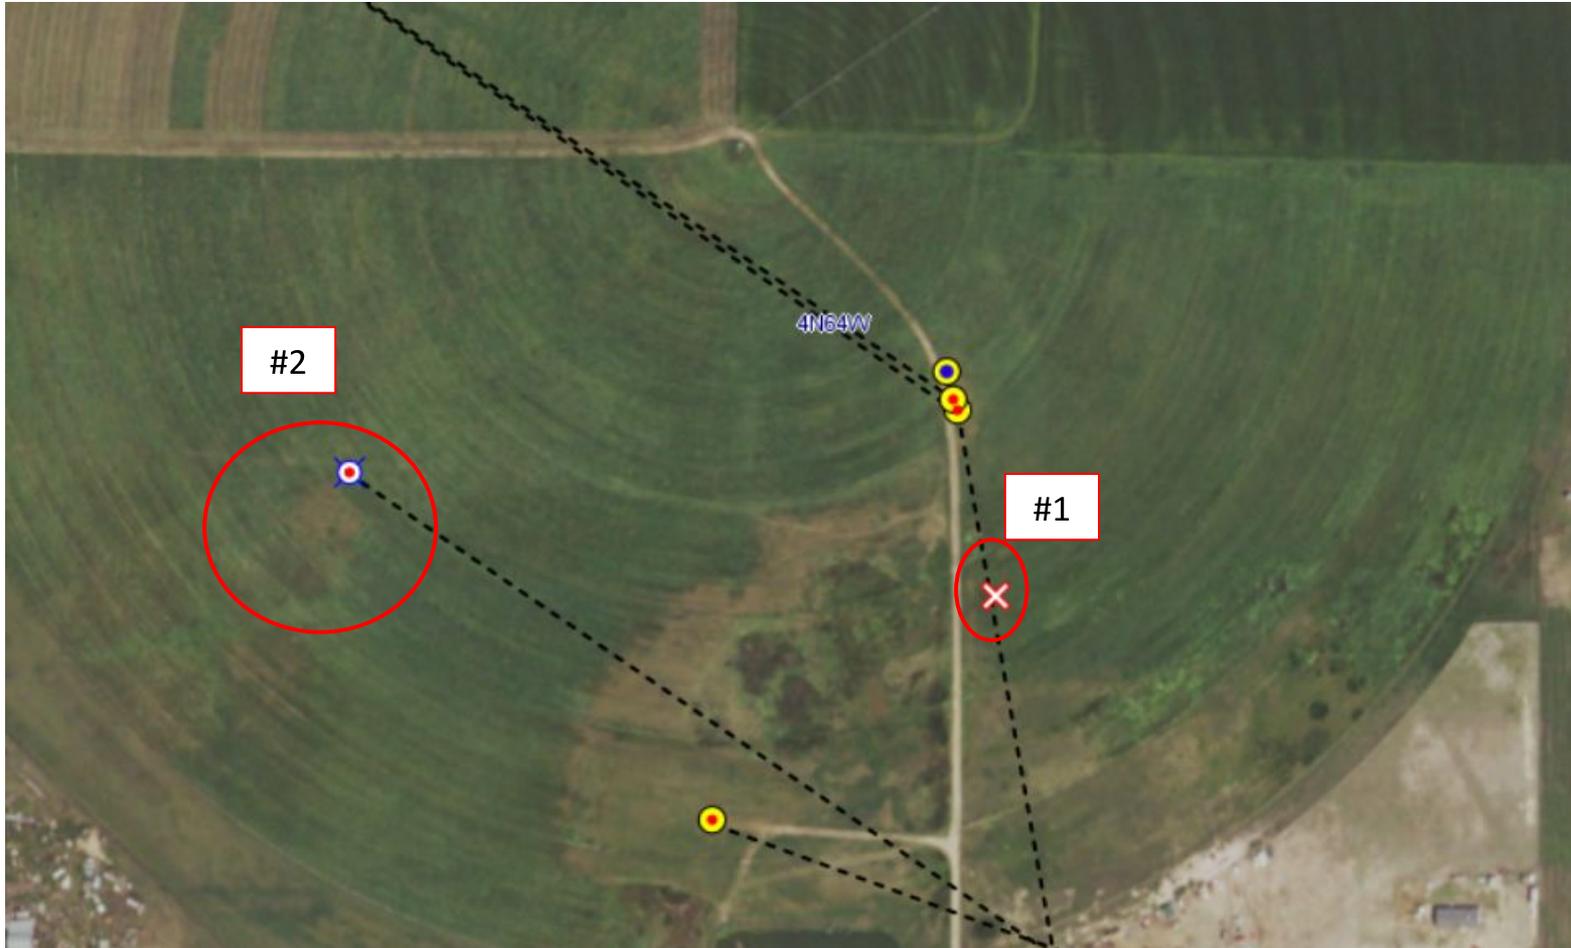
Photo 1. Aerial imagery taken in 2017. This complaint is in regards to two issues (red circles).

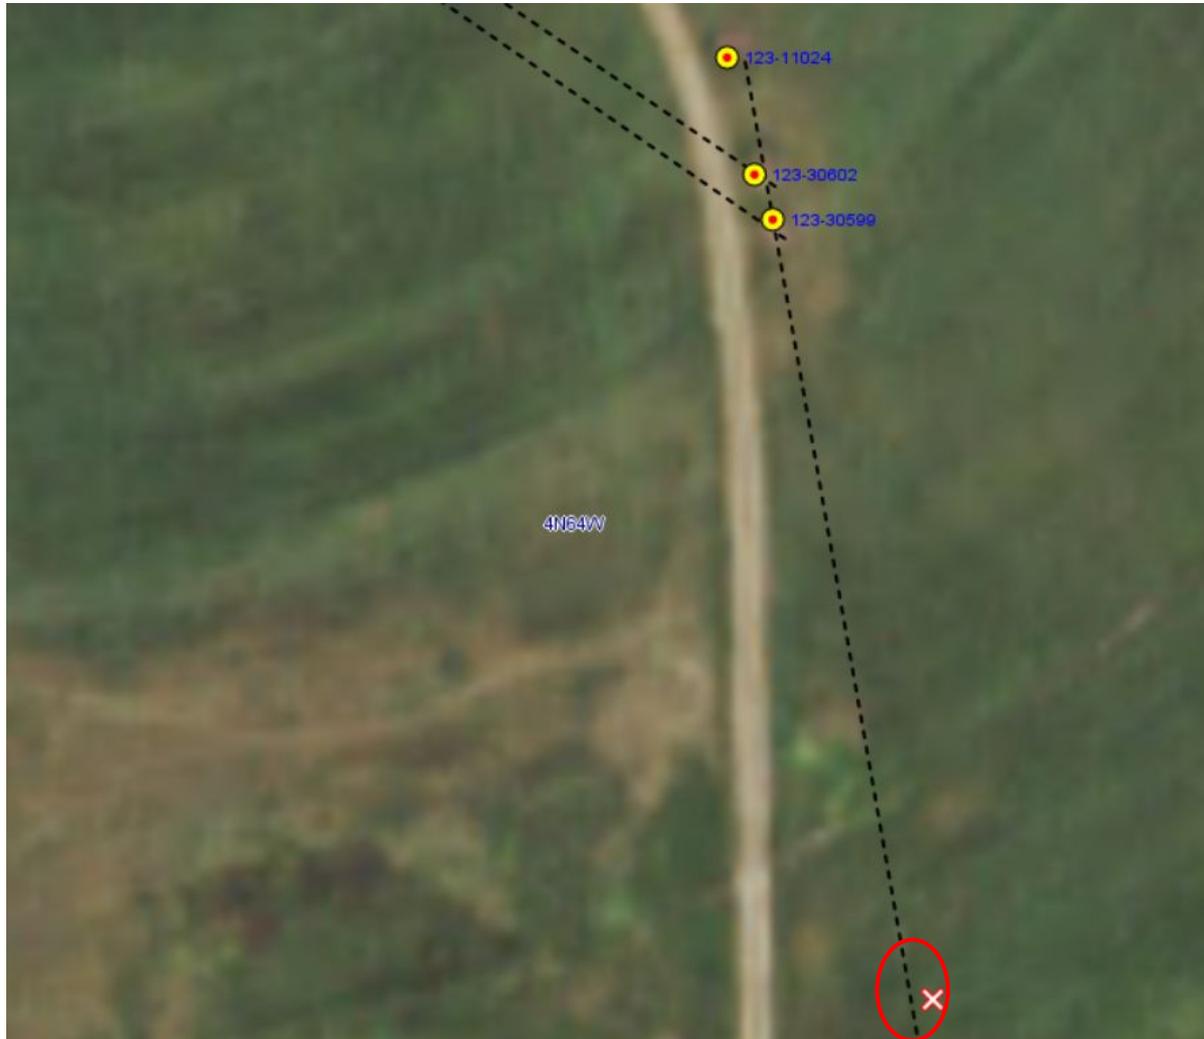
Photo 2. Aerial imagery taken in 2017. Aerial imagery of a subsidence area (red x) that appears to be associated with the flowline (black-dashed line= Active (inferred)) for well 123-11024. Subsidence is located at the approximate Lat/Long coordinates: 40.321403, -104.539956.

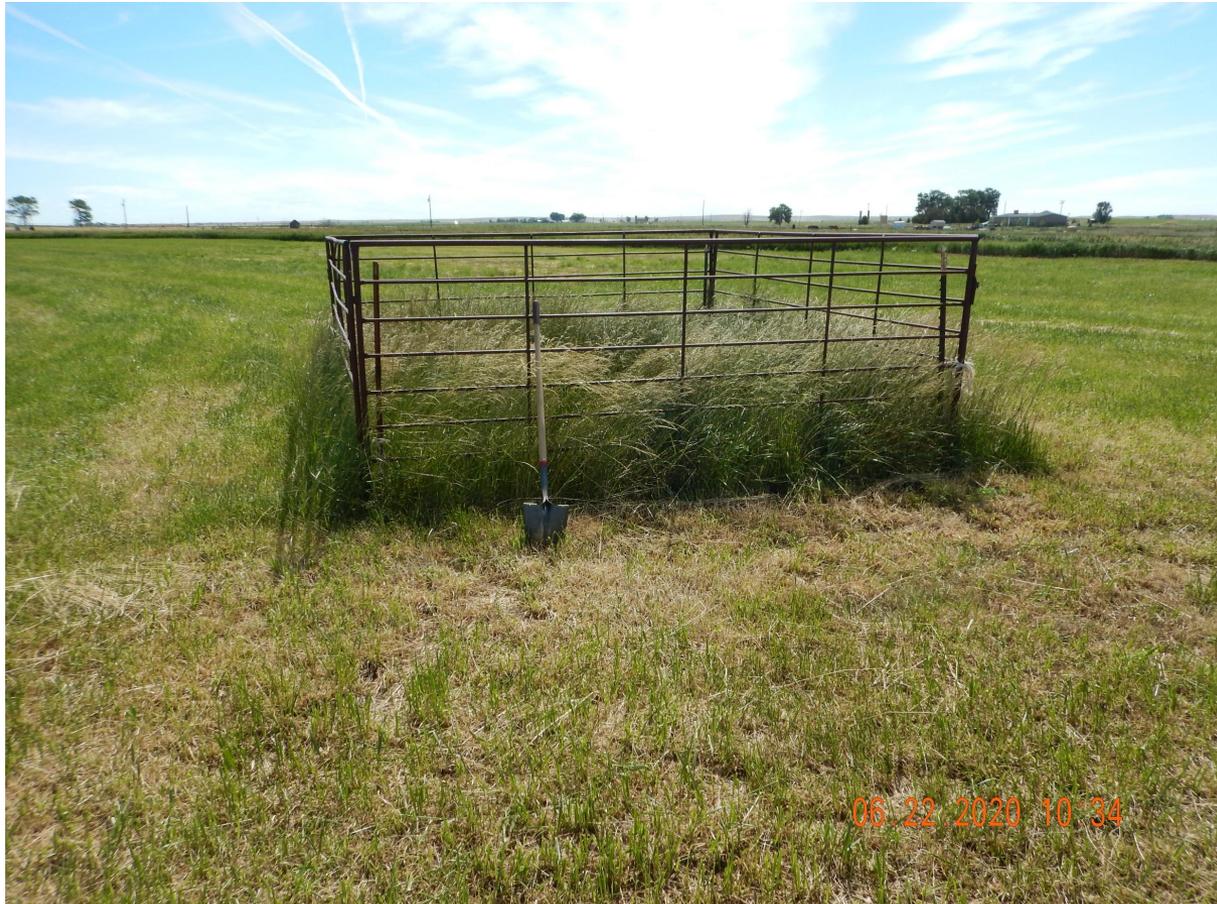
Photo 3. Photo taken from the subsidence area, facing East. Photo illustrates fencing that has been put in place by the surface owner to mitigate any safety hazards with livestock and farming equipment.

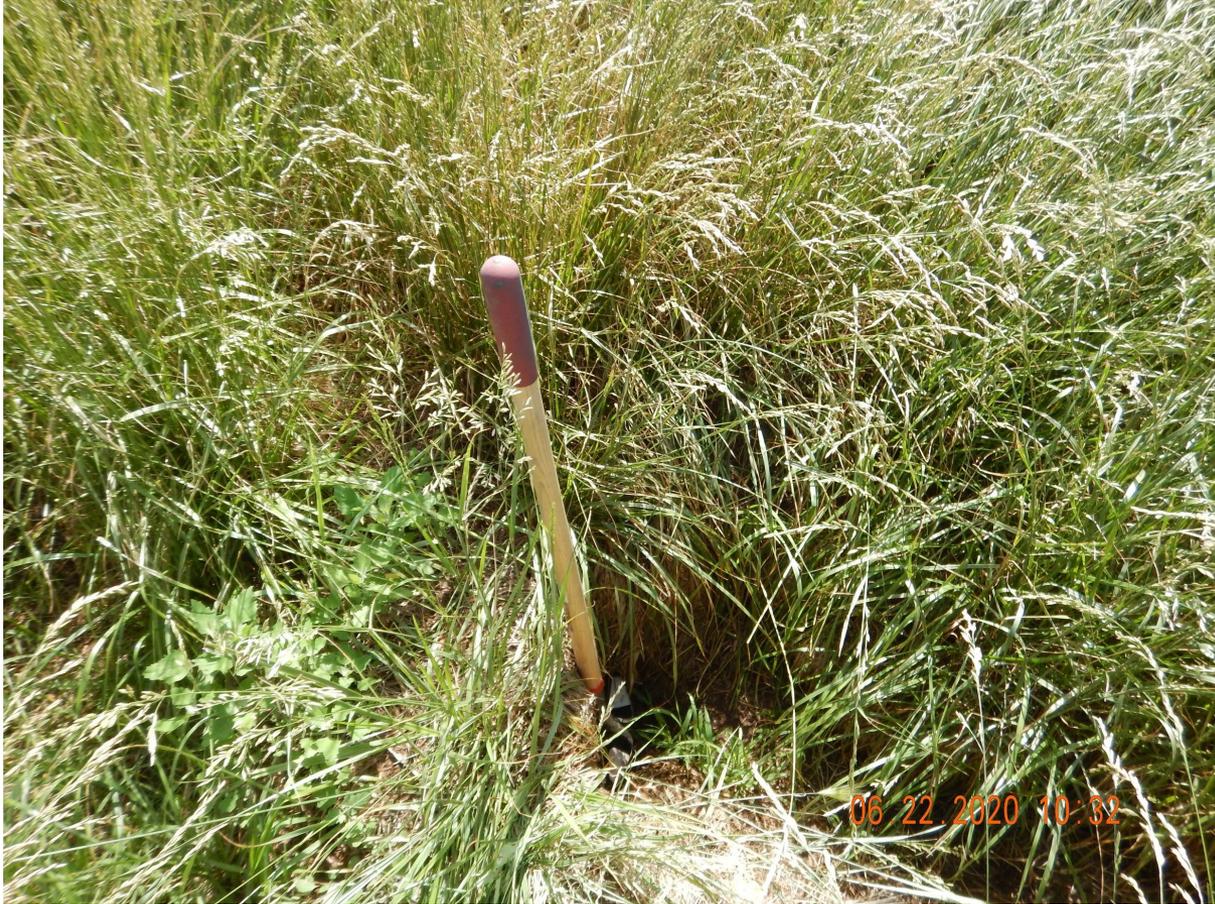
Photo 4. Photo taken from the area of subsidence. Photo illustrates a standard shovel placed into the subsidence which is ~3 feet deep.

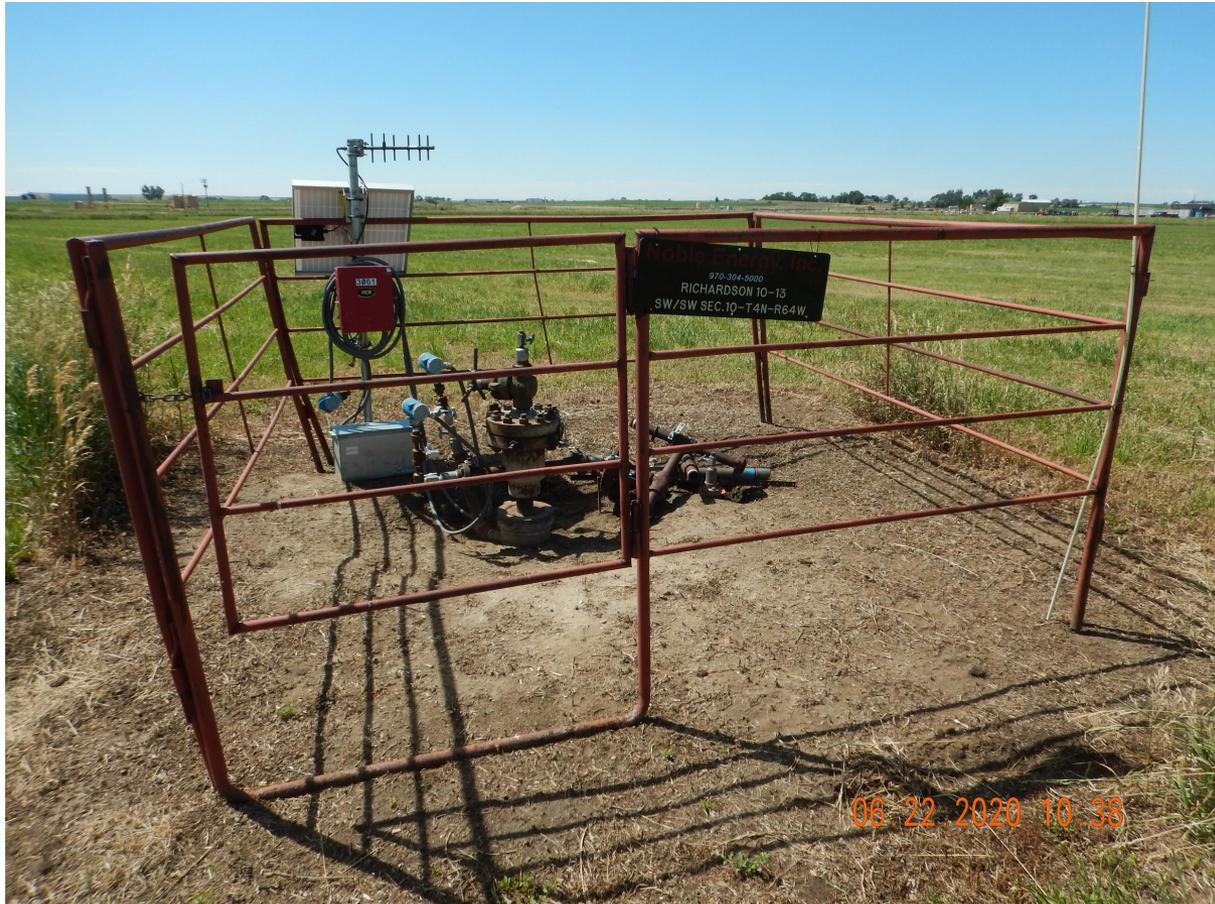
Photo 5. Photo taken from the well location, facing South. Photo illustrates the well is temporarily abandoned. Complainant thought the well was plugged but not abandoned.

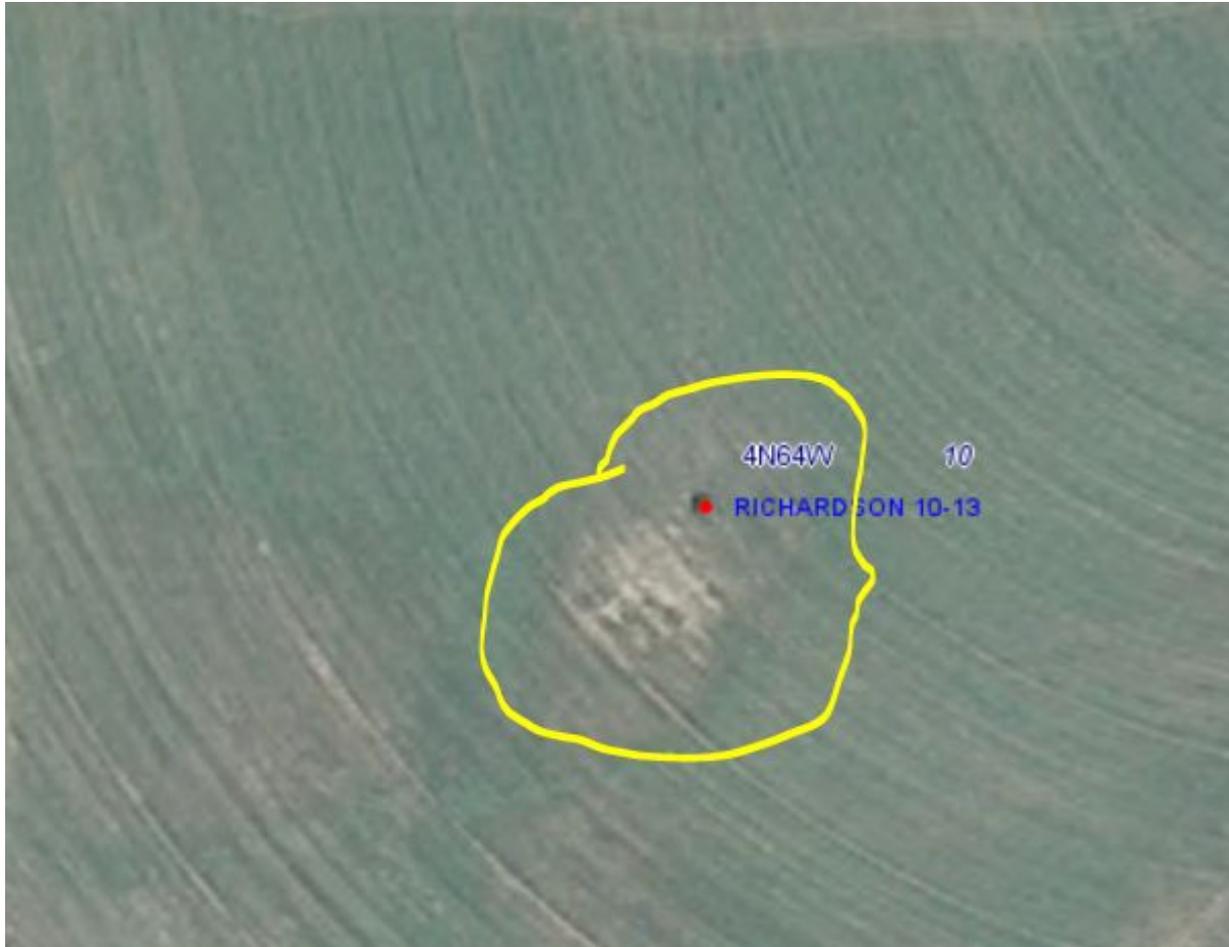
Photo 6. Aerial imagery taken in 2011. Aerial imagery shows a disturbance area around the wellhead that is not reflective of reference area vegetation.

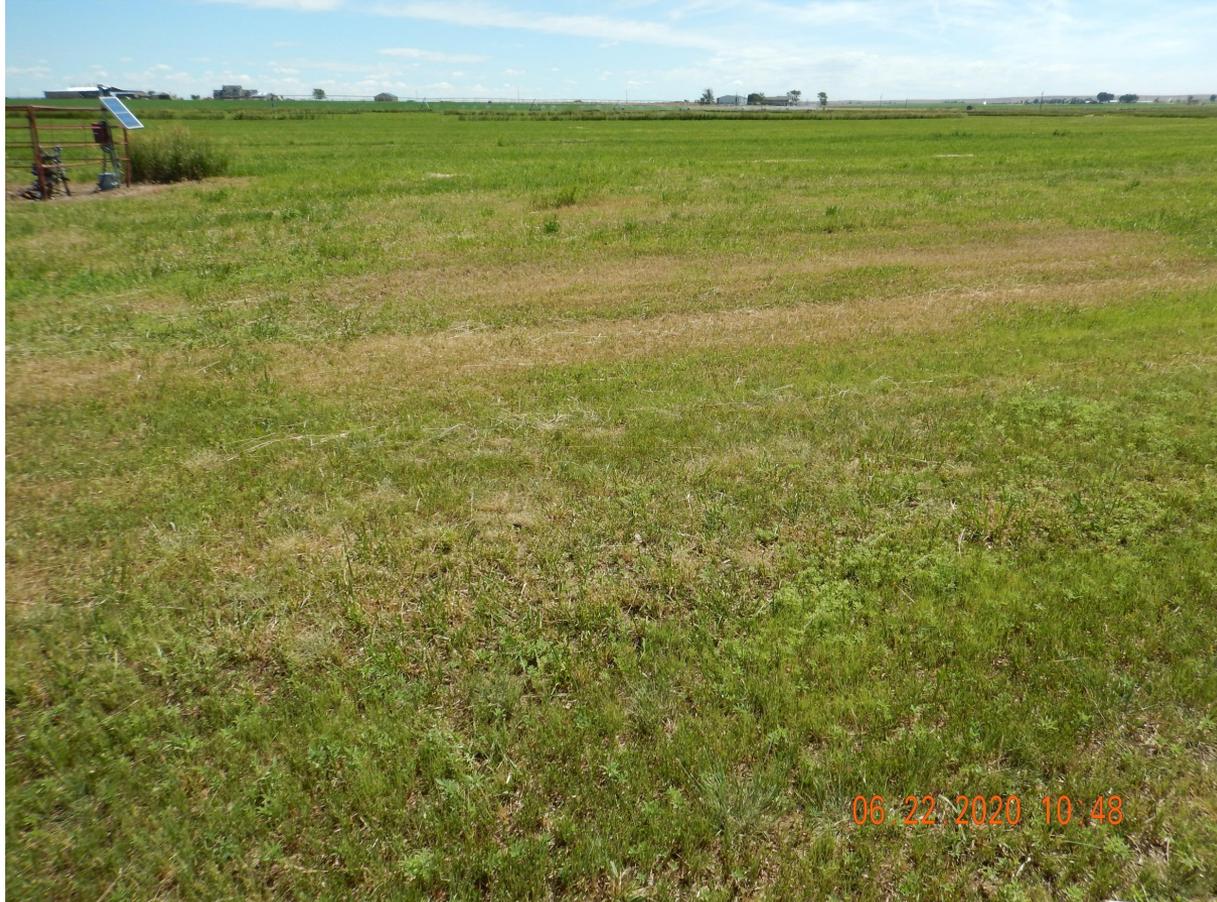
Photo 7. Photo taken adjacent to the well location, facing Southeast. Photo illustrates a disturbance area that has not been properly contoured and is not reflective of reference area vegetation. This was part of a previous complaint from 2019 that has not been addressed. This field has already been mowed so the vegetation issue is hard to observe. Refer to Photos 8-11 taken in May 2019 that better illustrate the vegetation issue.

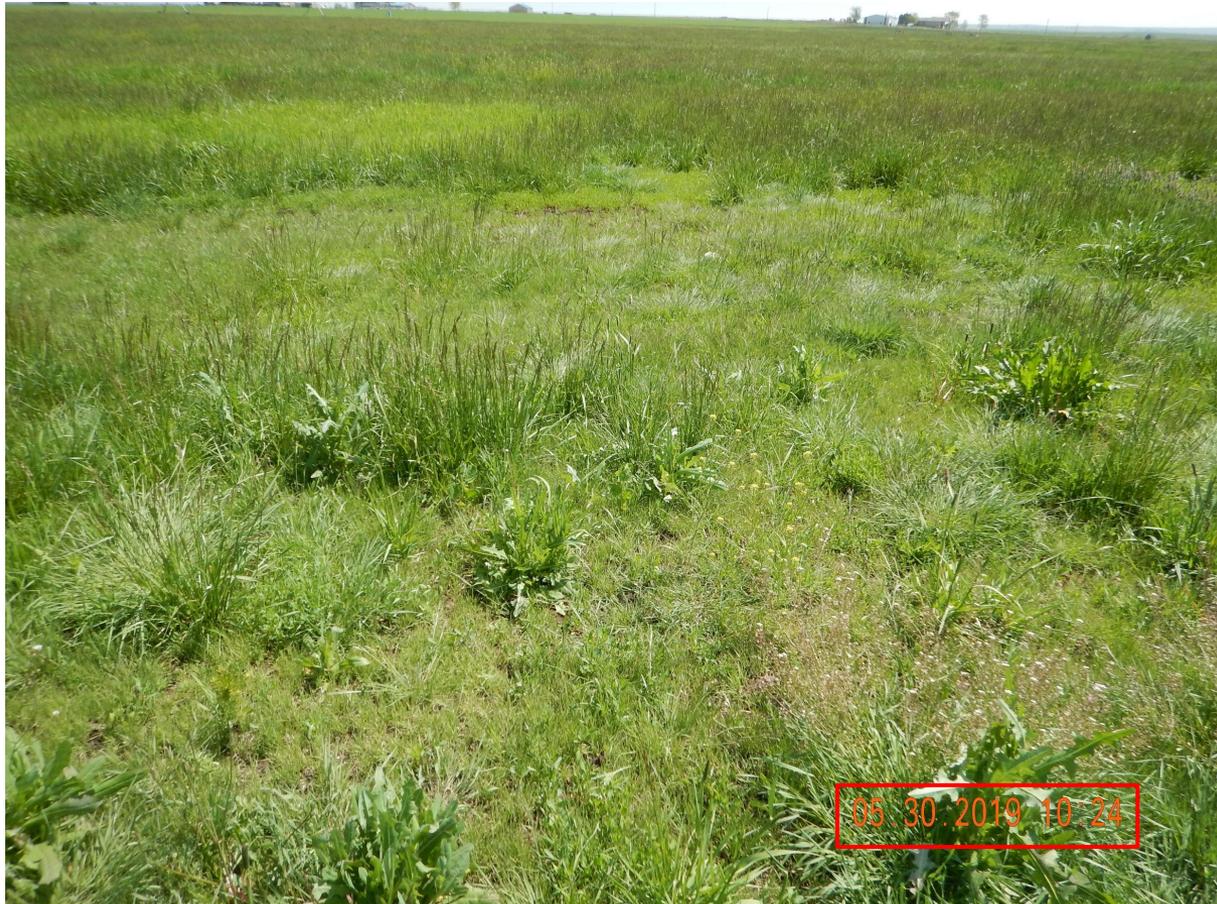
Photo 8. Photo taken adjacent to the well location on 5/30/2019, facing South. Photo illustrates a disturbance that is not reflective of reference area vegetation. Uniform establishment of reference area perennial species has not been achieved.

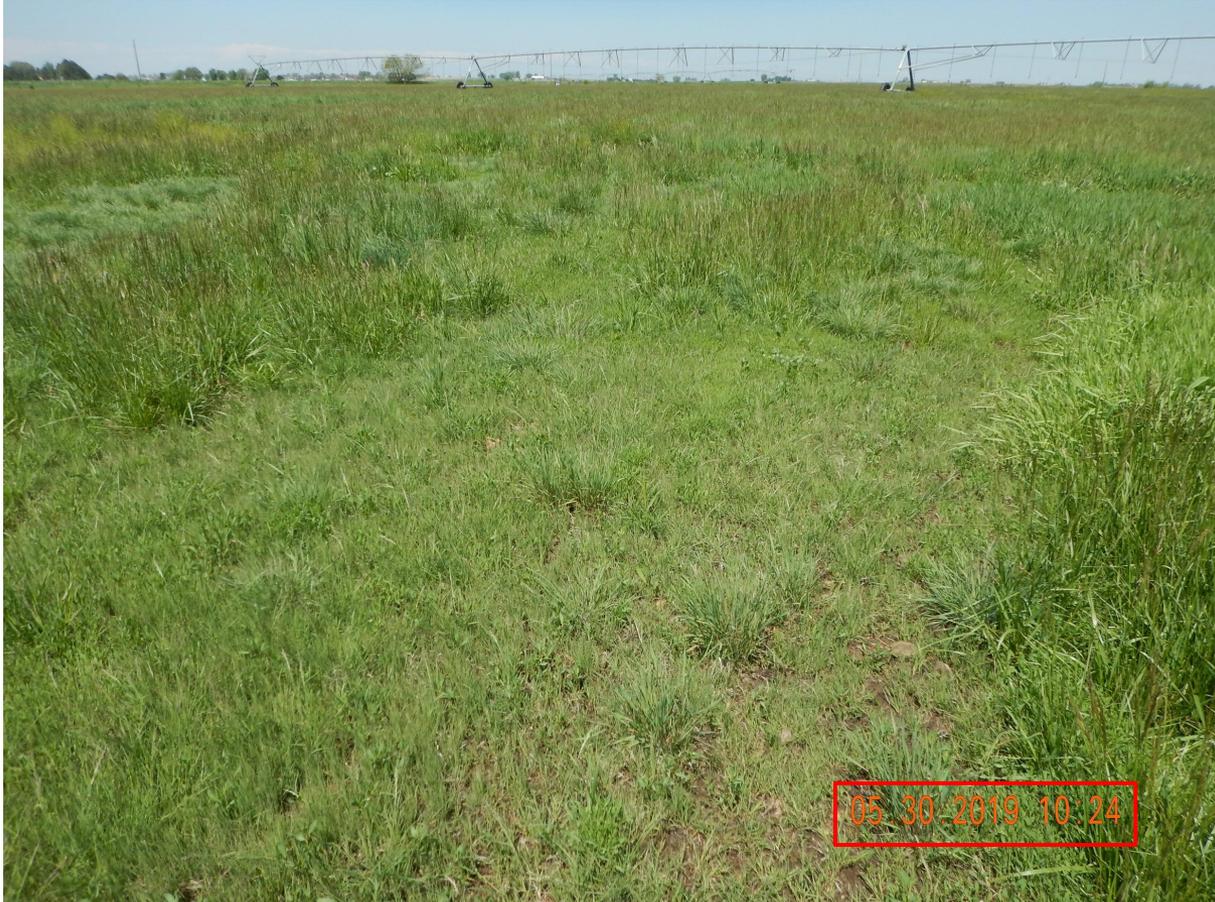
Photo 9. Photo taken adjacent to the well location on 5/30/2019, facing West. See comments under Photo 8.

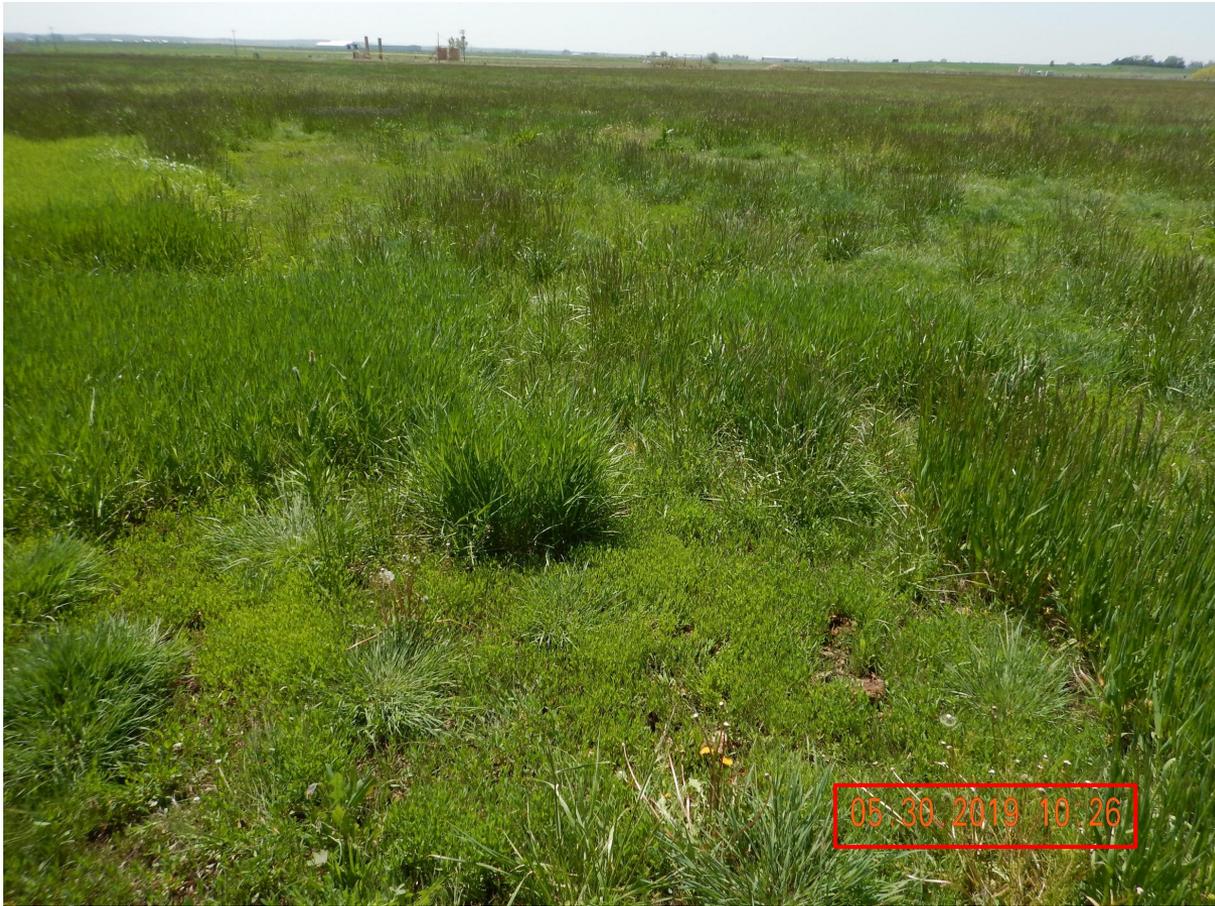
Photo 10. Photo taken adjacent to the well location on 5/30/2019, facing East. See comments under Photo 8.

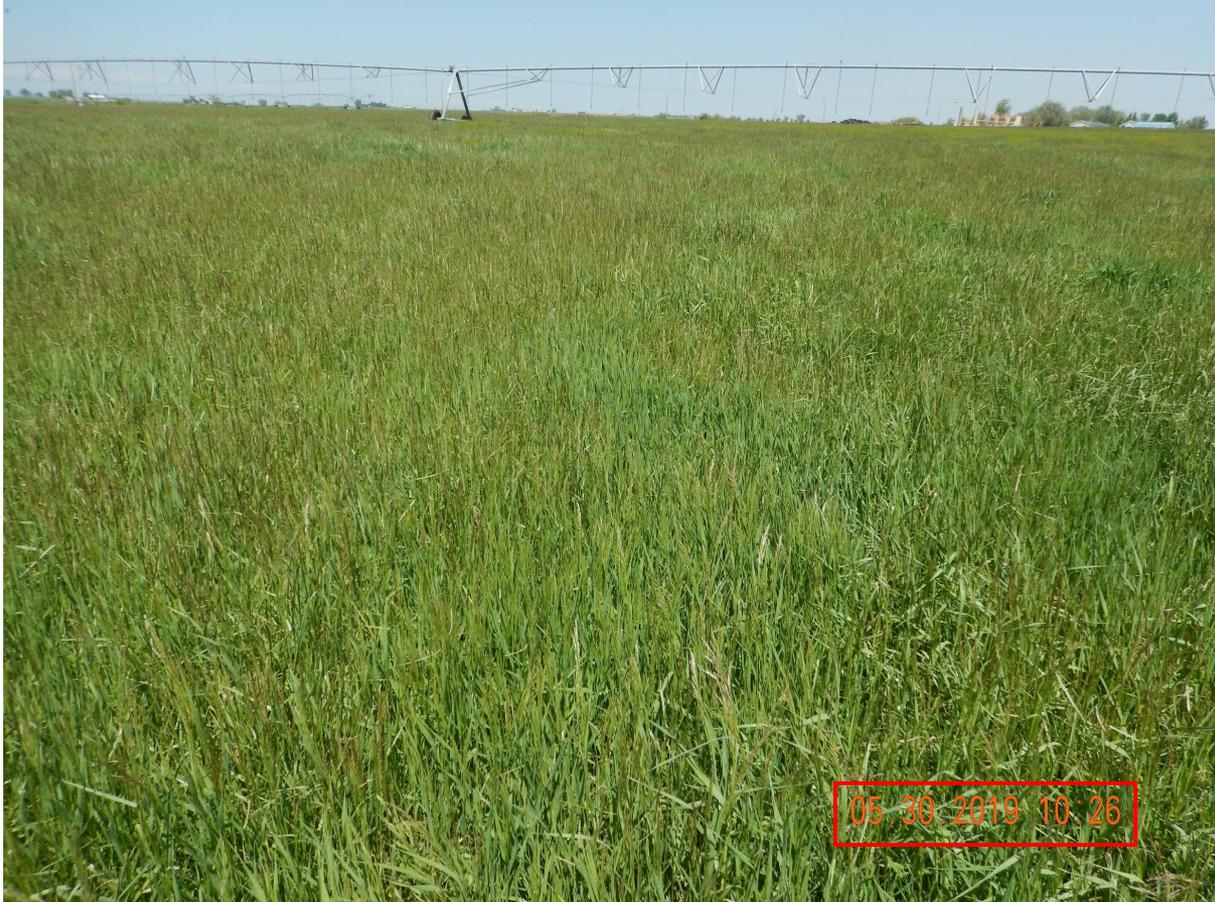
Photo 11. Reference photo taken west of the well location on 5/30/2019, facing West. See comments under Photo 8.
