## Inspection Photos

Location Name: Coal Gulch 68S101W 9SWSE Pad & Federal 15-9

Location ID: #334470 & Spill/Release ID: #476598

Inspection Date: June 19, 2020

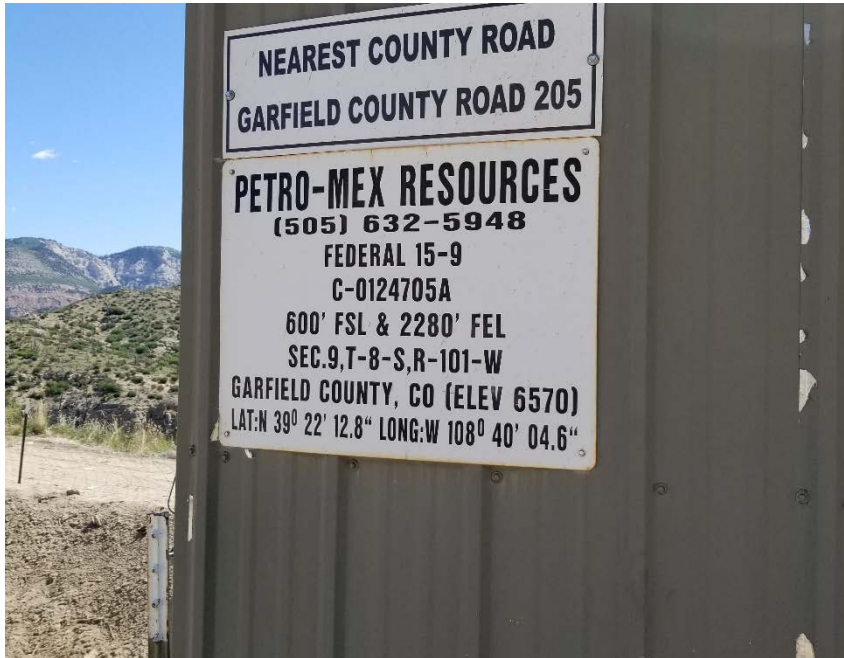
Photo #1 – Well pad sign.

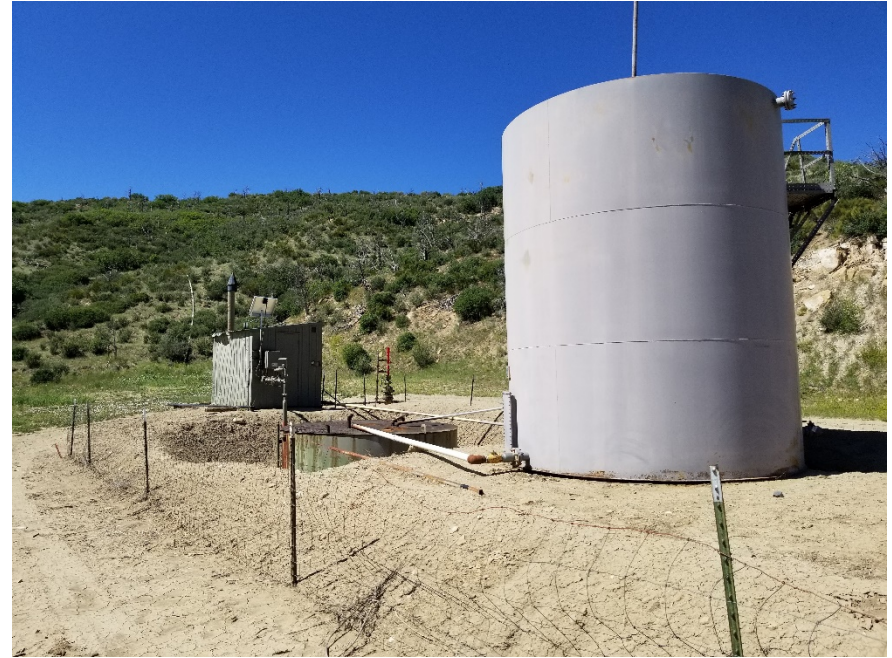
Photo #2 – View of tank battery and separator from northeast.

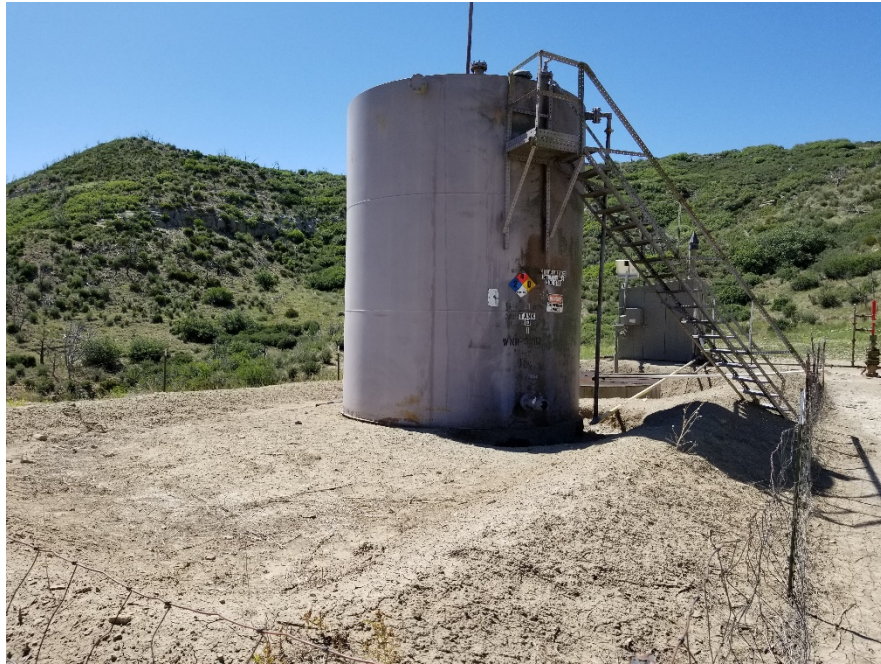
**Photo #3 – View of 300 bbl condensate AST from northwest. Note berm is shallow and eroded.**

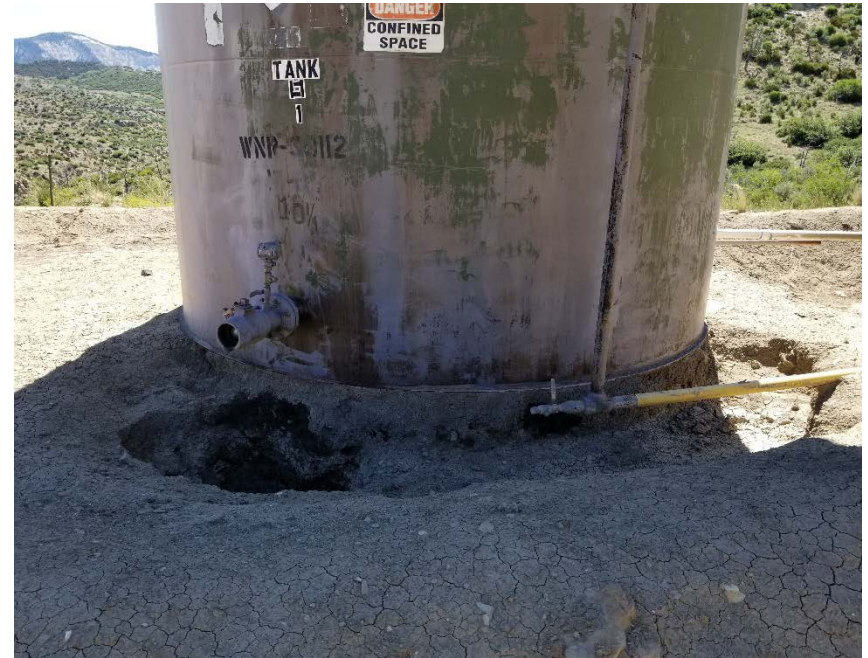
**Photo #4 – Partially excavated area at base of condensate tank. Additional site investigation and remediation required in this location to address impacts from Spill #476598.**

**Released fluids demonstrate permeability of base of secondary containment area.**

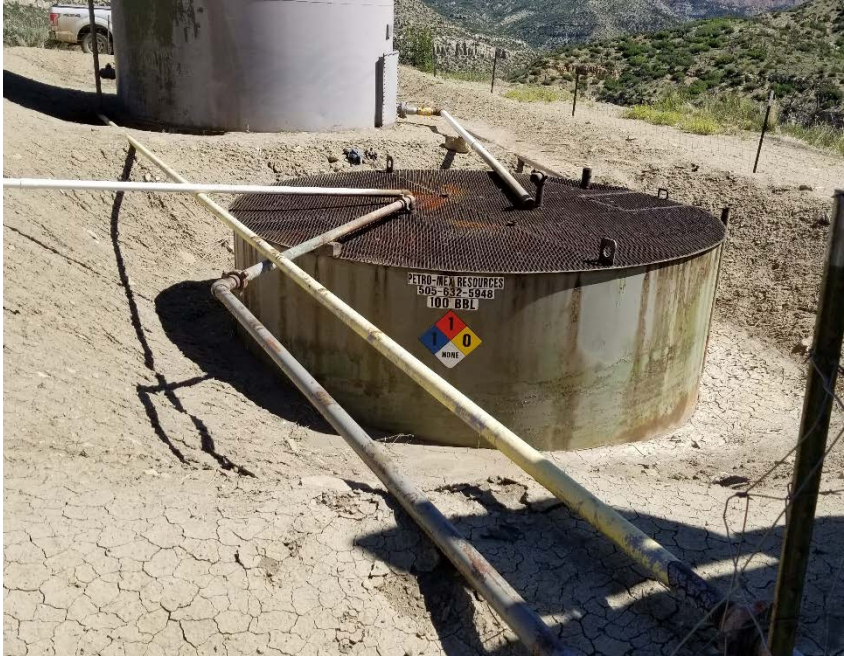
**Photo #5 – View of 100 bbl fiberglass PBV skim tank from southwest. Note tank lacks content label.**

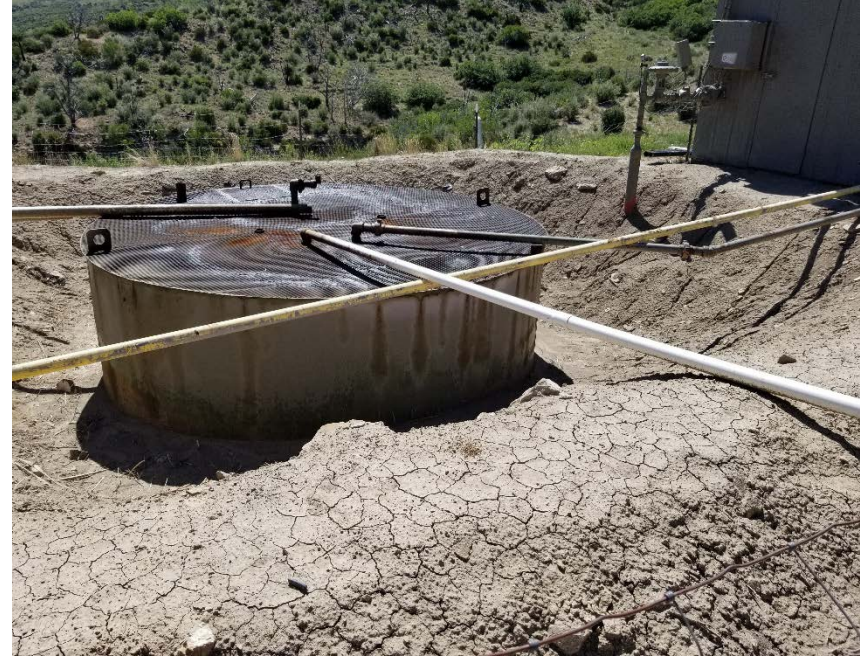
**Photo #6 – View of 100 bbl fiberglass PBV skim tank from northwest. Tank is located inside of former Pit Facility ID #113000. Pit Facility status remains AC (active) in COGCC database.**

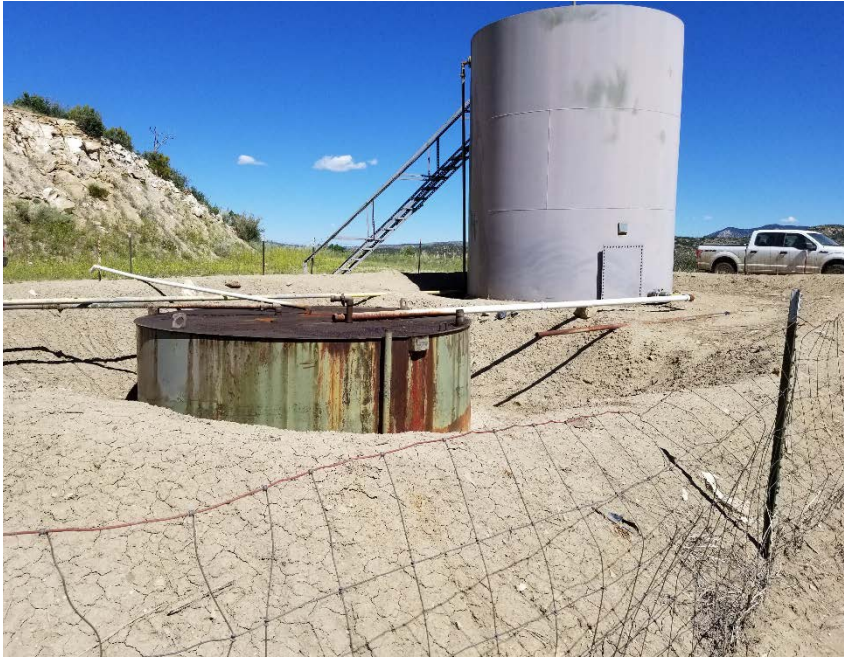
**Photo #7 – View of tank battery from southeast. Note earthen berms are shallow and eroded.**

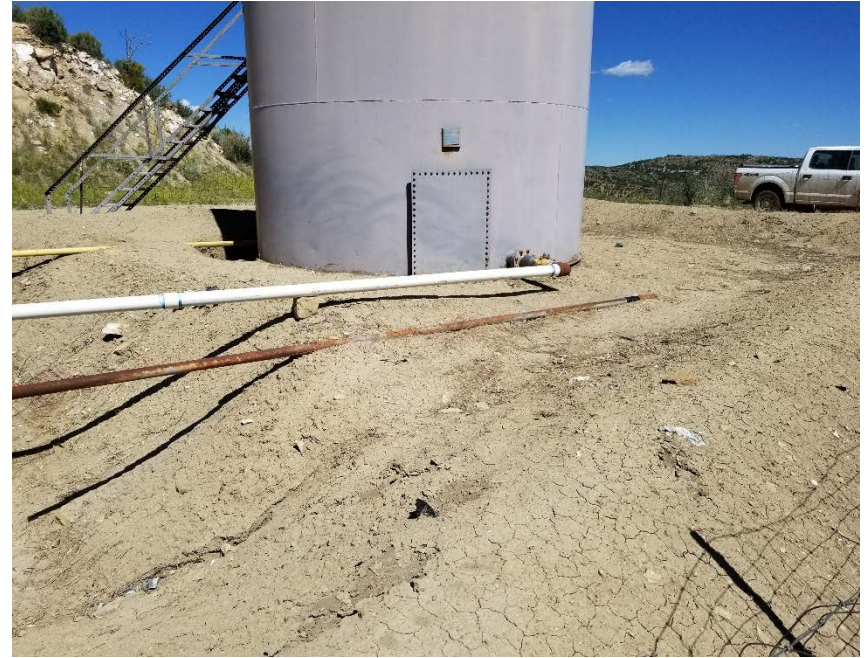
**Photo #8 – Unused pipe and eroded berms on east side of tank battery.**

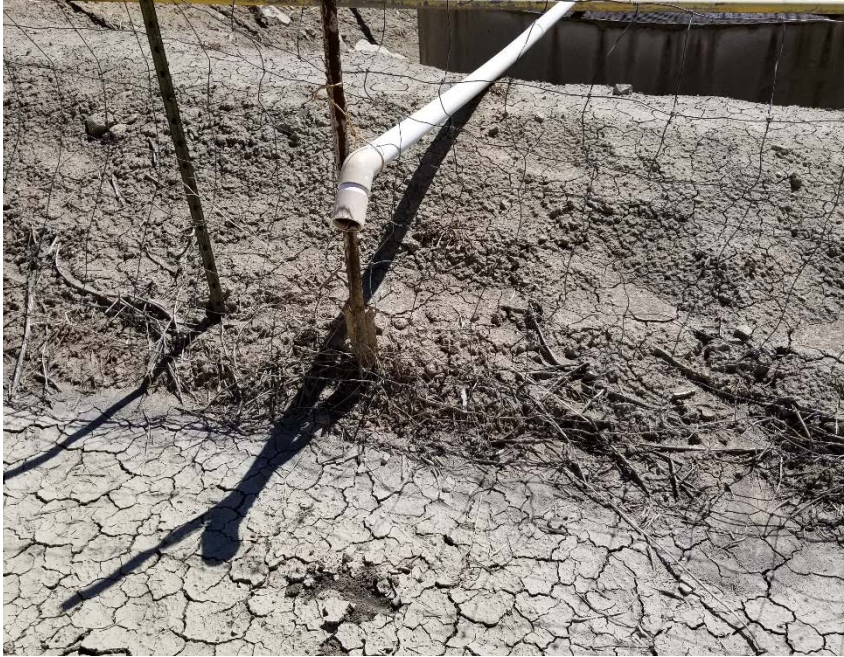
**Photo #9 – Truck loadout from fiberglass PBV on west side of tank battery. Note that loadout lacks secondary containment device. Also note presence of mud cracks in loadout area is indicative of stormwater pooling in this location.**

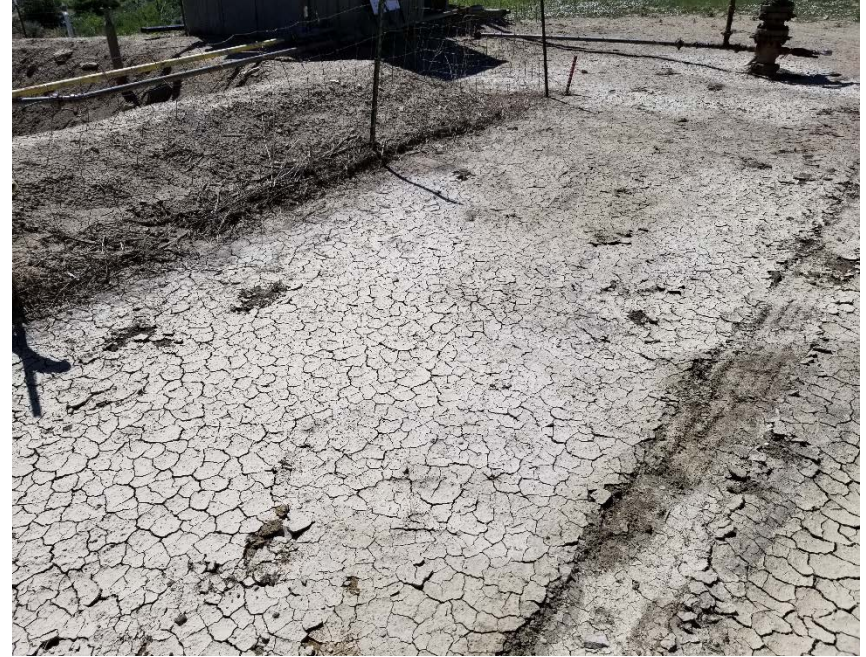
**Photo #10 - Presence of mud cracks in loadout area and along west side of tank battery is indicative of stormwater pooling in this location.**

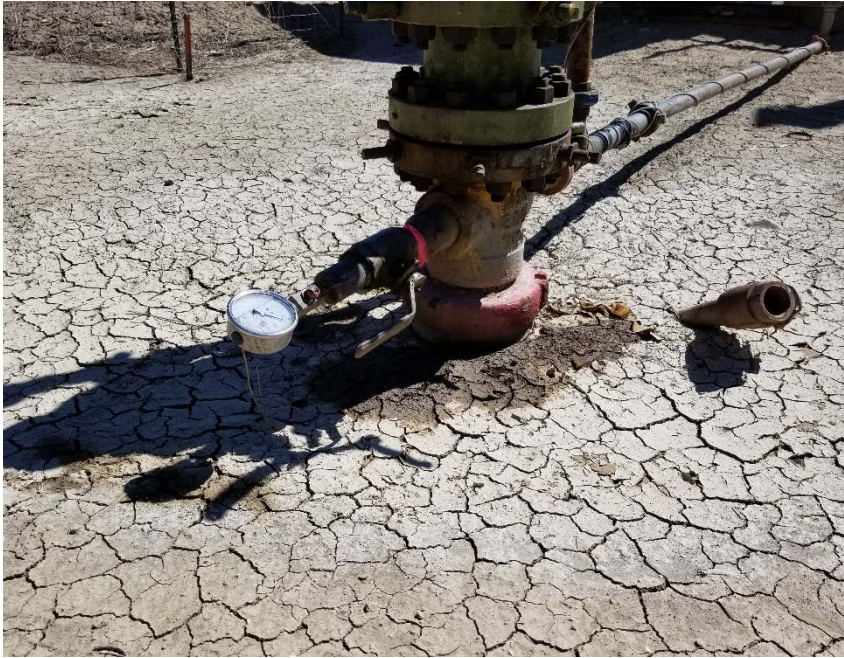
**Photo #11 – Localized accumulation of oil-stained soil beneath wellhead. Note presence of mud cracks in wellhead area is indicative of stormwater pooling in this location.**

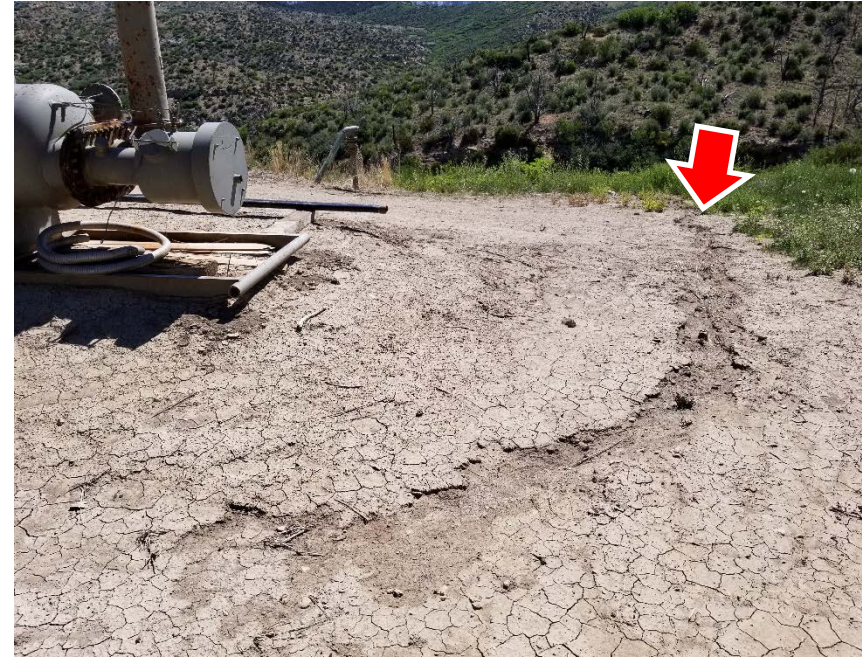
**Photo #12 – Erosion feature observed in southeast corner of pad (red arrow) indicates direction of stormwater runoff.**

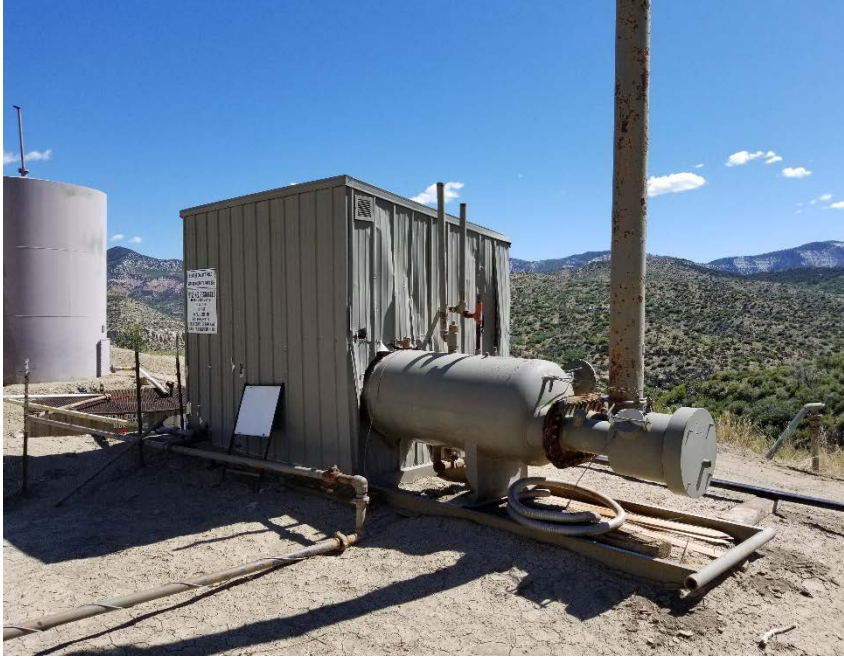
**Photo #13 – View of heated horizontal separator located south of tank battery.**

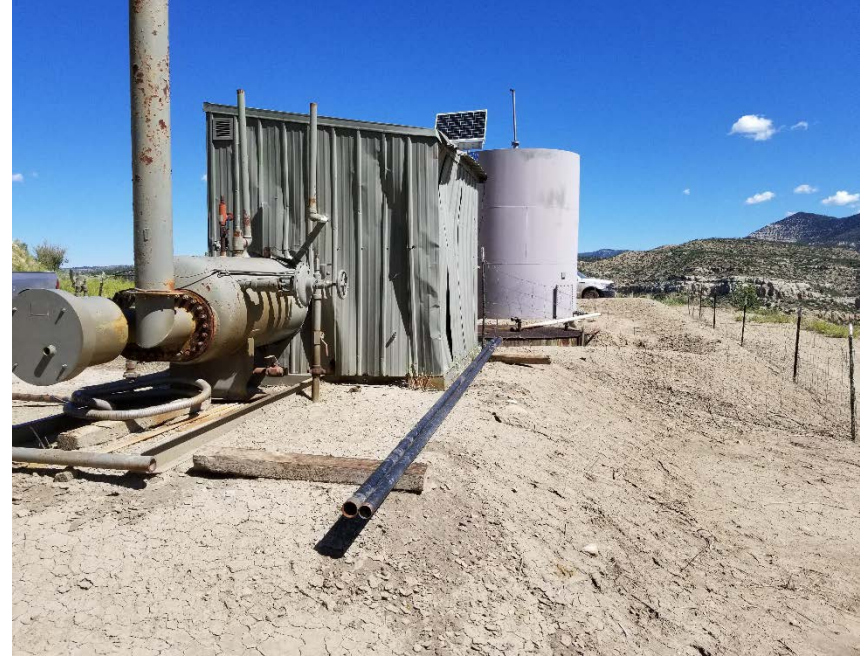
**Photo #14 – Unused pipe located east of separator.**

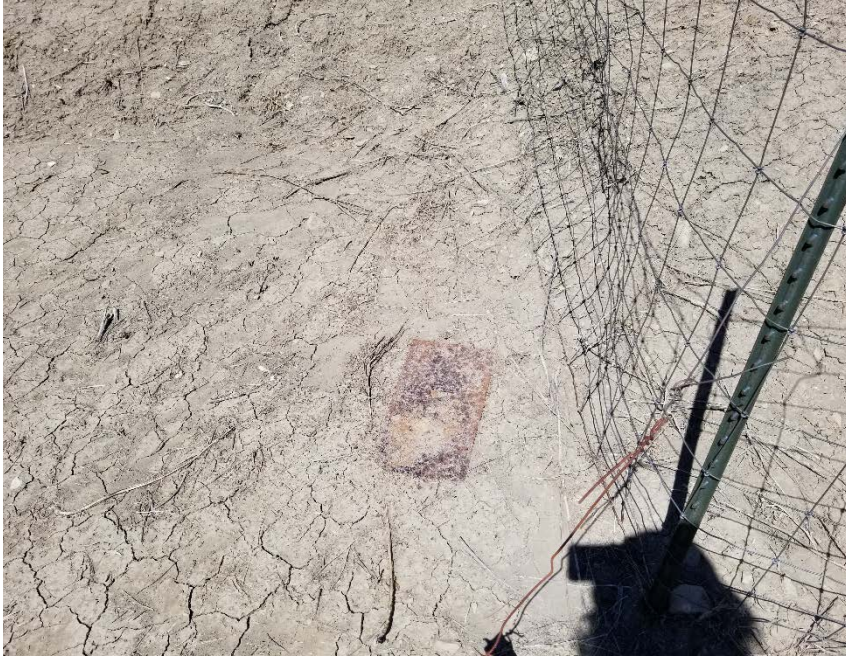
**Photo #15 – Metal scrap located outside of southeast corner of tank battery.**

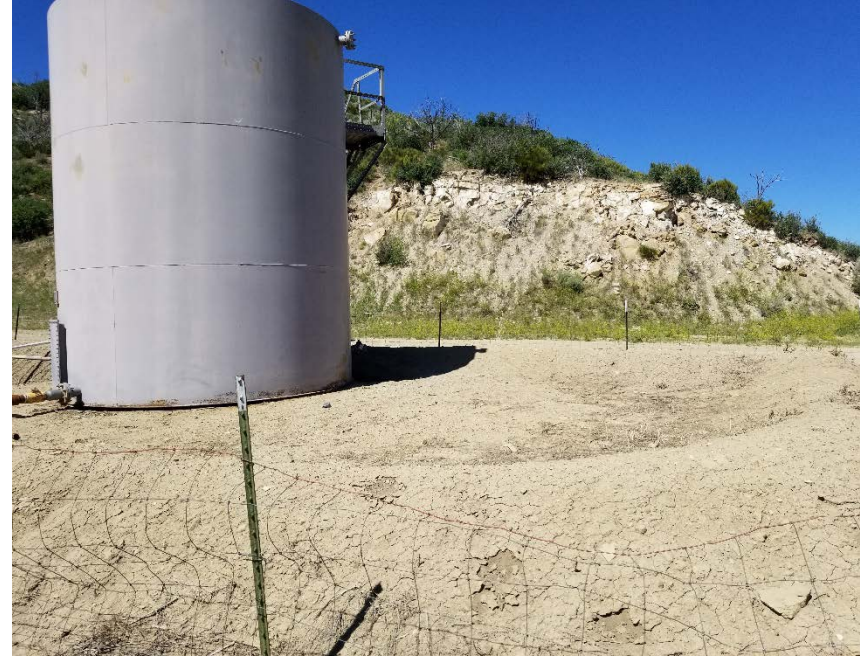
**Photo #16 – View of shallow, eroded berms on north side of tank battery.**
