Final Reclamation Inspection

Operator: NOBLE ENERGY INC - #100322

Location ID: 329752

Location Name: STATE-64N64W /16NWNE

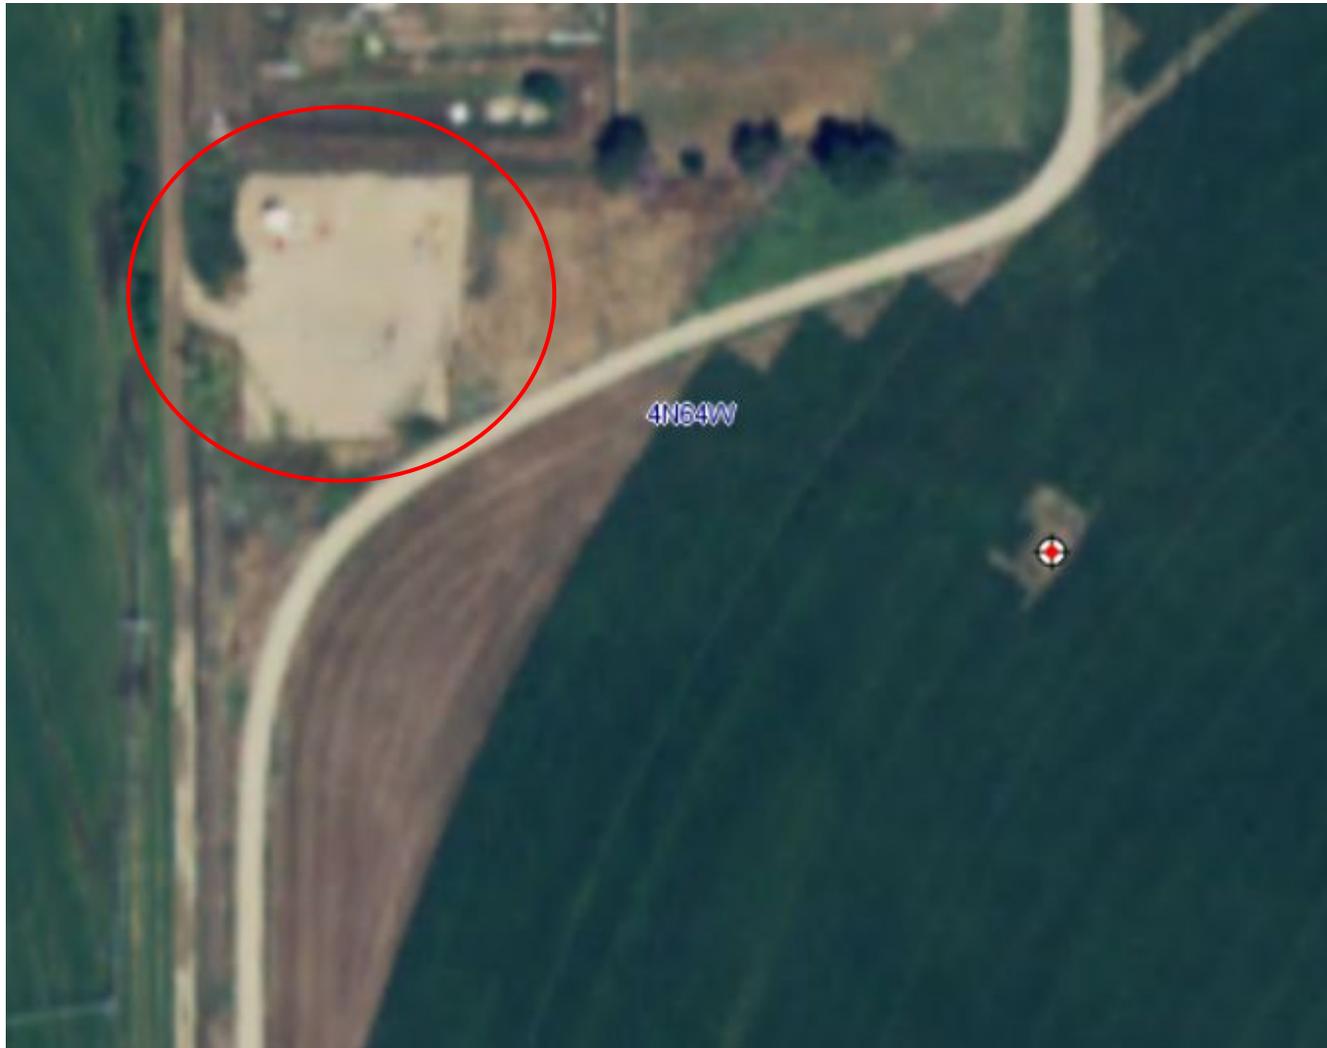
Photo 1. Aerial imagery taken in 2015 during active operations. This complaint is in regards to associated offsite tank battery location (red circle).

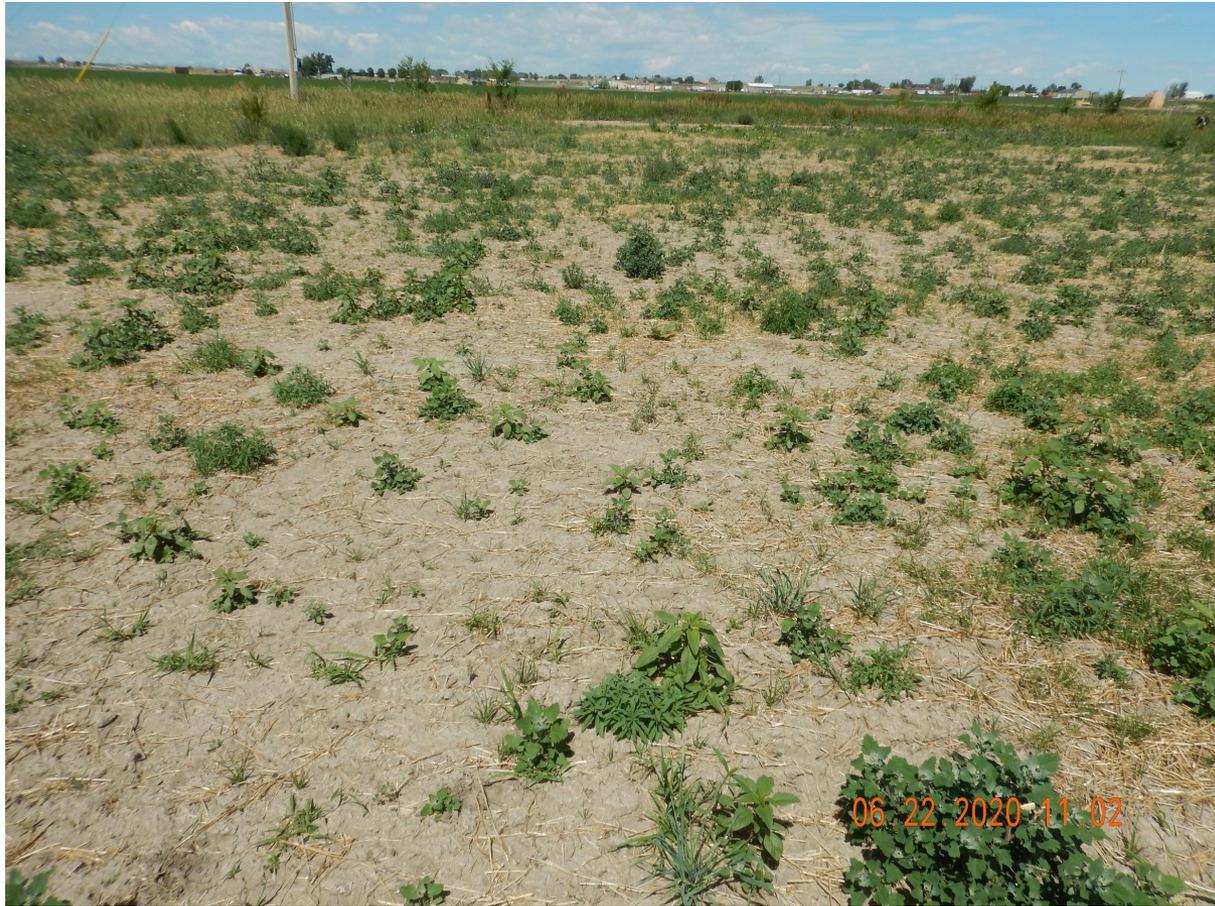
Photo 2. Photo taken from the southeastern tank battery, facing West. Photo illustrates the Operator has performed recent final reclamation activities with the evidence of fresh mulch and germination of some desirable plant species. However, annual weedy vegetation (lambsquarter, Kochia and *Setaria sp.* (foxtail)) and some noxious weeds (Canada thistle and puncturevine) were observed.

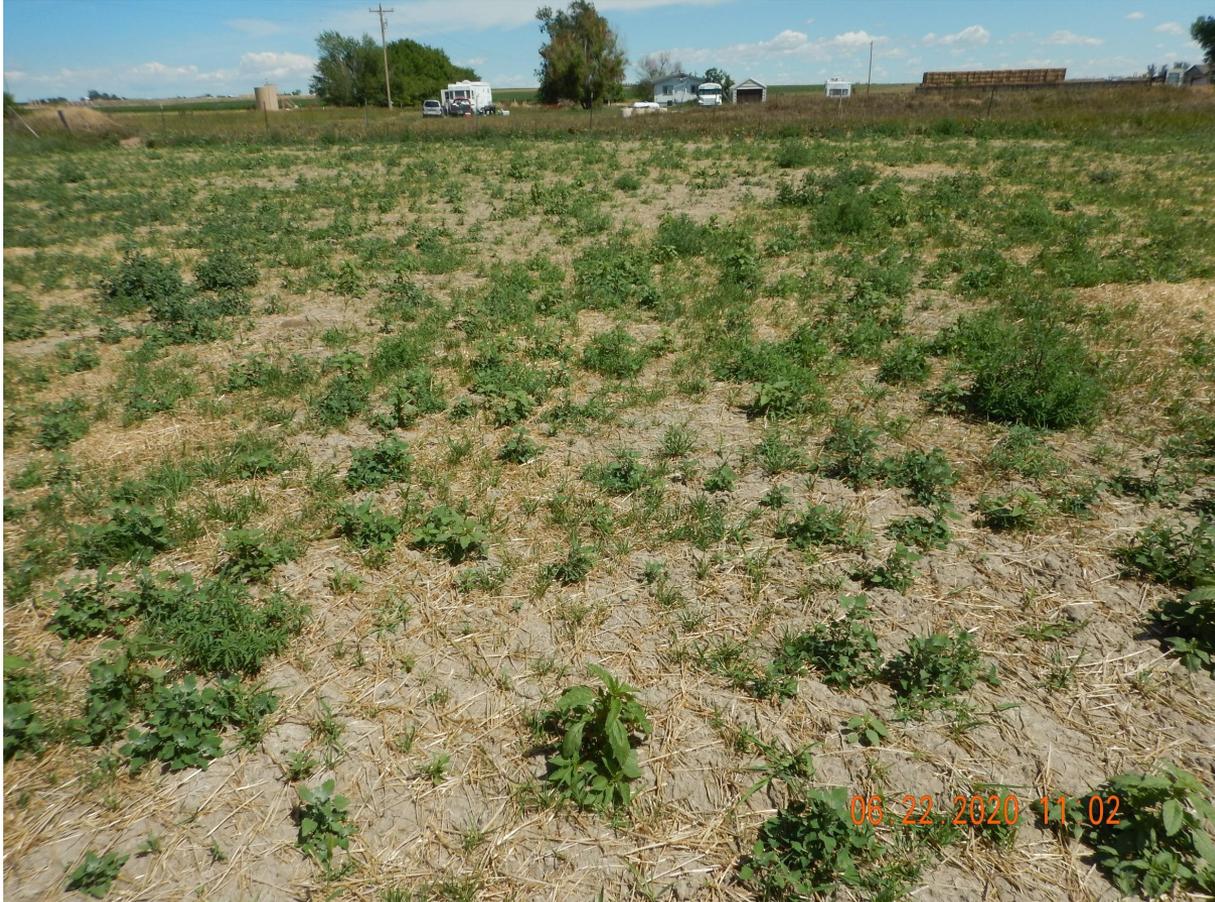
Photo 3. Photo taken from the southern tank battery, facing North. See comments under Photo 2.

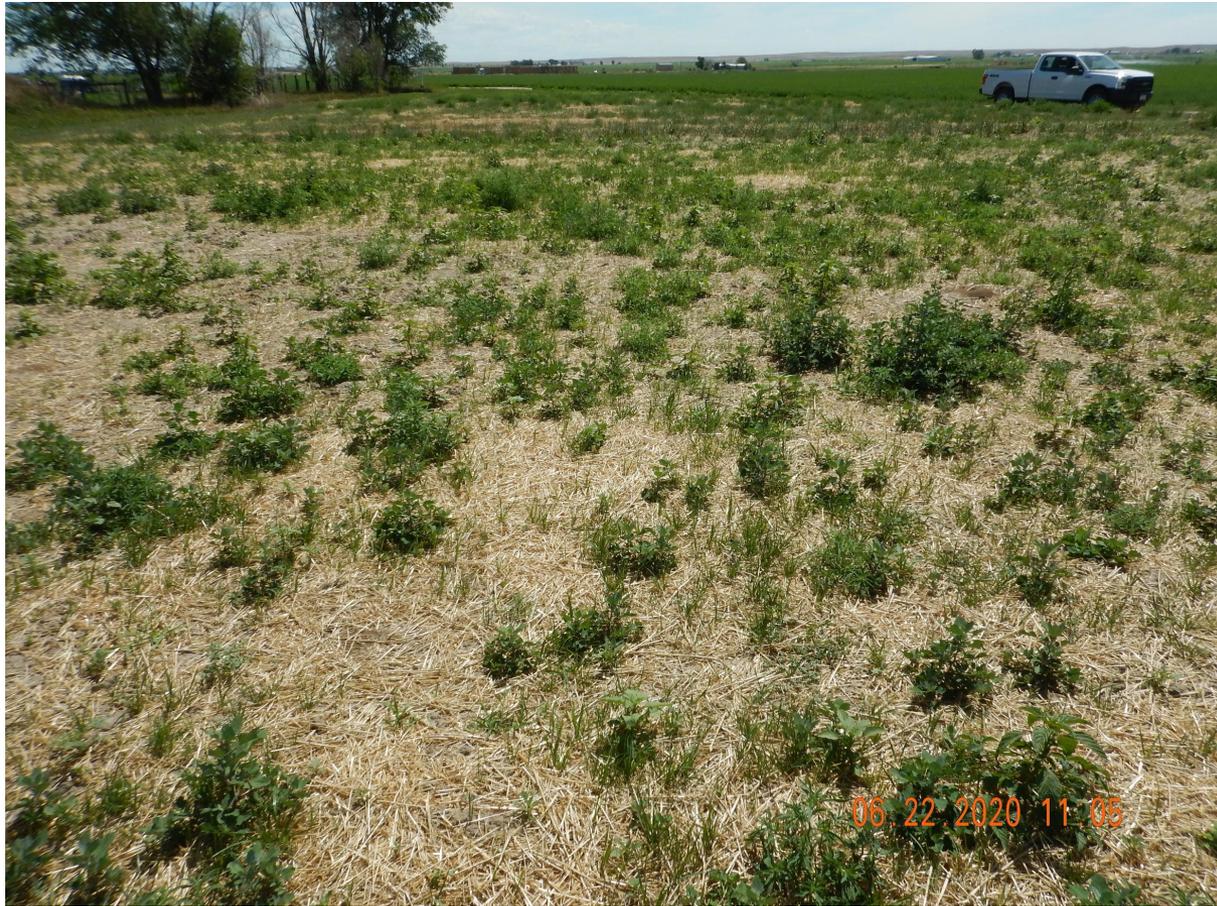
Photo 4. Photo taken from the central tank battery, facing East. See comments under Photo 2.

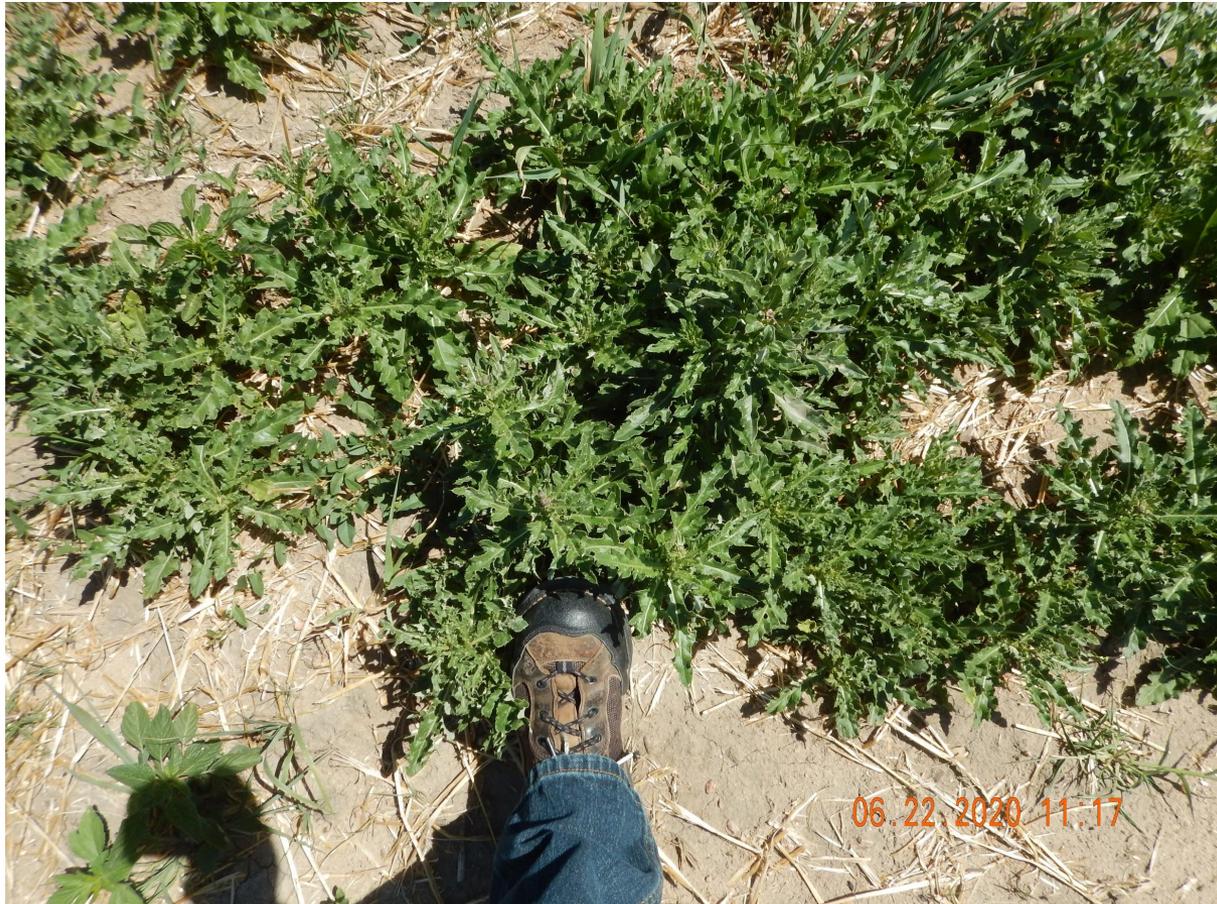
Photo 5. Photo taken from the northwestern tank battery. Photo illustrates a List B Colorado noxious weed, Canada thistle.

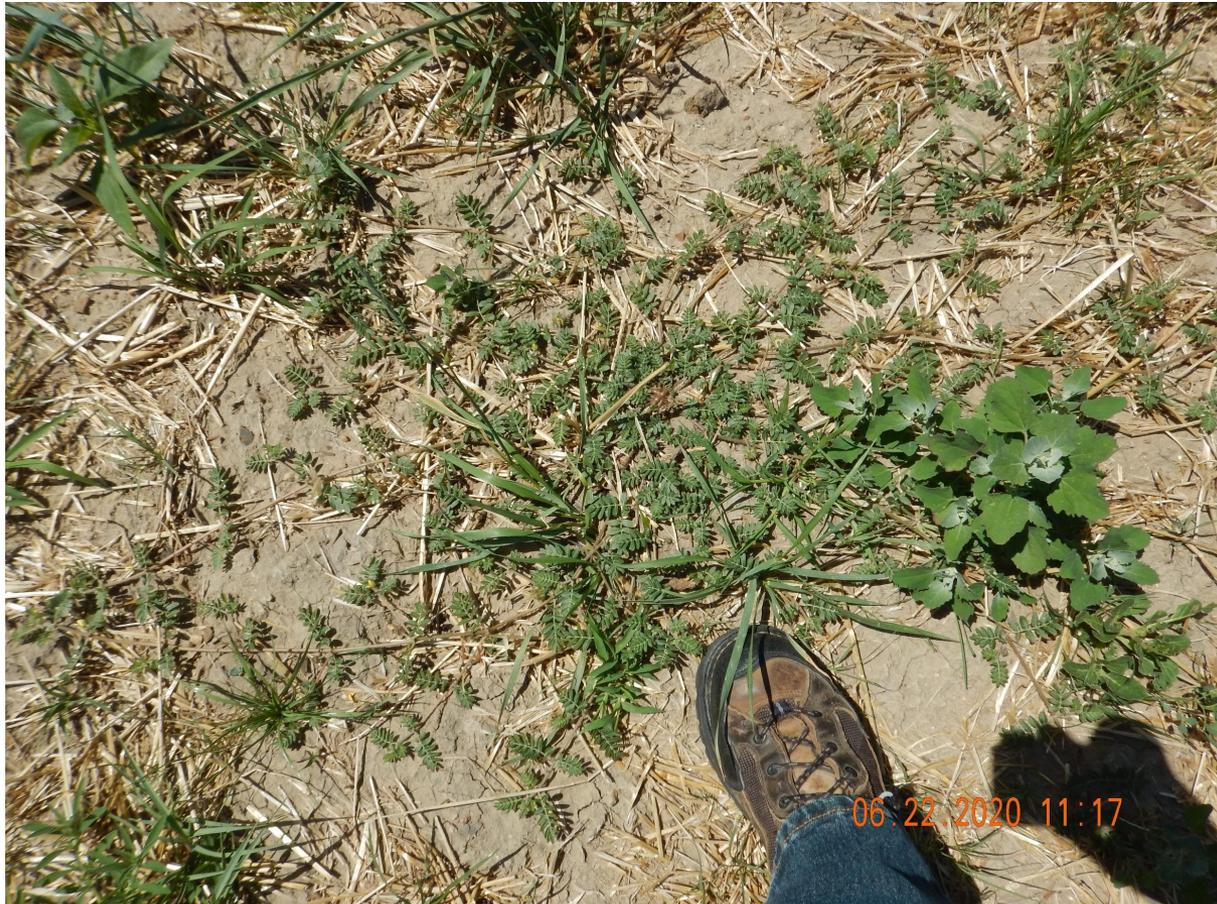
Photo 6. Photo taken from the northwestern tank battery. Photo illustrates a List C Colorado noxious weed, Puncturevine.

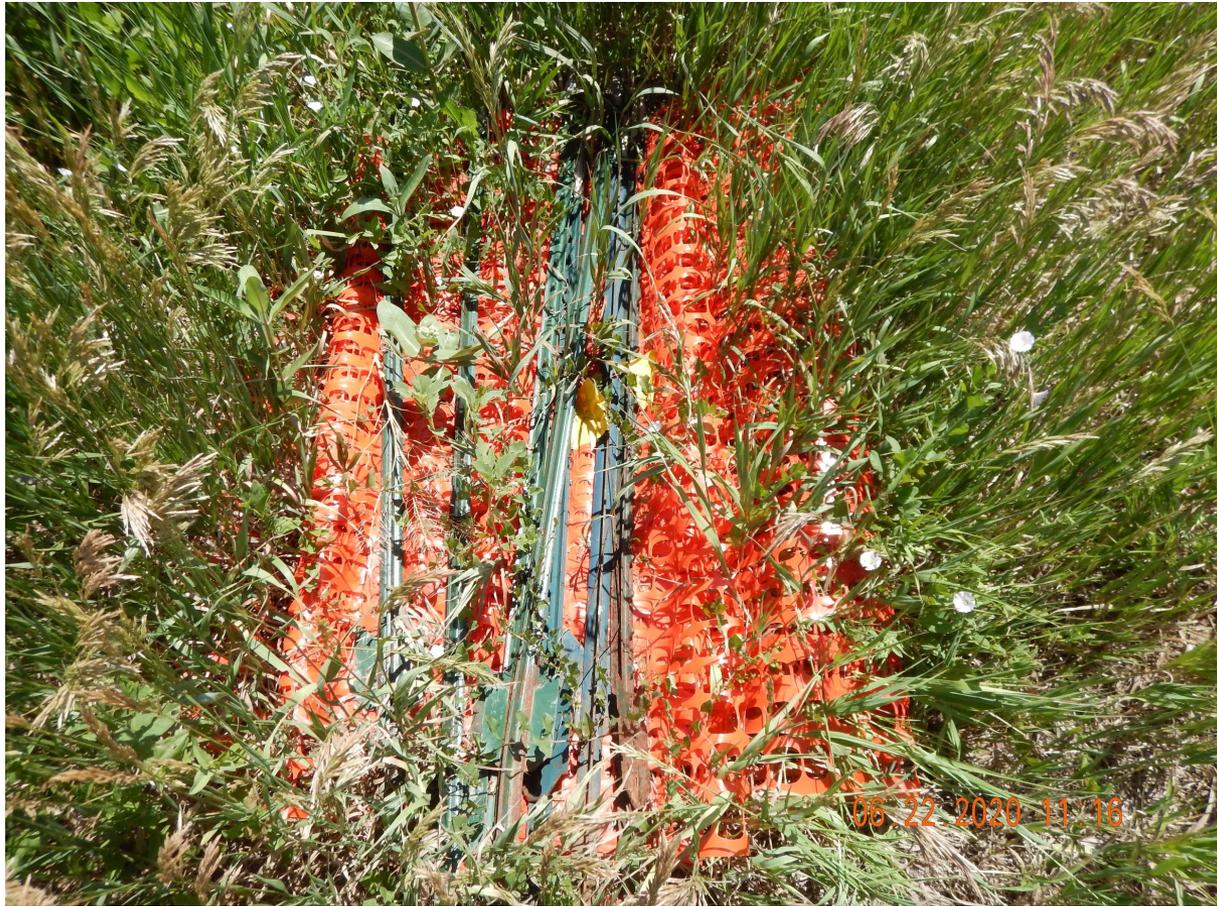
Photo 7. Photo taken from the northern entrance of the tank battery. Photo illustrates unused supplies left at the entrance.

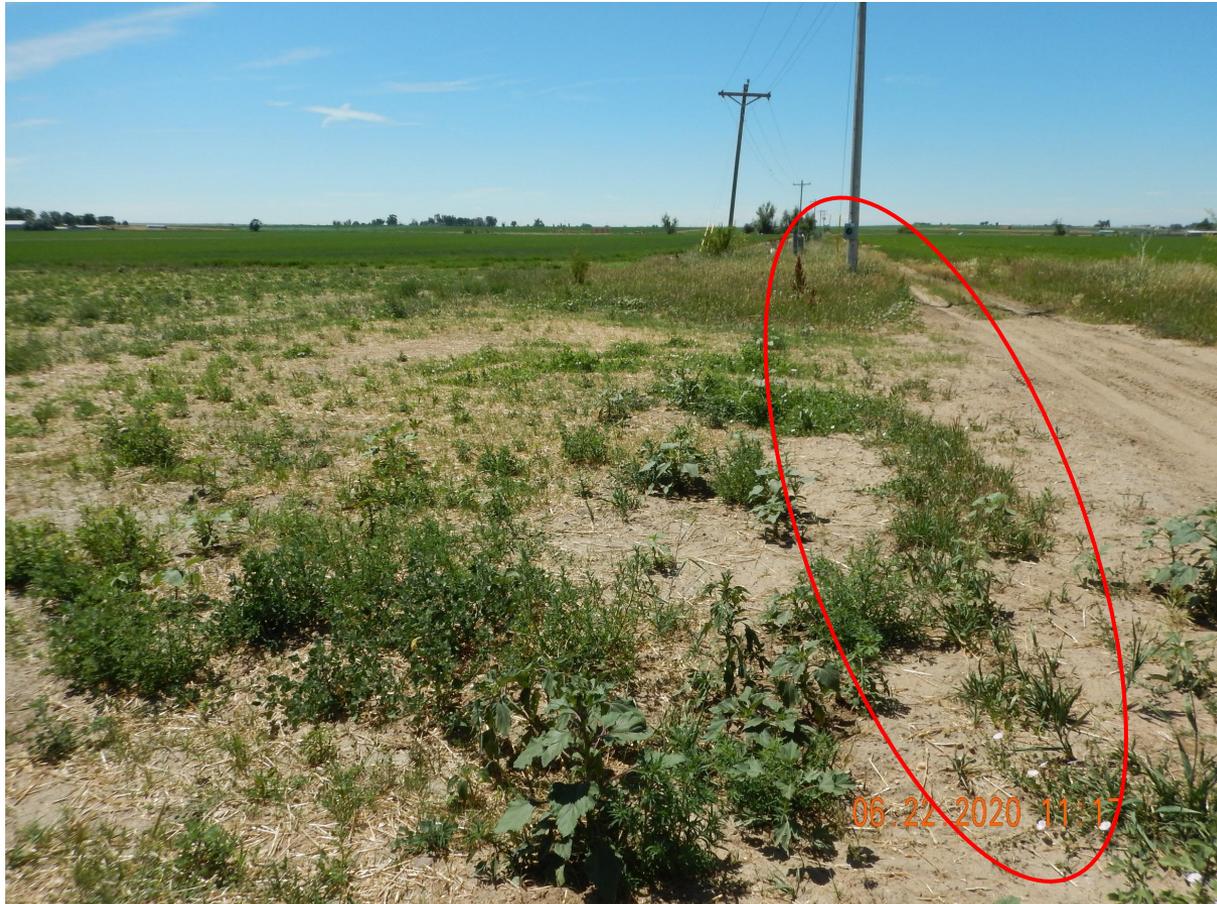
Photo 8. Photo taken from the northern entrance of the tank battery, facing South. Photo illustrates the Operator has failed to re-install fencing.

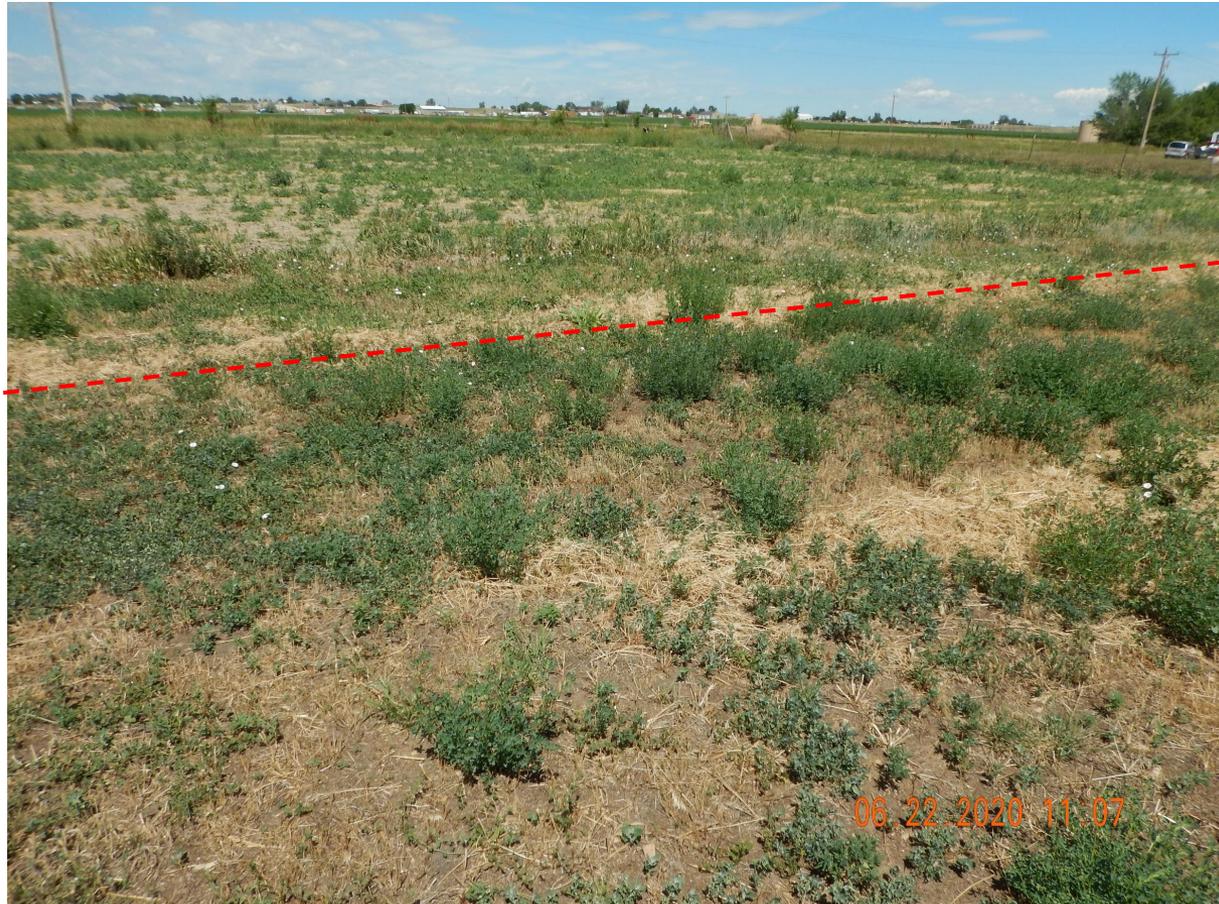
Photo 9. Reference photo taken east of the tank battery, facing West. Reference area (below red-dashed line) illustrates the establishment of alfalfa.
