Interim Reclamation Inspection

June 22, 2020

Operator: NOBLE ENERGY INC - #100322

Inspection Photos
Location Name: EHRLICH STATE PC F /36-32D
Location ID: 330389

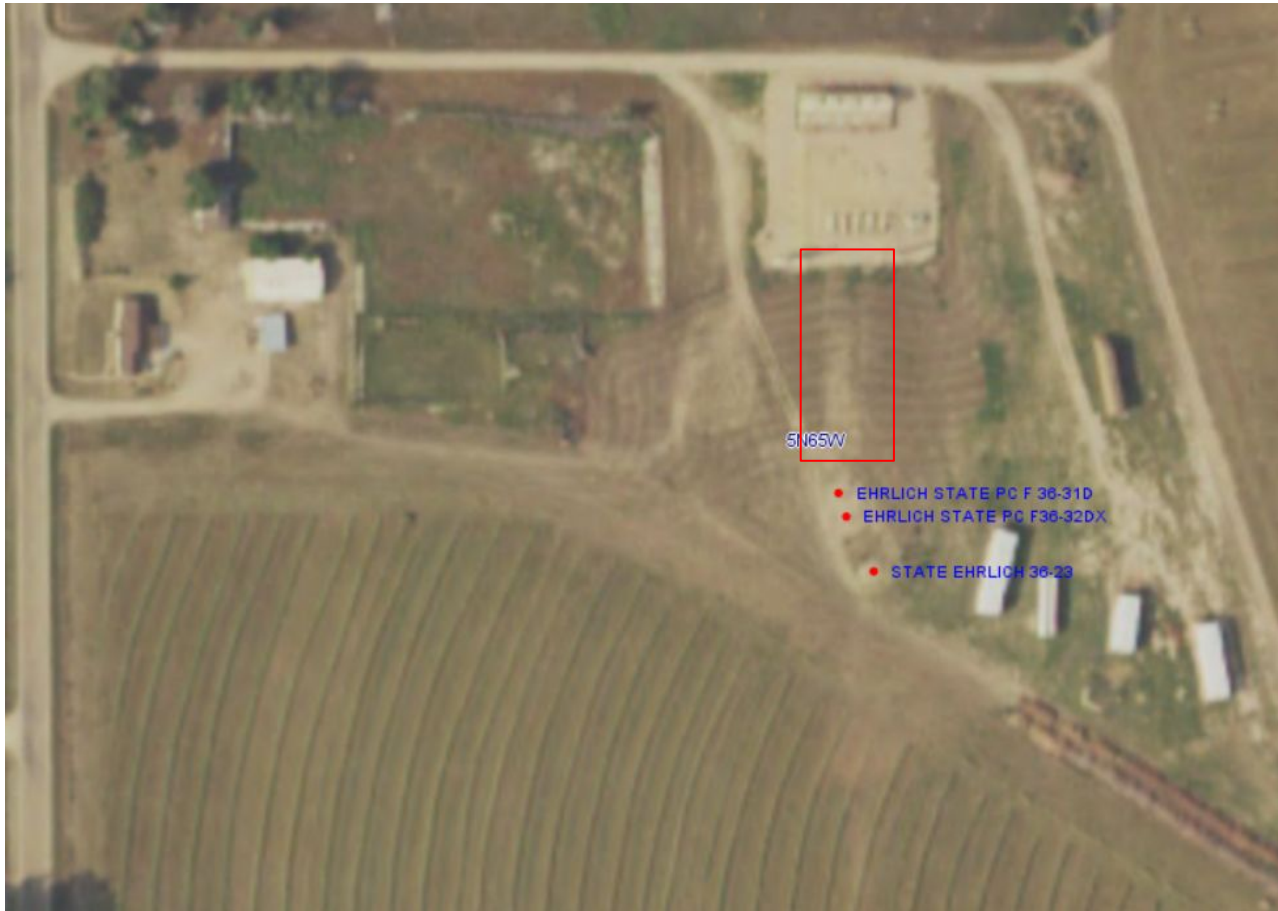
Photo 1. Aerial imagery taken in 2017. Aerial imagery shows a flowline area that was associated with two previous complaints from 2019.

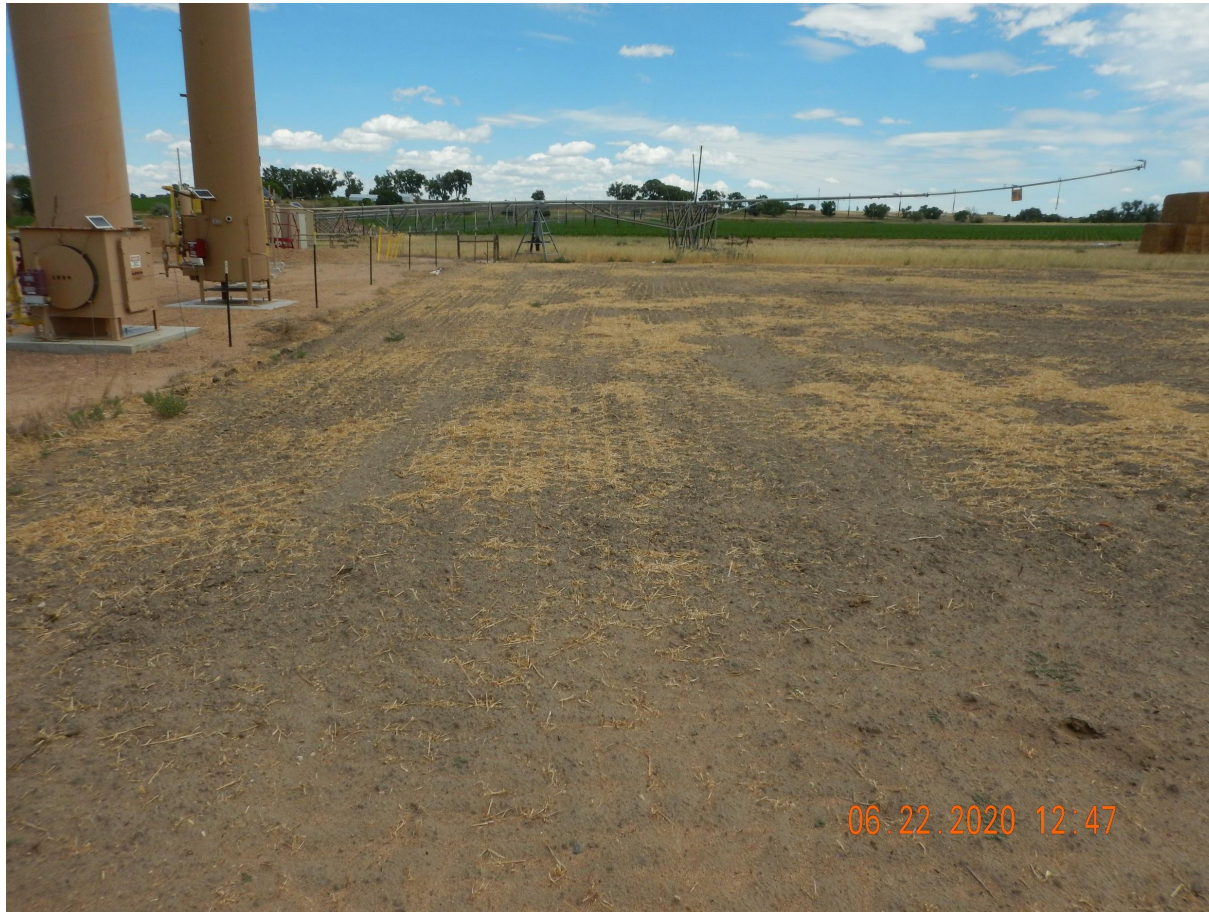
Photo 2. Photo taken from the northern portion of the flowline area, facing East. Photo illustrates the Operator has performed reclamation activities with the evidence of straw crimped mulch and drill seed rows. However, there was very little germination of any species. Note: much of the straw mulch has blown off the flowline area, which is not protecting the seeded soil from wind and water erosion. A native grass mix was believed to be planted which only gets planted $\frac{1}{4}$ "- $\frac{1}{2}$ " depth. Wind erosion could have potentially blown seed away.

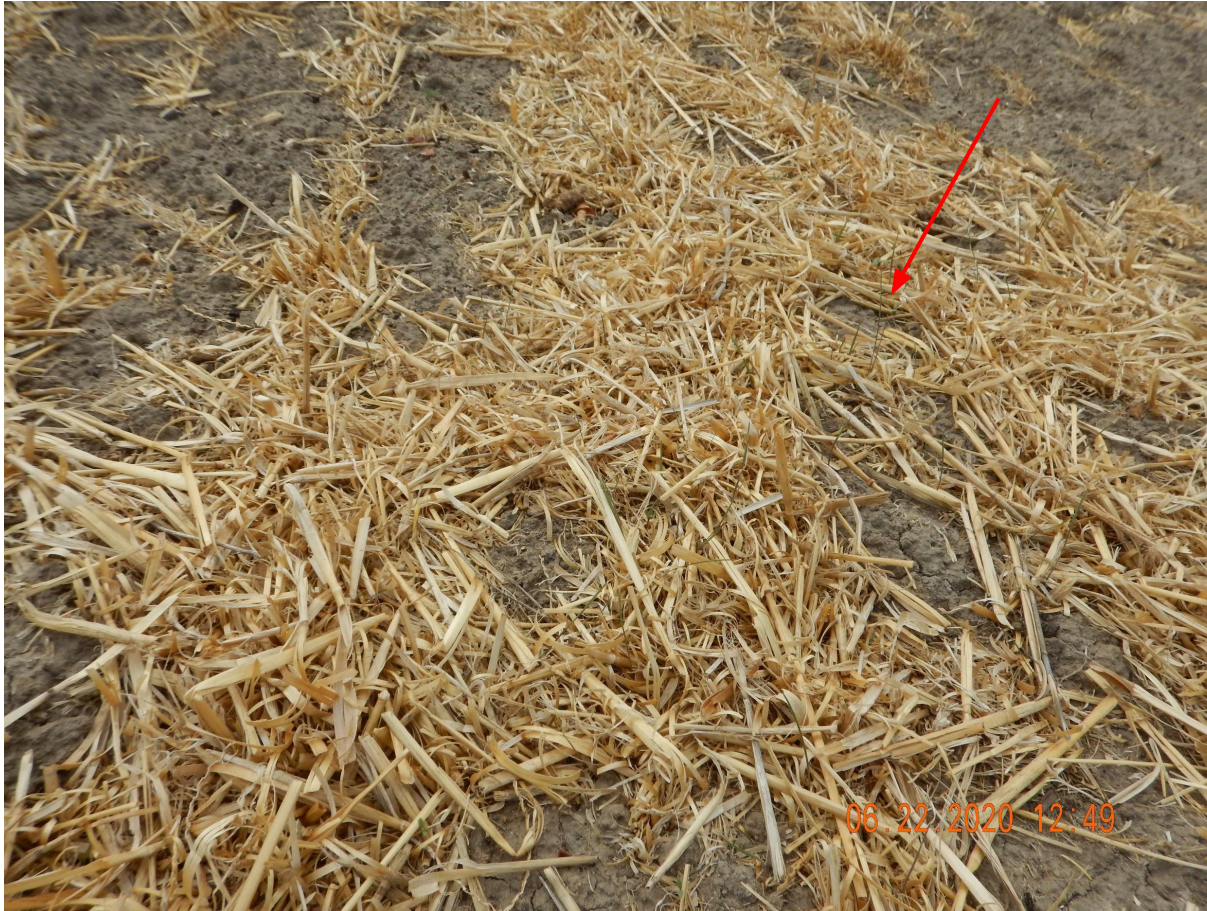
Photo 3. Close up photo taken from a portion of the flowline area. Photo illustrates some germination of grass species within the mulch but unable to determine what grass species.

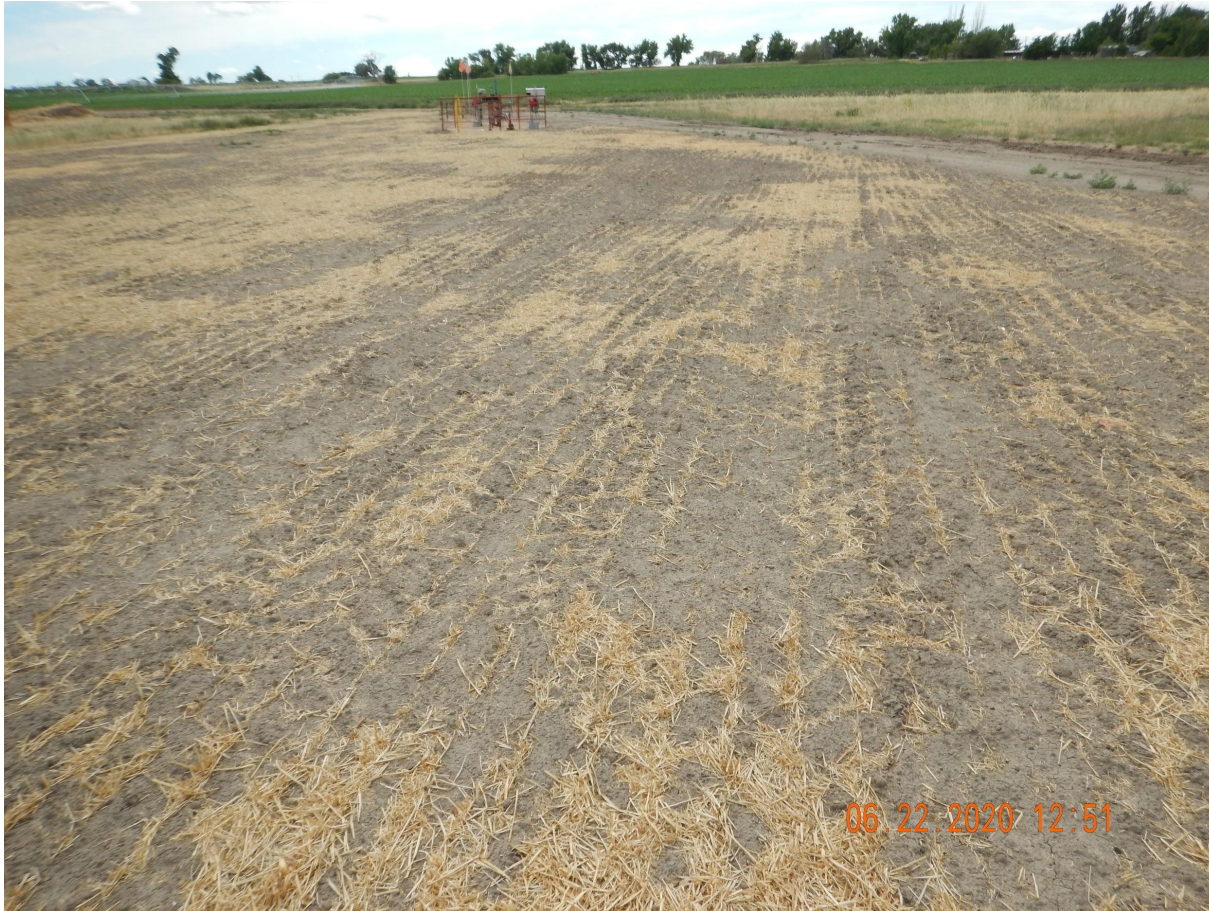
Photo 4. Photo taken from the northern portion of the flowline area, facing South.
See comments under Photo 2.

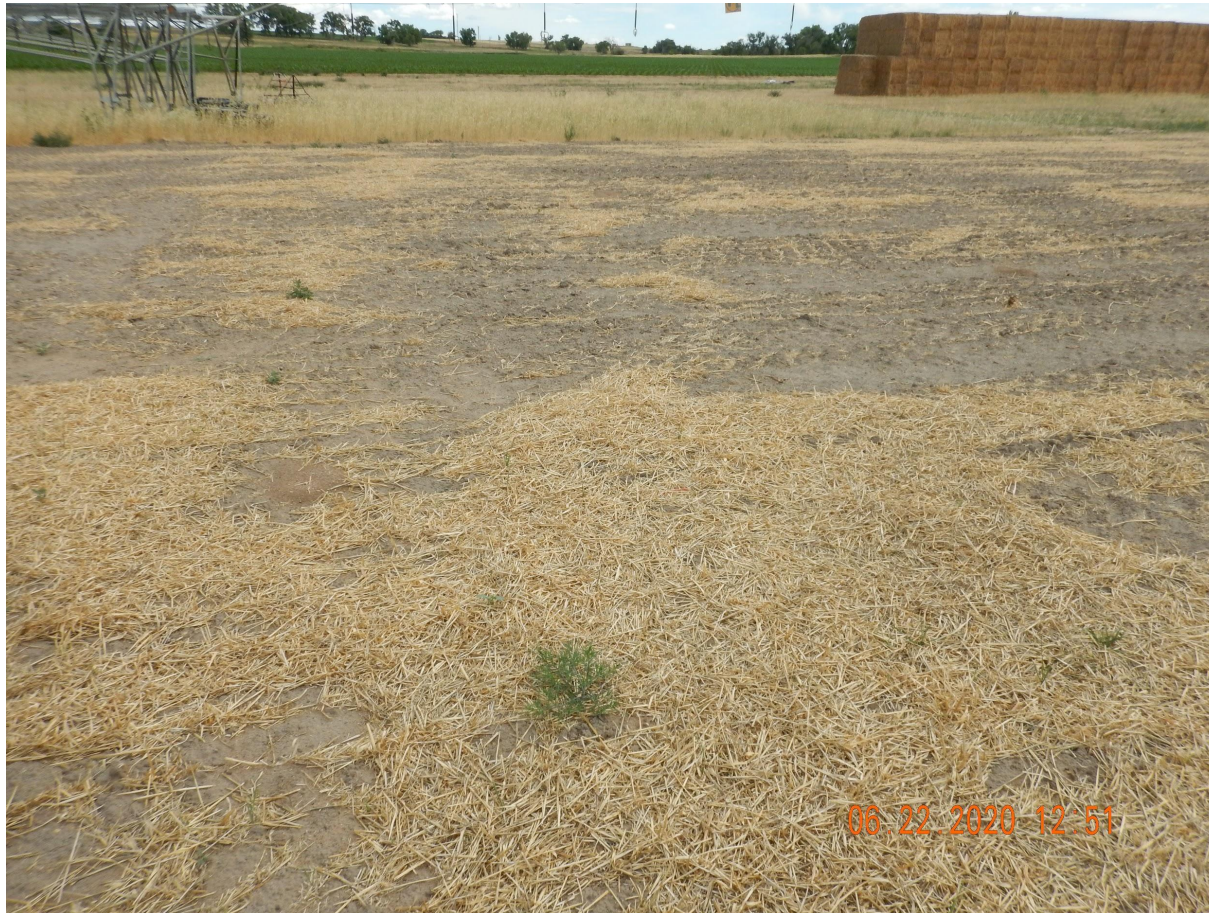
Photo 5. Photo taken from the central portion of the flowline area, facing East. See comments under Photo 2.

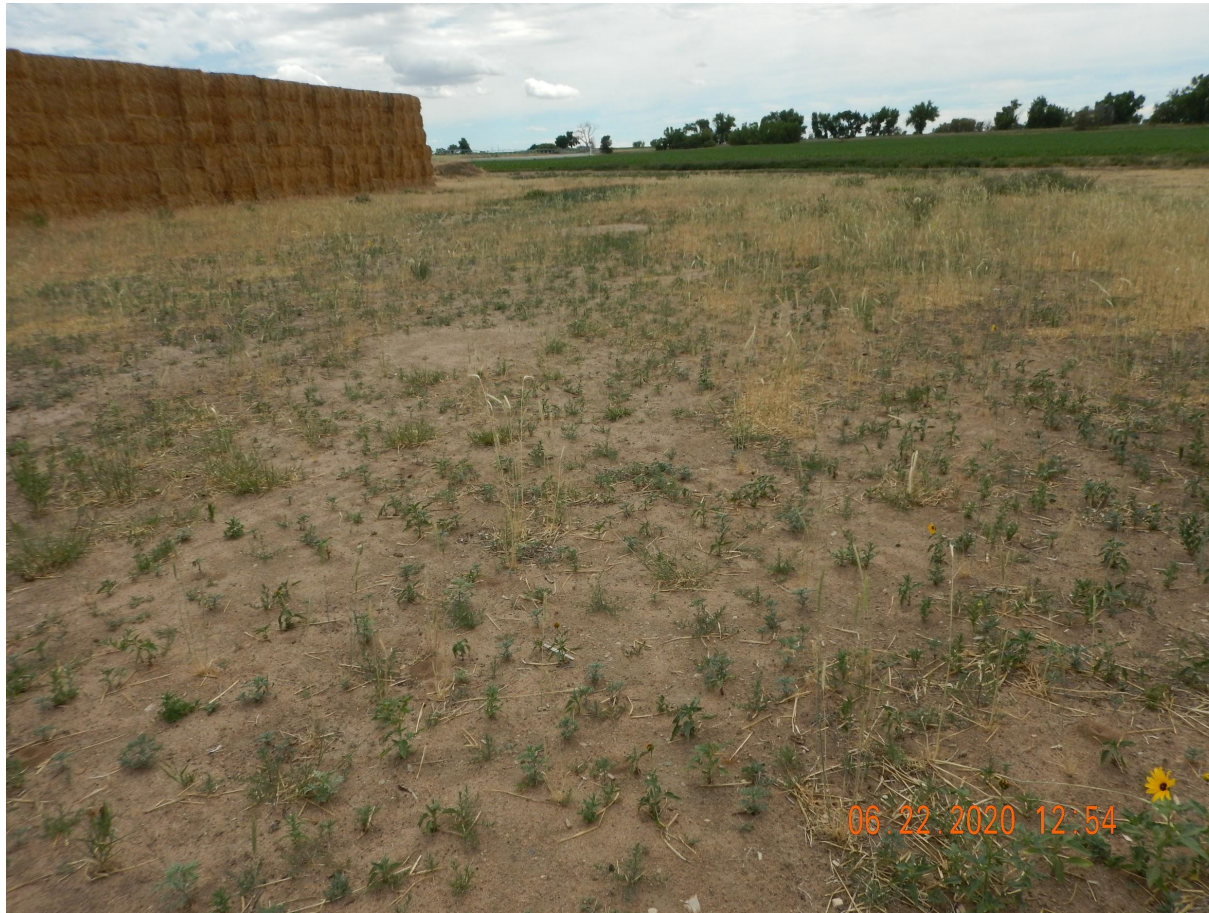
Photo 6. Photo taken east of the flowline area, facing South. Surface owner claims the Operator disturbed this area during subsequent operations of the nearby wells. Operator is responsible for reclaiming any disturbance associated with any operation.

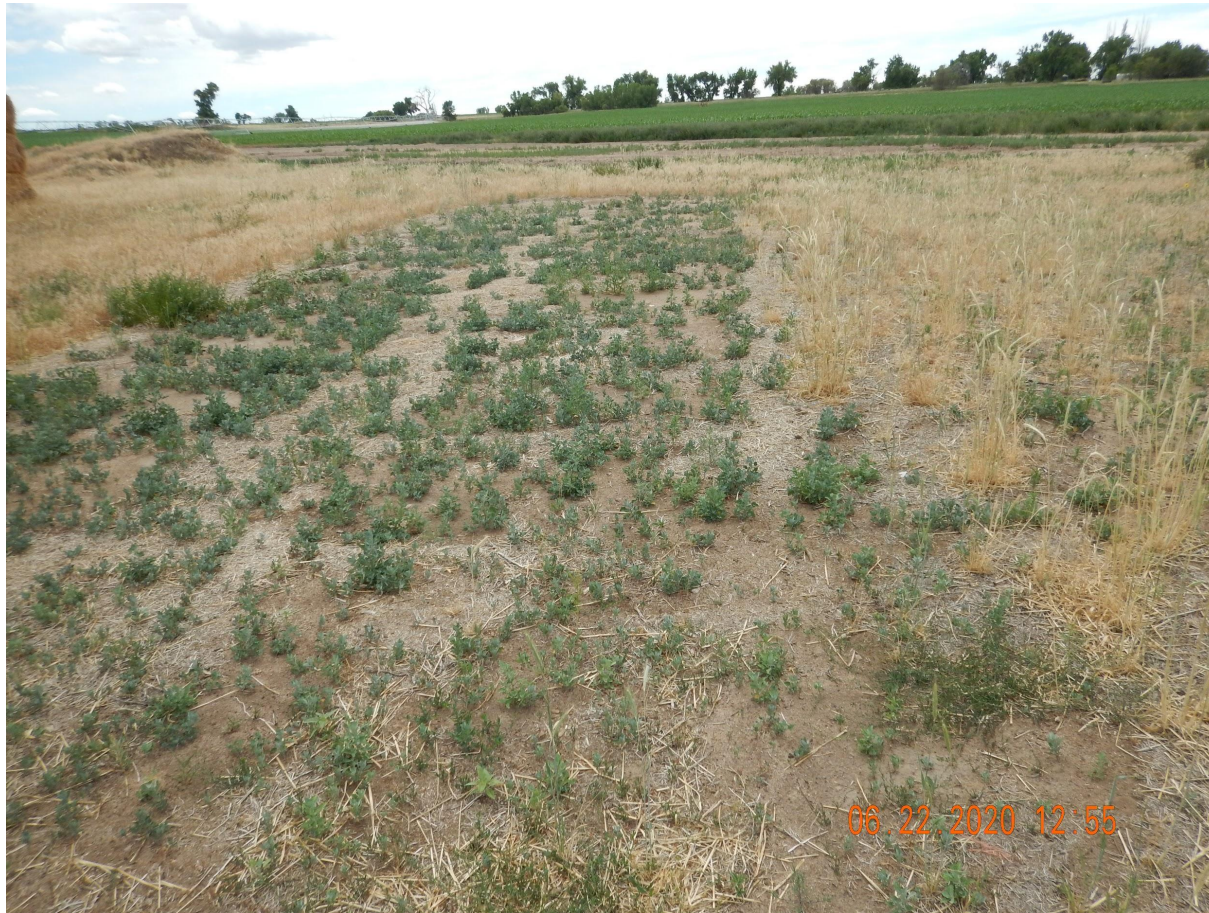
Photo 7. Photo taken east of the flowline area, facing South. Photo illustrates a disturbance area that the surface owner claims was disturbed during subsequent operations of the nearby wells
