Mustang
1-35-6S-94W
Location # 322298

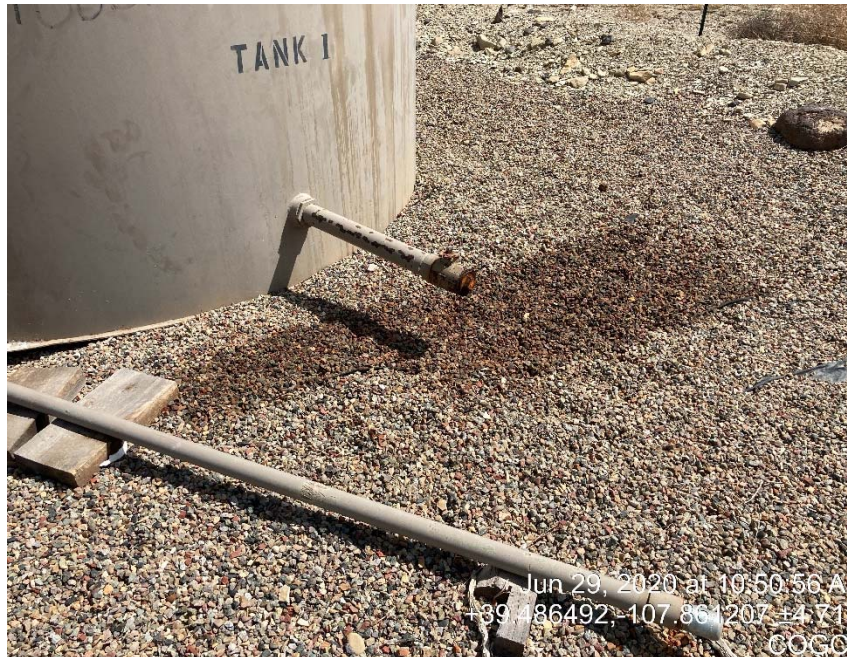
Staining next to tank

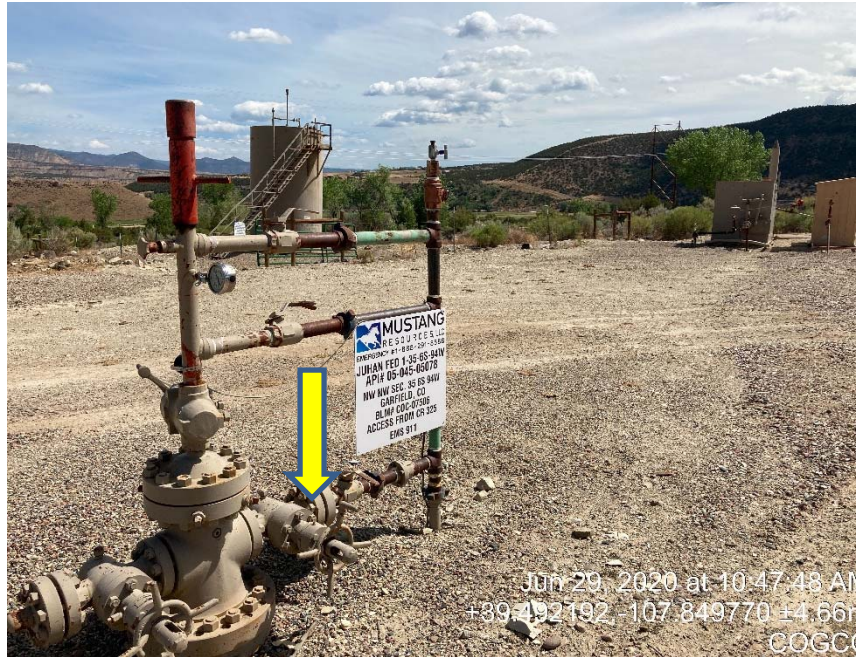
wheel valve is hissing gas
