**Inspection Photos**  
**Operator: BP America**  
**API: 067-06631**  
**Date: 6/29/2020**

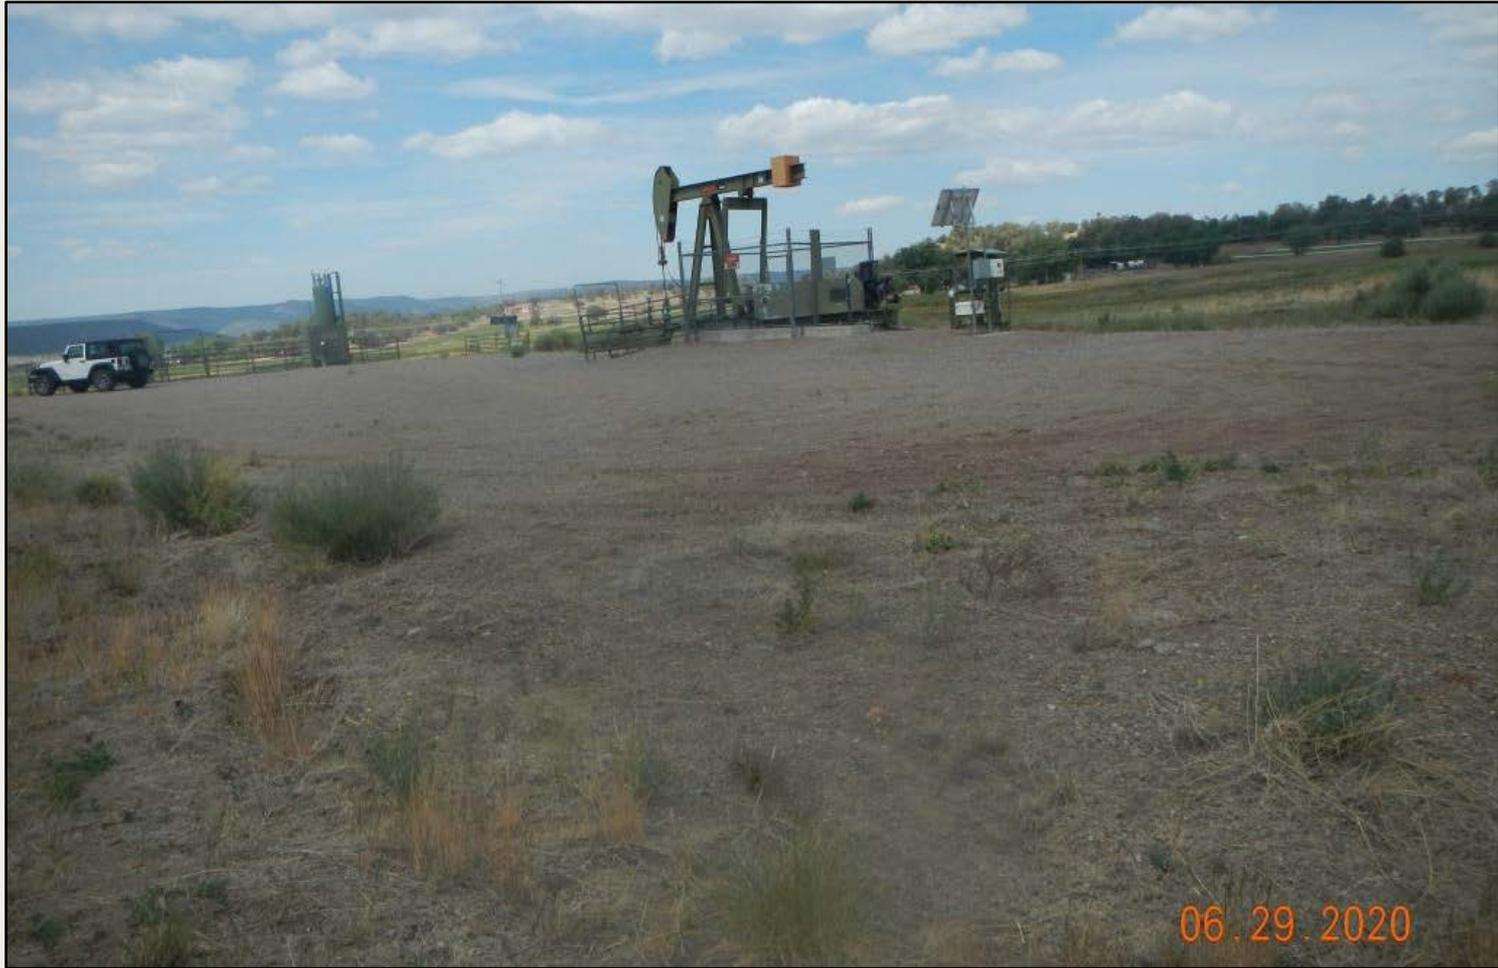
Photo 1. View of the project area from the southeastern corner facing center.

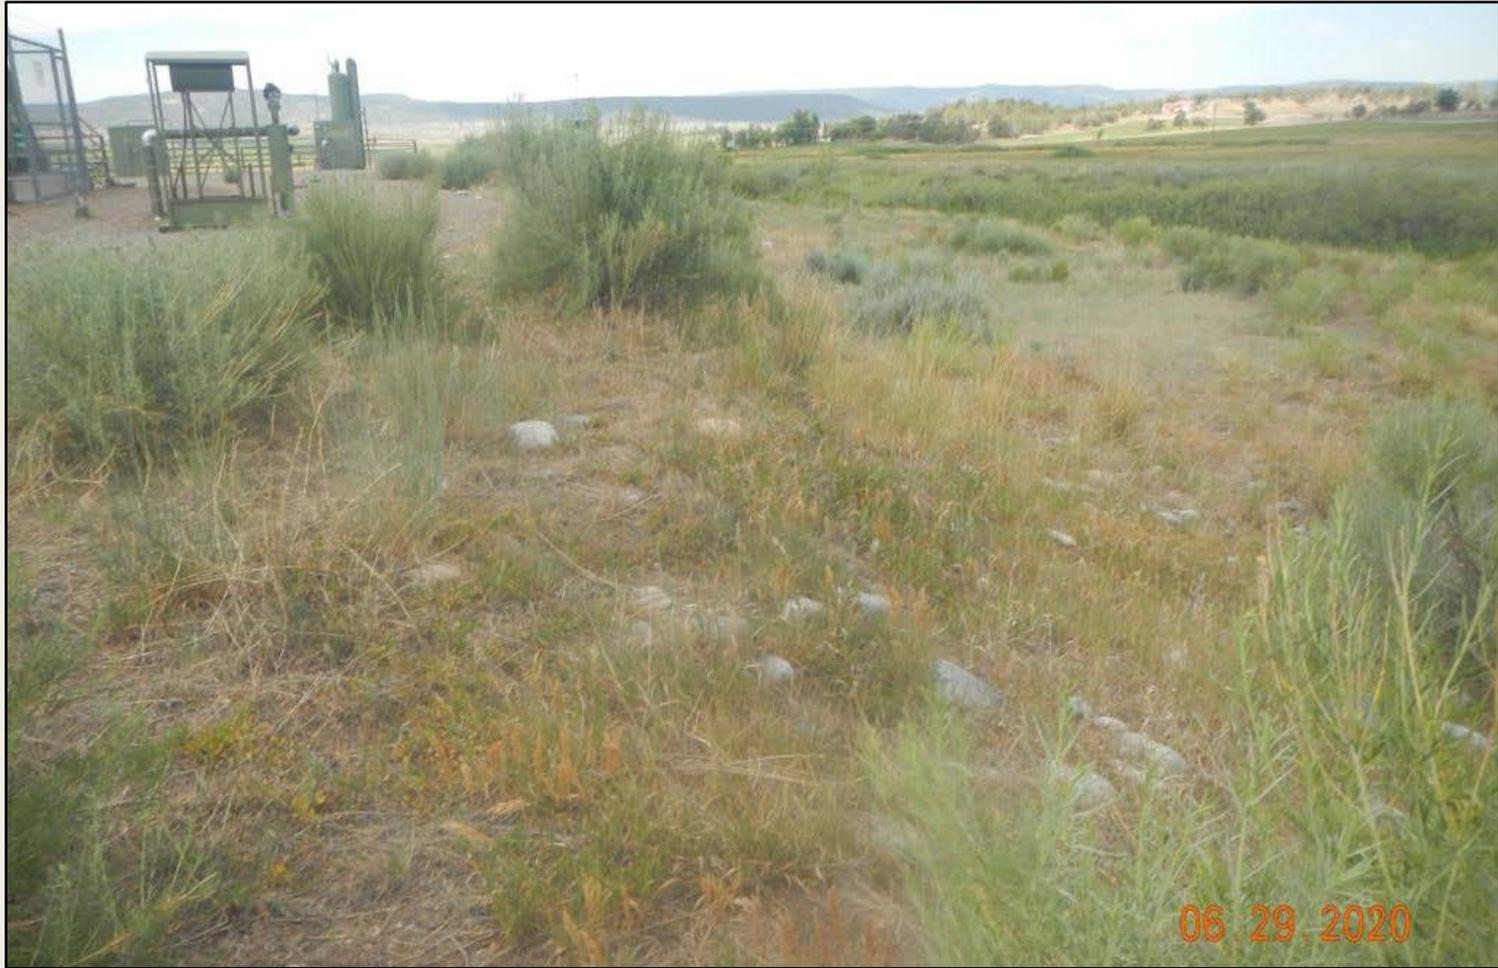
Photo 2. View of the northern fill slope from the northeastern corner facing westward.

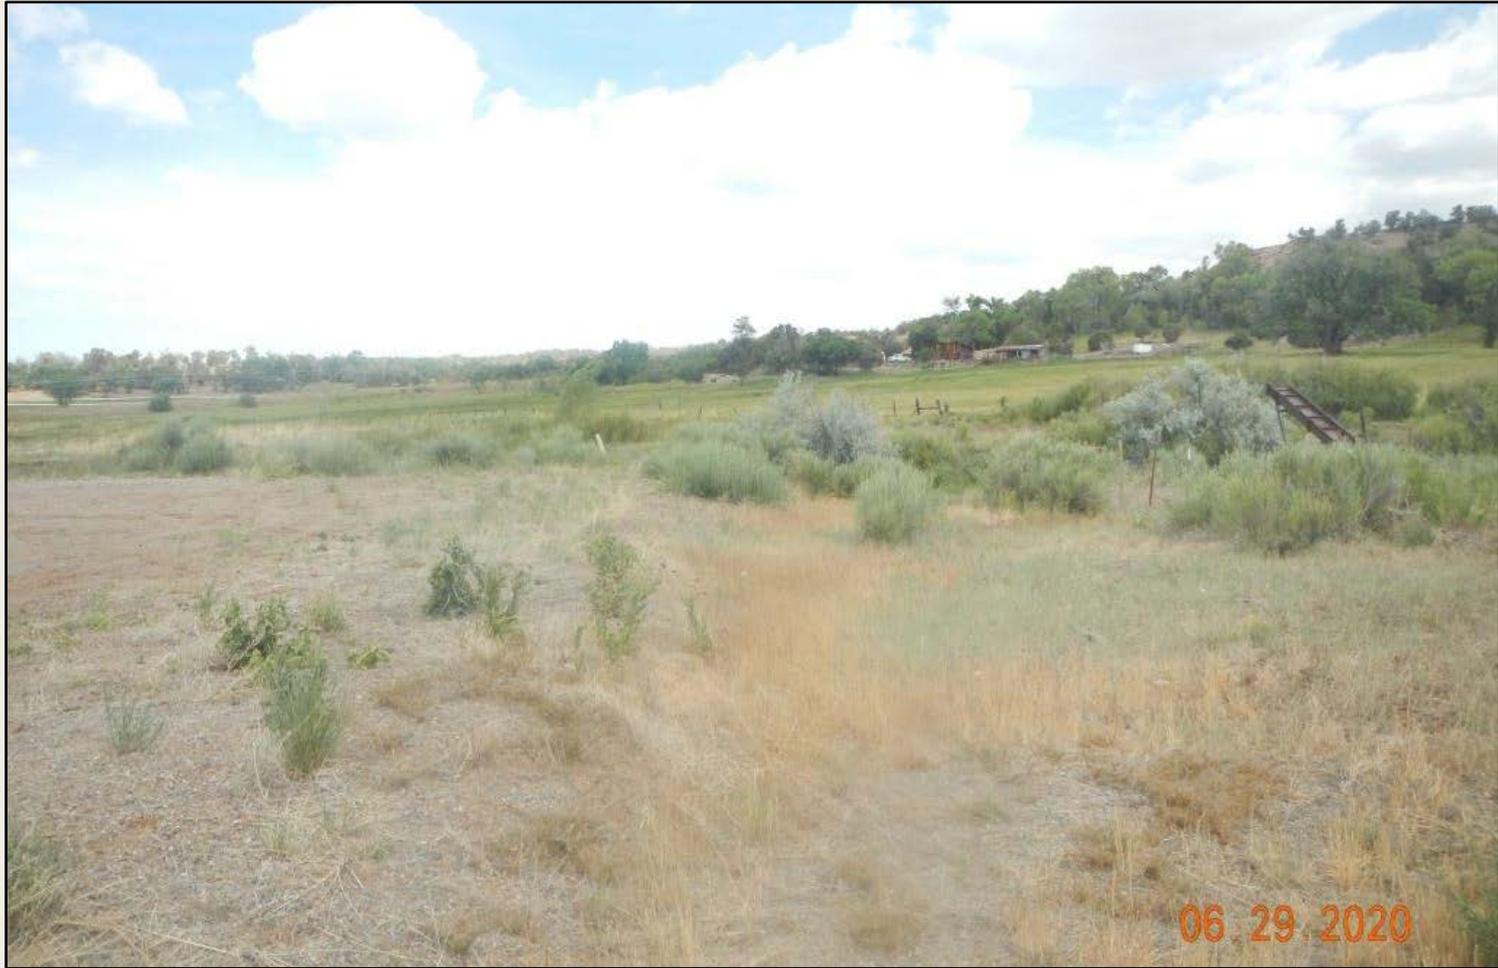
Photo 3. View of the eastern project area from the southeastern corner facing northward.

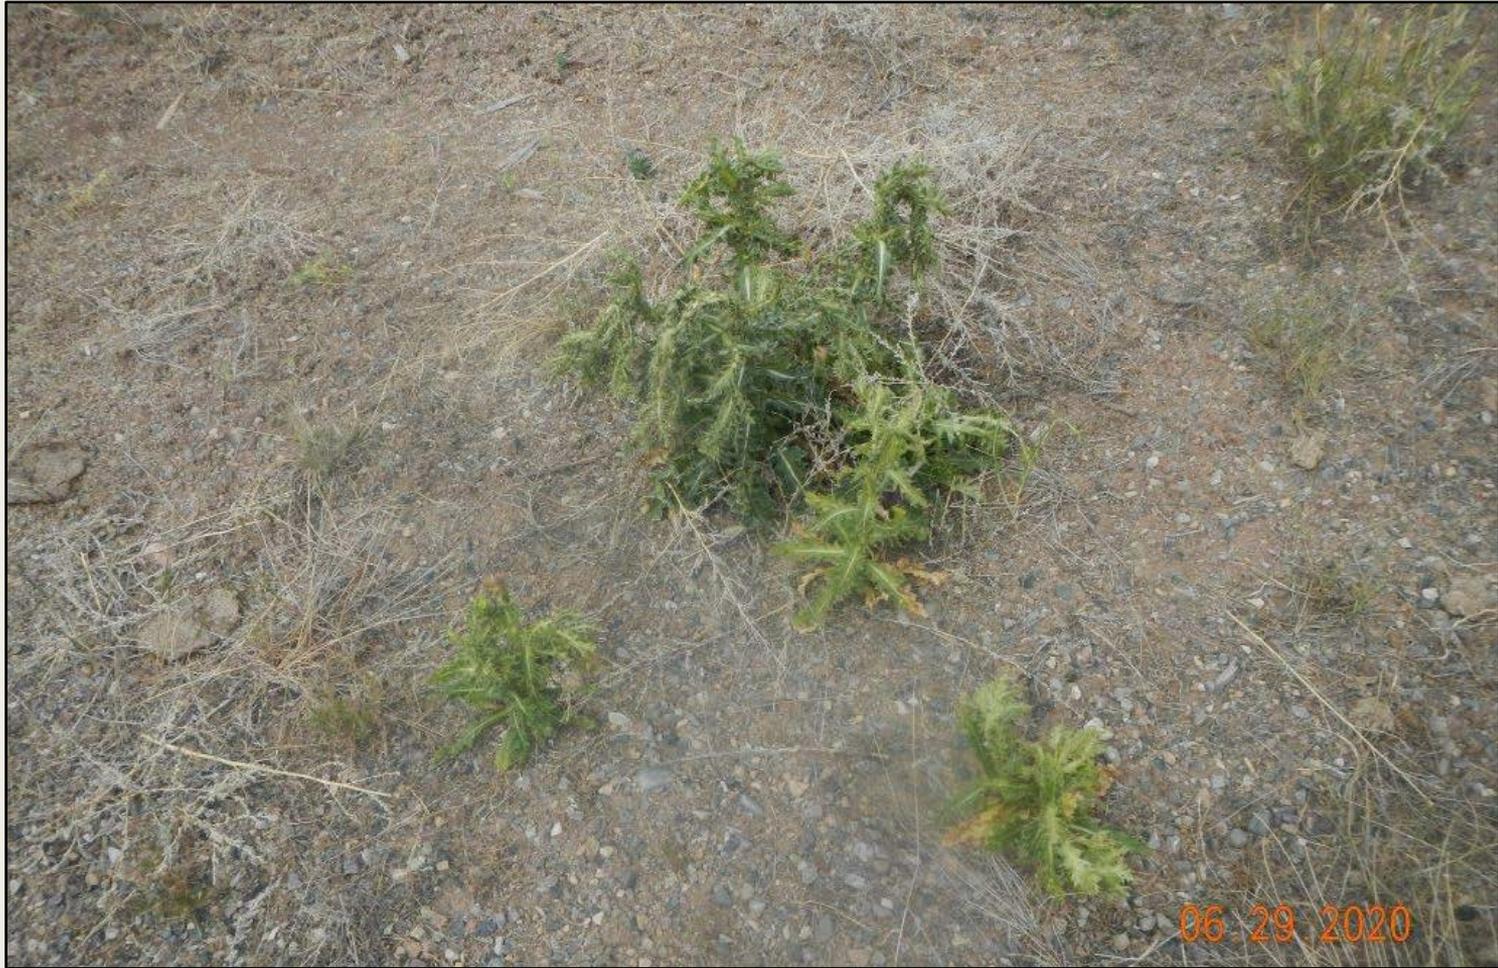
Photo 4. View of musk thistles wilting from what appears to be herbicide treatment within the eastern project area.

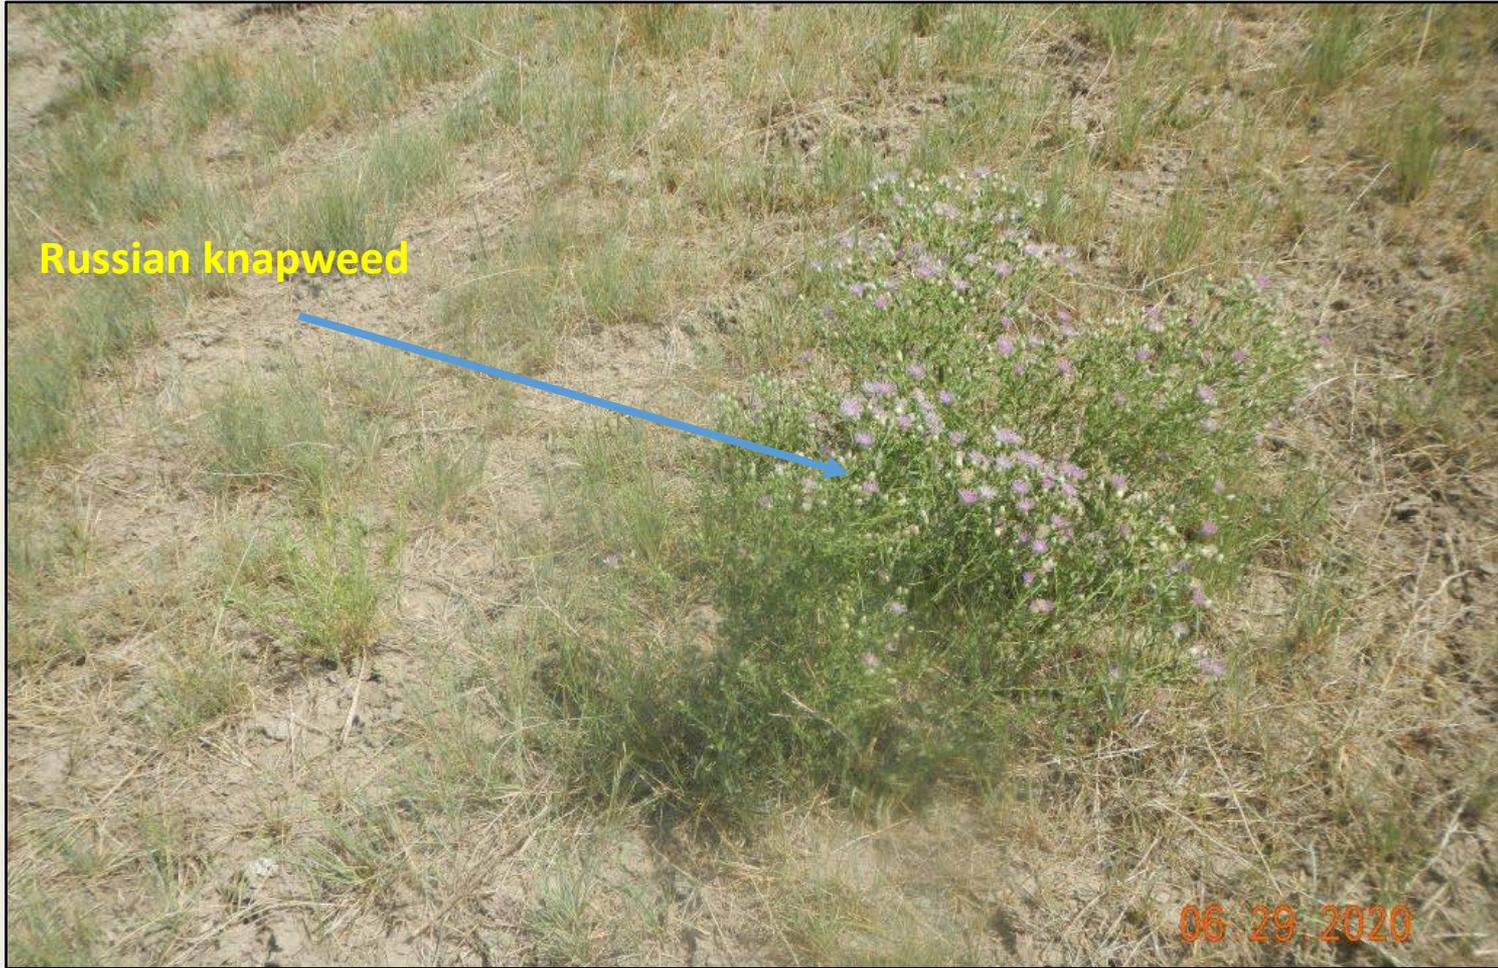
Photo 5. View of Russian knapweeds blooming within the northern project area. Approximately 100 individuals observed.

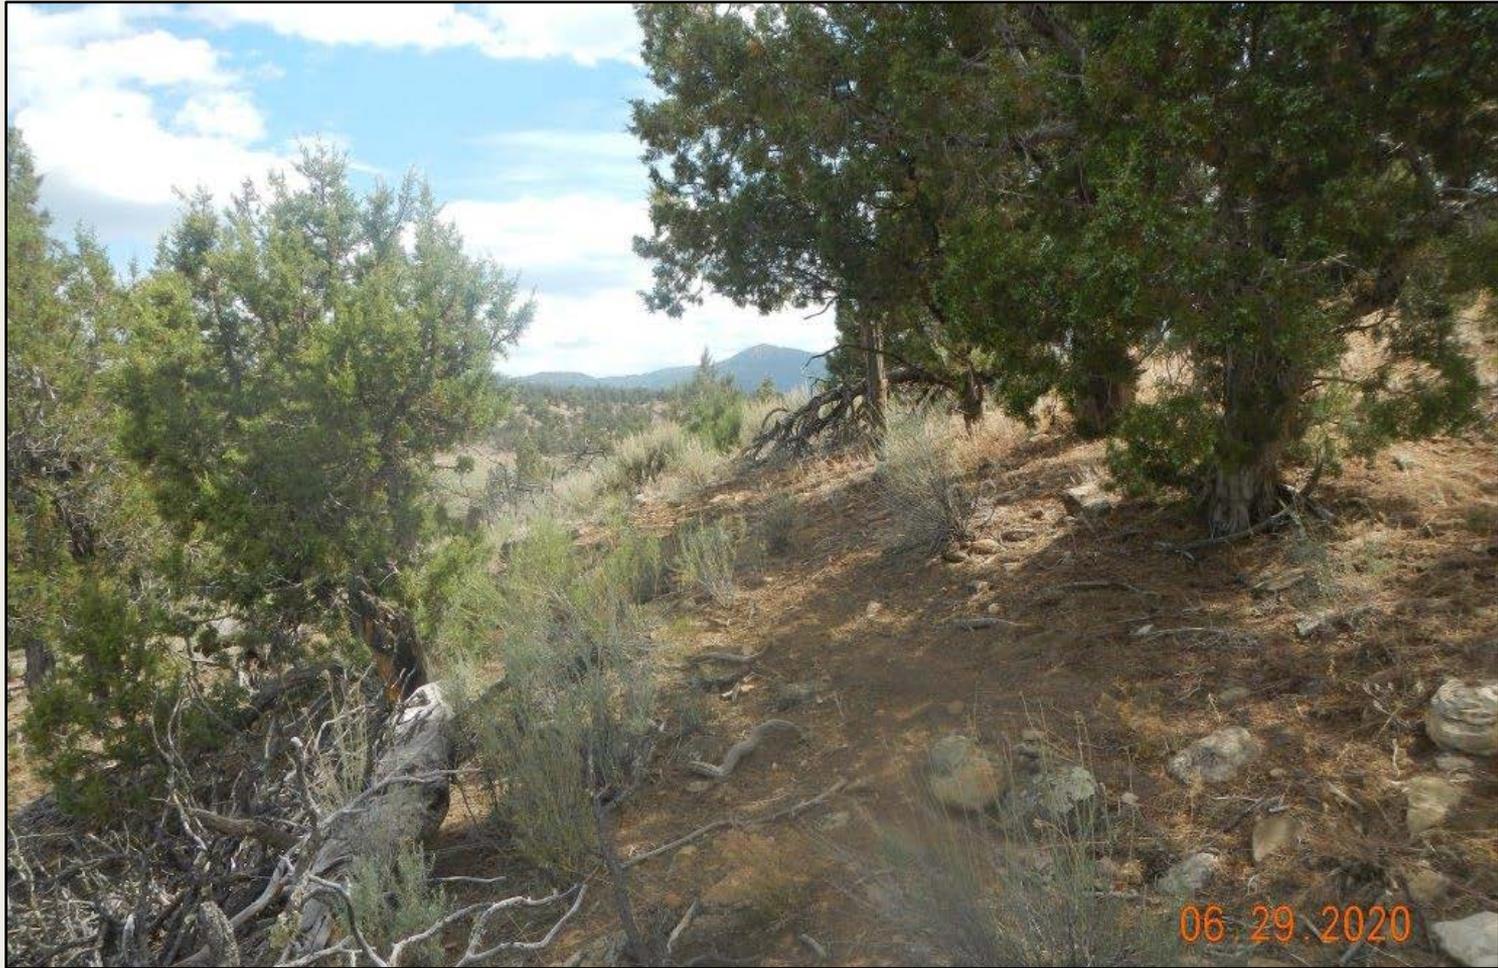
Photo 6. View of the reference area, comprised of pinyon juniper woodland with sagebrush, blue grama, and penstemon in the understory.
