Inspection Photos
Operator: BP America
API: 067-06783
Date: 6/29/2020

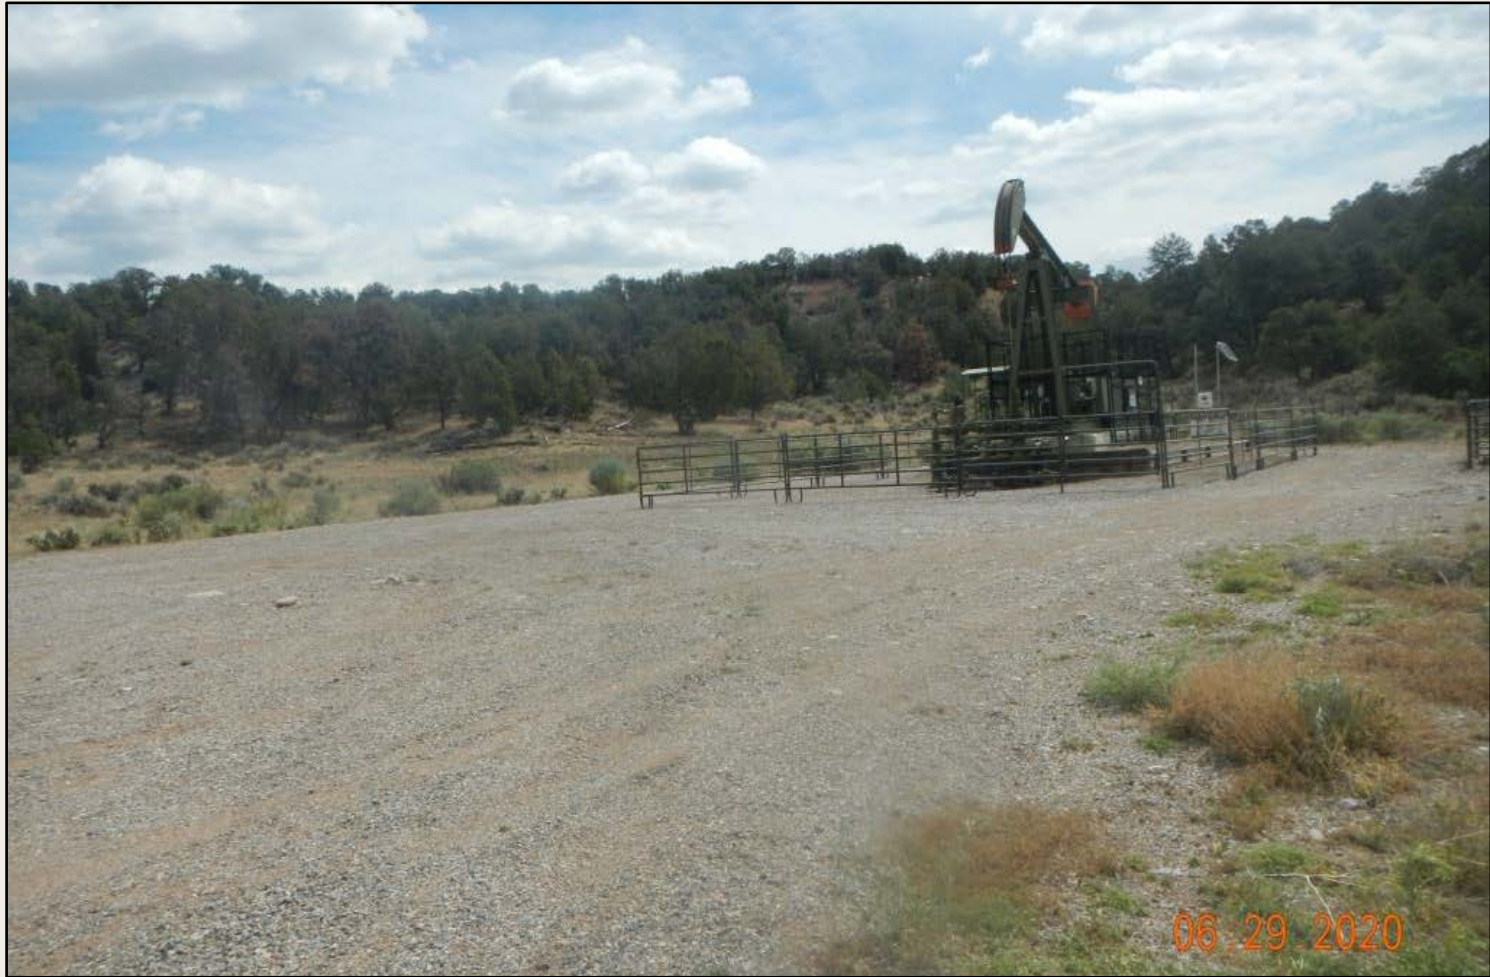
Photo 1. View of the project area from the well pad entrance facing center.

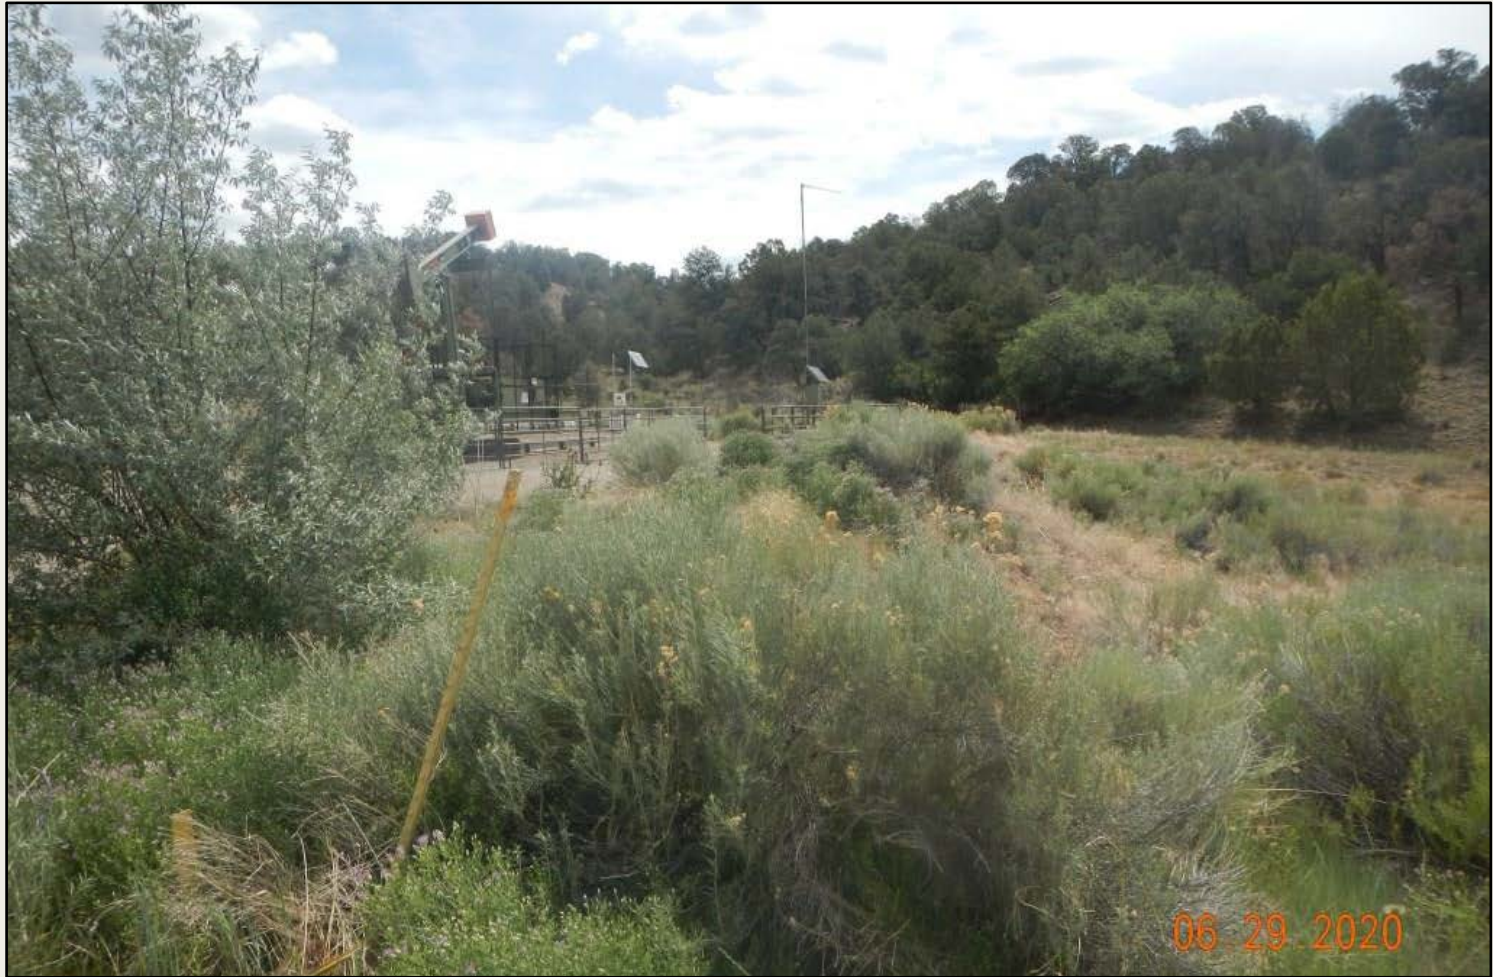
Photo 2. View of the northern fill slope from the northwestern corner facing eastward.

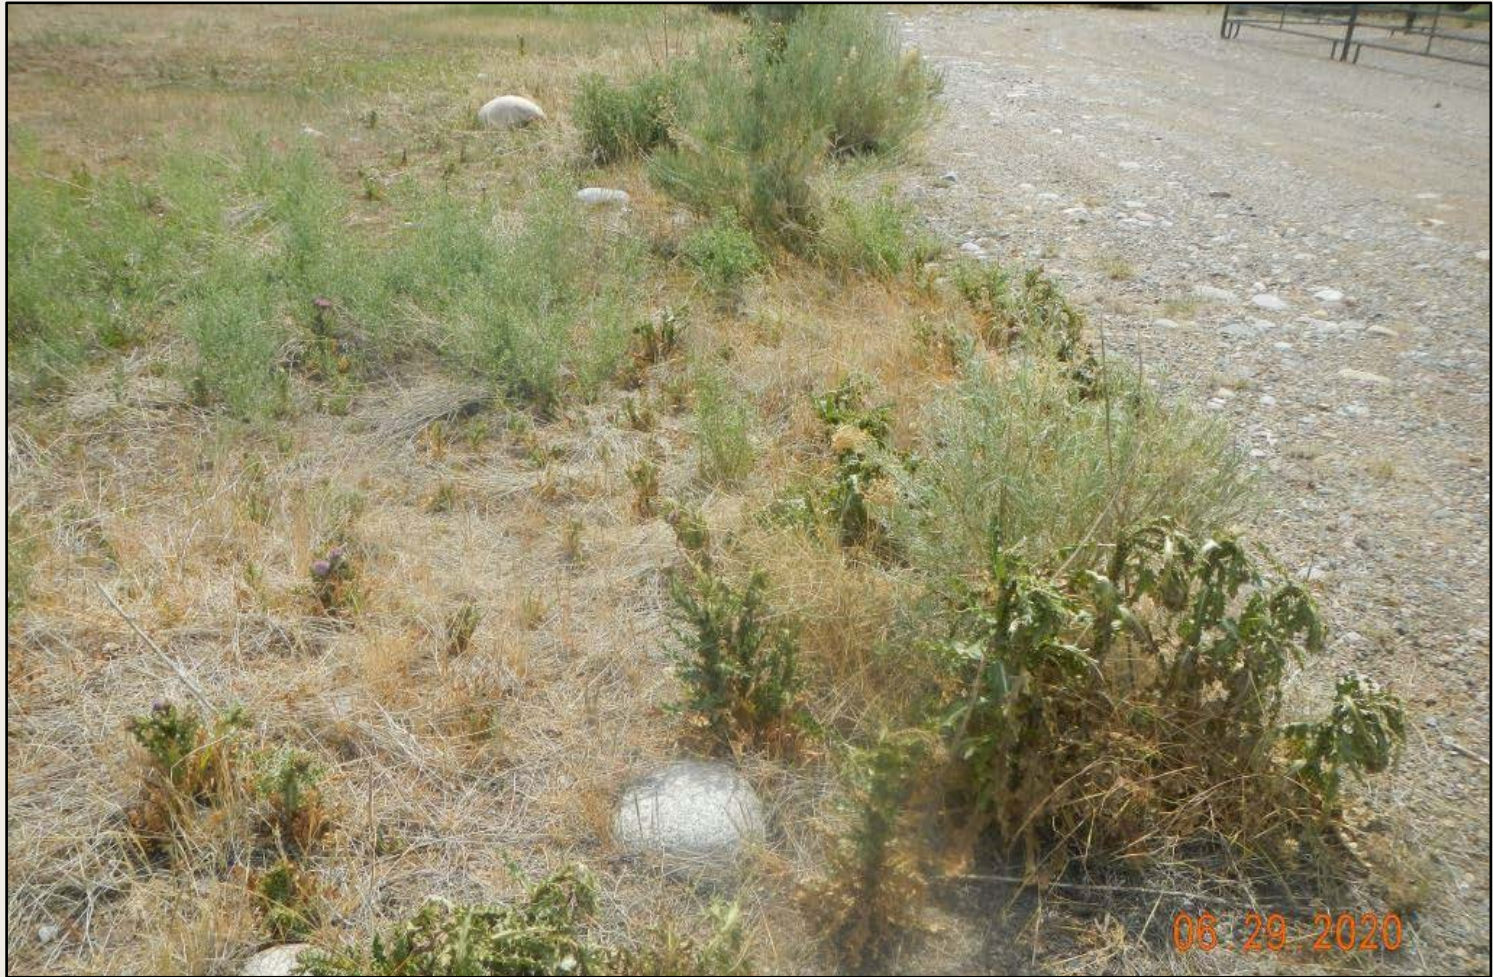
Photo 3. View of herbicide treated musk thistles within the northern project area.

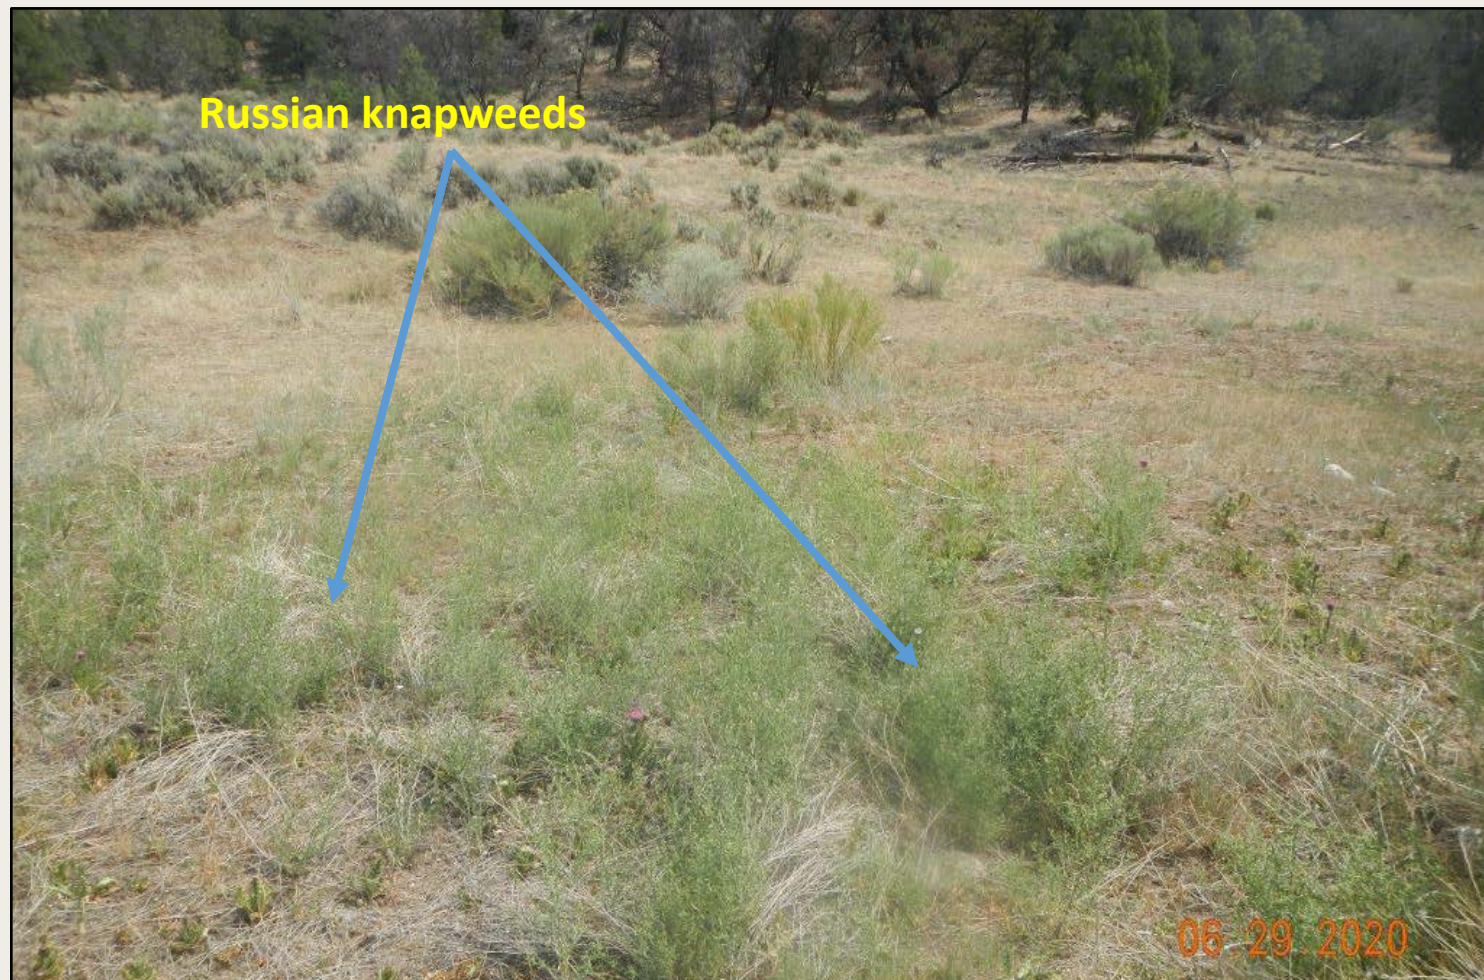
Photo 4. View of Russian knapweeds within the northern project area. Approximately 1000 individuals observed.

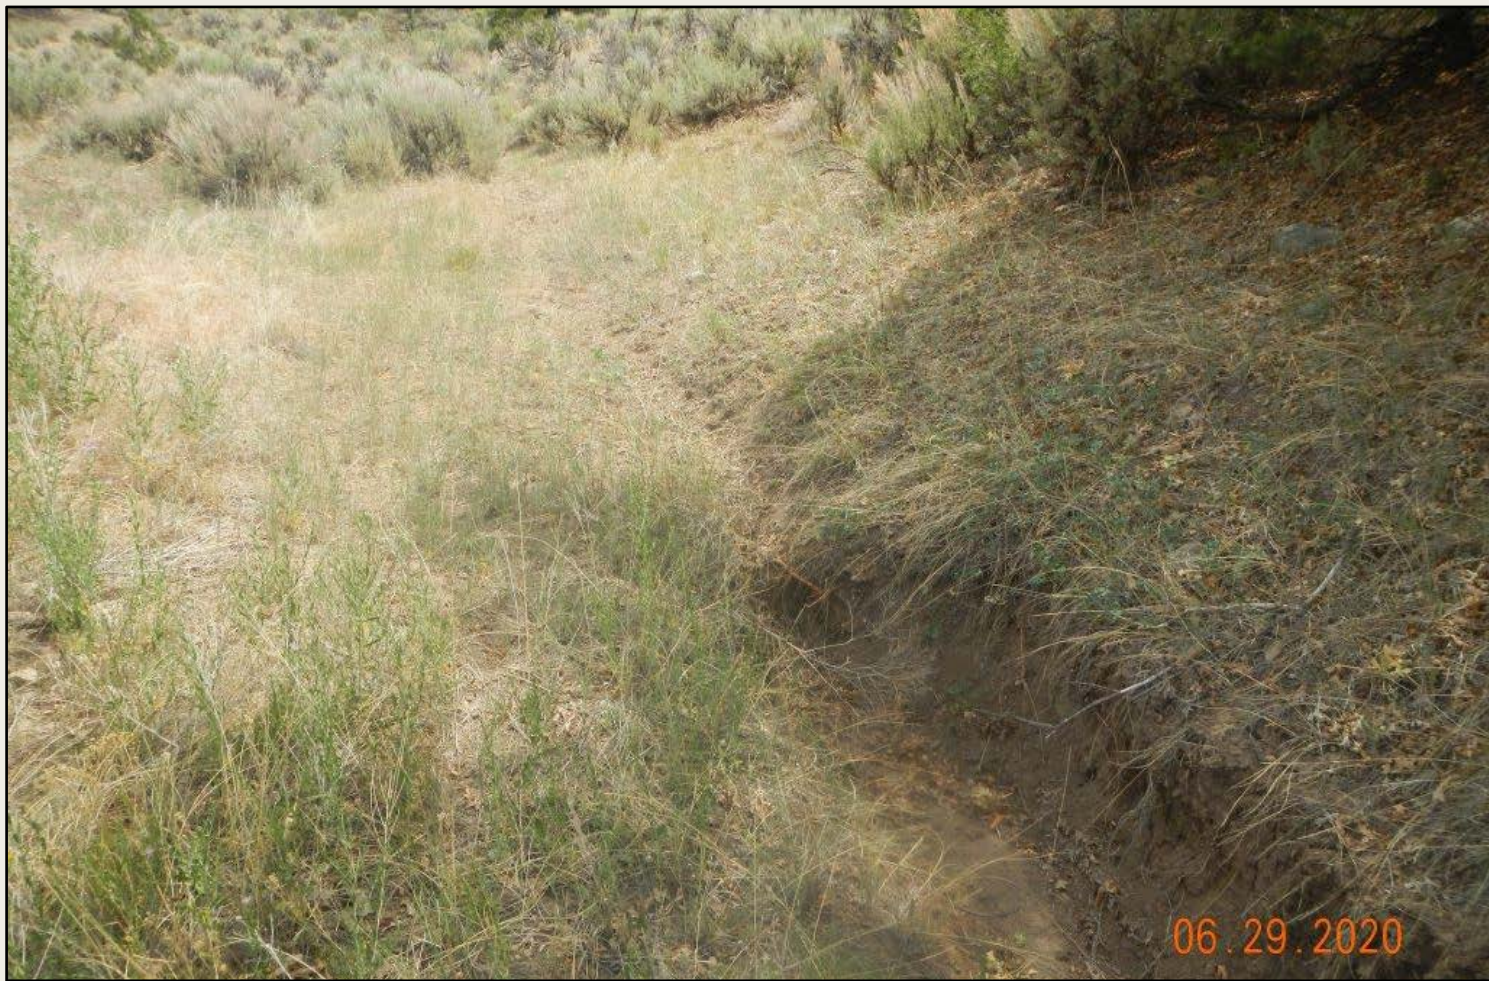
Photo 5. View of erosional headcut, approximately 3 feet wide and 2 feet deep, within the eastern stormwater diversion.

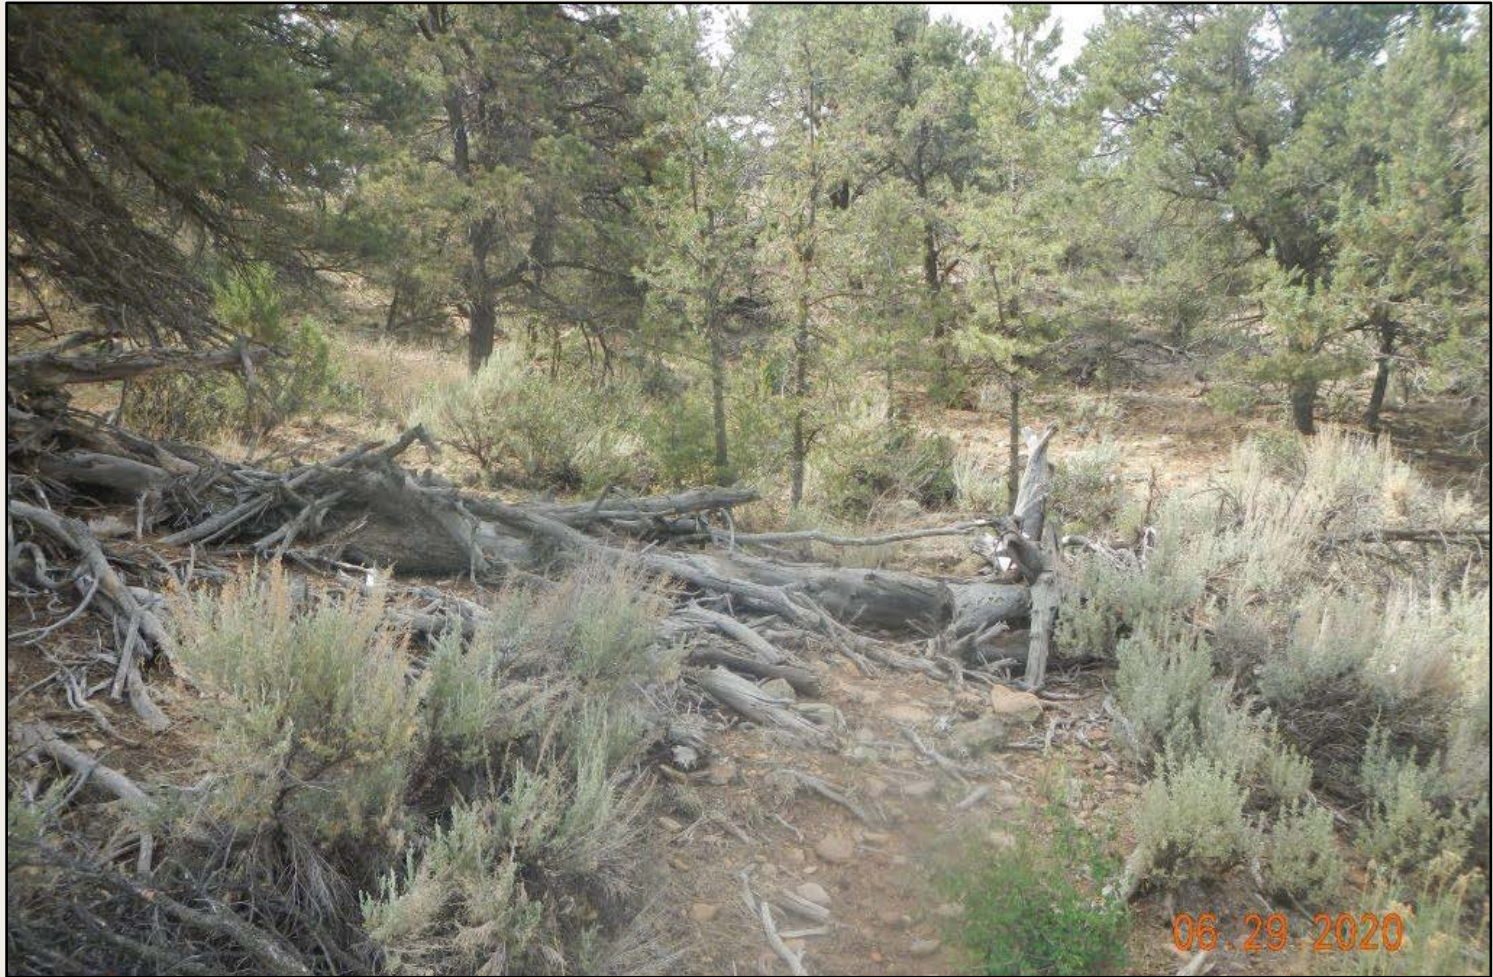
Photo 6. View of the reference area, comprised of pinyon juniper woodland with sagebrush, blue grama, and penstemon in the understory.
