KP Kauffman - COGCC Inspection Photos
Location: Nessu Consolidation OLF Release
Spill ID # 476987 Date 6/29/2020

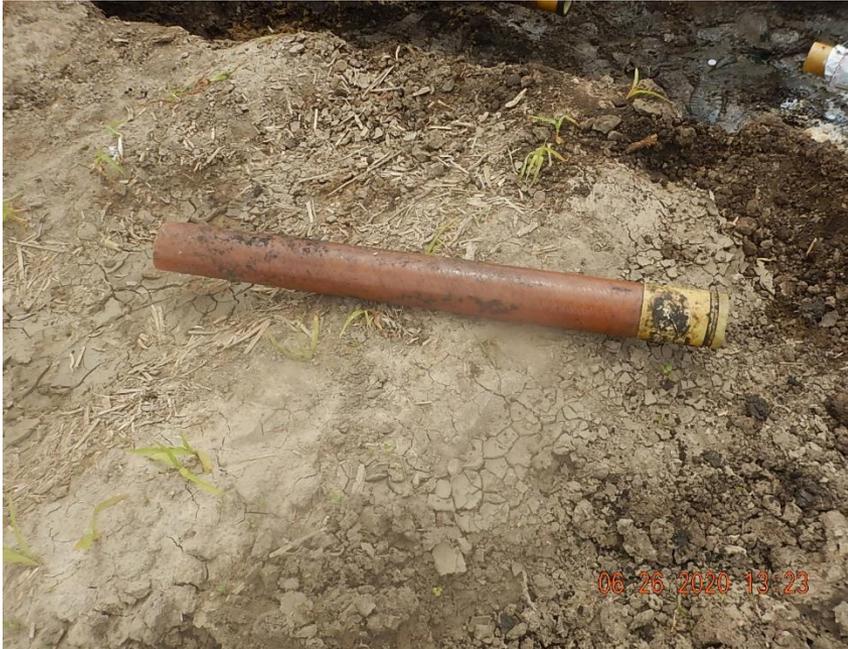
View of failed section of fiberglass pipe and fitting installed as part of repair completed by KPK in response to reportable spill ID #470915 submitted to COGCC on 1/17/2020.

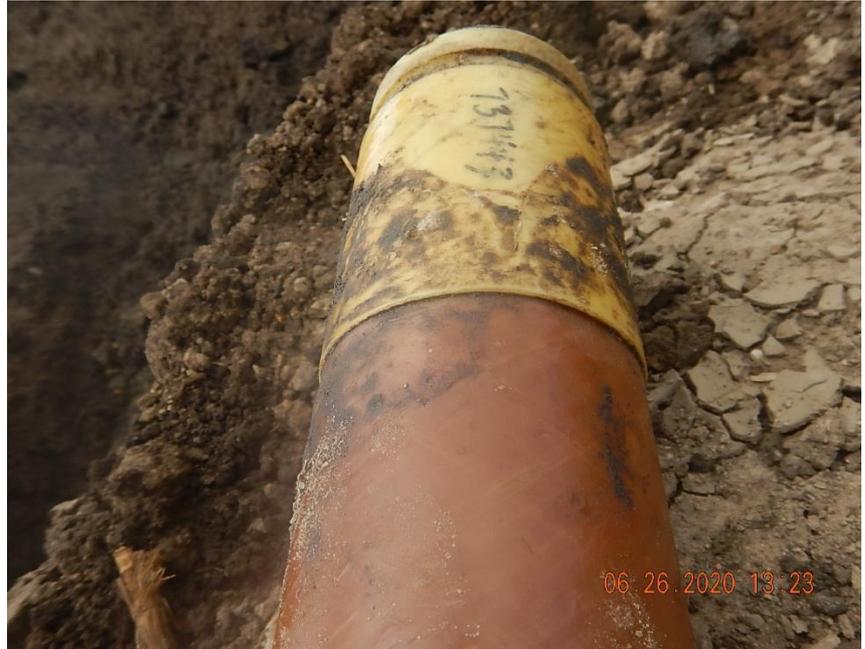
Closer view of fitting on cut end of pipe section; KPK crew informed COGCC Inspector a leak is suspected to have developed between fitting and outside wall of FG pipe. Integrity/ adhesion failure of the prior repair is suspected to have caused second reportable spill (#476987)

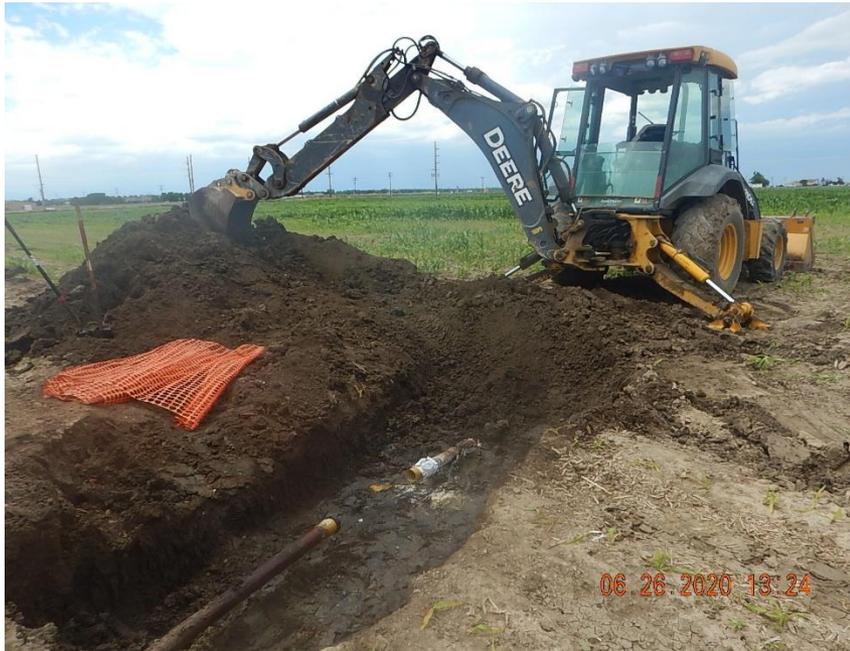
View of excavation and NESSSU Consolidation OLF repair in process of being completed on 6/26/2020. Looking North.

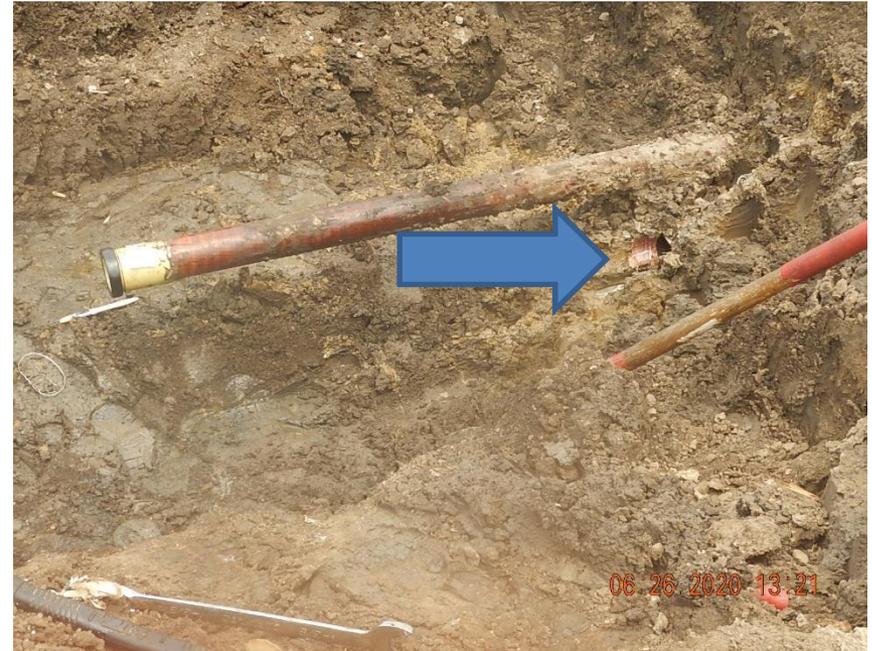
Close up view of South wall of excavation at Spill ID # 476987 with flowlines exposed; cut end of a second 3" fiberglass flowline can be seen between pipe stub and shovel handle. Date 6/26/2020.

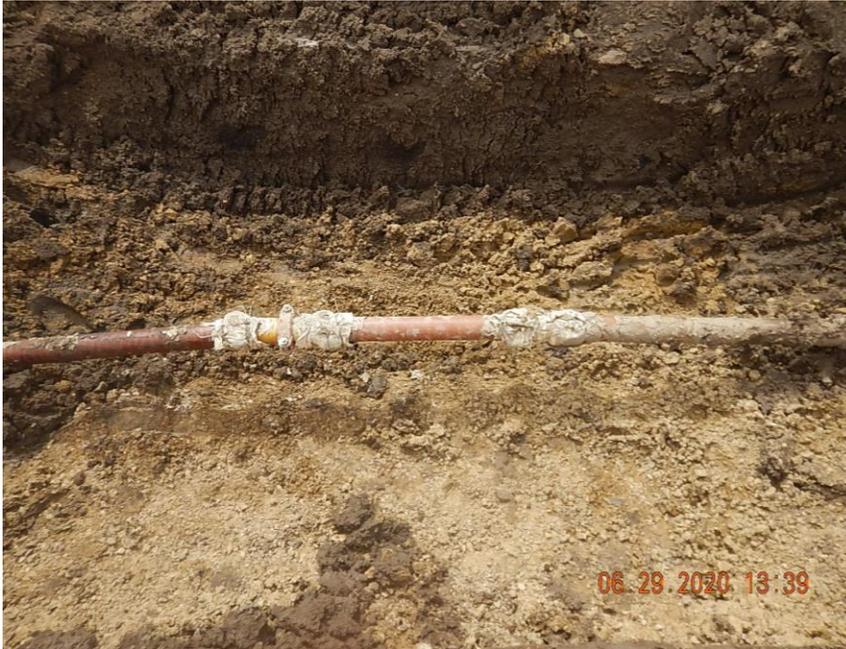
Repair completed to Nesssu Consolidation OLF; a bolted clamp has been used as part of the flowline repair.

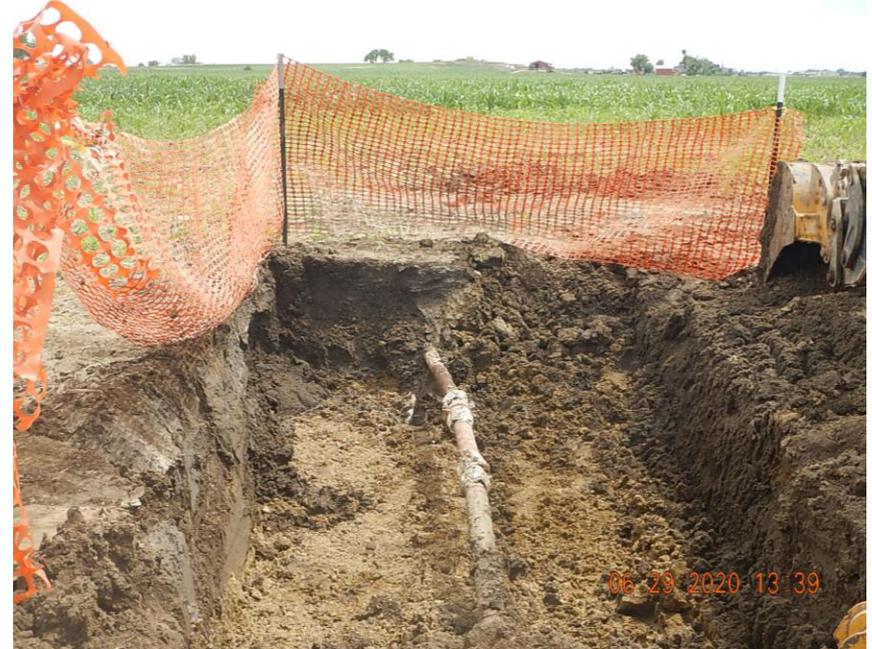
View of repair completed to Nesssu Consolidation OLF; looking South. A bend can be seen in the repaired section of flowline; cut ends and repair stub section do not appear to align. Date 6/29/2020.
