February 18, 2016

Inspection Photos USDEPE/077-06795

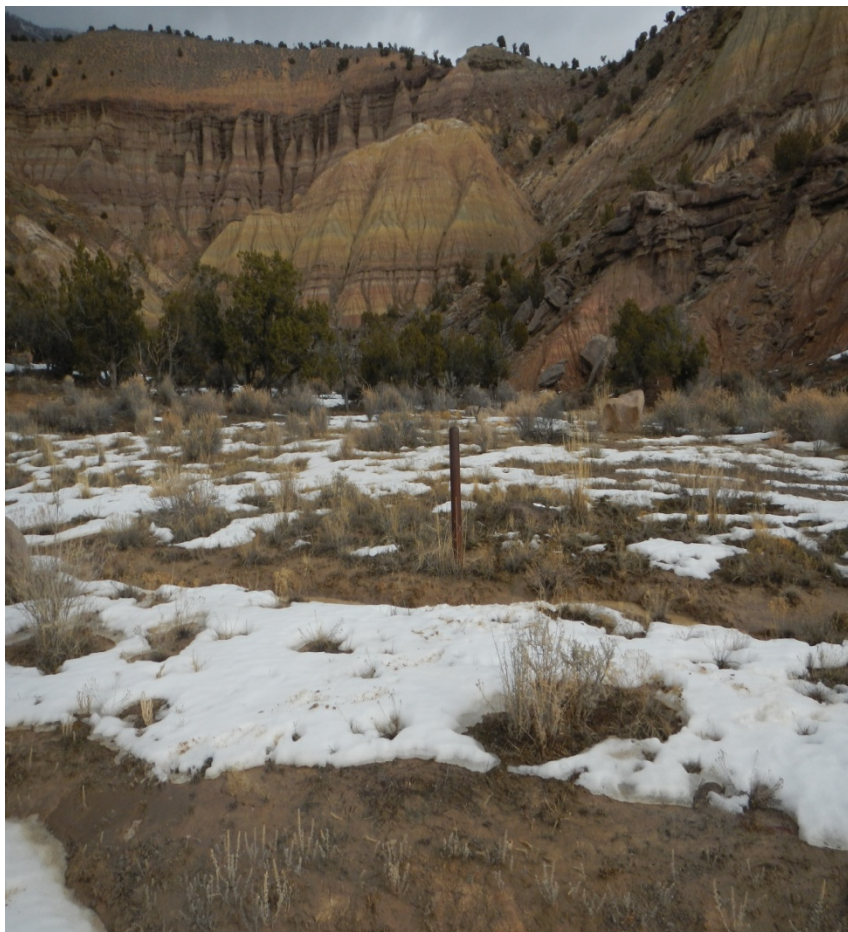
Photo#1:
Overview of Location to North

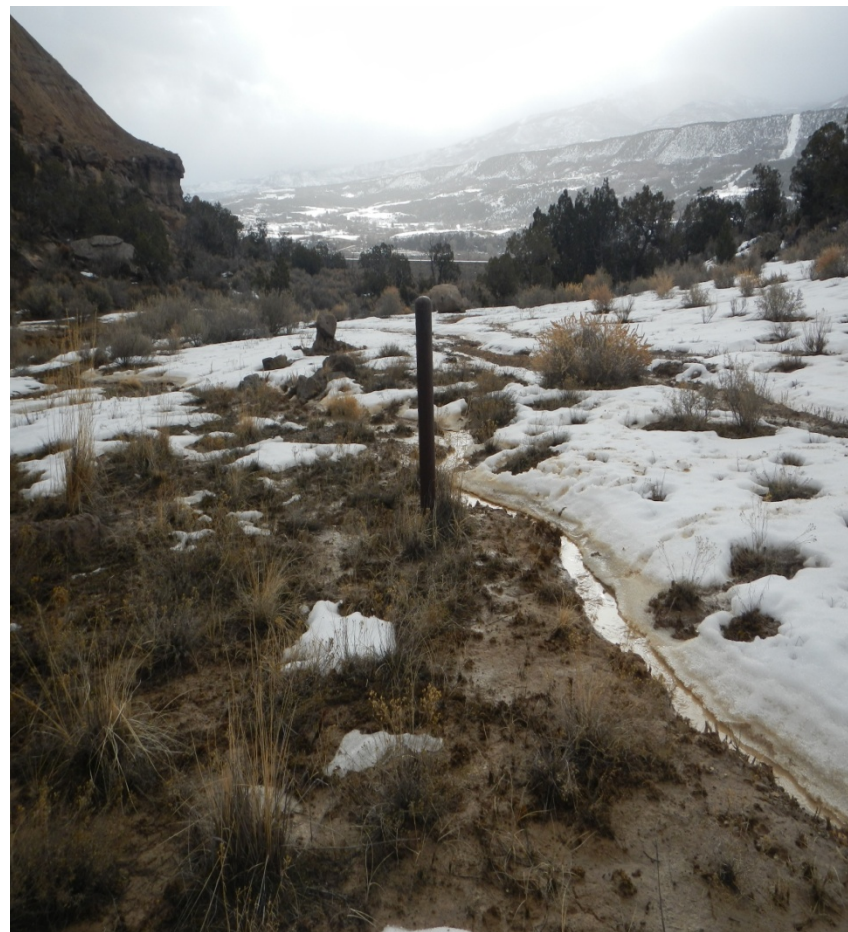
Photo#2:
Overview of Location to East

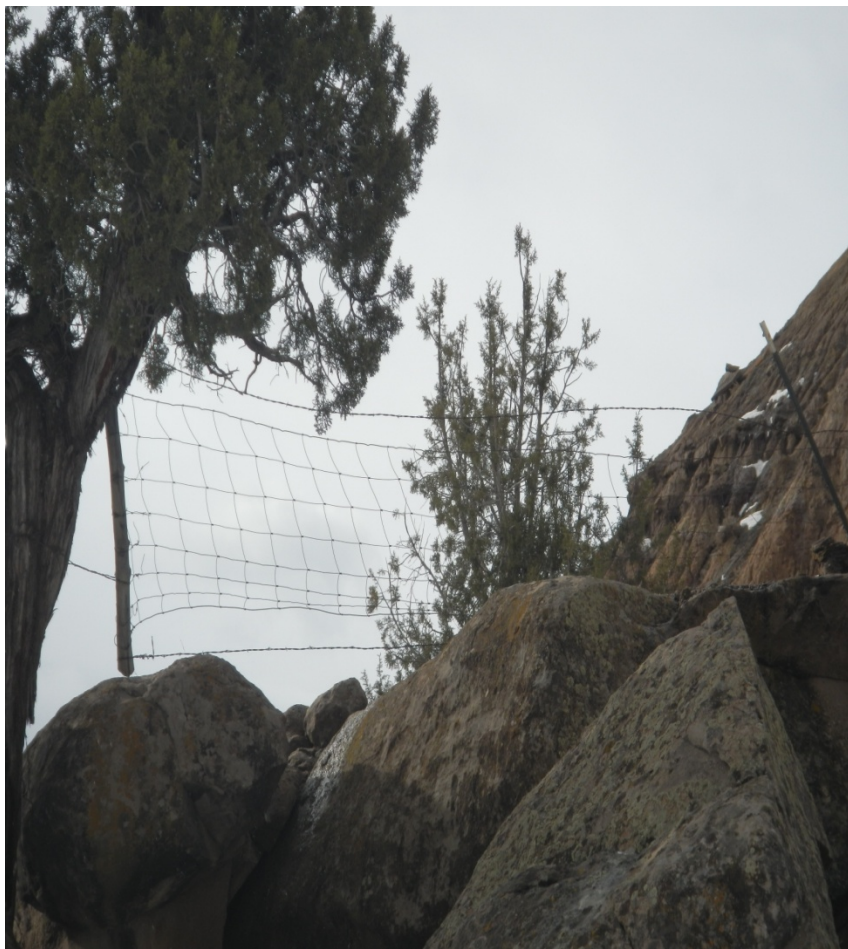
Photo#3:

Point where Net fencing begins at SE corner of Location.

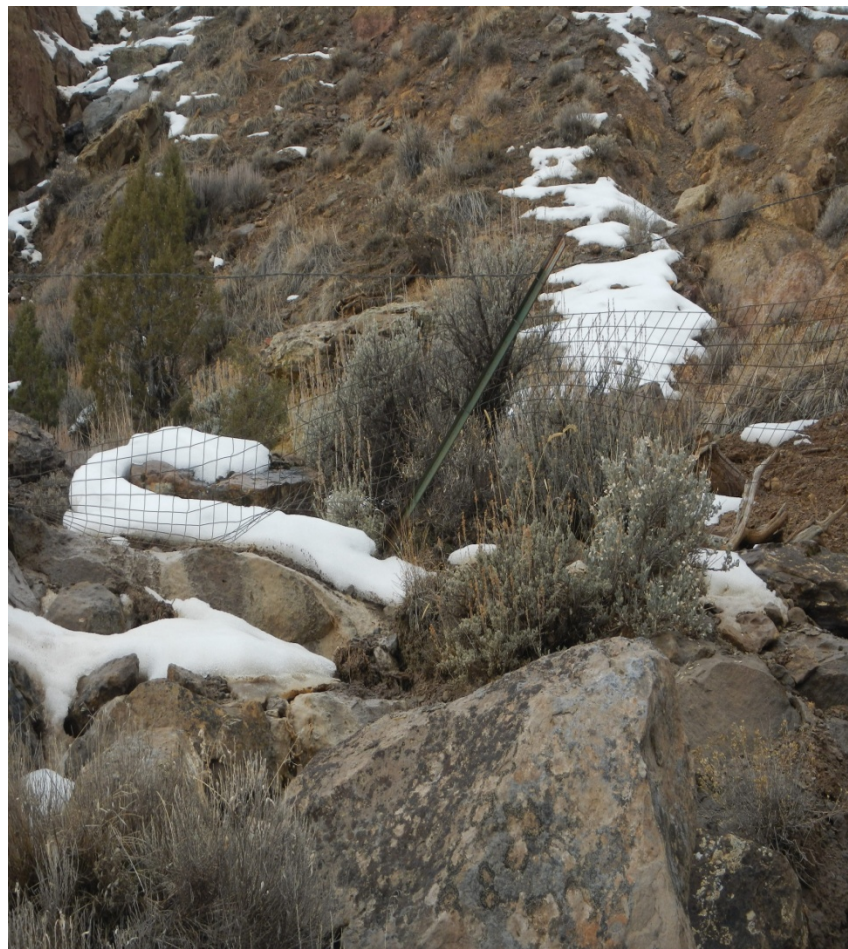
Photo#4:

Net Fencing encircles Location on three Sides.

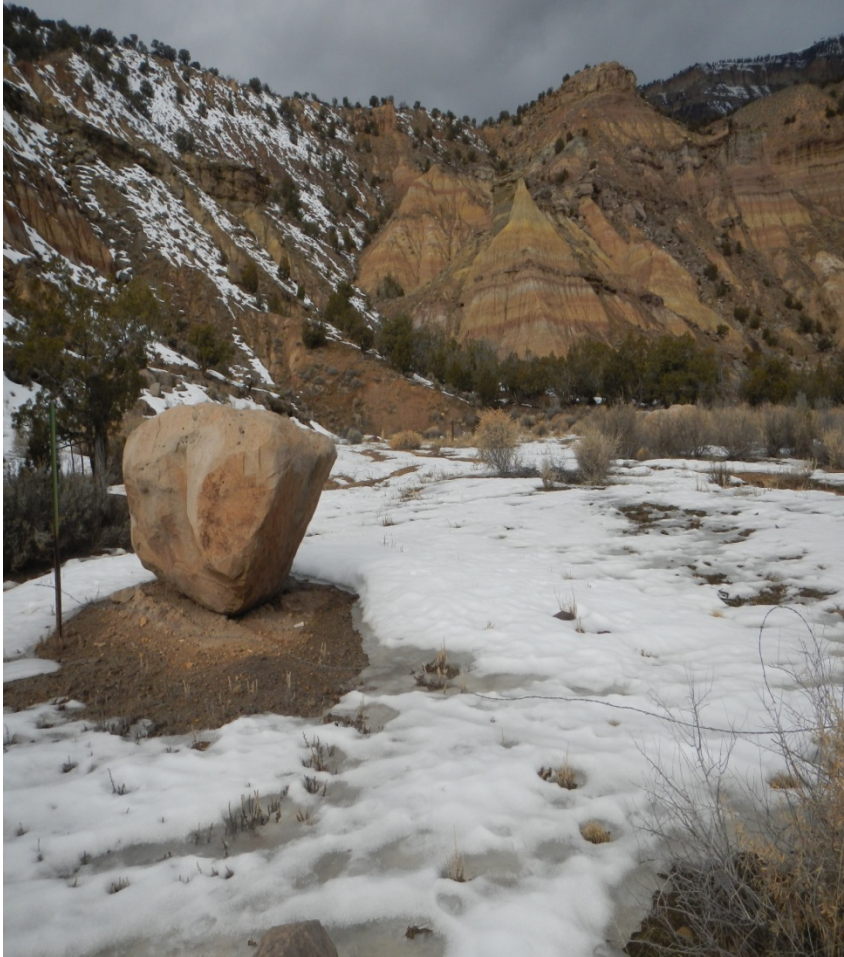
Photo#5:

Entrance to Location, downed Barbed wire fence.

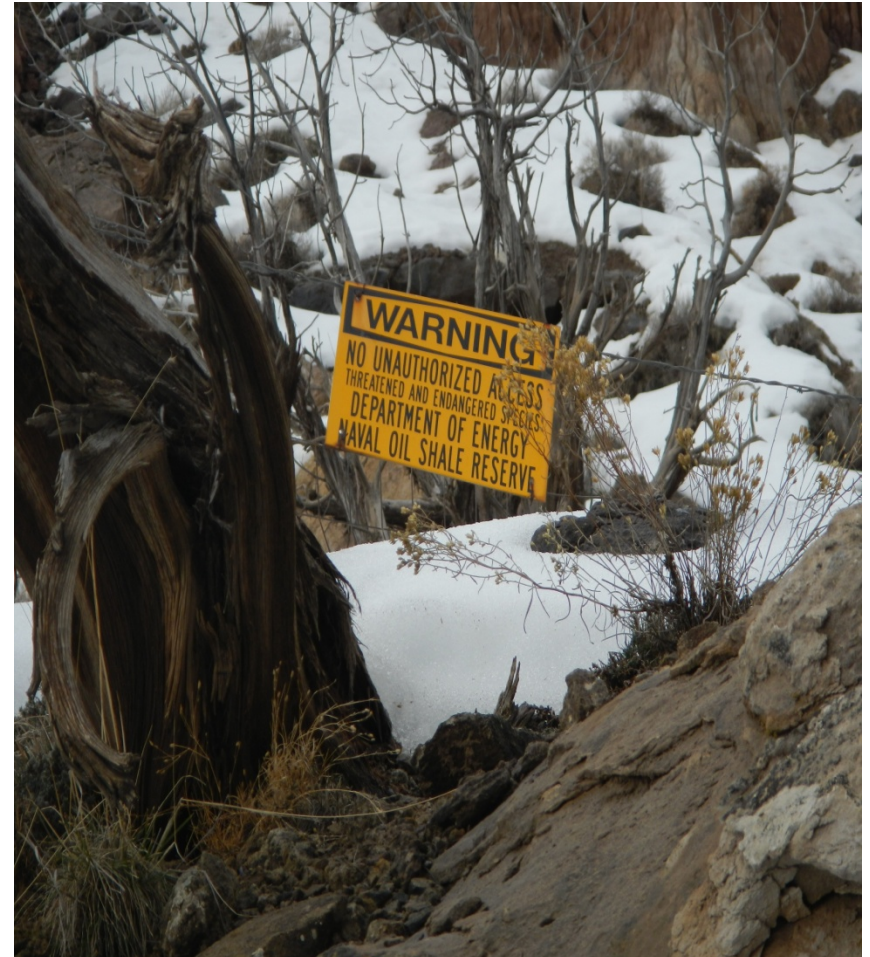
Photo#6:

Lease Location Sign.

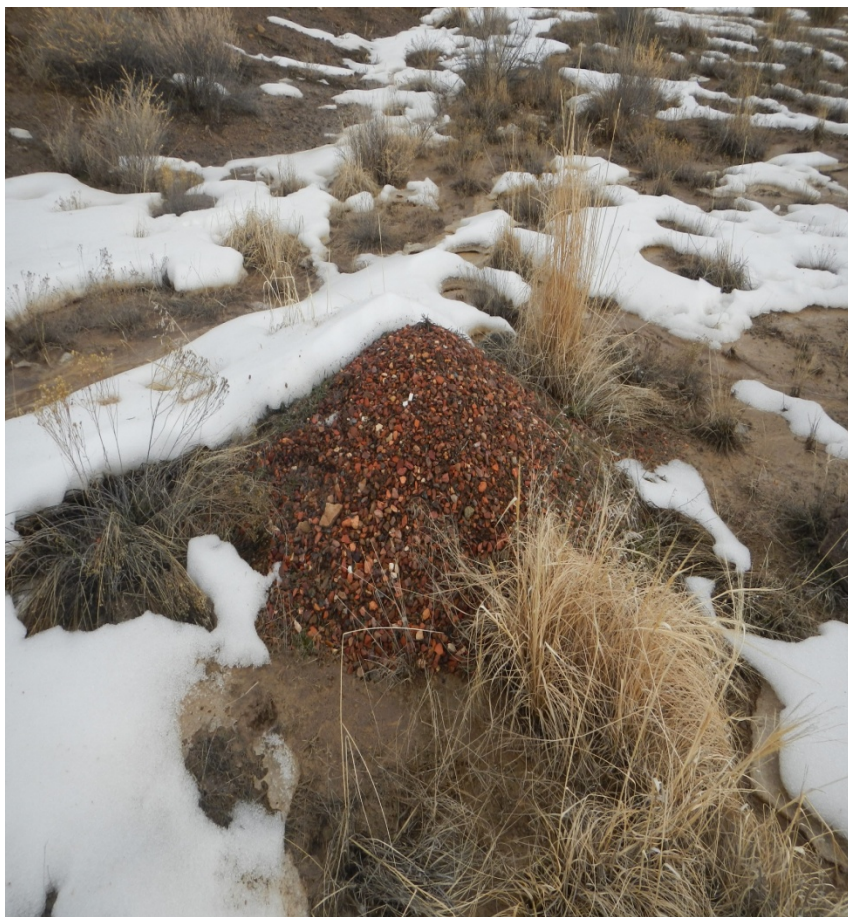
Photo#7:

Small Gravel pile on Location.

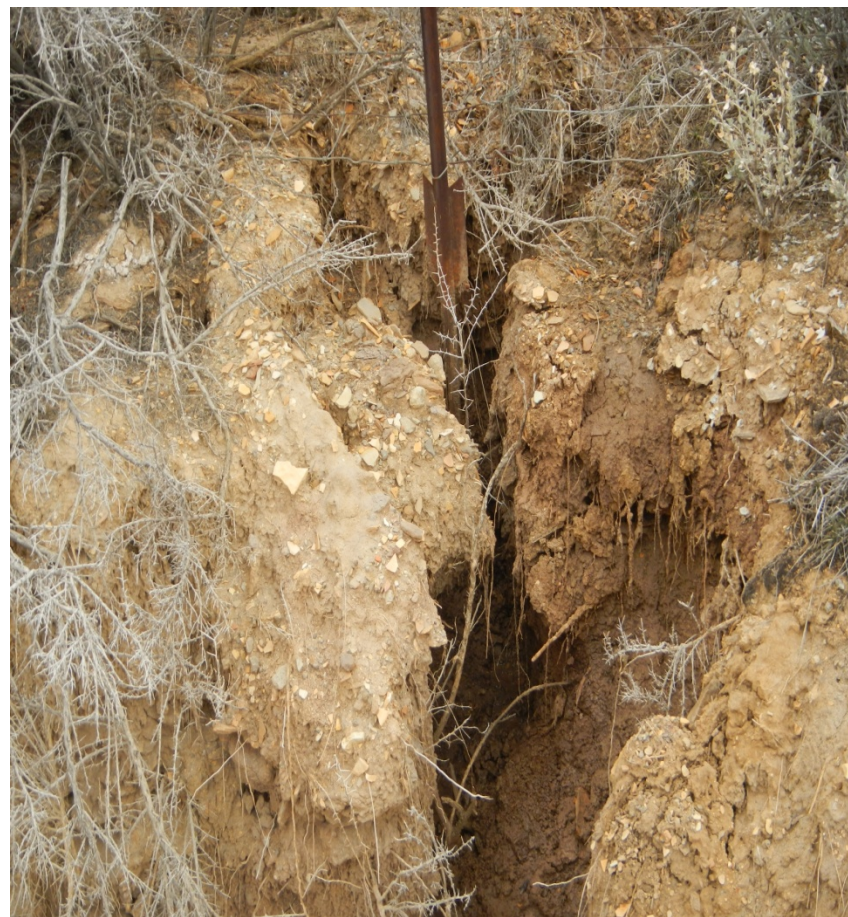
Photo#8:

Erosion, Run on at Fence disturbance site.

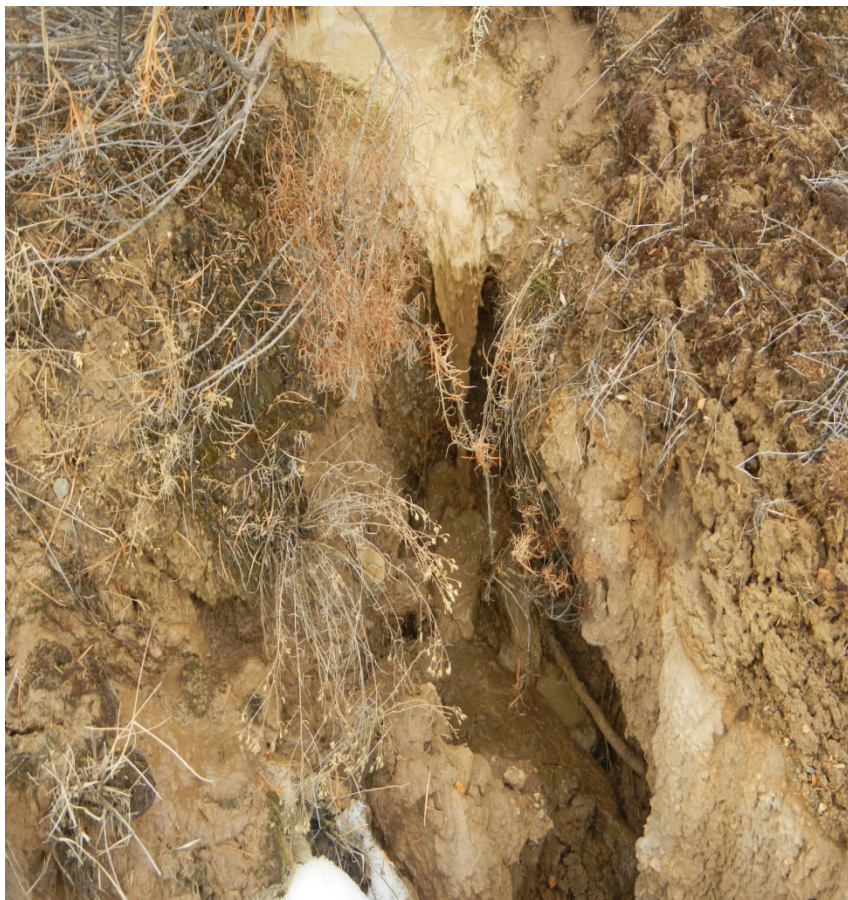
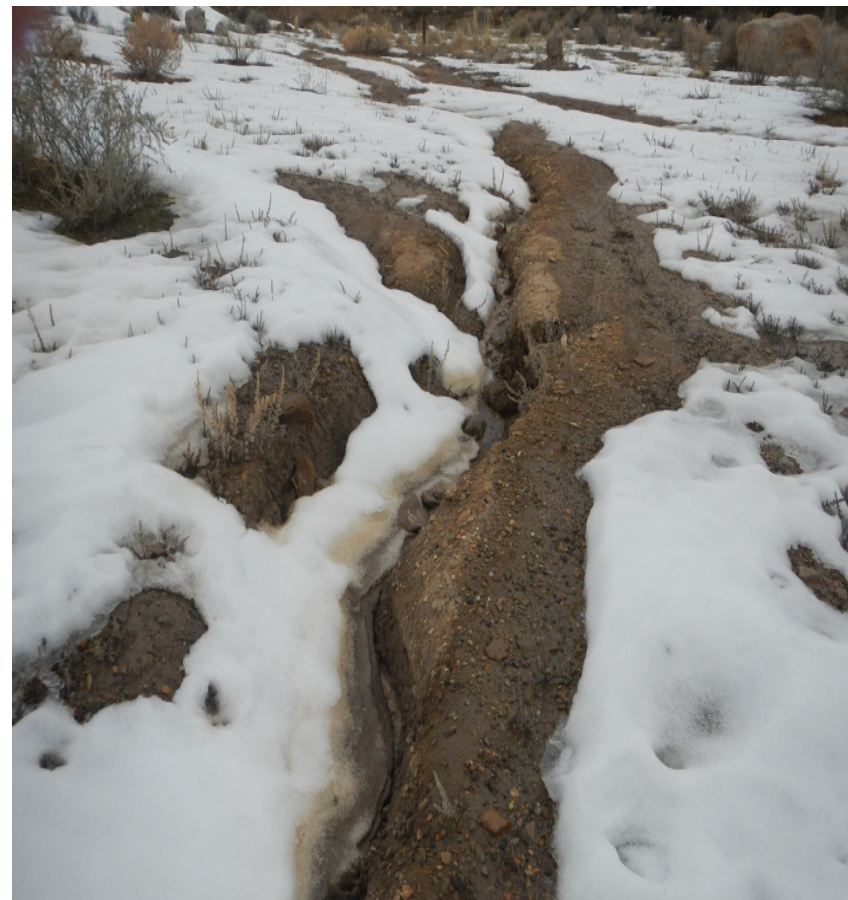
Run Off from Location causing Erosion Channels

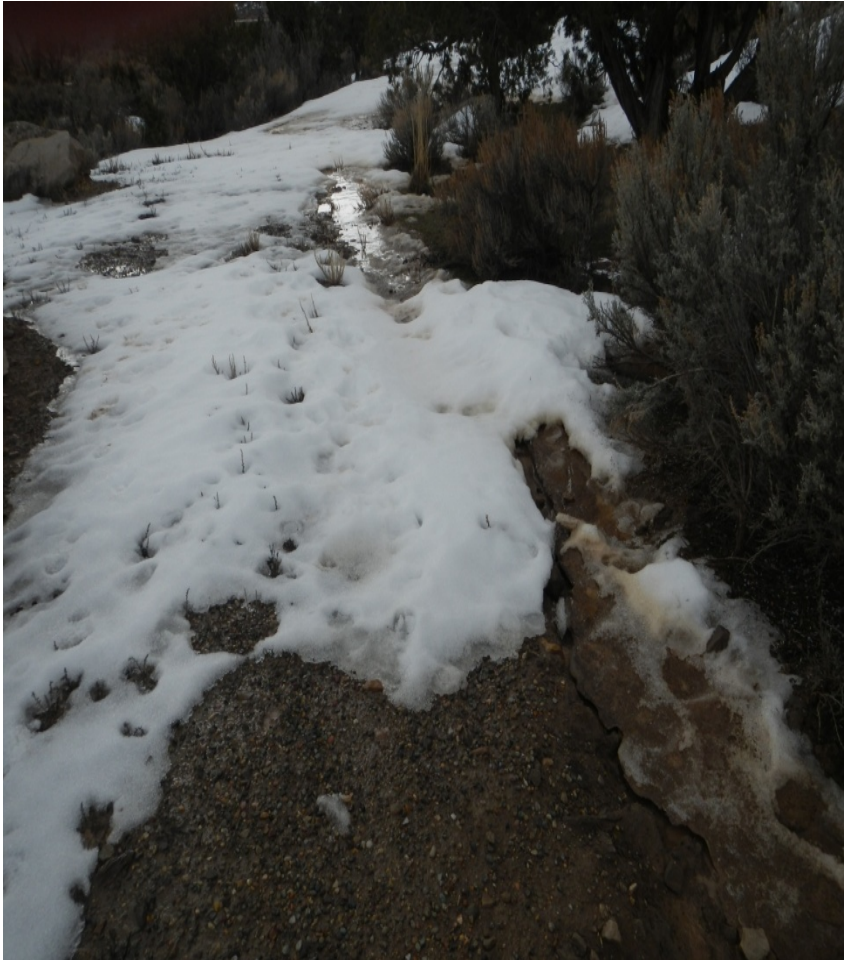
Photo#11:

Un Reclaimed Access Road leading out of Location to SE .

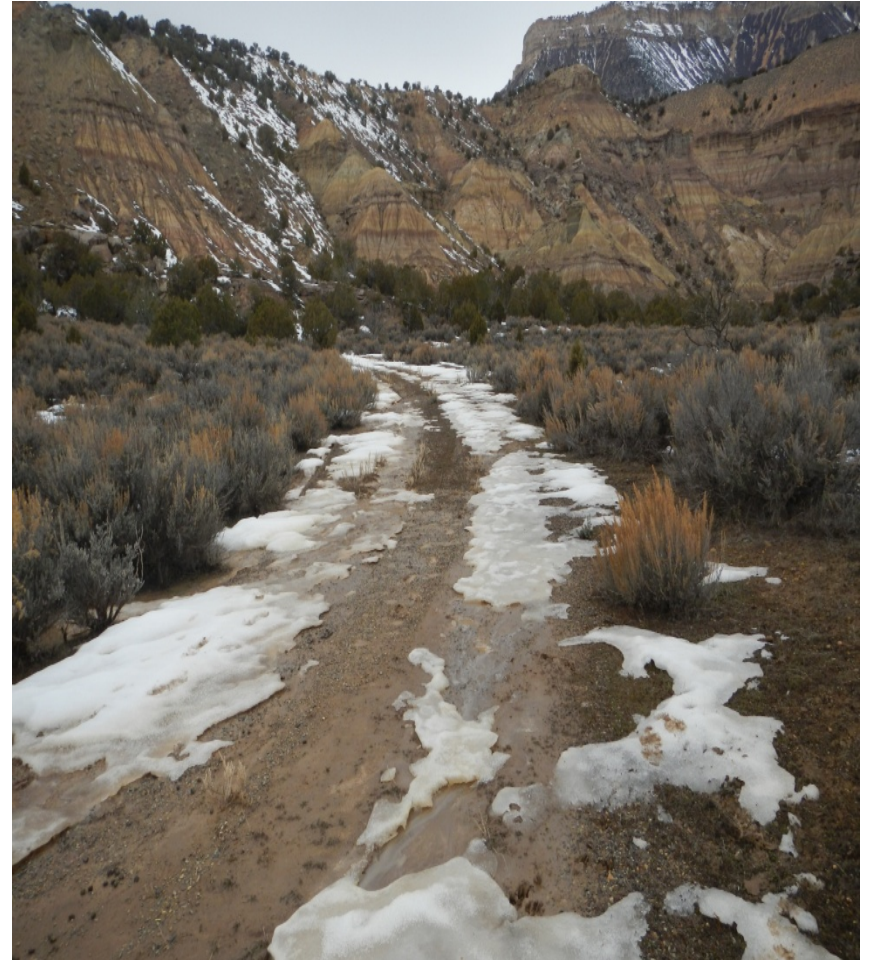
Photo#12:

Access Road into Location , View NW.
