Inspection Photos

API: 055-06101

Operator: MANZANO LLC

Inspection Date: 7/8/2020

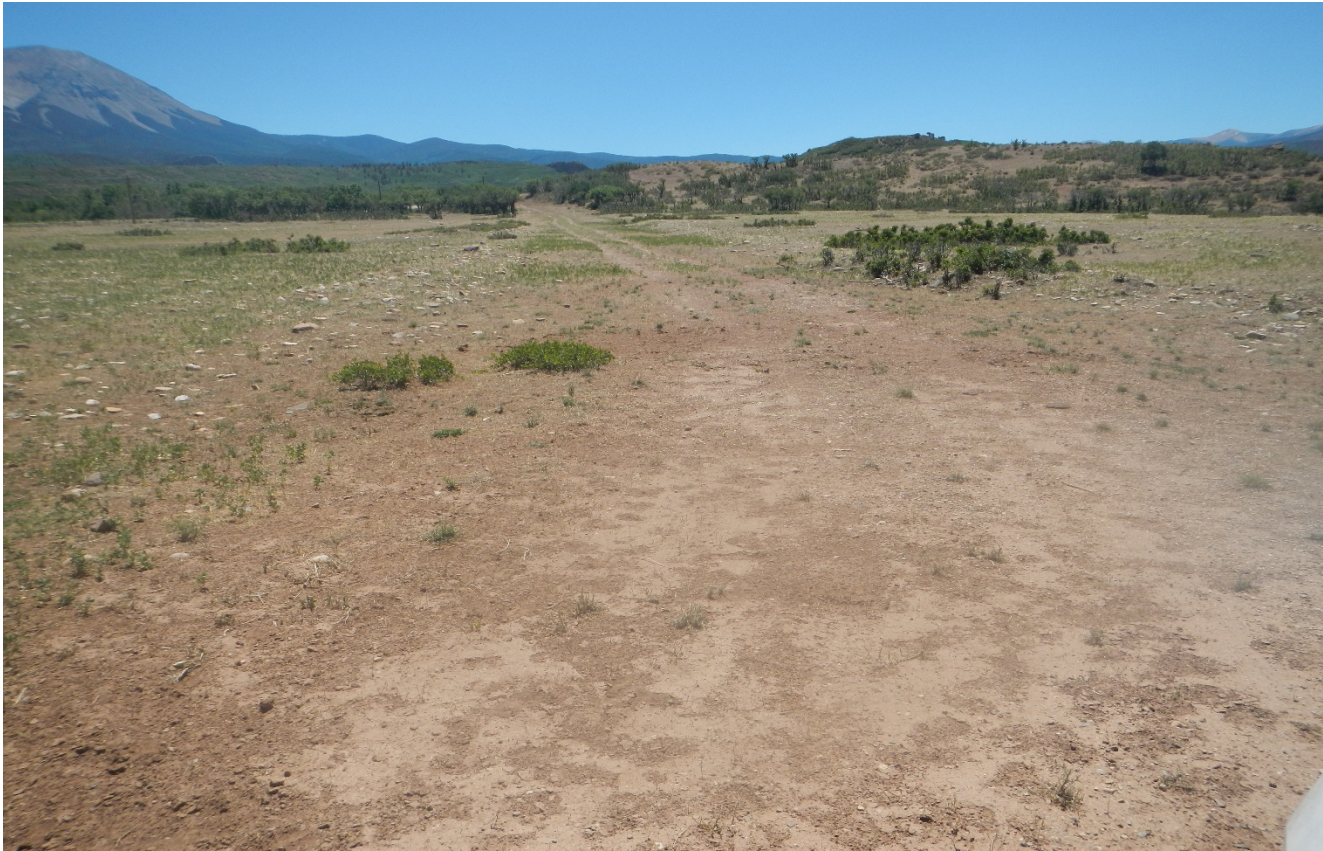
Photo 1. Facing south along the access road, which has not been reclaimed.

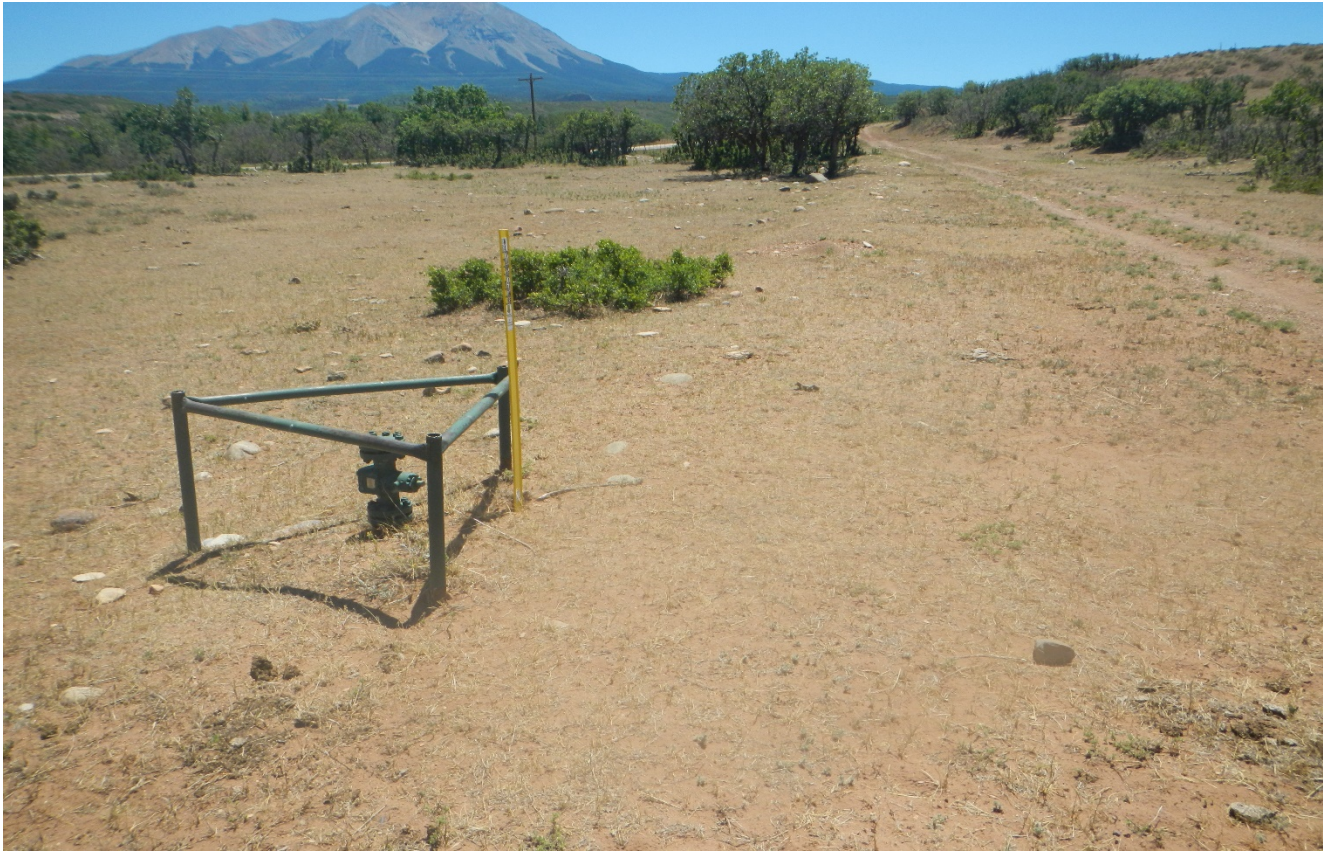
Photo 2. There is a pipe riser that remains along the access road. Approximate Lat/Long:37.473,-105.024.

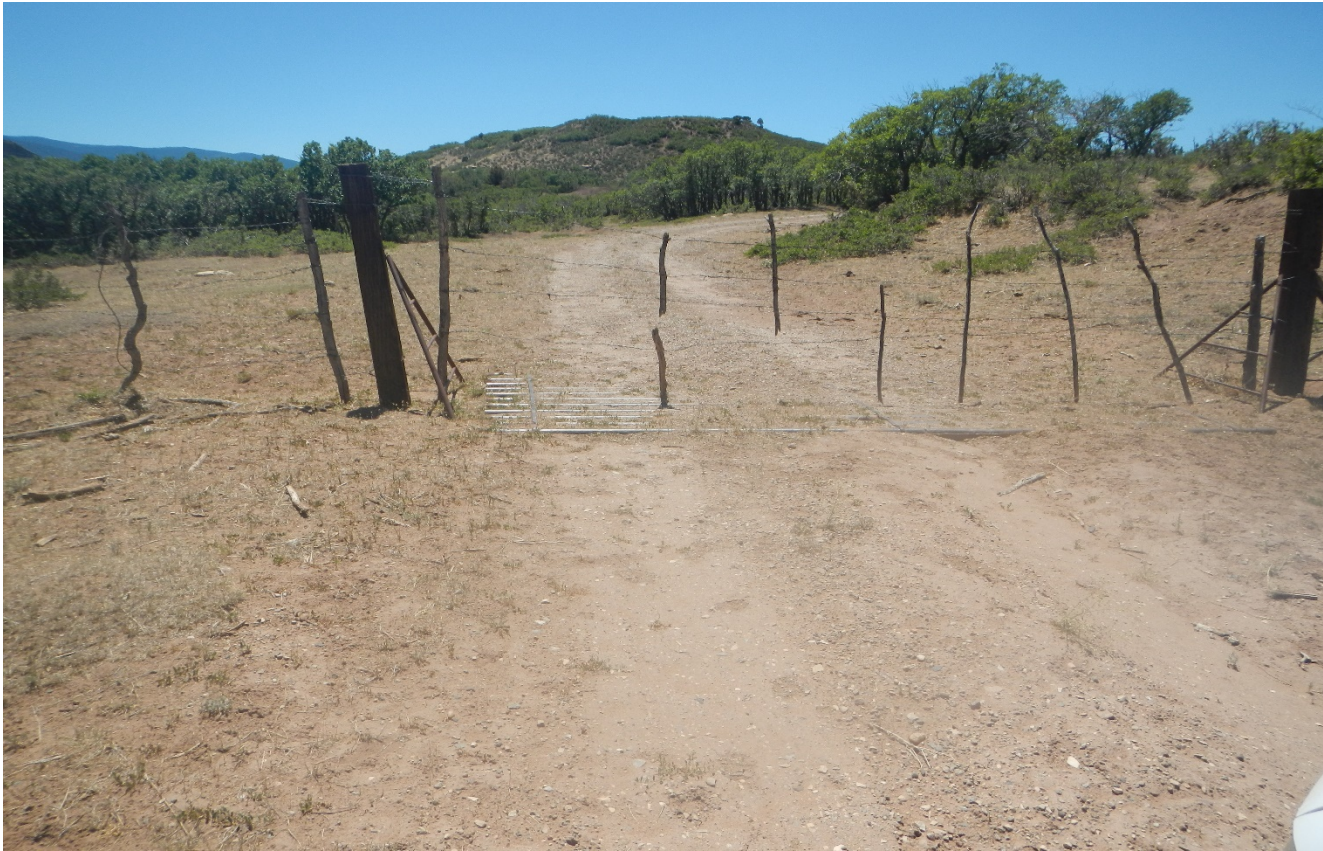
Photo 3. Facing south along the access road. The cattle guard remains and is filled in with sediment.

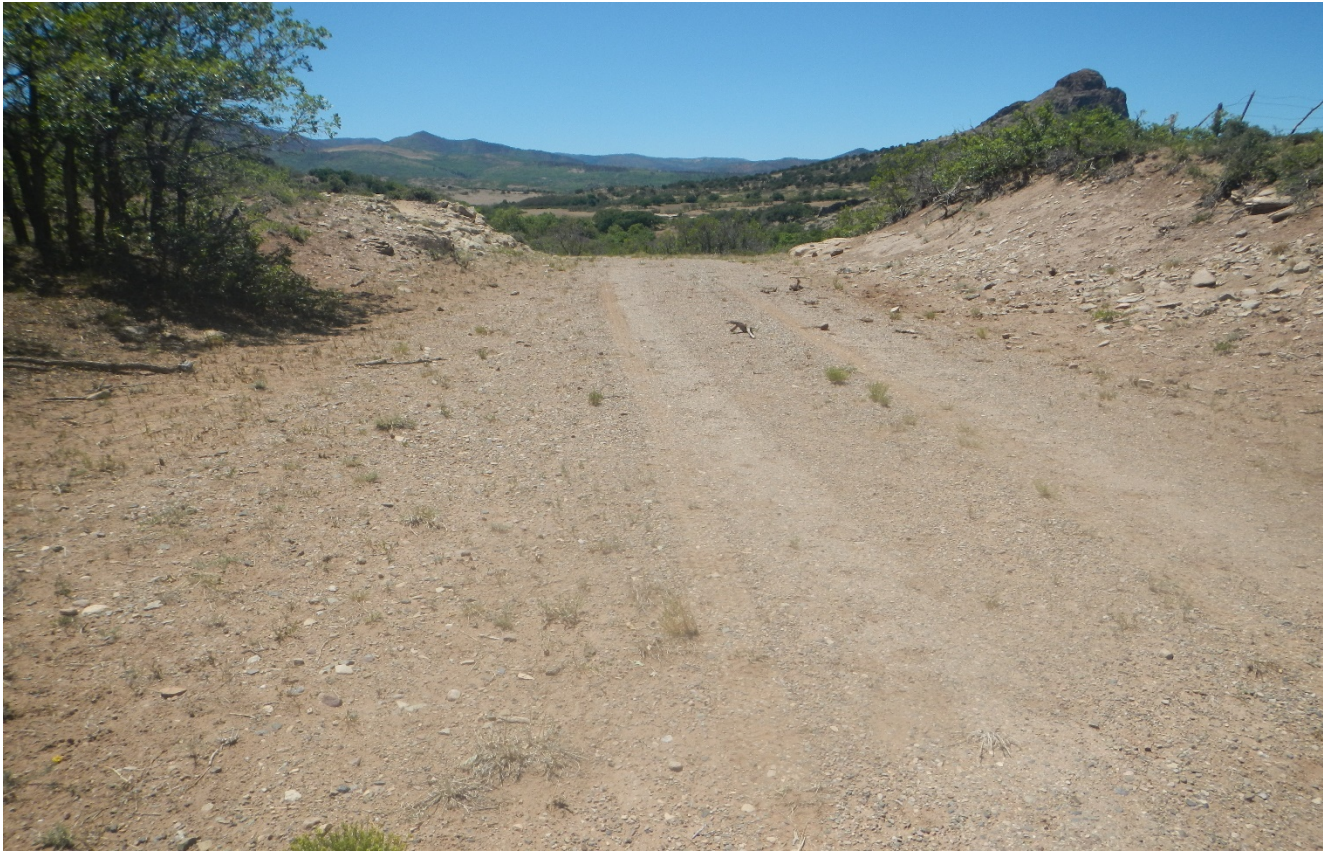
Photo 4. Facing south along the access road. Access road has not been recontoured and reclaimed.

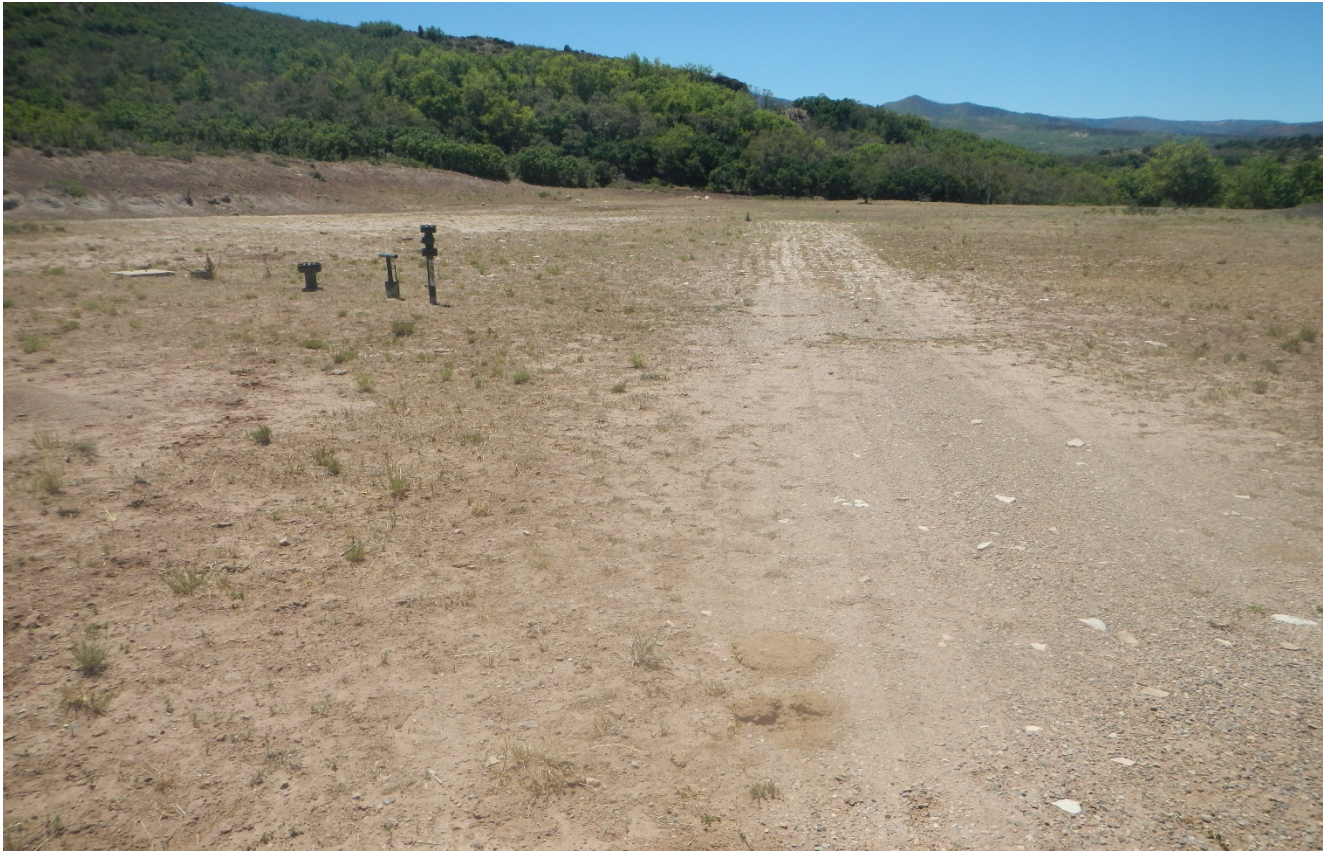
Photo 5. Facing southwest toward the location. The location has not been recontoured and reclaimed.

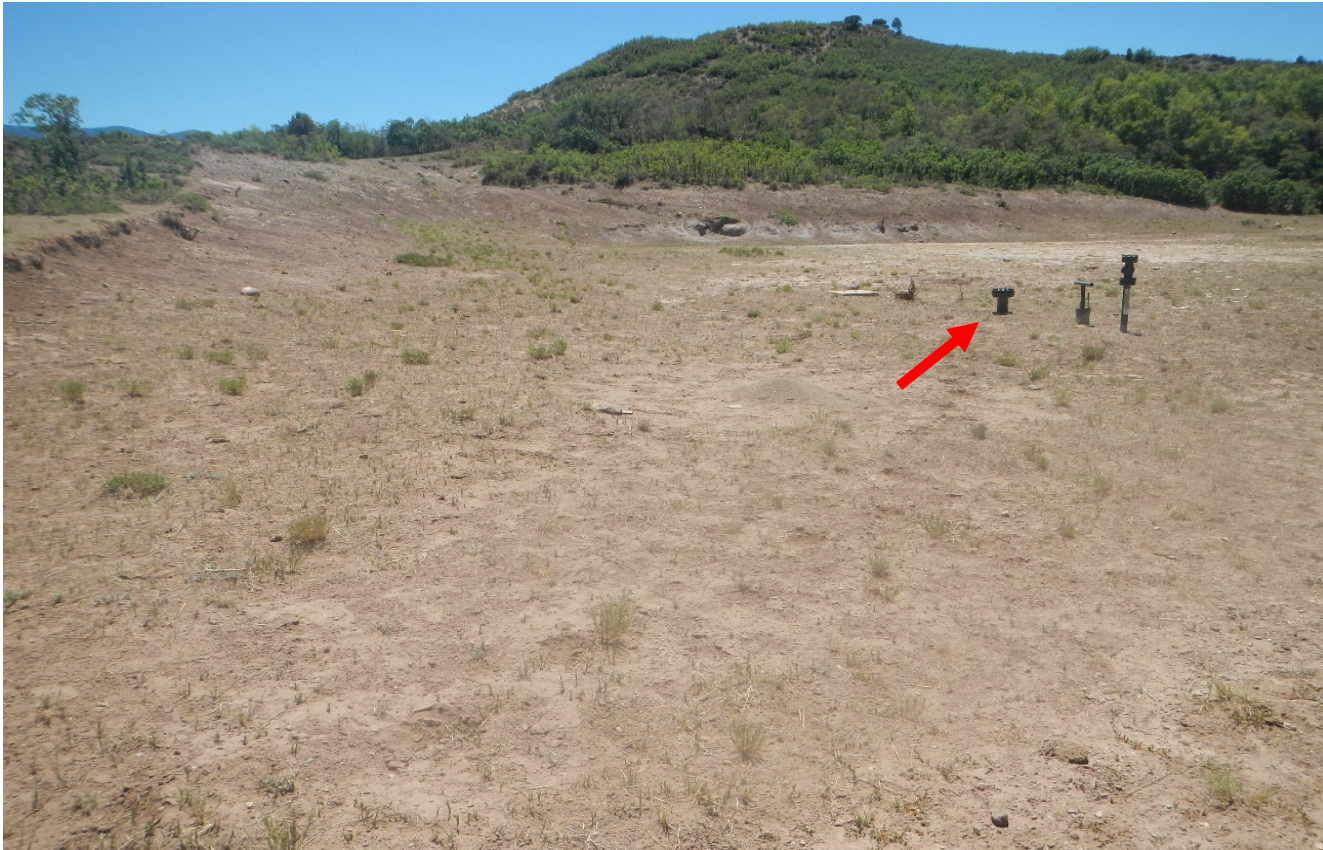
Photo 6. Facing south toward eastern side of the location. There is pipe risers and equipment that remain shown at red arrow.

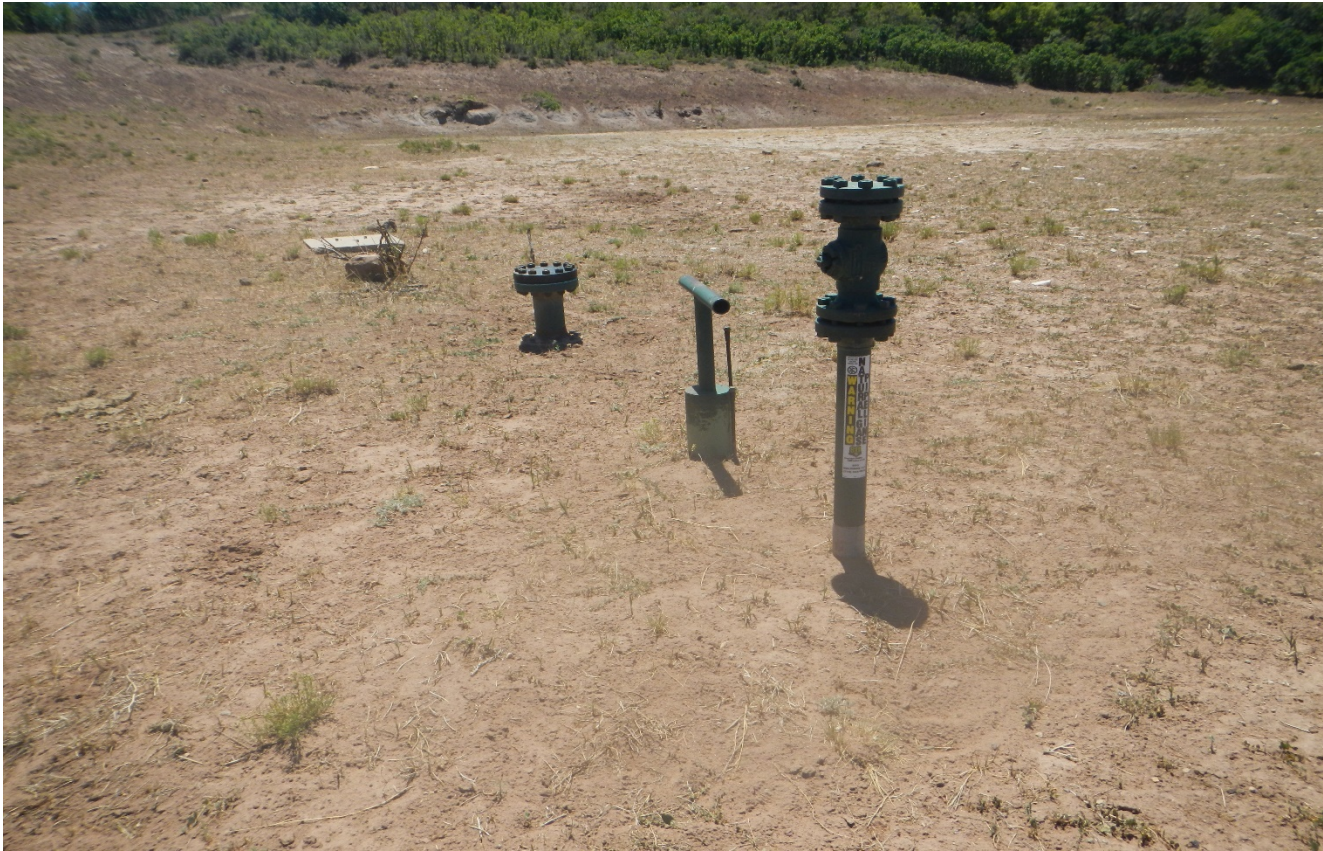
Photo 7. There are pipe risers and a cement base that remain.

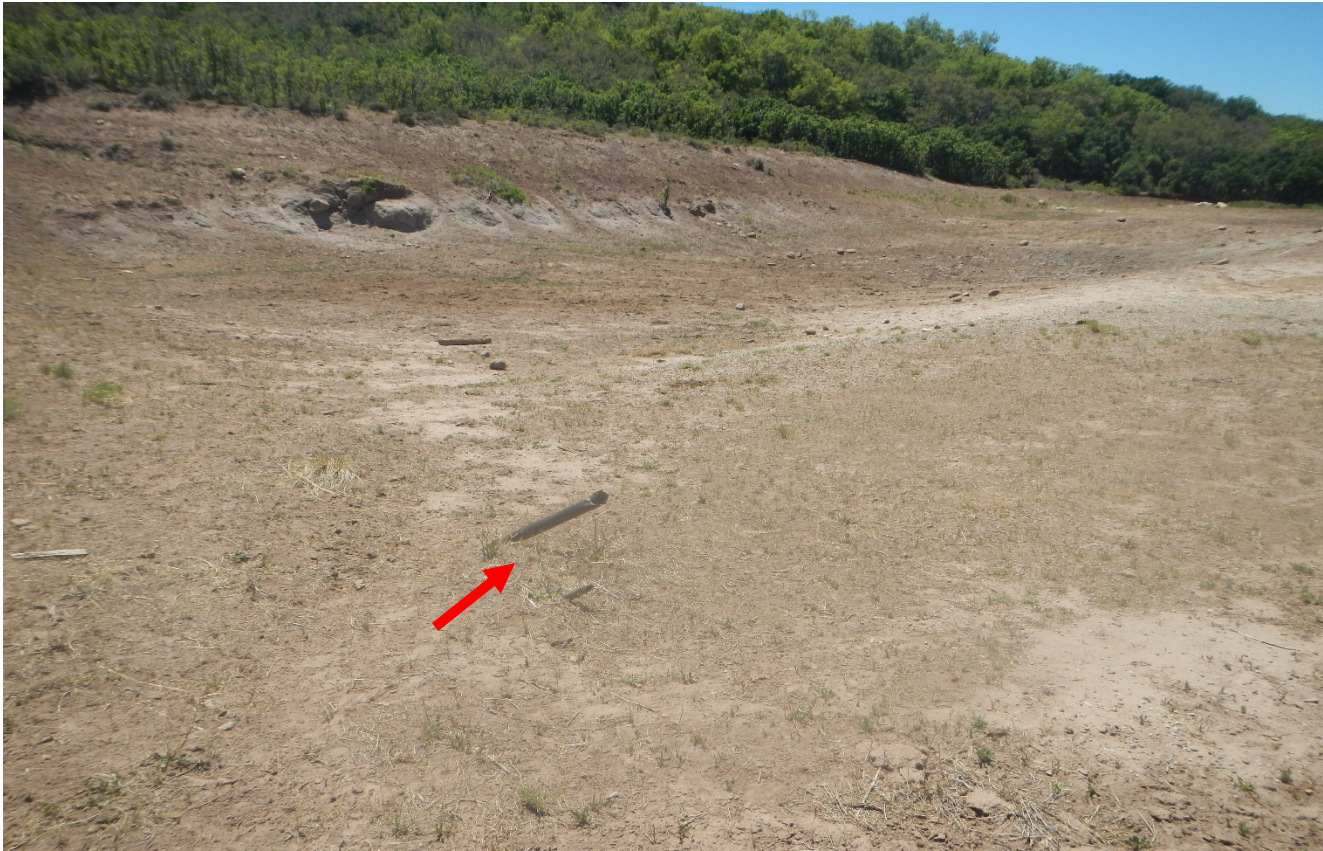
Photo 8. Facing southwest toward the cut slope. There is a shallow depression which appears to be where a pit was located. There is a black plastic pipe extending out of the surface shown at red arrow.

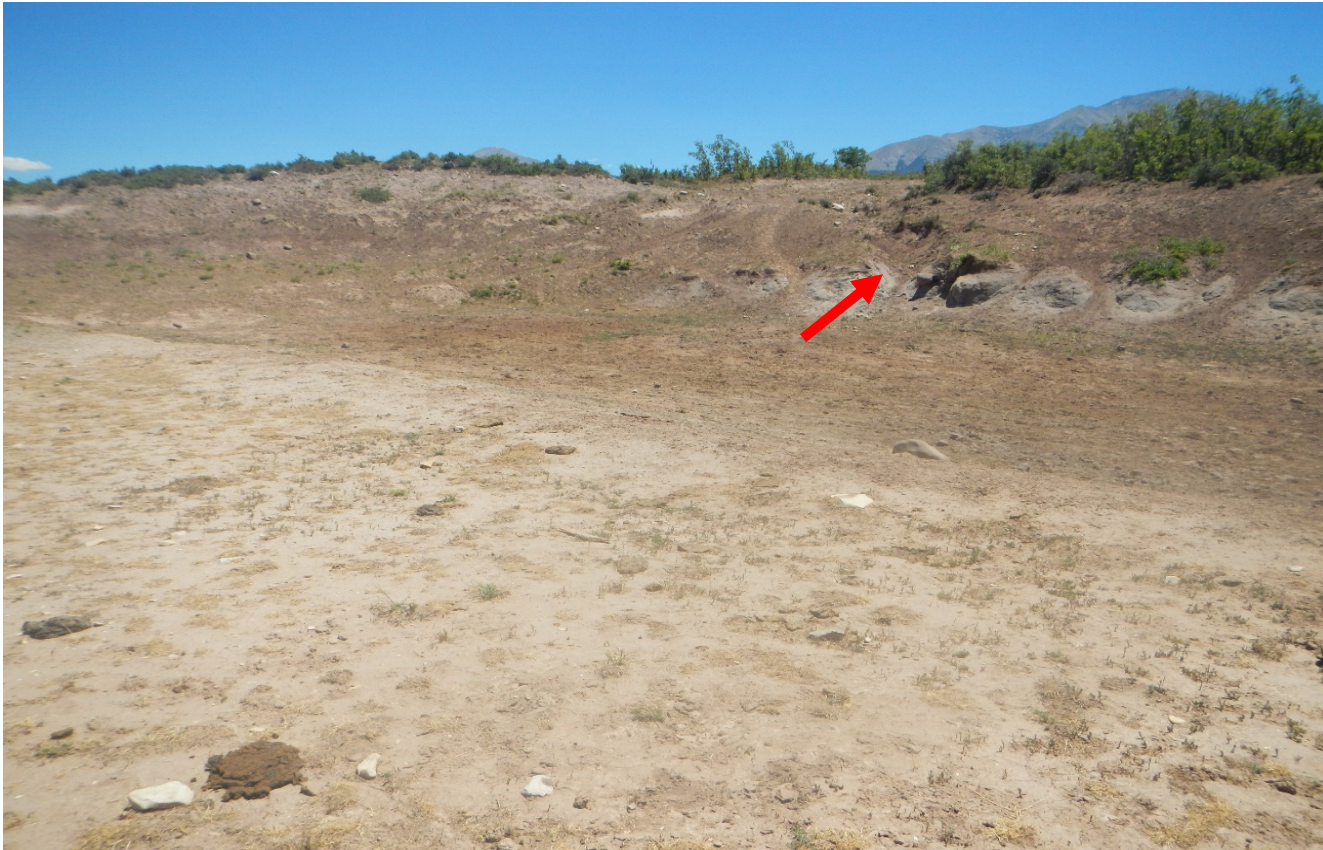
Photo 9. Facing southeast toward the cut slope of the location which is approximately 30 ft. height. Red arrow points to an erosion channel at the cut slope.

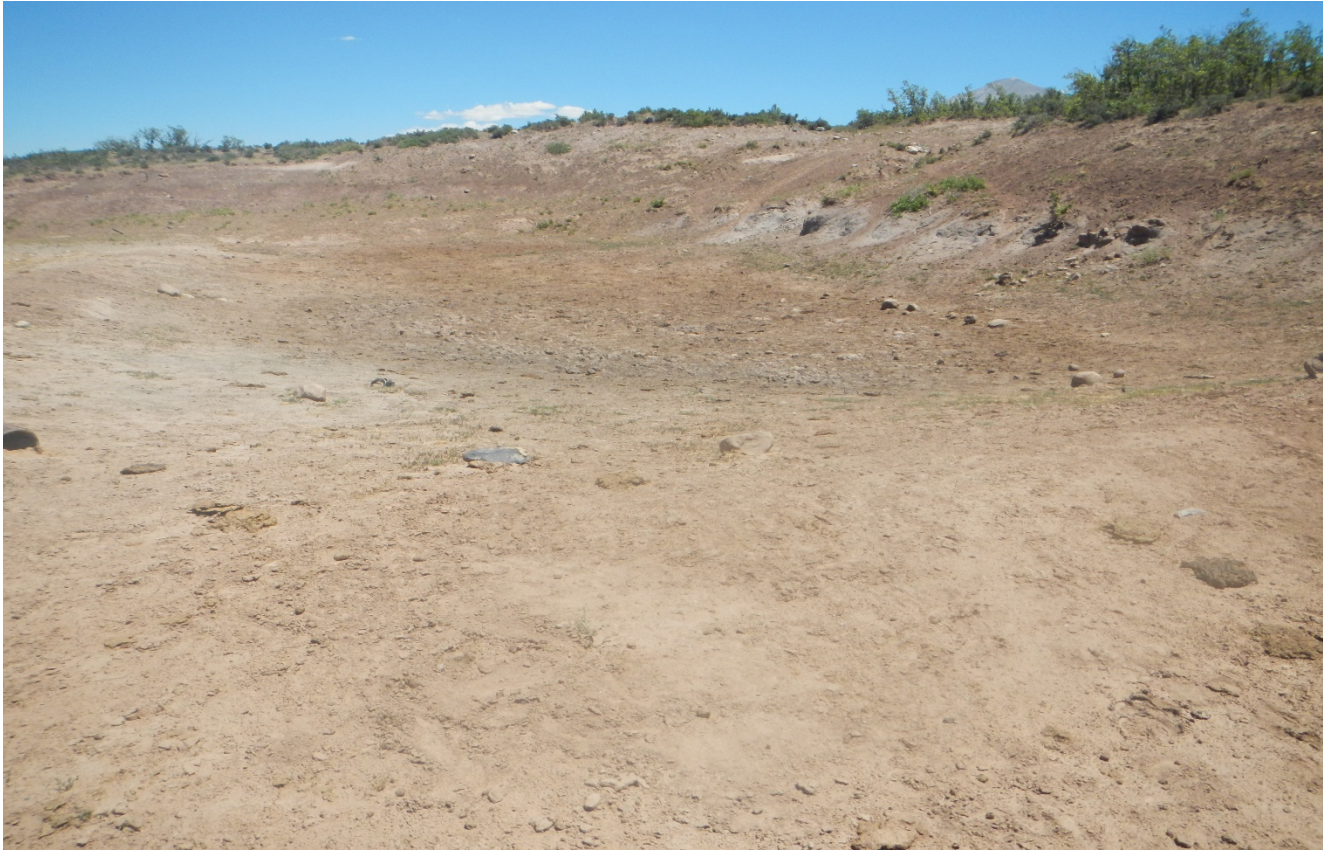
Photo 10. Facing southwest toward shallow depression which appears to be where a pit was located.

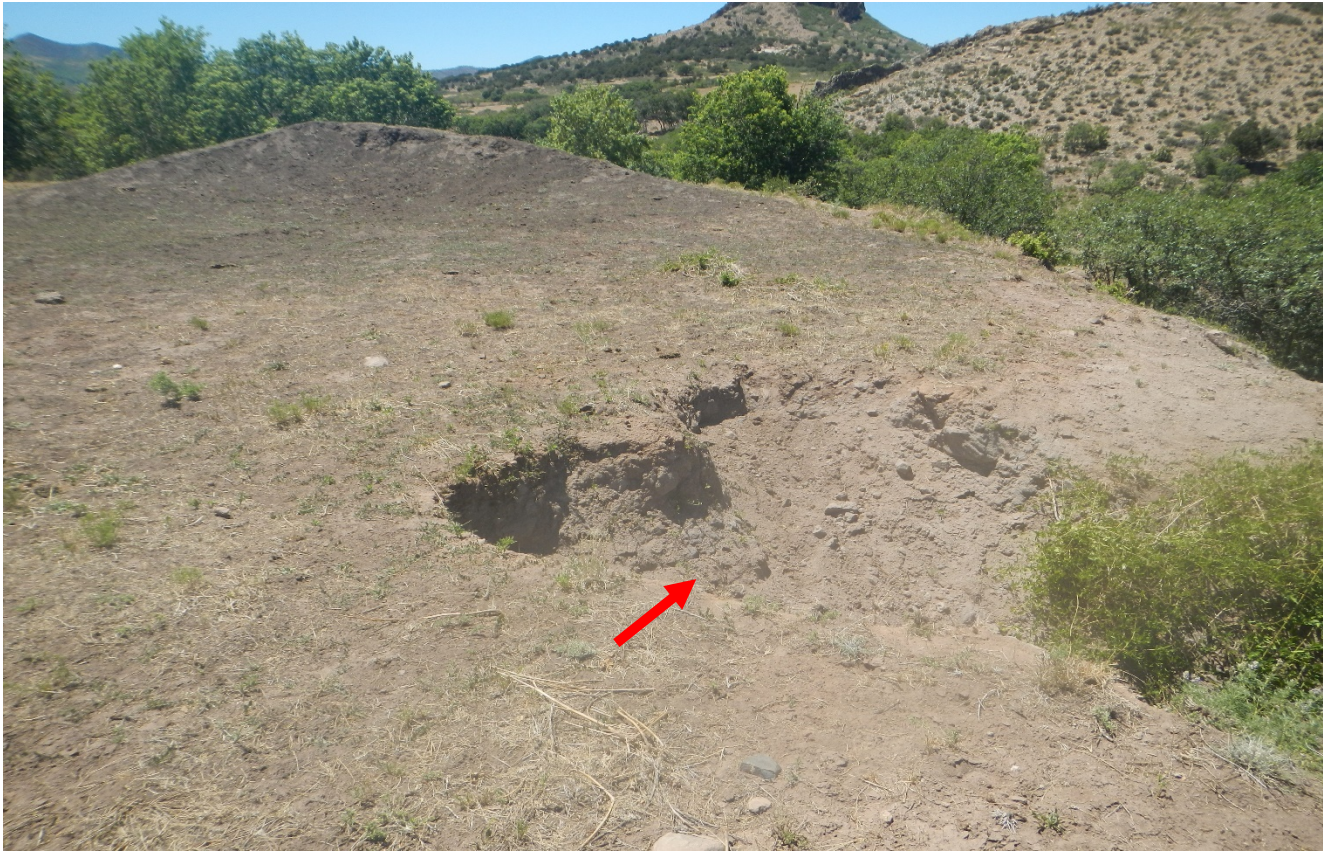
Photo 12. Facing toward northeast corner of the location. There is a soil pile at this side of the location and erosion channel shown at red arrow.

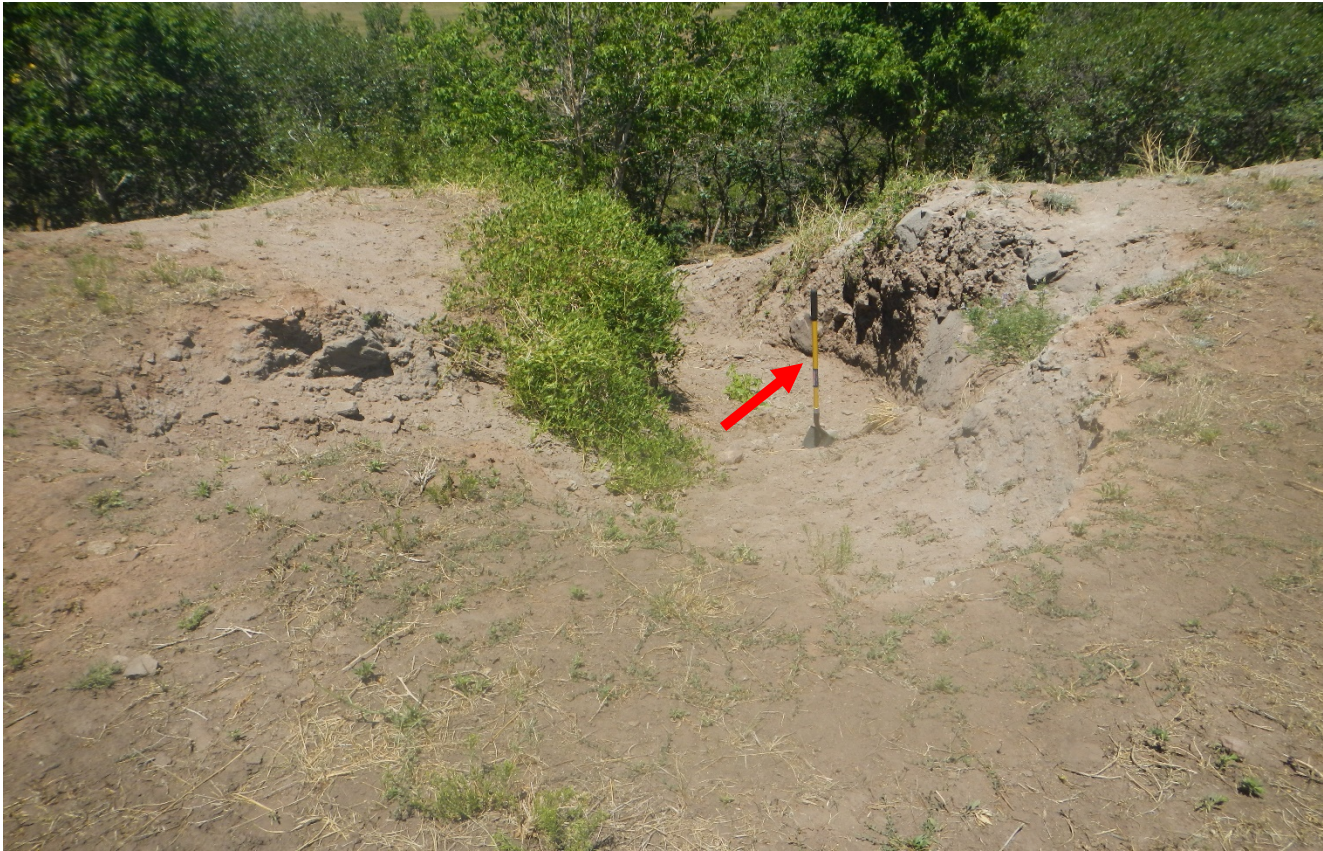
Photo 13. There is a deep gully erosion of the northeast fill slope. Red arrow points to 4.5 ft. shovel to show side of erosion.

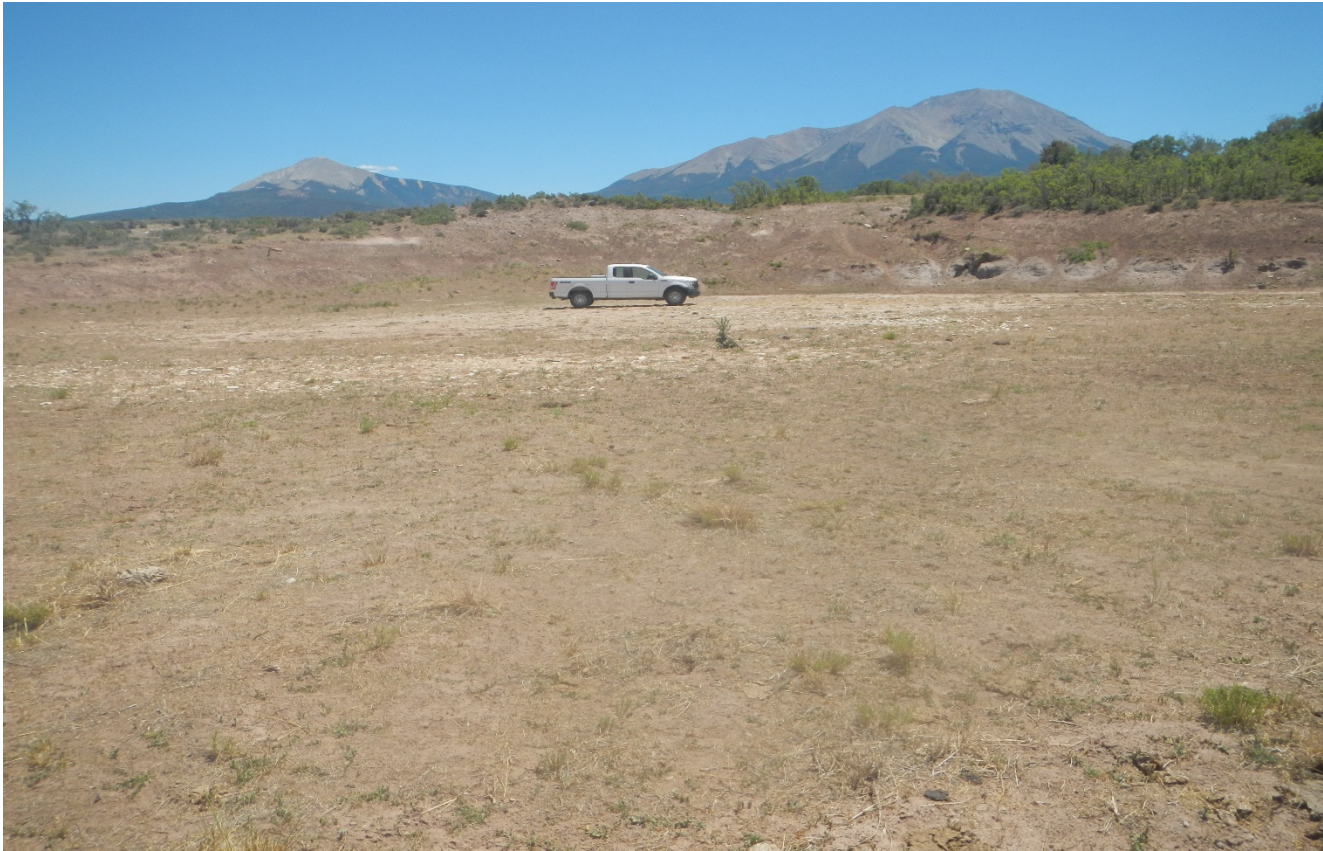
Photo 15. Facing southeast toward the location. The cut slope is approximately 30 ft.
