Inspection Photos
Location Name: McElvain Dakota #1
API: 05-067-05373

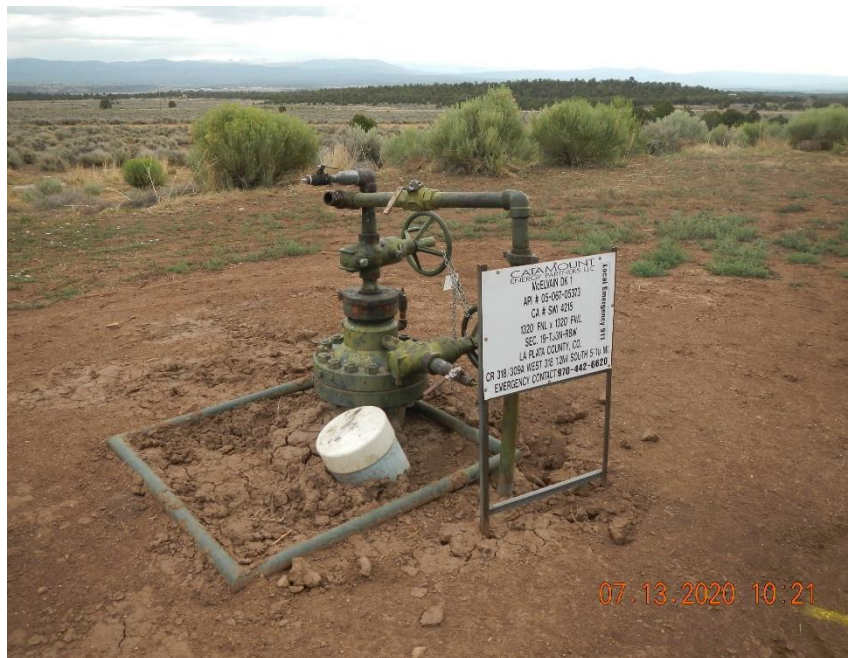
McElvain Dakota #1 well head. Flow line disconnected at well head.

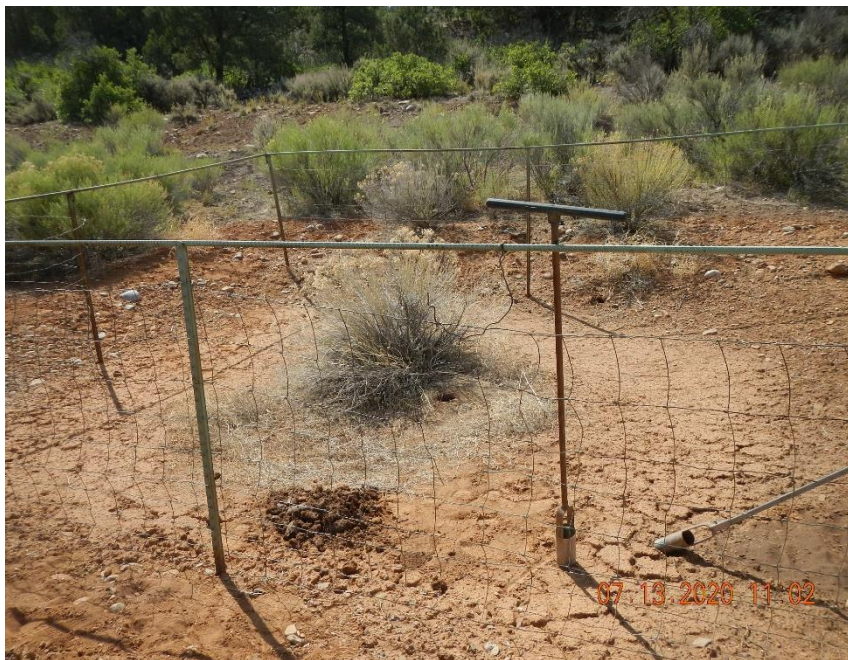
Hand augured boring #1, near the center of the pit area.

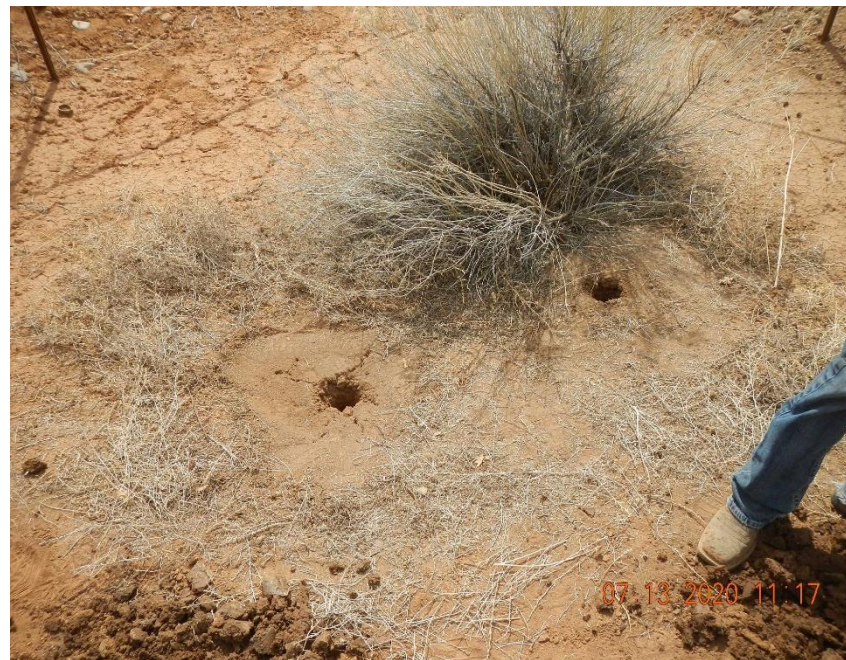
Second hand augured boring.

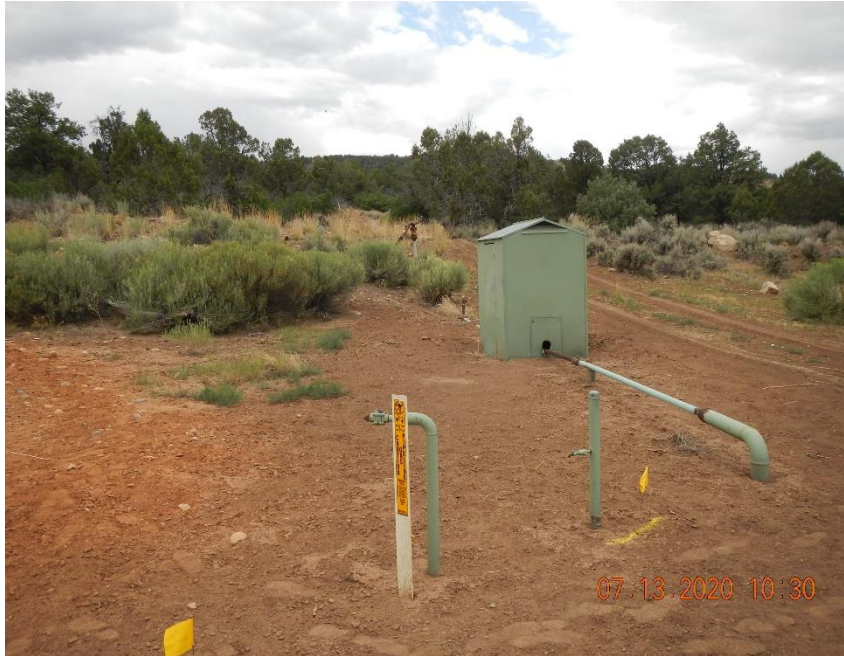
Unused risers in the foreground.

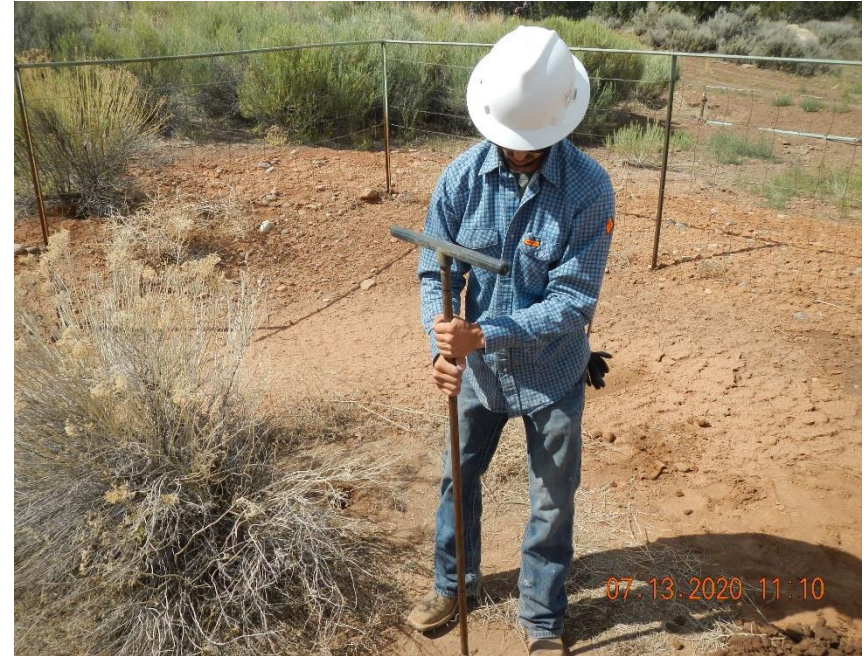
Hand auguring second boring.
