Inspection Photos

Location Name: MARALEX RESOURCES INC SOUTH SHALE RIDGE-68S98W /24SWNE

Location ID: 312609

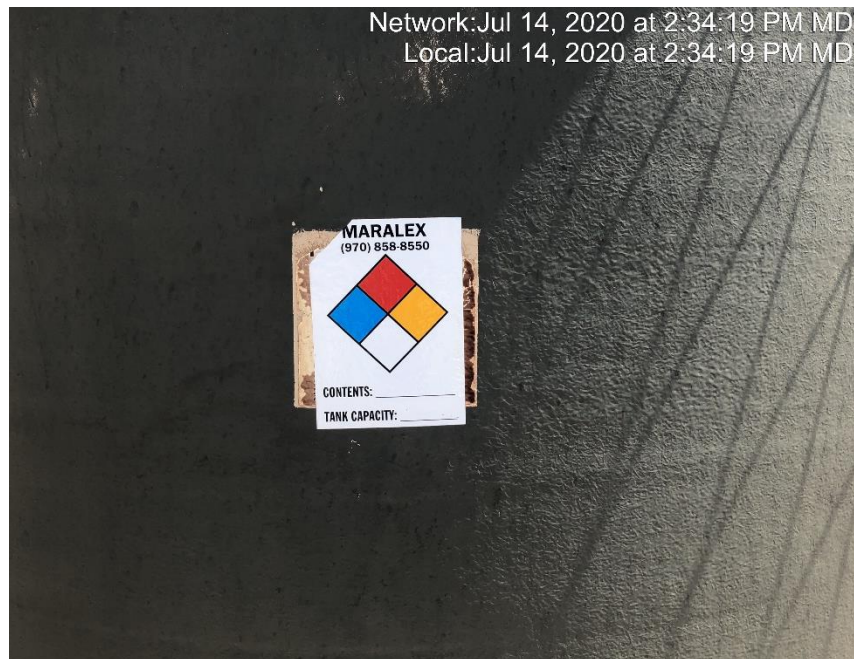
Photo #1526 Tank capacity and contents not legible.

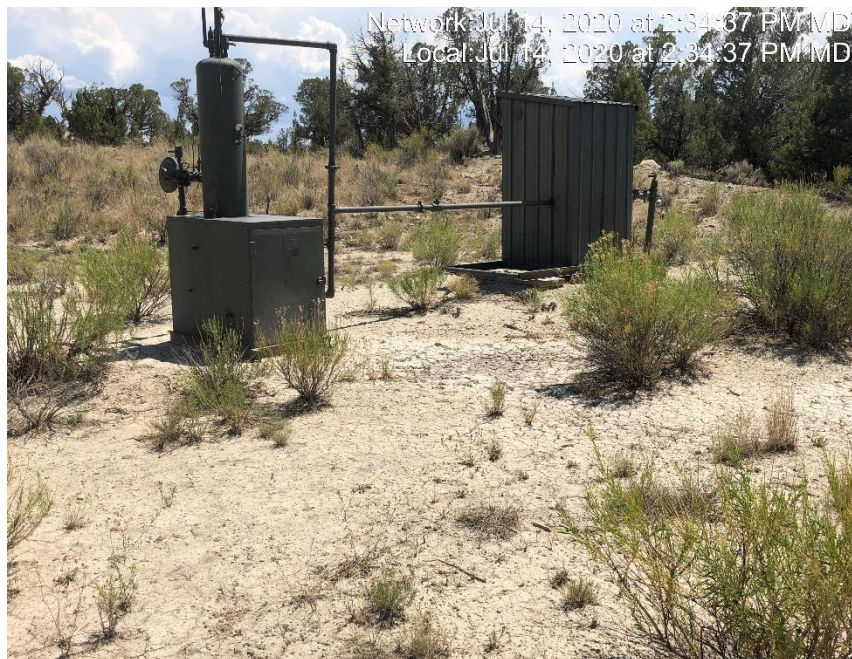
Photo #1527 Multiple places with debris on location.

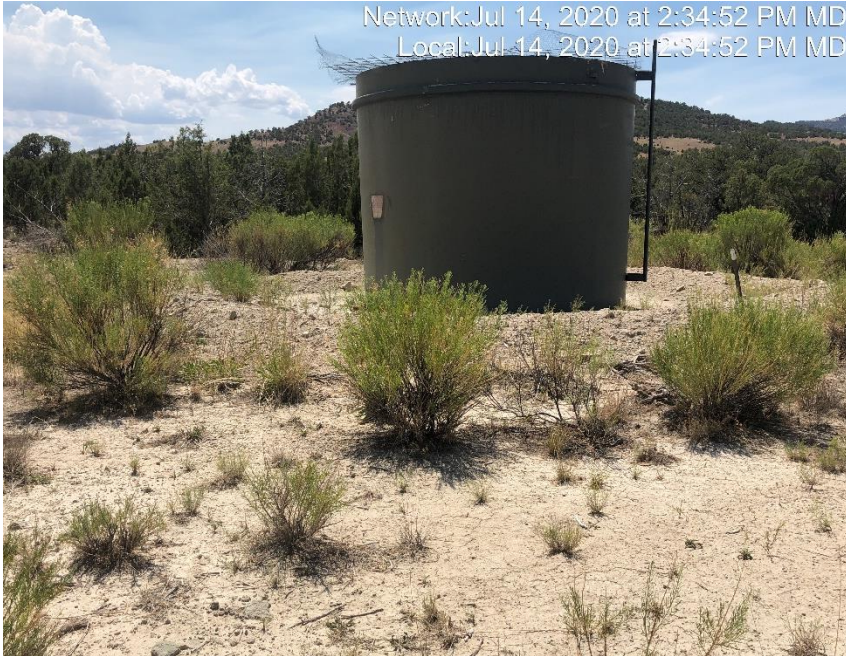
Photo #1528 Multiple places with debris on location.

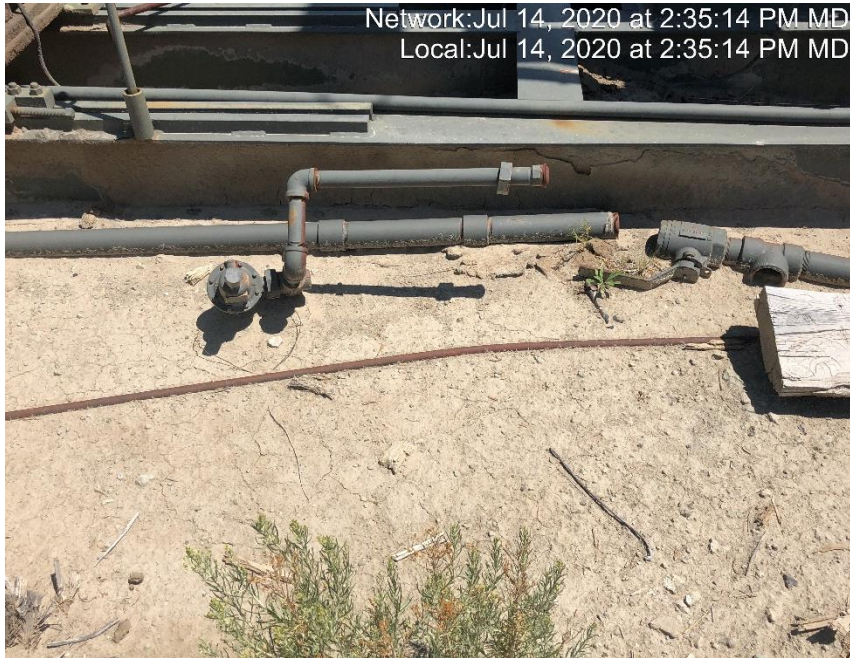
Photo #1529 Unused equipment on location.
