Inspection Photos

API: 061-06899

Operator: MCCOY PETROLEUM CORPORATION

Inspection Date: 7/13/2020

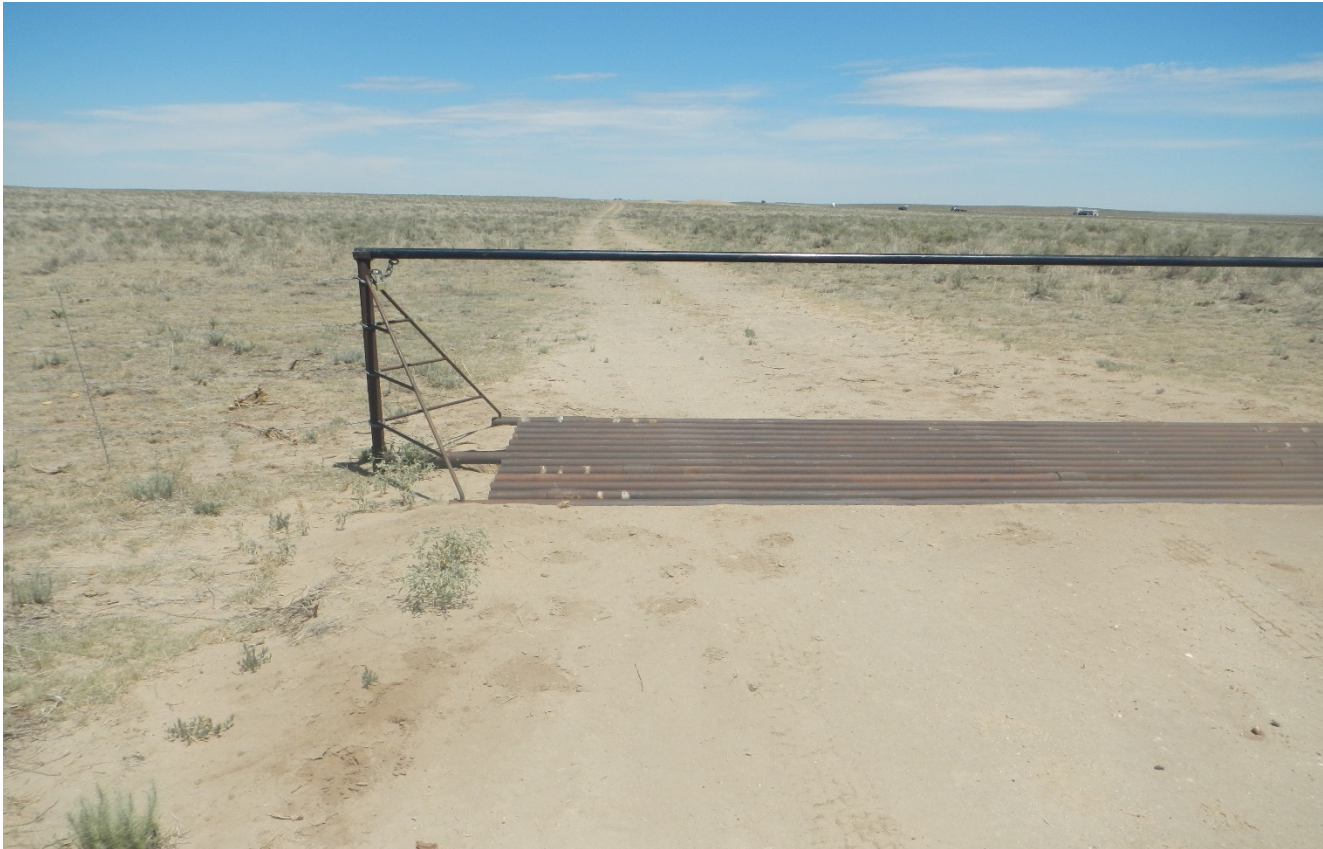
Photo 1. Facing north at the beginning of the access road. Gate was locked at the cattle guard.

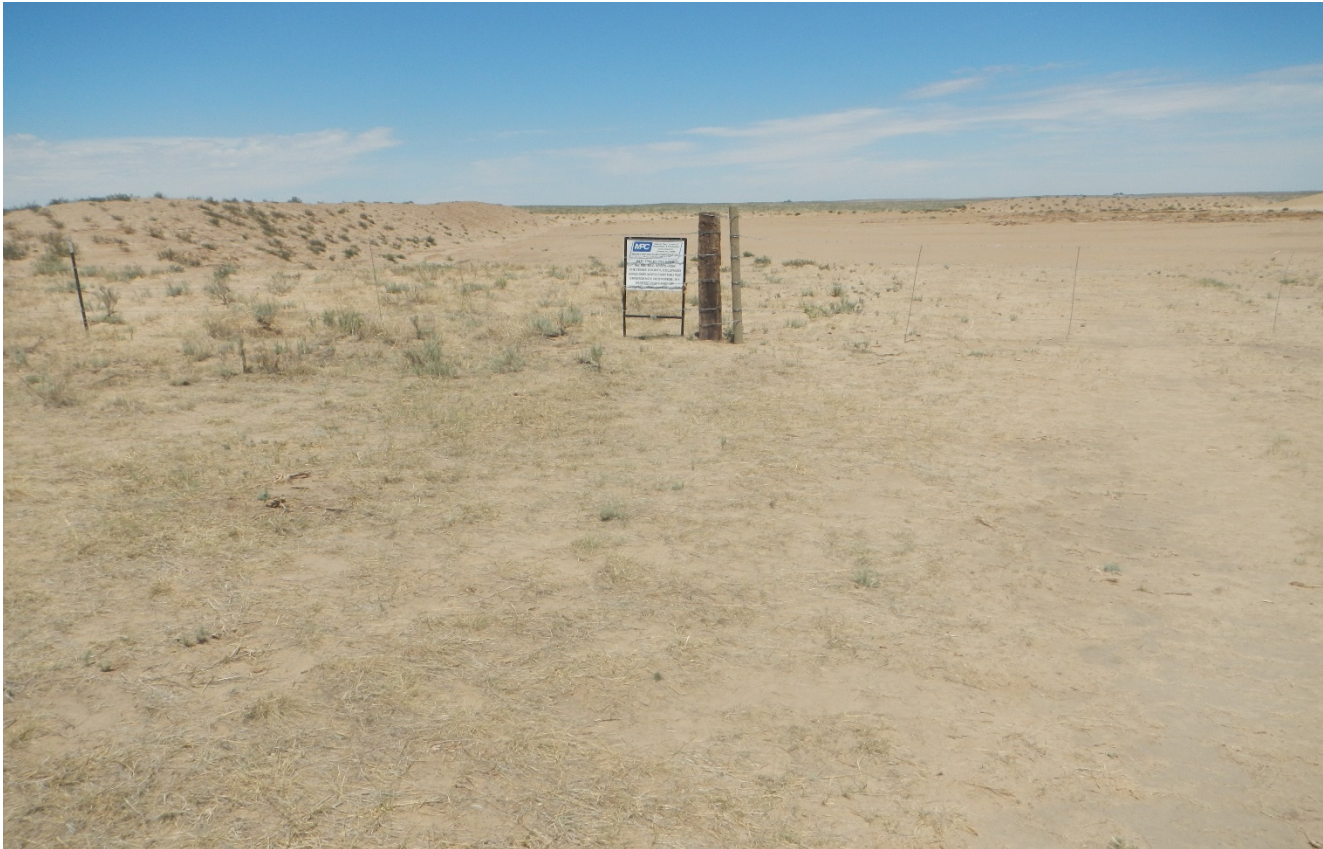
Photo 2. Facing north toward the location. Sign is posted at gate of fenced location.

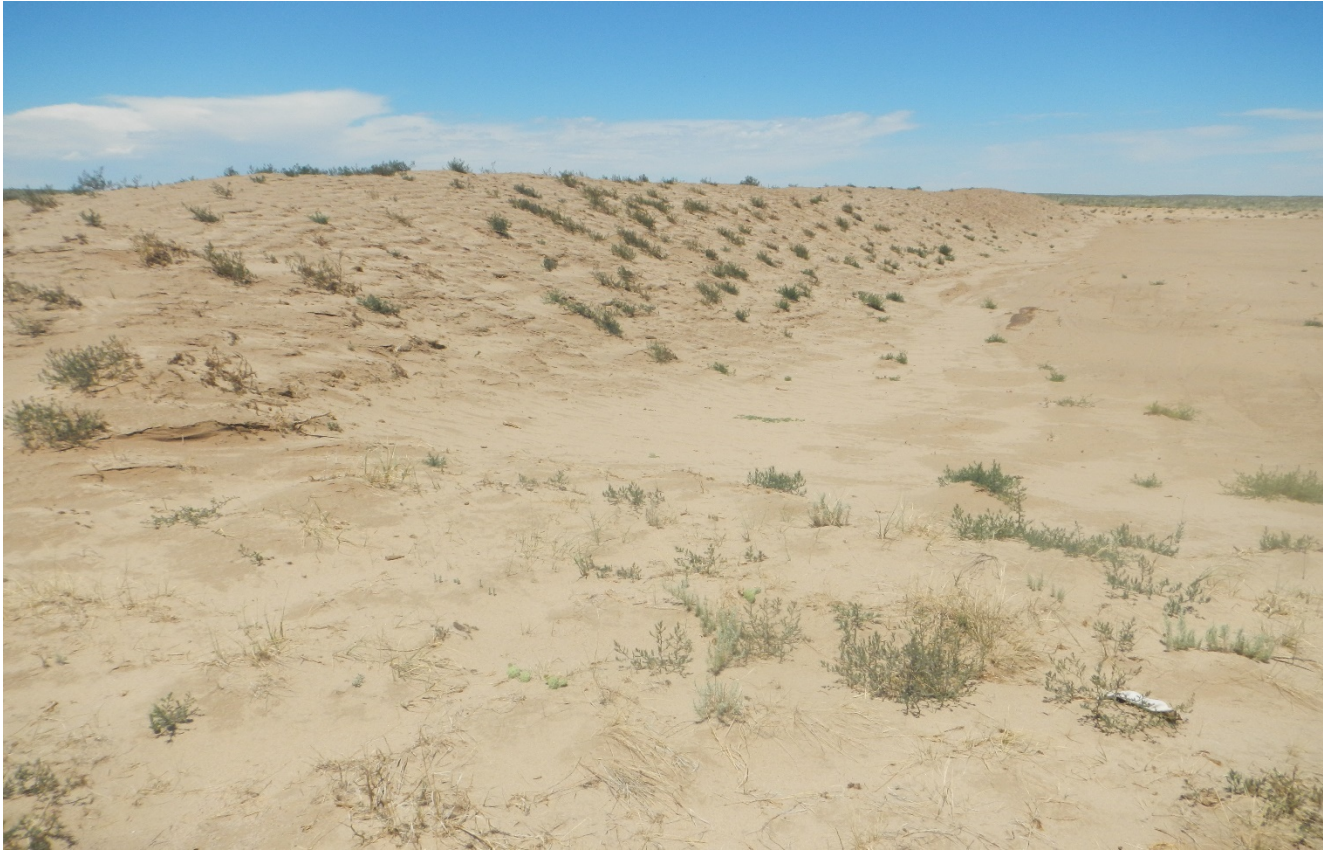
Photo 3. Facing toward the topsoil pile. The soil is not stabilized and there are signs of erosion.

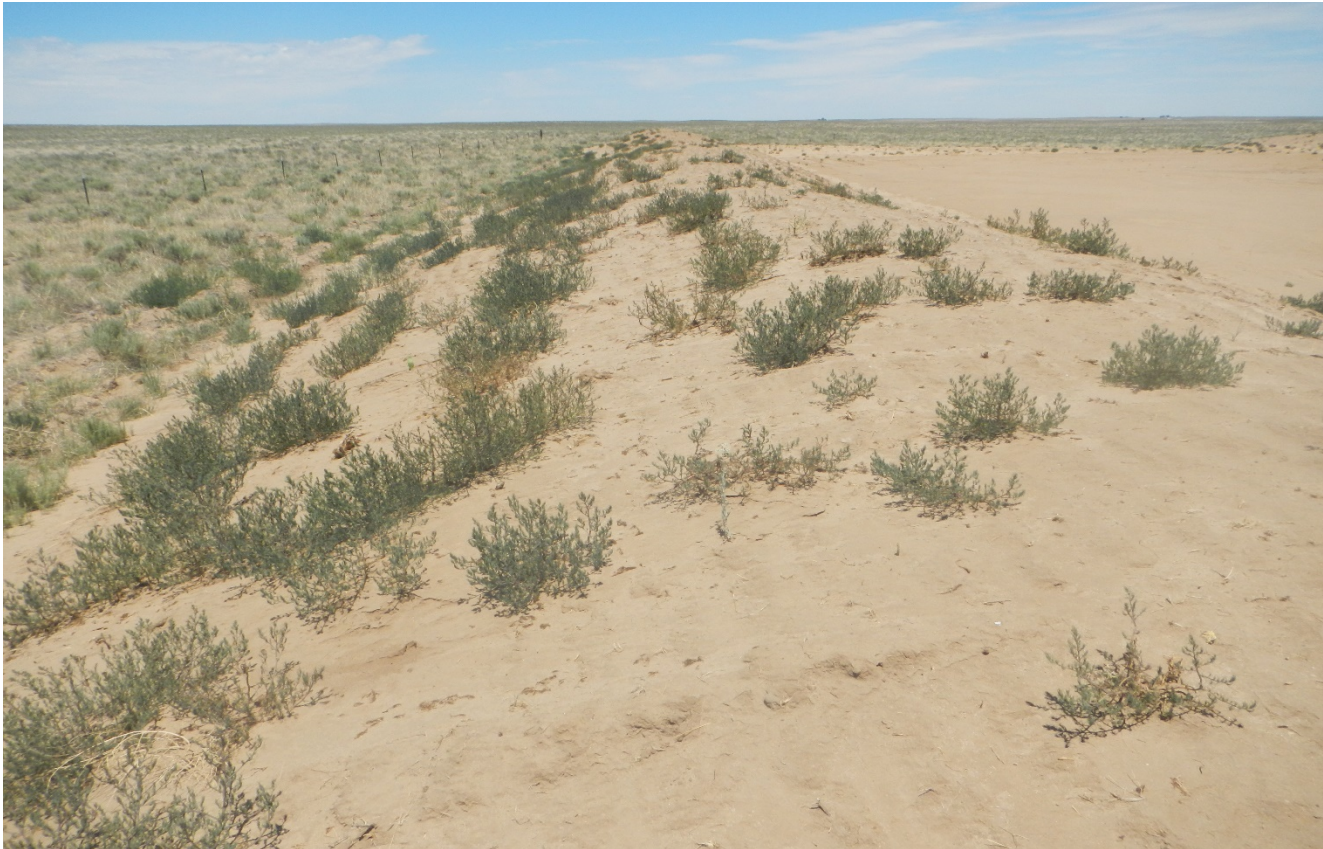
Photo 4. Facing north on topsoil pile. There are undesirable weeds along the soil pile.

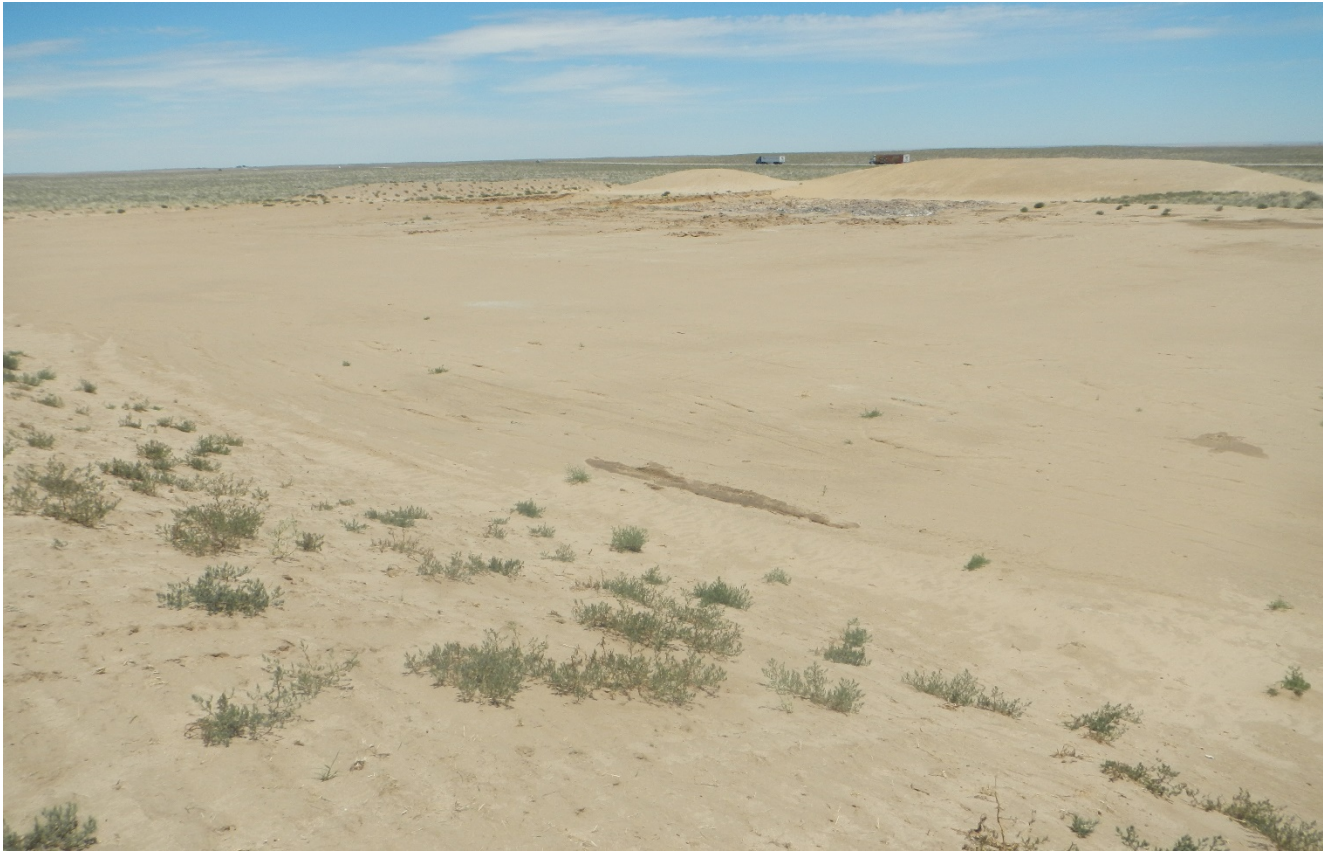
Photo 5. Facing northeast toward the location.

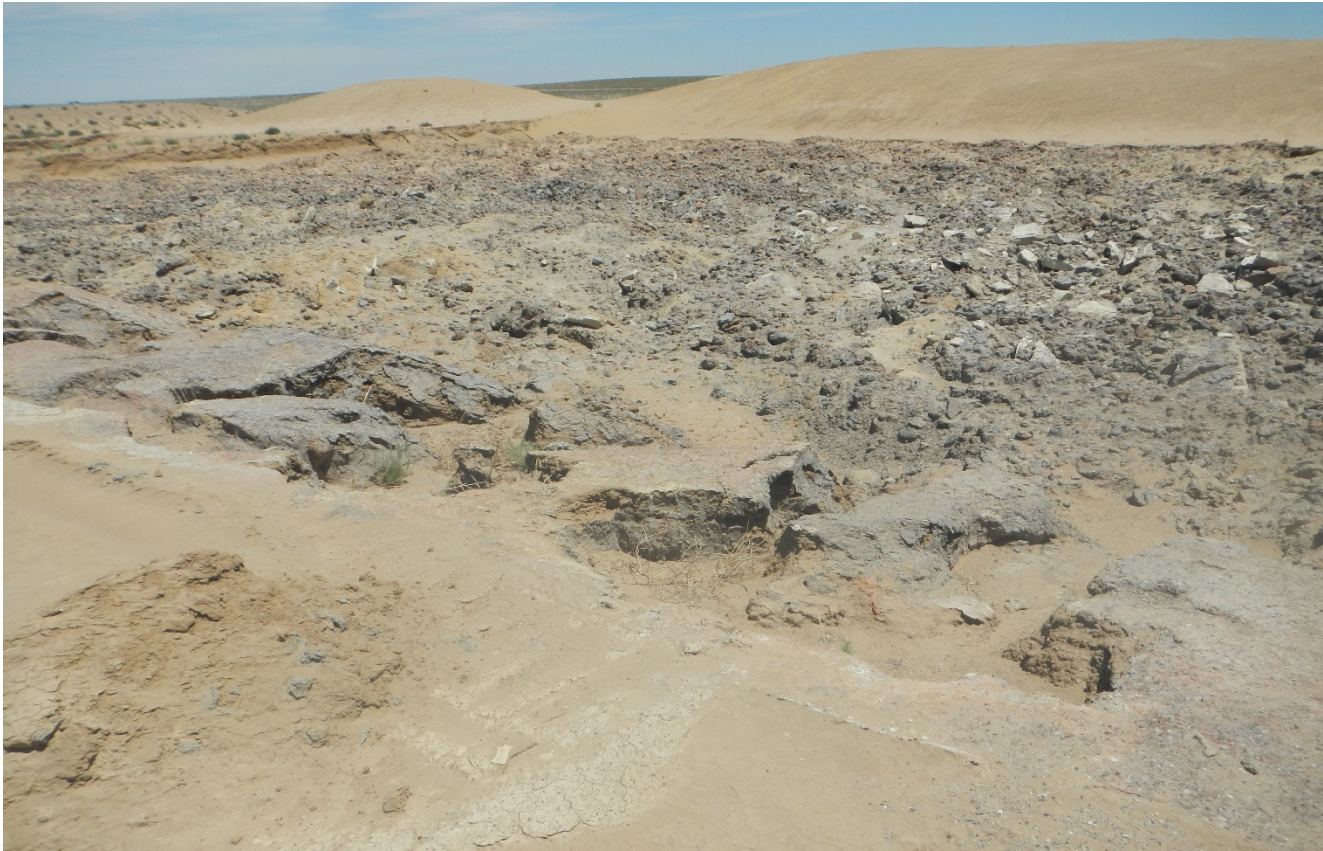
Photo 6. Facing northeast toward the drilling pit.

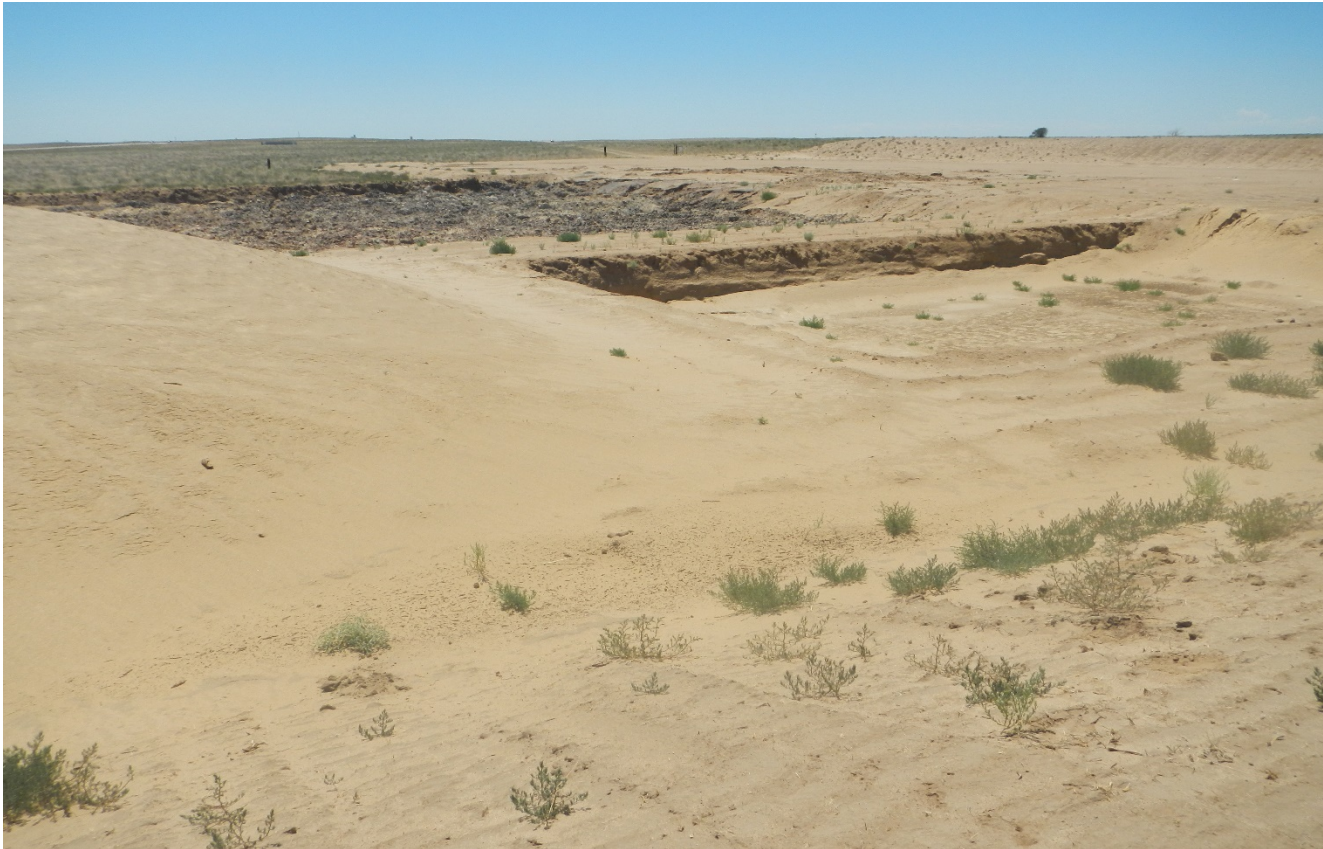
Photo 7. Facing southwest toward the location.

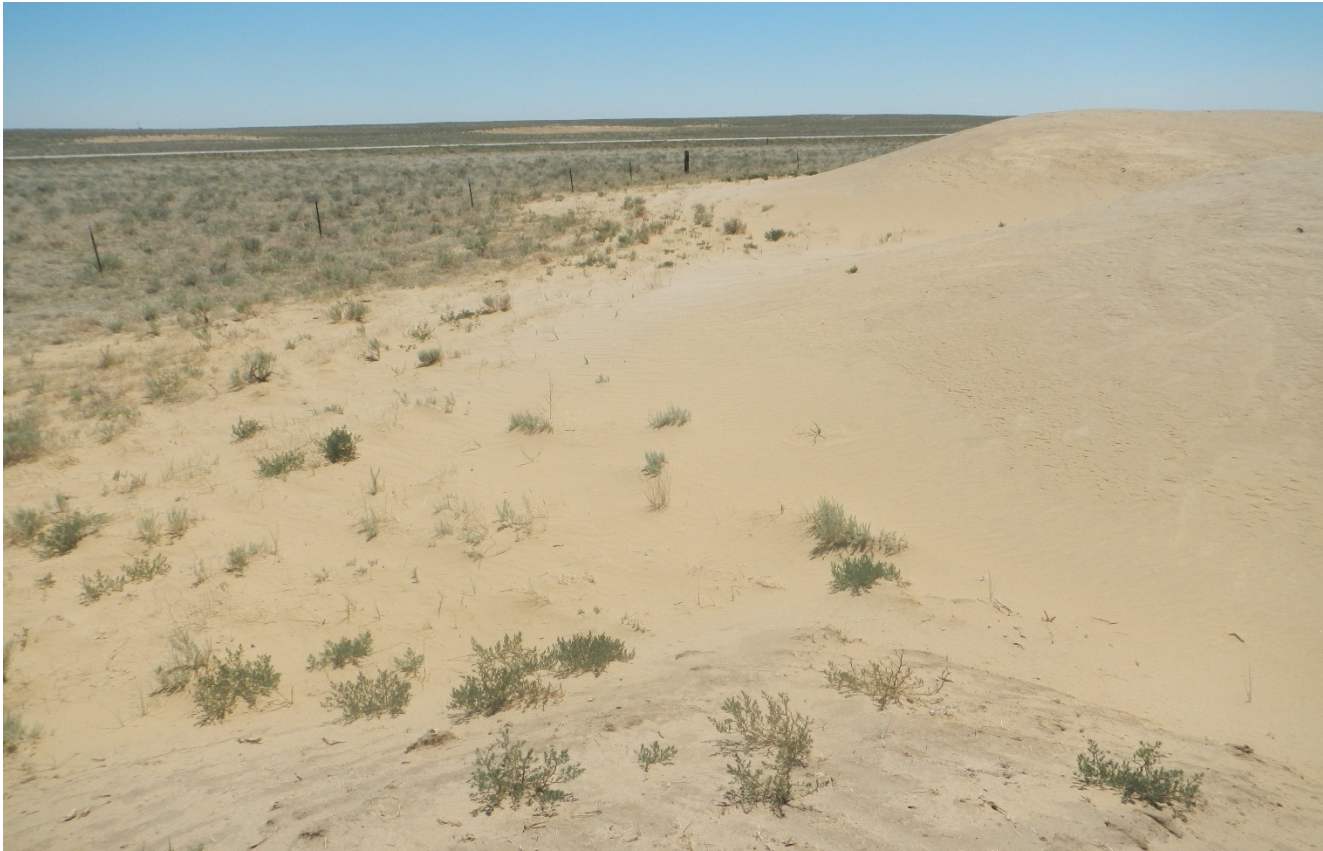
Photo 8. Facing toward the backside of the soil pile at eastside of the location. There is wind erosion occurring of the sandy soils which are not stabilized.

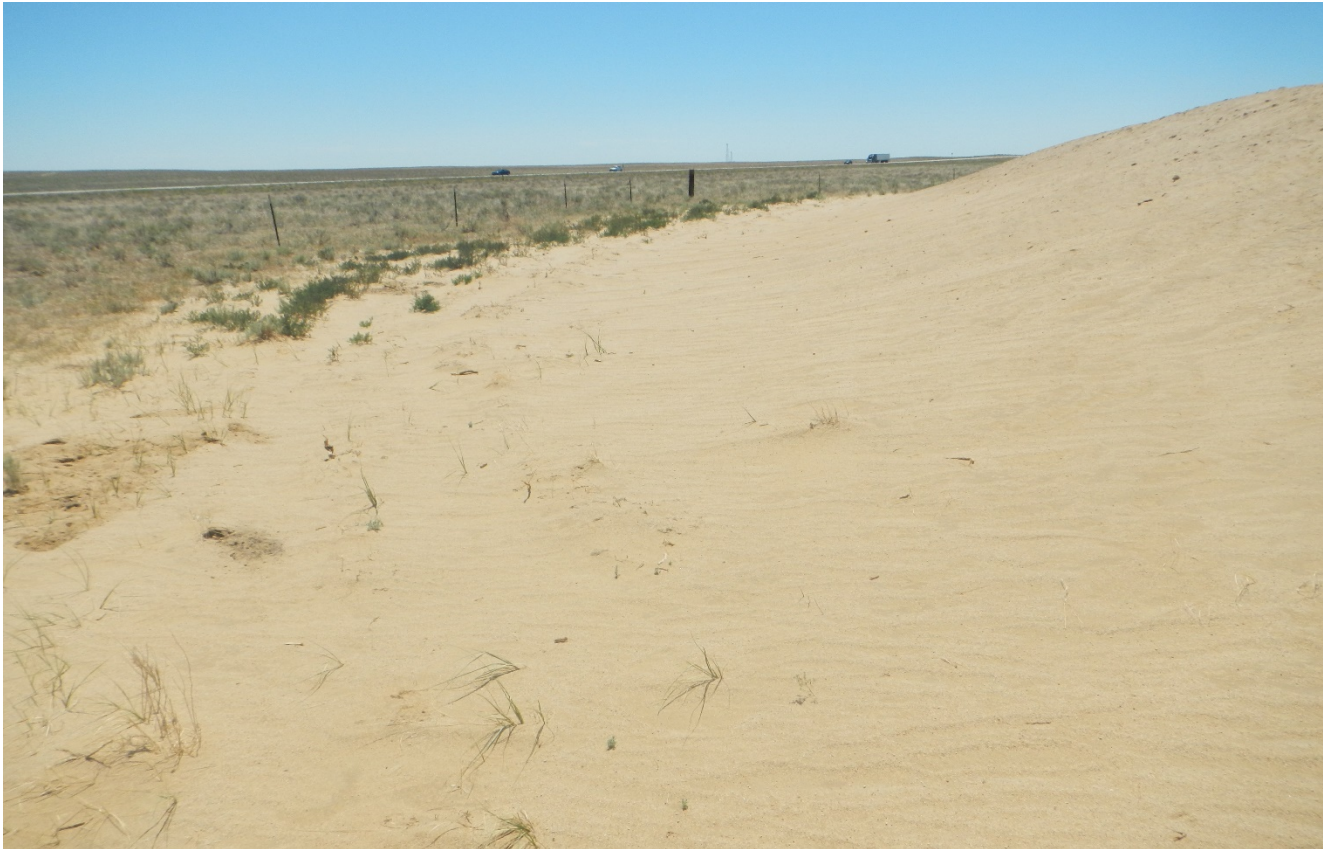
Photo 9. The sandy soils have eroded offsite and there is no perimeter erosion controls.

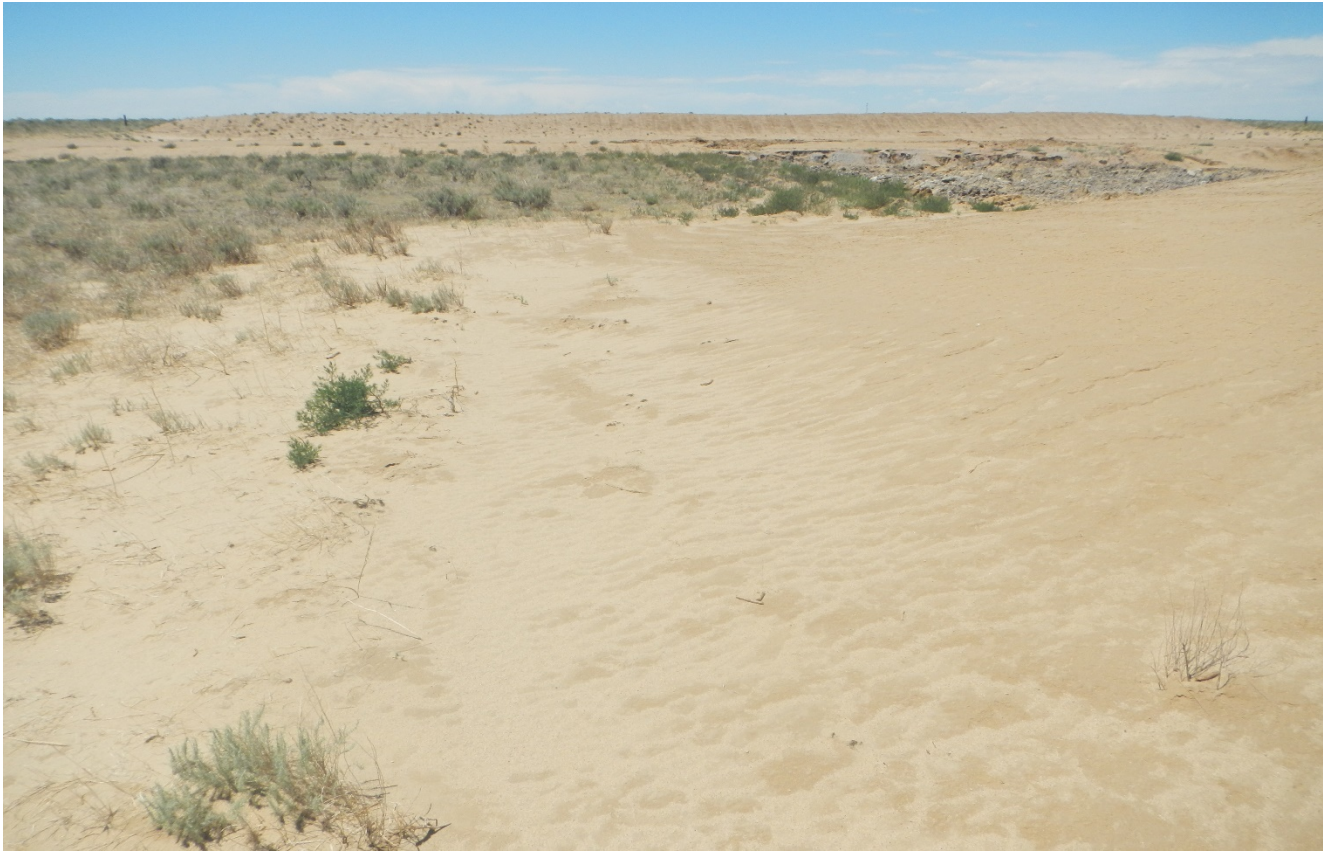
Photo 10. East side of the location facing west.
