## Annual Inspection Form

Site: Mahalo 6	Project: 50117002
Date: 12/5/2019	Time on/off site: 14:20/14:50
Inspector: Brandon Finn	
Conditions: Cloudy, snow, rain 30's	Annual Inspection: <input checked="" type="checkbox"/> Yes <input type="checkbox"/> No

**Wiepking Fullerton Energy LLC, Mahalo 6**

Project: 050117002	Wiepking Fullerton Energy LLC, Annual Inspection Form

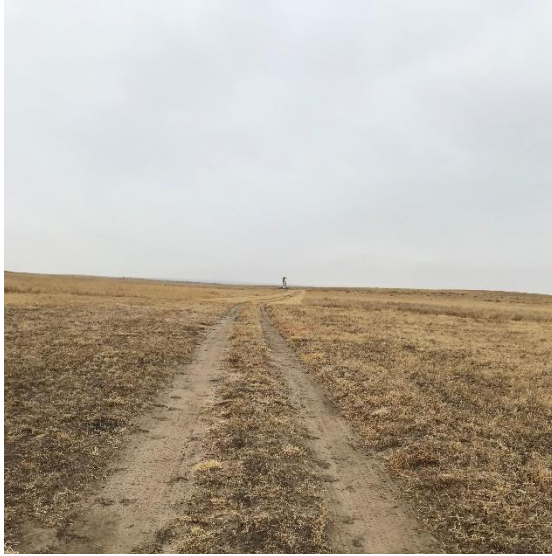
**Photograph 1:** View north from the center of the Subject Property.

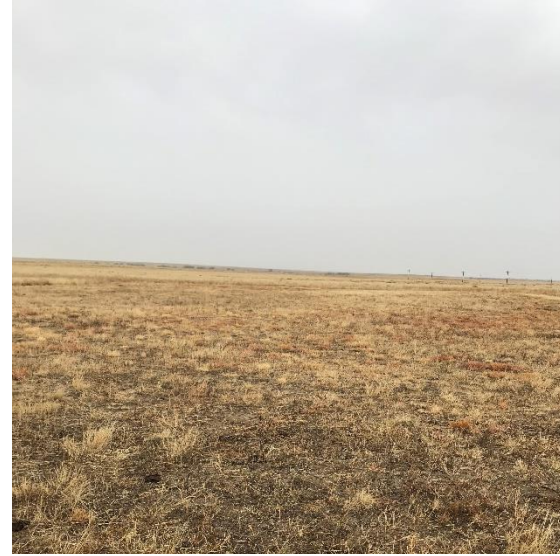
**Photograph 2:** View east from the center of the Subject Property.

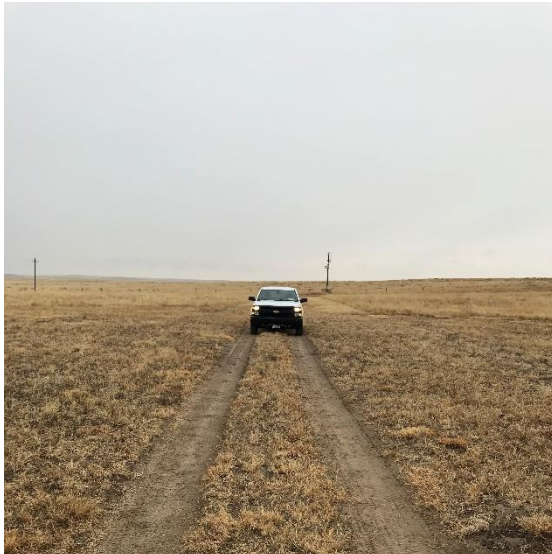
**Photograph 3:** View south from the center of the Subject Property.

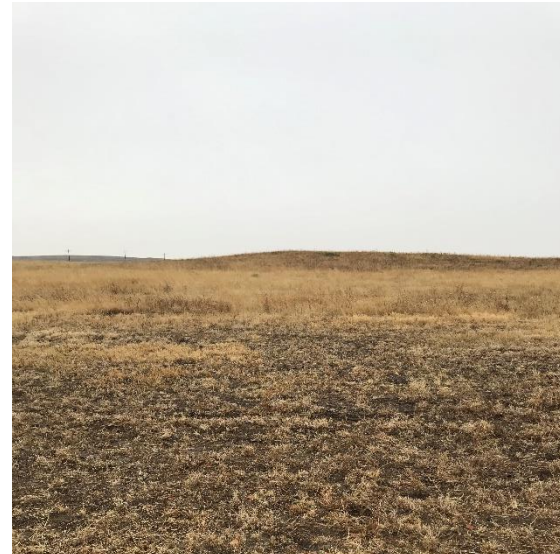
**Photograph 4:** View west from the center of the Subject Property.
