## Inspection Photos

Location Name: SLUGGER NO. 11 & SLUGGER NO. 1

API#: 05-067-09751 & 067-08985

INSP. #: 695102992

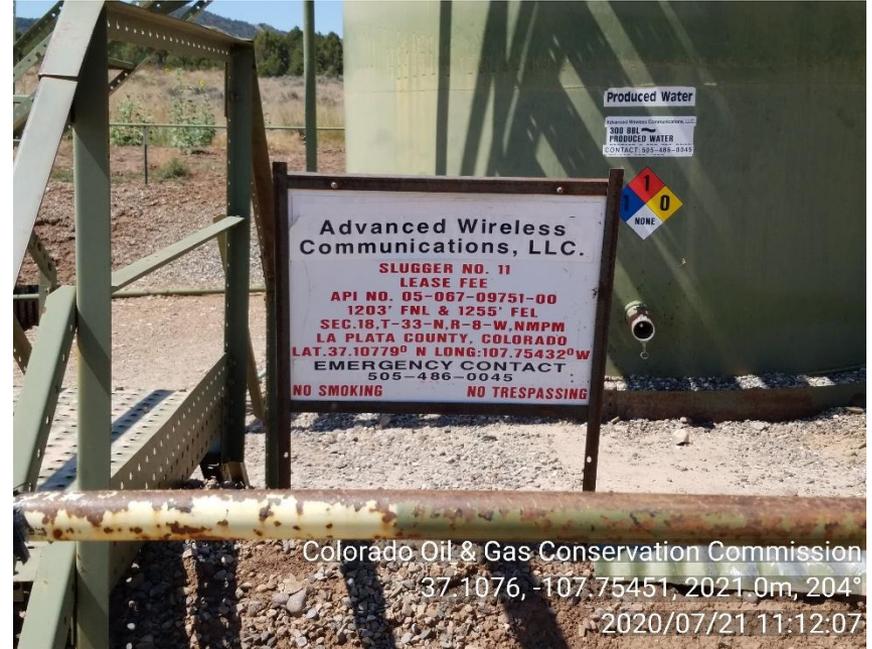
PHOTO 2: WELL SIGN/ 911 NOT LISTED AS EMERGENCY CALL NUMBER ON BATTERY SIGN. **INSTALL SIGN TO COMPLY WITH RULE 210.b. CA DATE 10-21-20.**

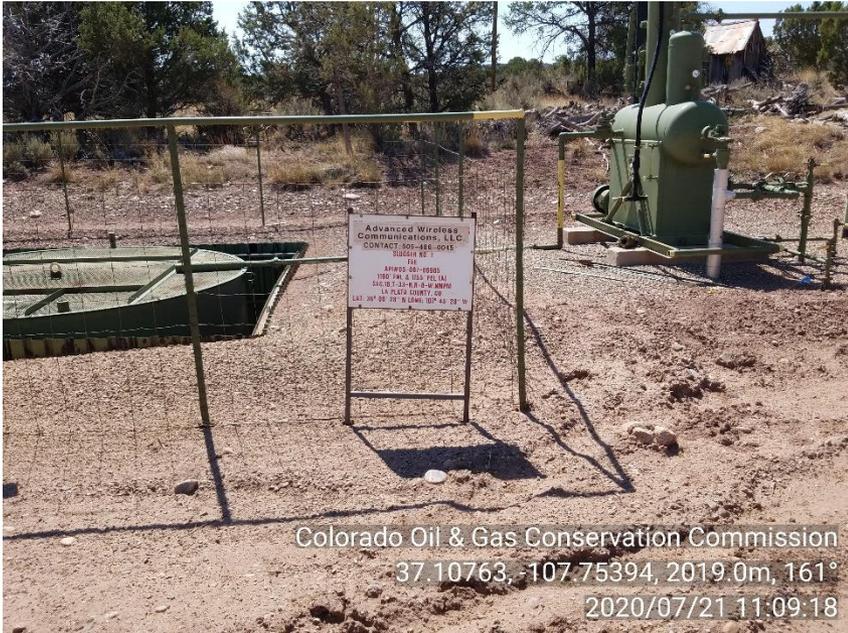
**PHOTO 3: WELL SIGN/ 911 NOT LISTED AS EMERGENCY CALL NUMBER ON BATTERY SIGN. **INSTALL SIGN TO COMPLY WITH RULE 210.b. CA DATE 10-21-20.****

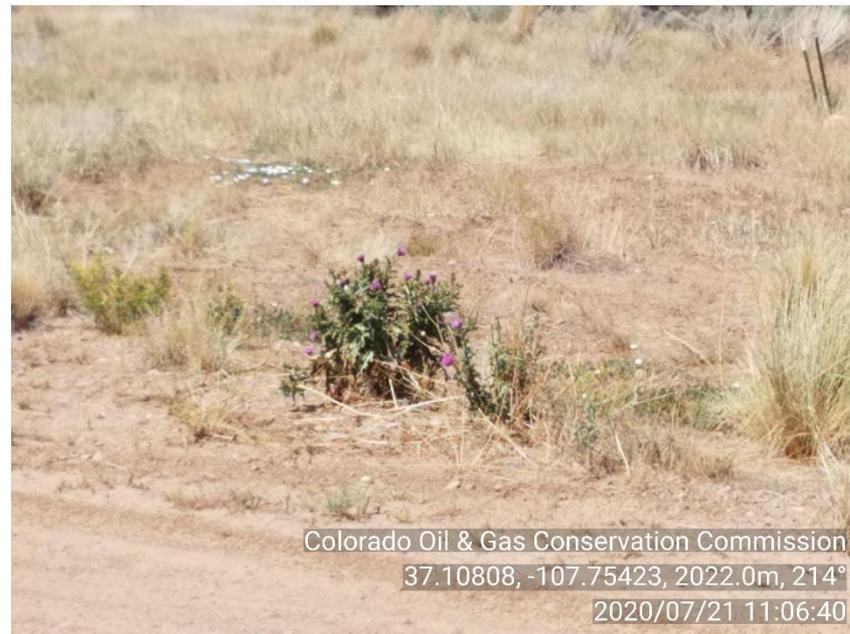
**PHOTO 6: NOXIOUS WEEDS ON THE OUTER PERIMETER OF LOCATION. REMOVE WEEDS IN ACCORDANCE WITH RULE 603.f. CA DATE 8-10-20.**

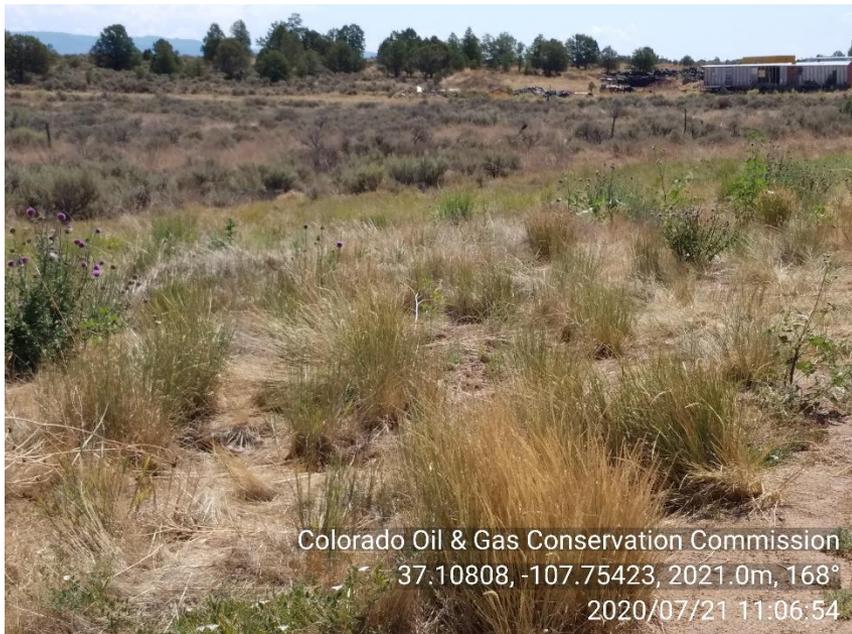
**PHOTO 7: MORE IMAGES OF NOXIOUS WEEDS. SEE PREVIOUS PHOTO FOR CORRECTIVE ACTION.**

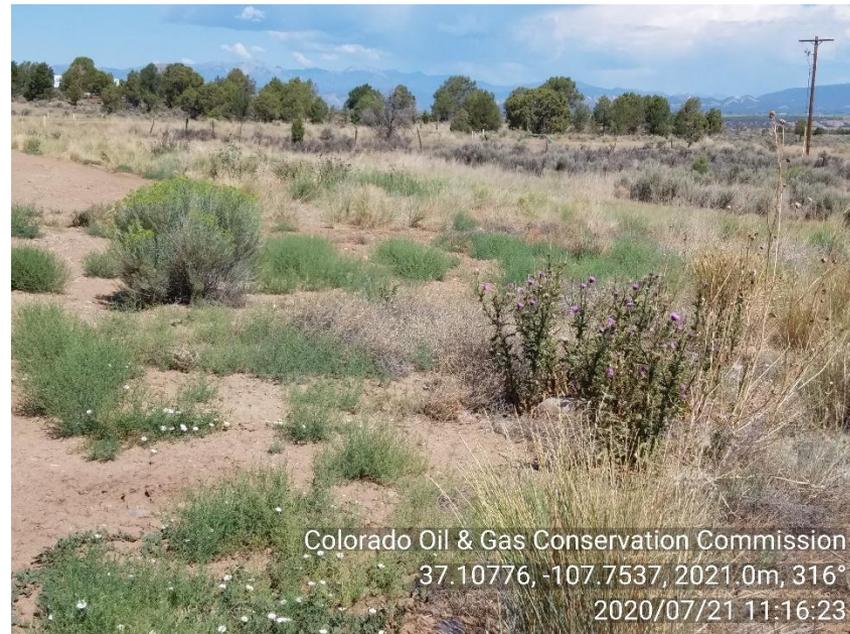
**PHOTO 8: MORE IMAGES OF NOXIOUS WEEDS. SEE PHOTO 6 FOR CORRECTIVE ACTION.**

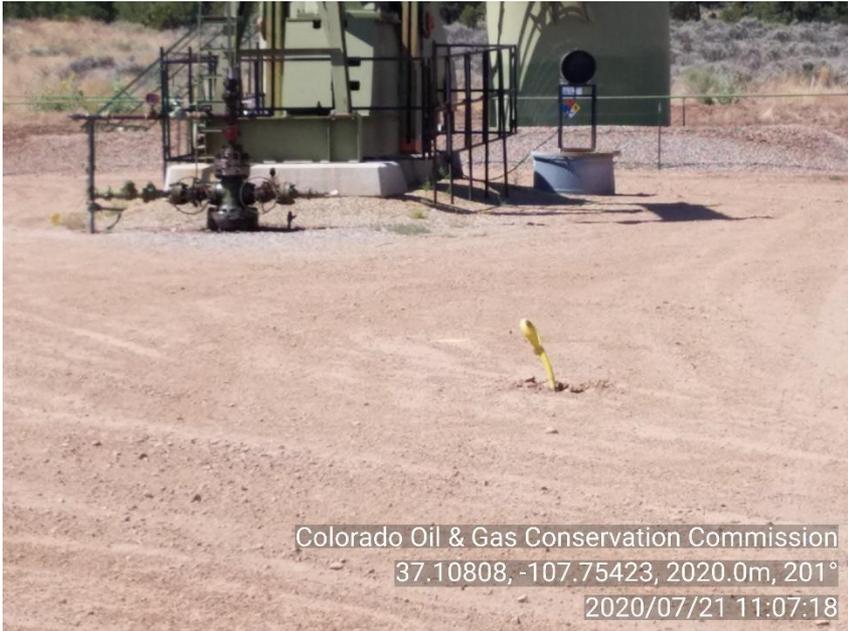
**PHOTO 9: NO ANCHOR MARKER ON ANCHOR IN FRONT OF SLUGGER NO. 11 WELLHEAD. Install proper guy line markers per Rule 1003.a CA DATE 10-21-20.**

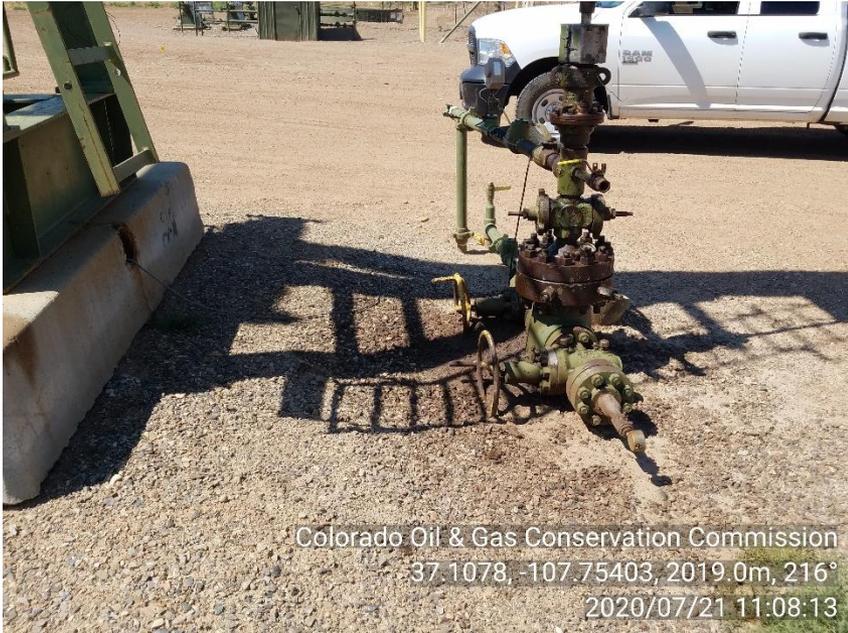
**PHOTO 11: AREA OF IMPACTED SOIL AROUND SLUGGER NO. 11 WELLHEAD. Conduct maintenance on equipment, cleanup stained material and review self inspection processes. CA DATE 10-21-20.**

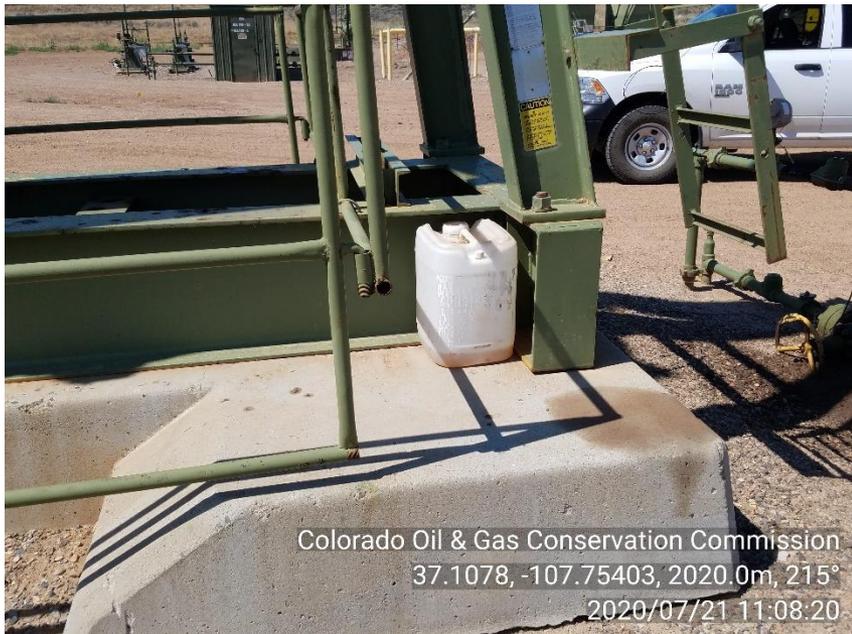
**PHOTO 13: TRASH ON LOCATION (5 GAL. BUCKET).  
REMOVE ALL TRASH ON AND AROUND LOCATION  
COMPLY WITH RULE 603.f. CA DATE 10-21-20.**

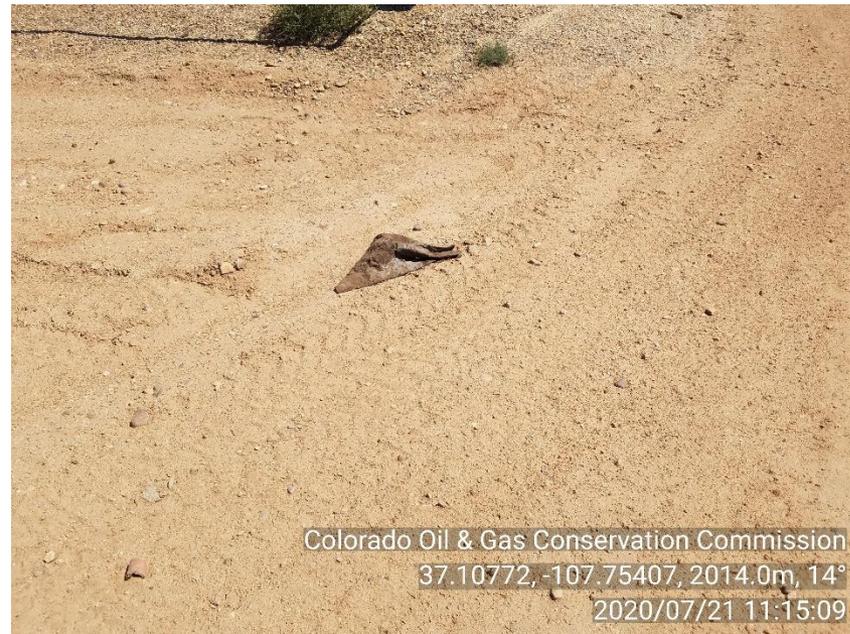
**PHOTO 14: TRASH ON LOCATION (NEAR SLUGGER NO.1  
PUMP JACK ENGINE). REMOVE ALL TRASH ON AND AROUND  
LOCATION COMPLY WITH RULE 603.f. CA DATE 10-21-20.**

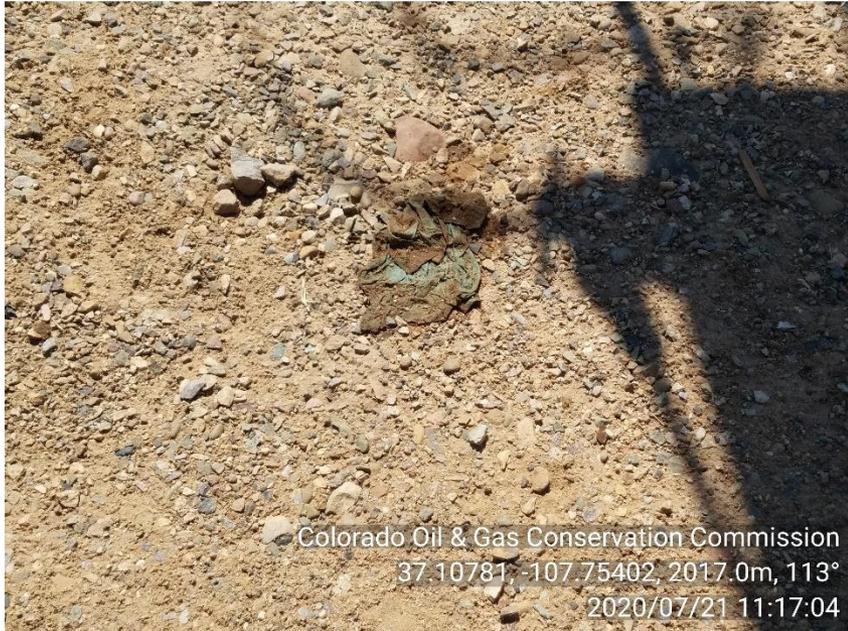
**PHOTO 15: TRASH ON LOCATION (IN FRONT OF SLUGGER NO.1 WELLHEAD). REMOVE ALL TRASH ON AND AROUND LOCATION COMPLY WITH RULE 603.f. CA DATE 10-21-20.**

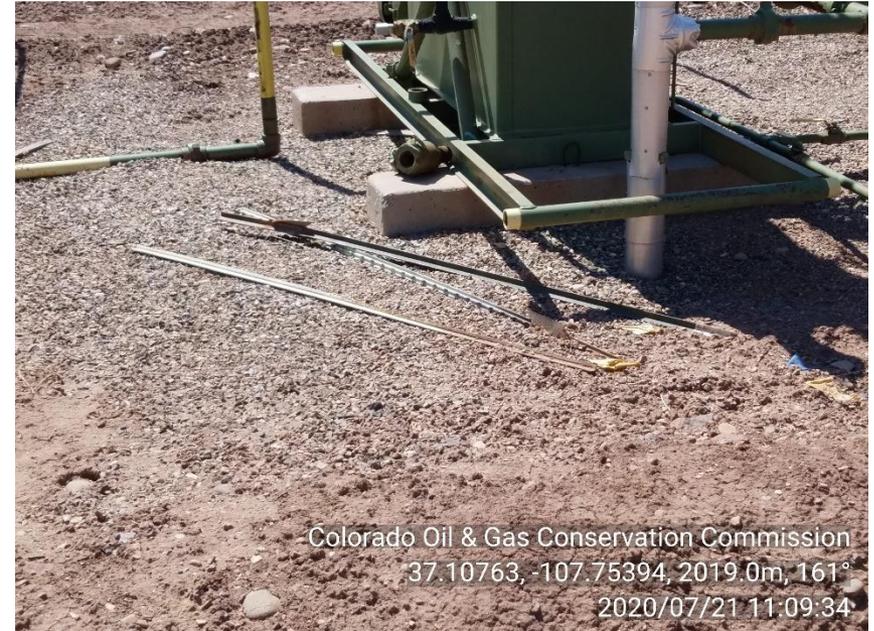
**PHOTO 16: UNUSED EQUIPMENT STORED ON LOCATION (T POSTS). REMOVE ALL UNUSED EQUIPMENT FROM LOCATION COMPLY WITH RULE 603.f. CA DATE 10-21-20.**

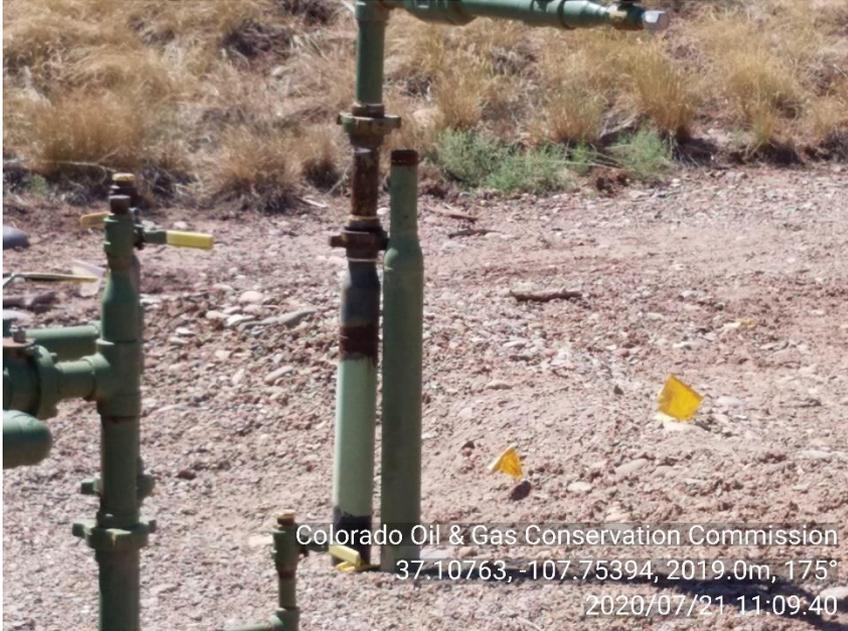
**PHOTO 17: UNUSED EQUIPMENT STORED ON LOCATION (UNUSED RISER). REMOVE ALL UNUSED EQUIPMENT FROM LOCATION COMPLY WITH RULE 603.f. CA DATE 10-21-20.**

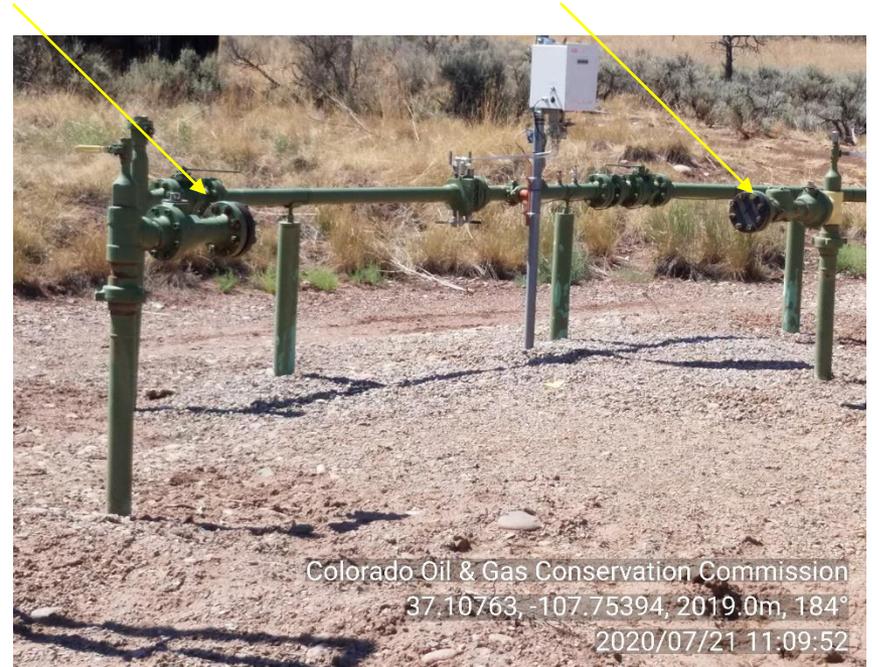
**PHOTO 18: UNUSED EQUIPMENT STORED ON LOCATION (UNUSED RISERS). REMOVE ALL UNUSED EQUIPMENT FROM LOCATION COMPLY WITH RULE 603.f. CA DATE 10-21-20.**

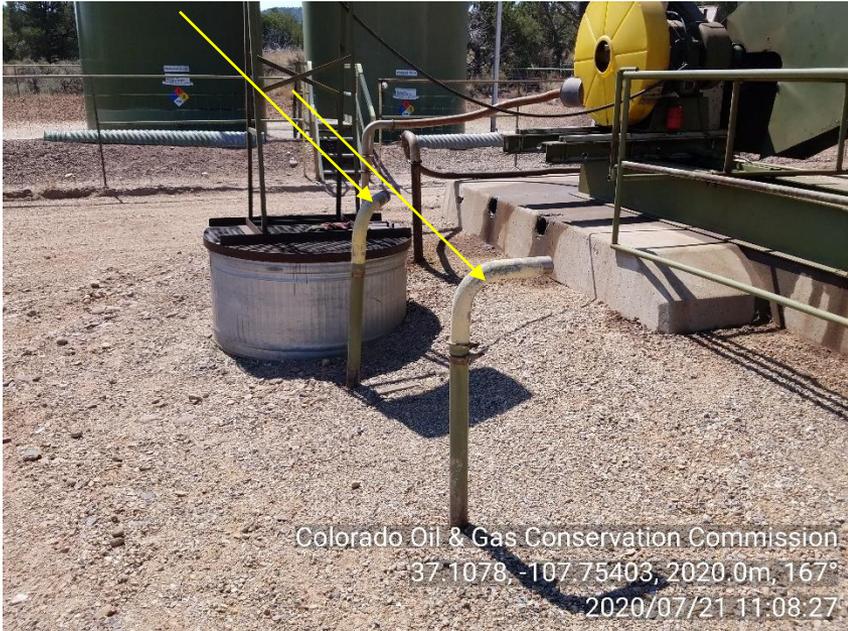
**PHOTO 19: UNUSED EQUIPMENT STORED ON LOCATION (UNUSED RISER). REMOVE ALL UNUSED EQUIPMENT FROM LOCATION COMPLY WITH RULE 603.f. CA DATE 10-21-20.**

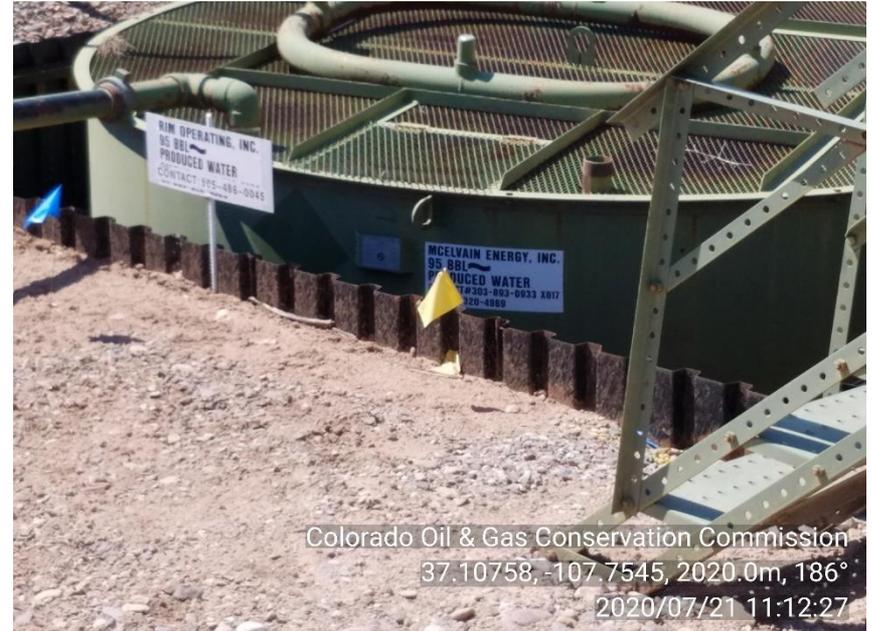
**PHOTO 20: IMPROPER OPERATOR NAME ON PRODUCED WATER TANK IN SLUGGER NO. 11 TANK BATTERY. Install sign to comply with Rule 210.b. CA DATE 10-21-20.**

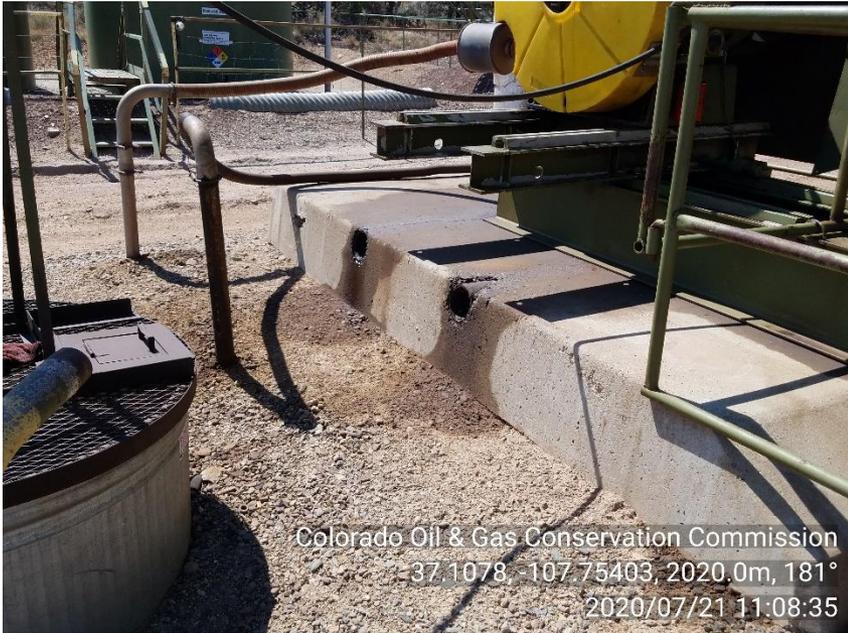
**PHOTO 21: AREA OF IMPACTED SOIL NEAR SLUGGER NO. 1 PUMP JACK MOTOR APPEARS TO BE OIL FROM LEAKING MOTOR. Securely fasten all valves, pipes, and fittings to ensure good mechanical condition, inspect at regular intervals and maintain in good mechanical condition per Rule 605.d. CA DATE 10-21-20.**

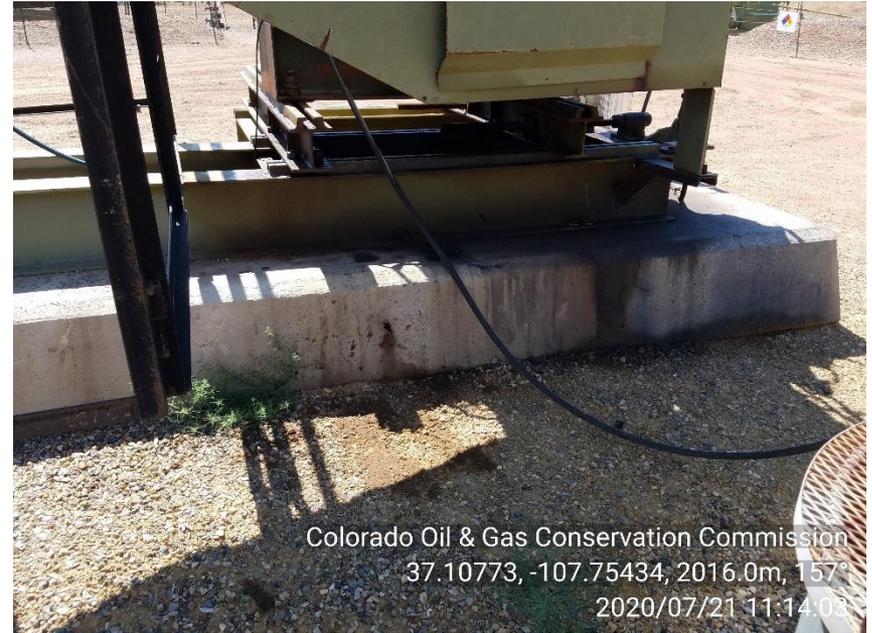
**PHOTO 22: AREA OF IMPACTED SOIL NEAR SLUGGER NO. 11 PUMP JACK MOTOR APPEARS TO BE OIL FROM LEAKING MOTOR. Securely fasten all valves, pipes, and fittings to ensure good mechanical condition, inspect at regular intervals and maintain in good mechanical condition per Rule 605.d. CA DATE 10-21-20.**
