**Inspection Photos**  
**Location Name: Fredrick State TB 2-36**  
**Location ID: 332928**

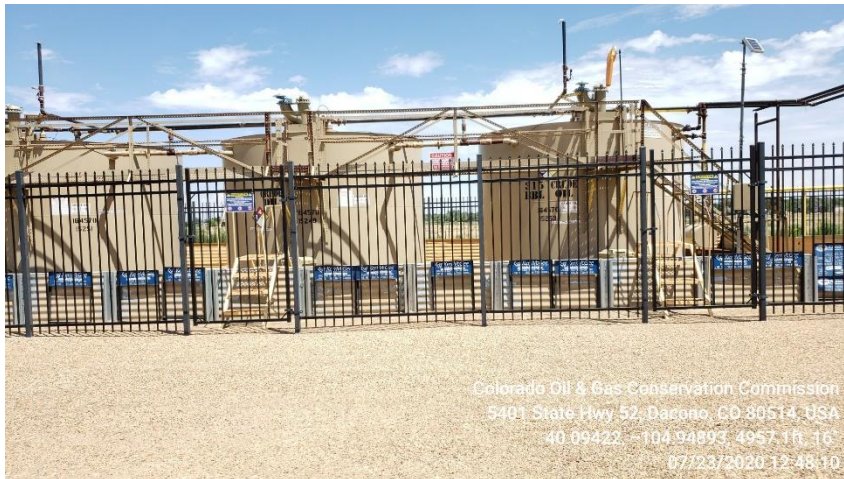
**Photo 1 TB signs**

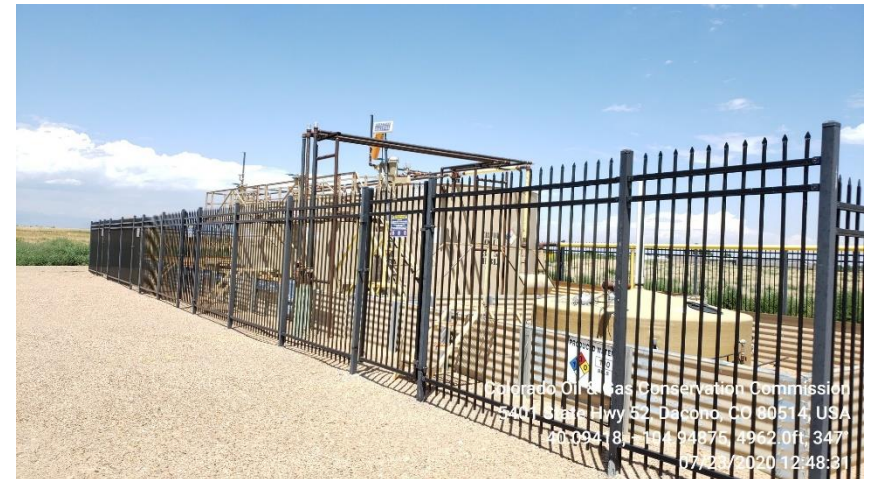
**Photo 2 TB**

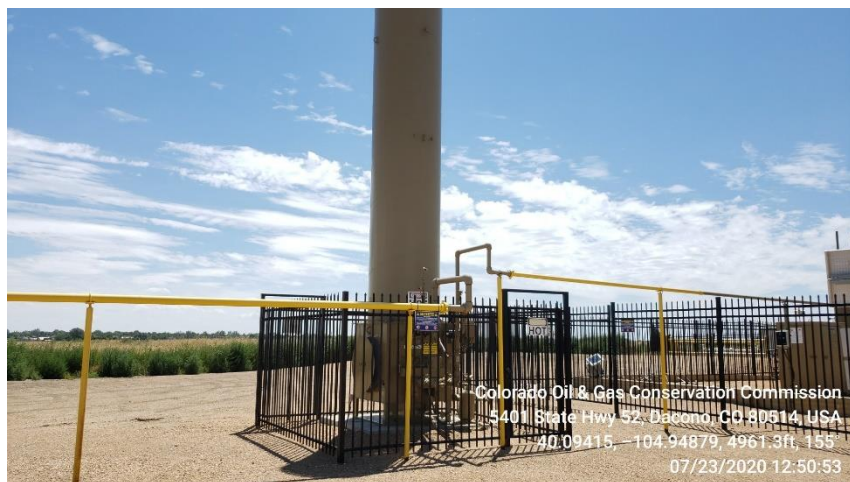
**Photo 3 ECD**

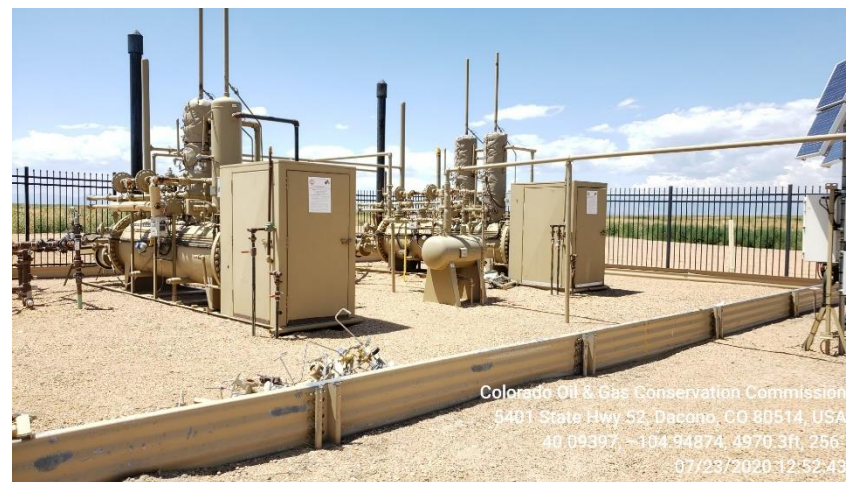
**Photo 4 Horizontal Heated Separators**

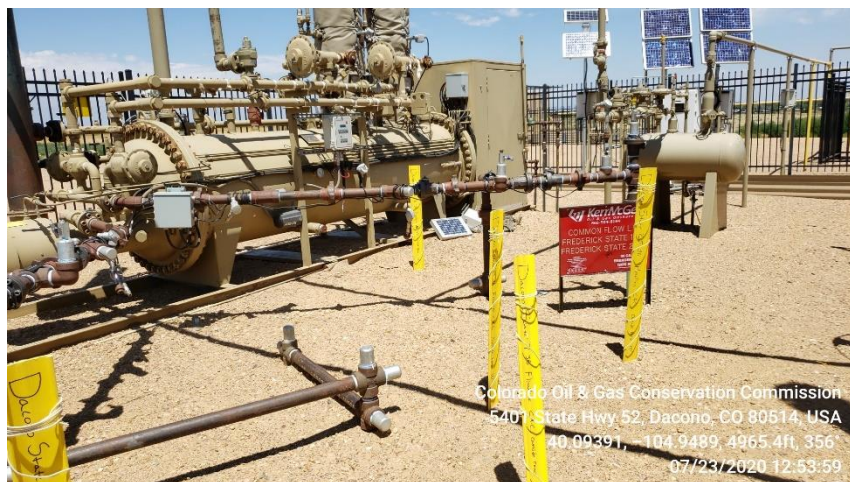
Photo 5 flow lines

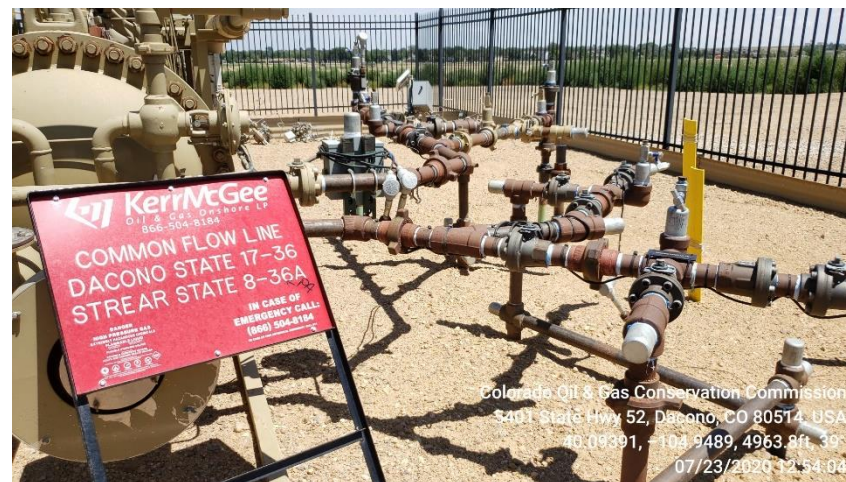
Photo 6 flow lines

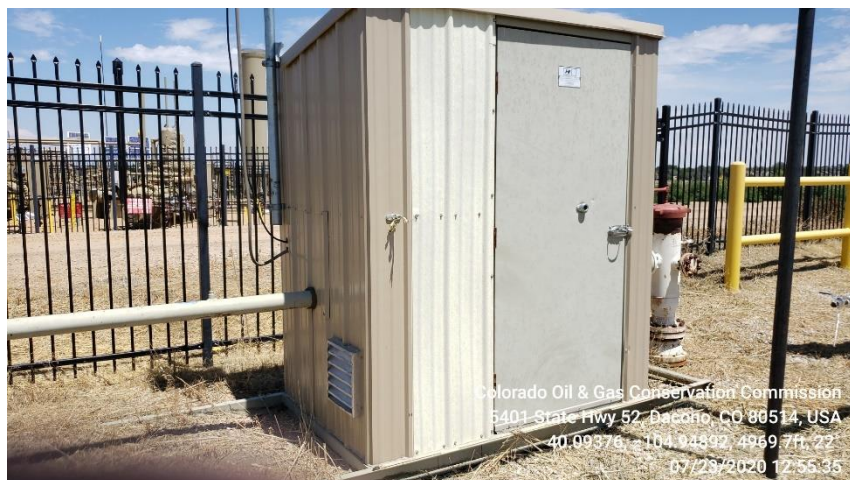
**Photo 7 Unused Gas Meter Run appears to be not connected to production lines**

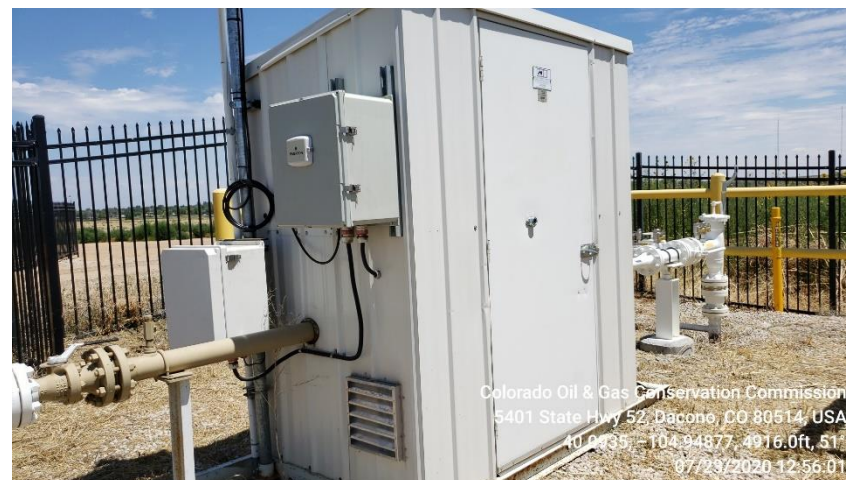
**Photo 8 Gas Meter Run**

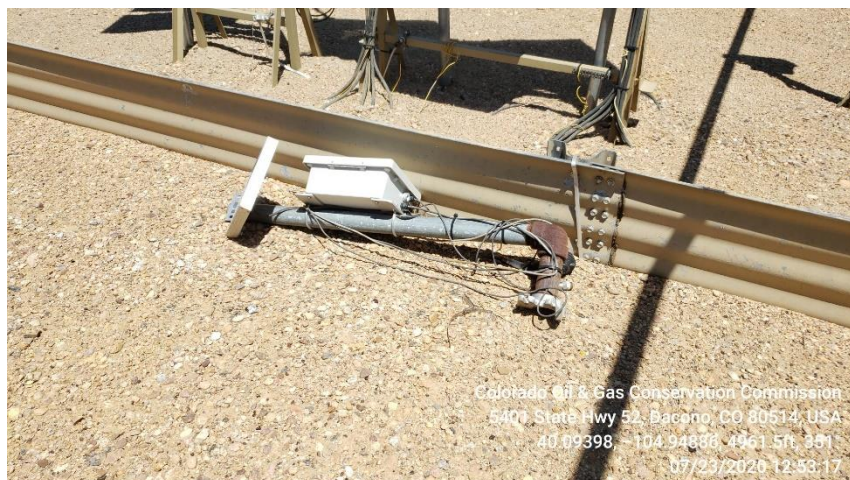
**Photo 11 unused equipment on loc.**

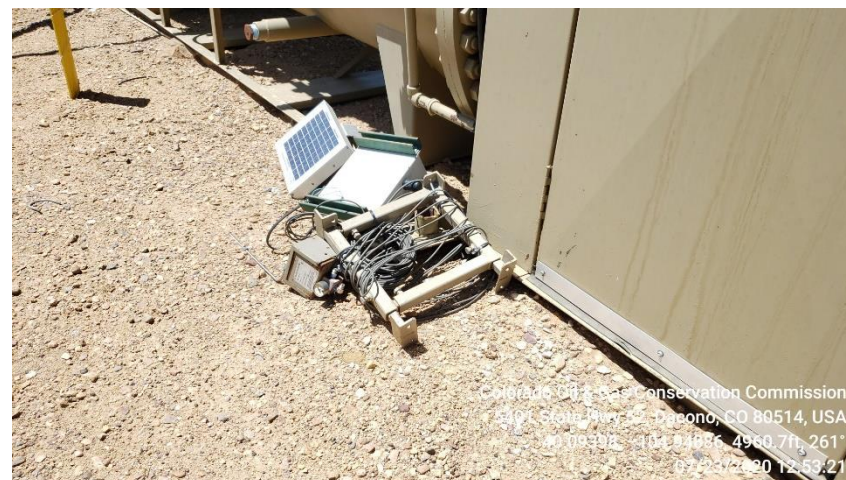
**Photo 12 unused equipment on loc.**

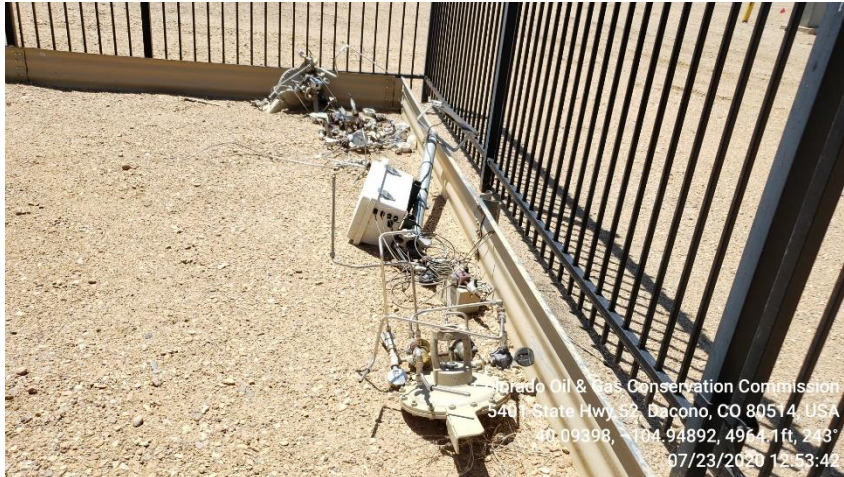
**Photo 13 unused equipment on loc.**
