**Inspection Photos**  
**Location Name: Carl A. Miller A #4**  
**Location ID: 31365**

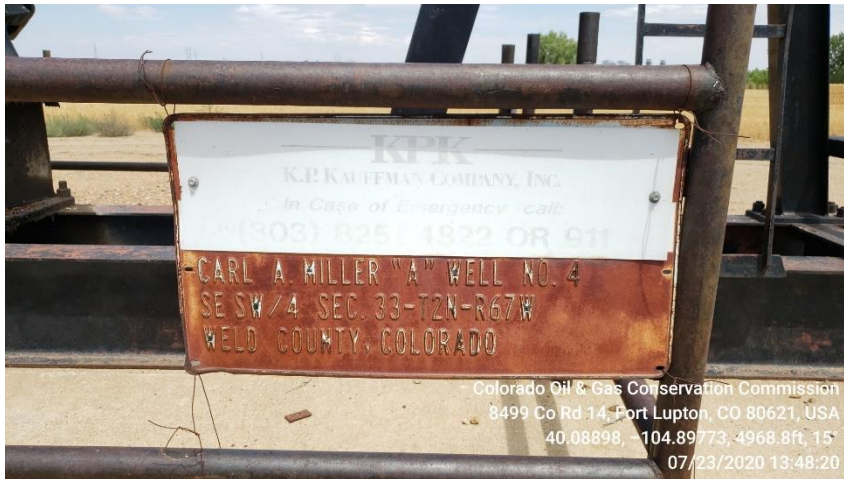
**Photo 1 WH sign faded will need replaced in the near future**

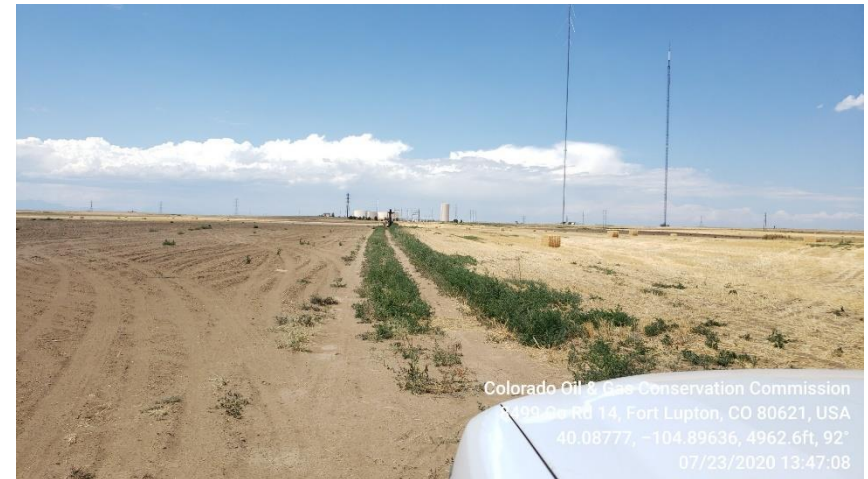
**Photo 4 Weeds growing along access road**

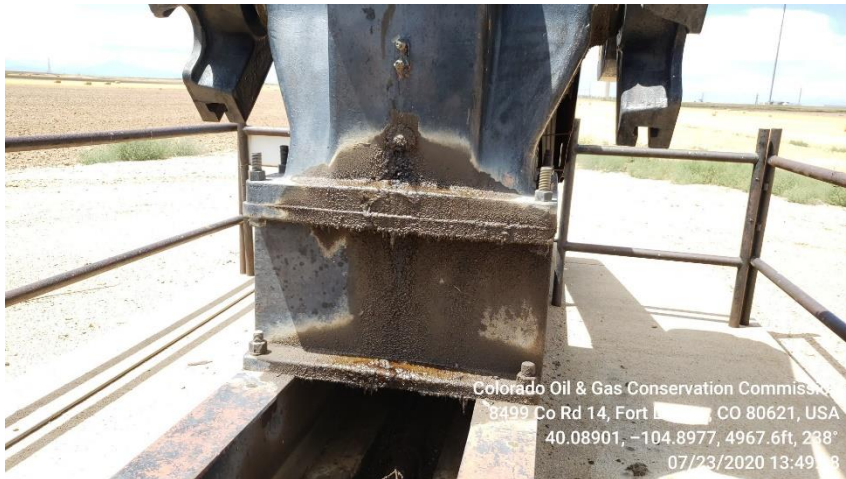
**Photo 5 leaking plug on pump jack gear box**

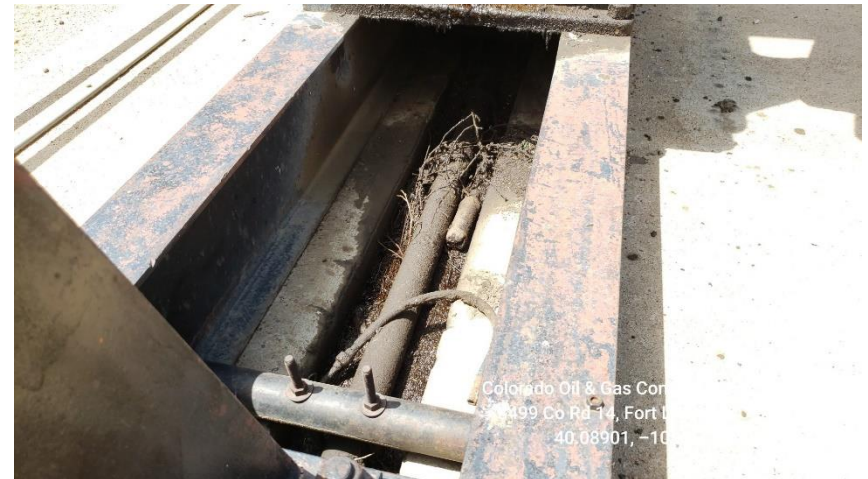
**Photo 6 Stained soil in pump jack base**
