# Inspection Photos

API: 061-06882

Operator: CHESAPEAKE OPERATING LLC

Inspection Date: 7/13/2020

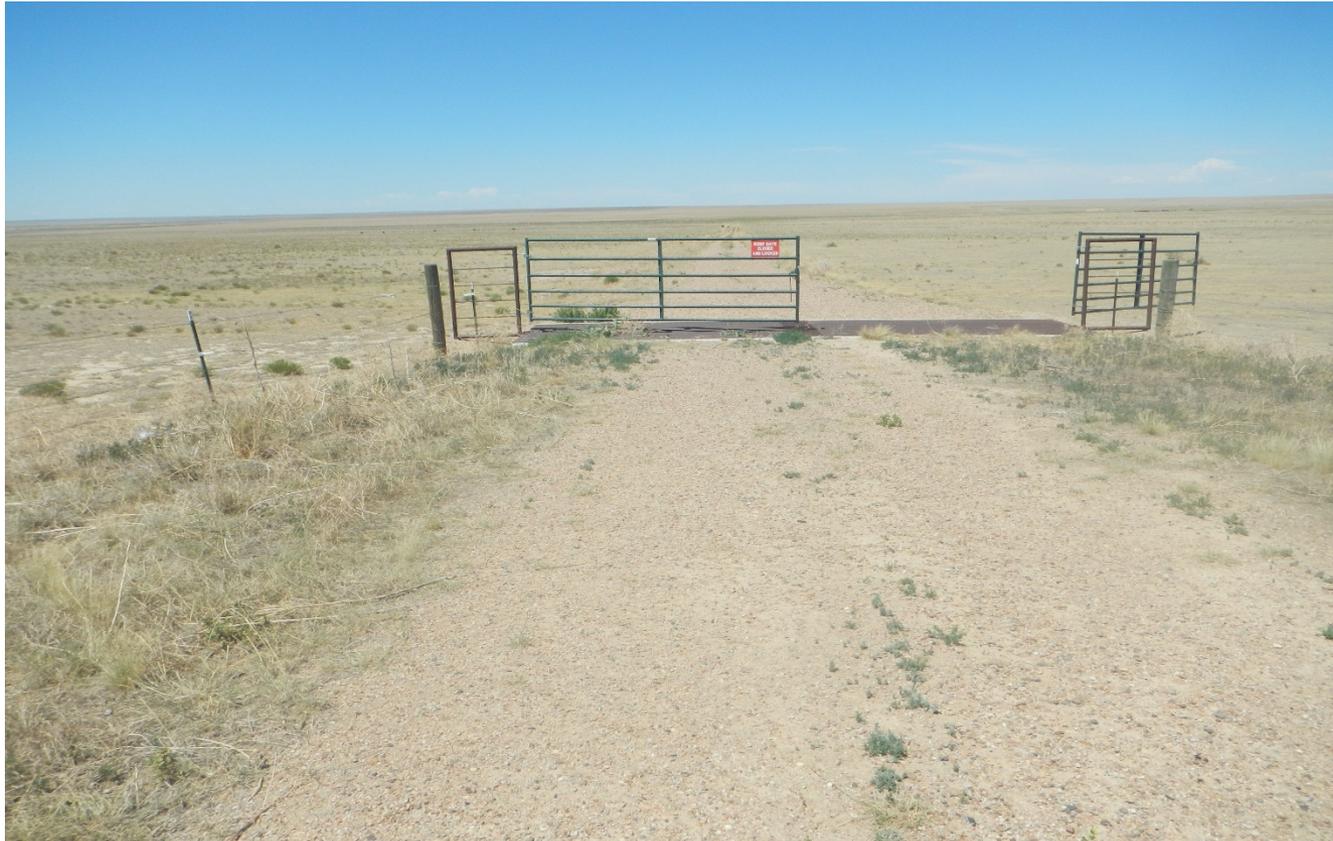
### Photo 1.

Facing west at the beginning of the access road. The access road, gate, and cattle guard remains per approved variance.

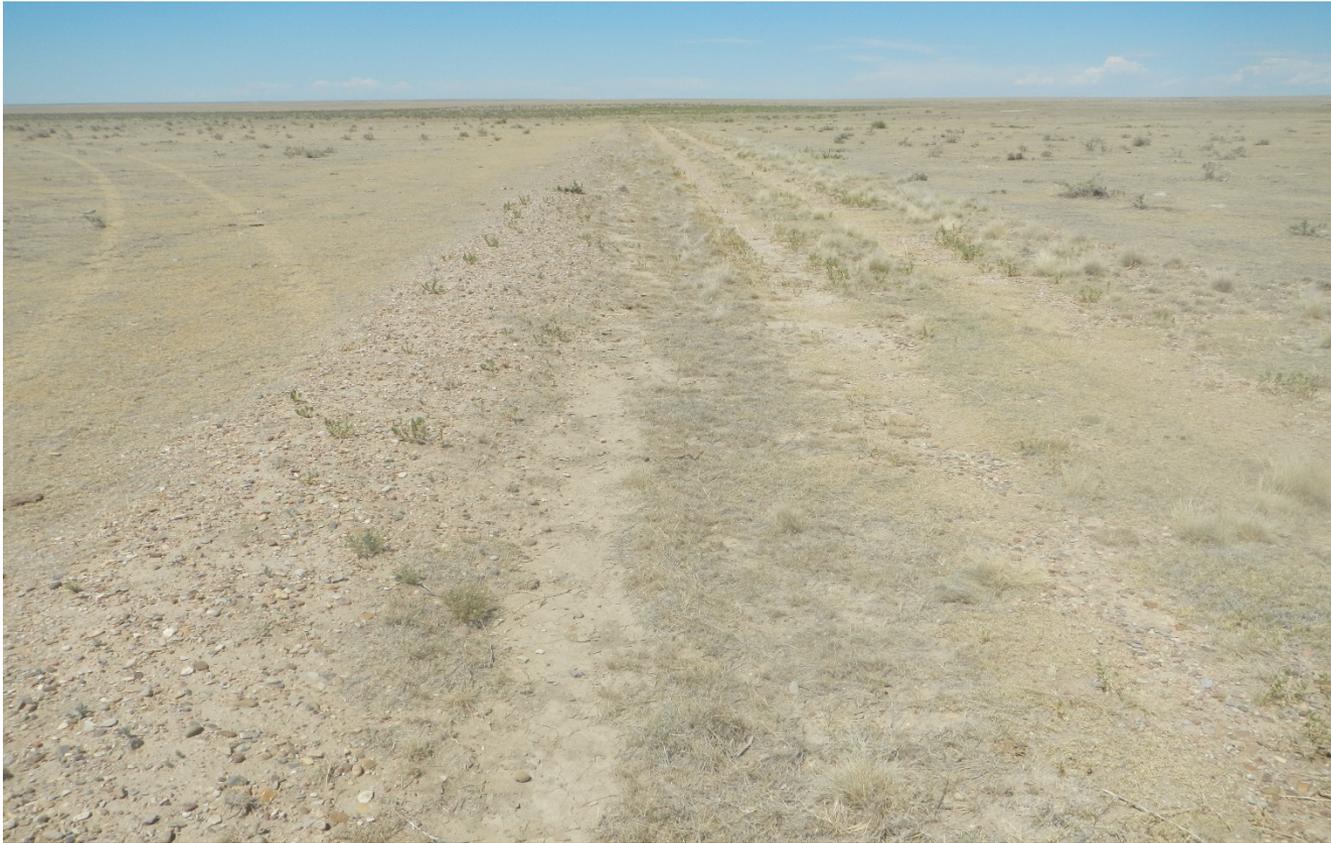
**Photo 2.** Facing east along the two track access road.

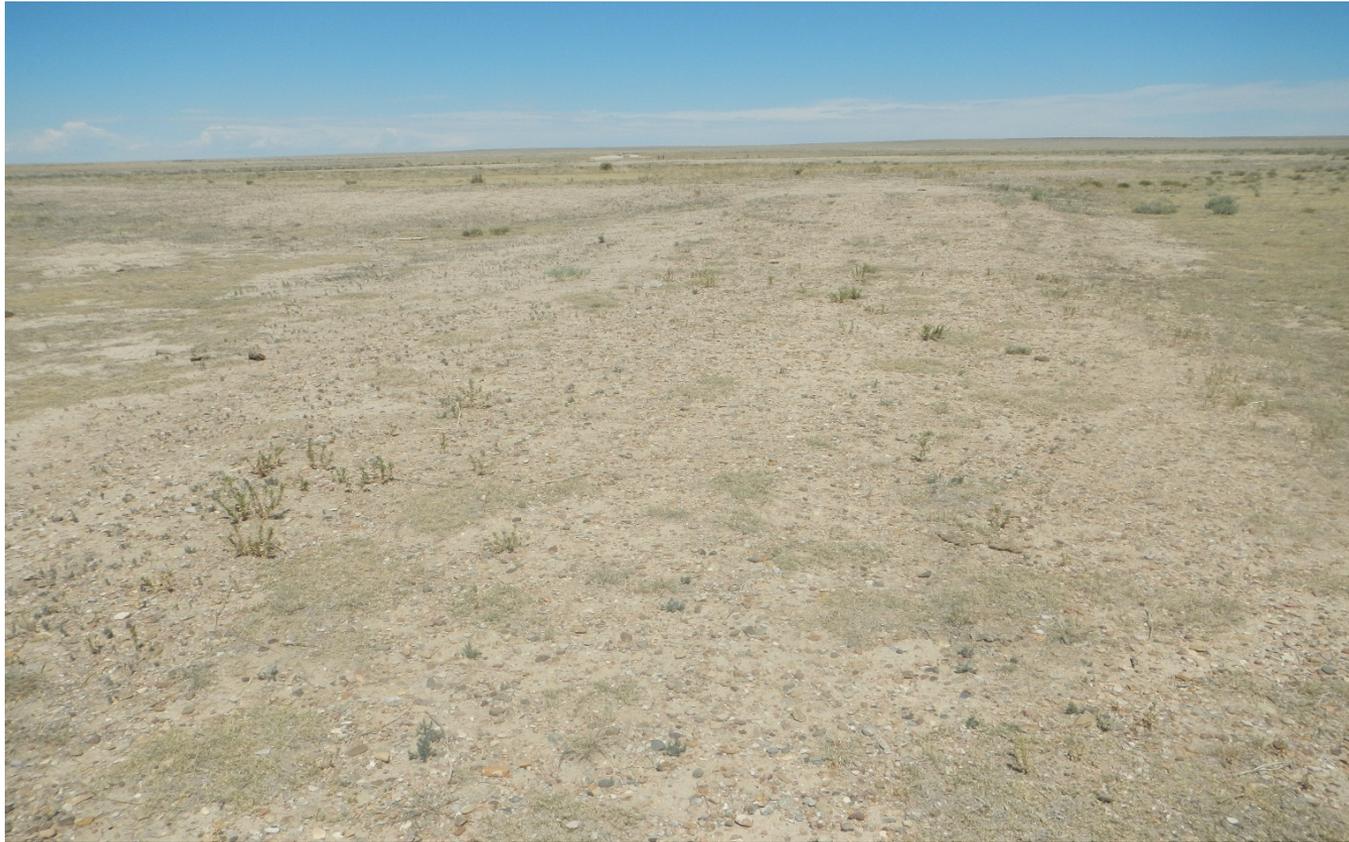
**Photo 3.** Facing northwest toward the location. This area of the location has not established vegetation and is not recontoured.

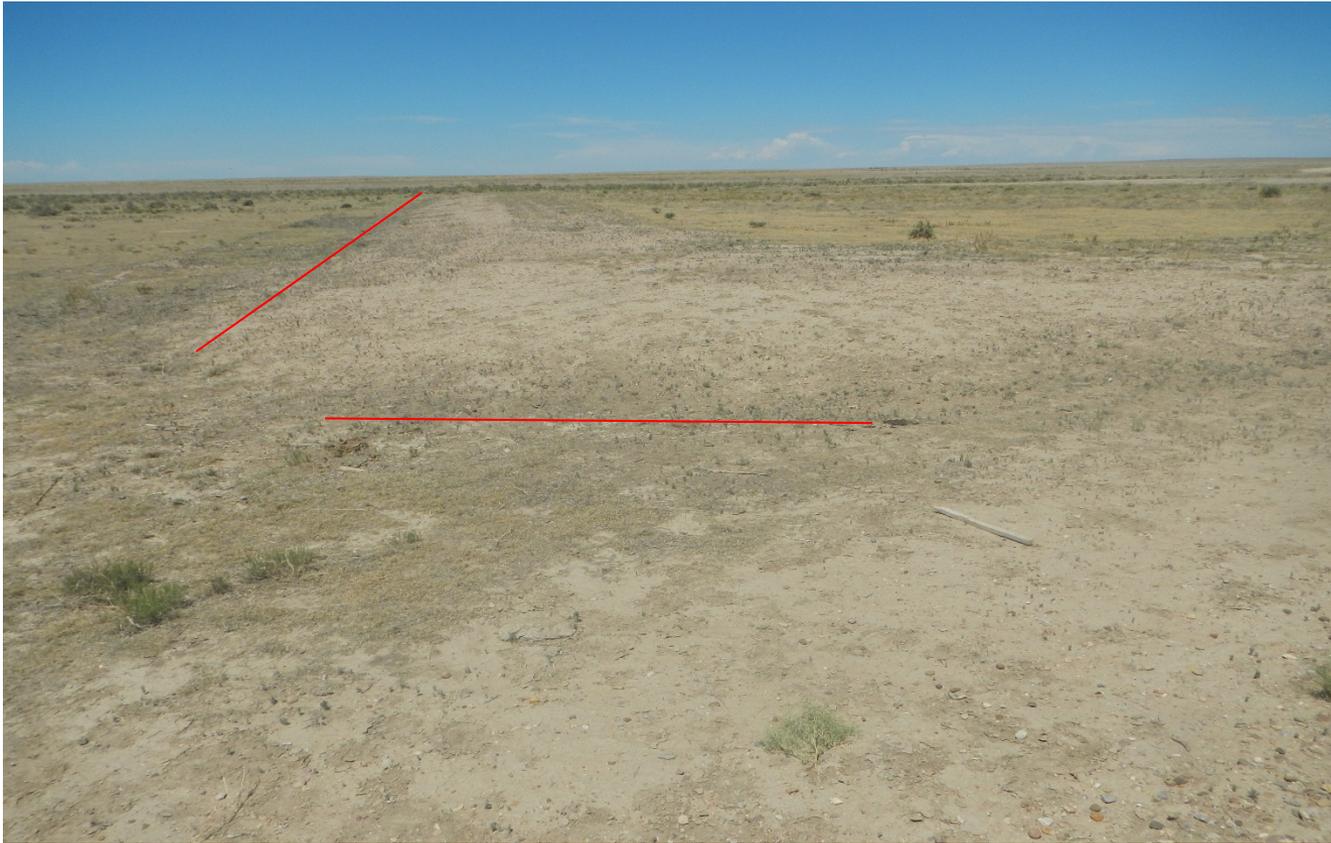
**Photo 4.** Facing west at the south side of the location. The area outlined has not been contoured and vegetation has not established.

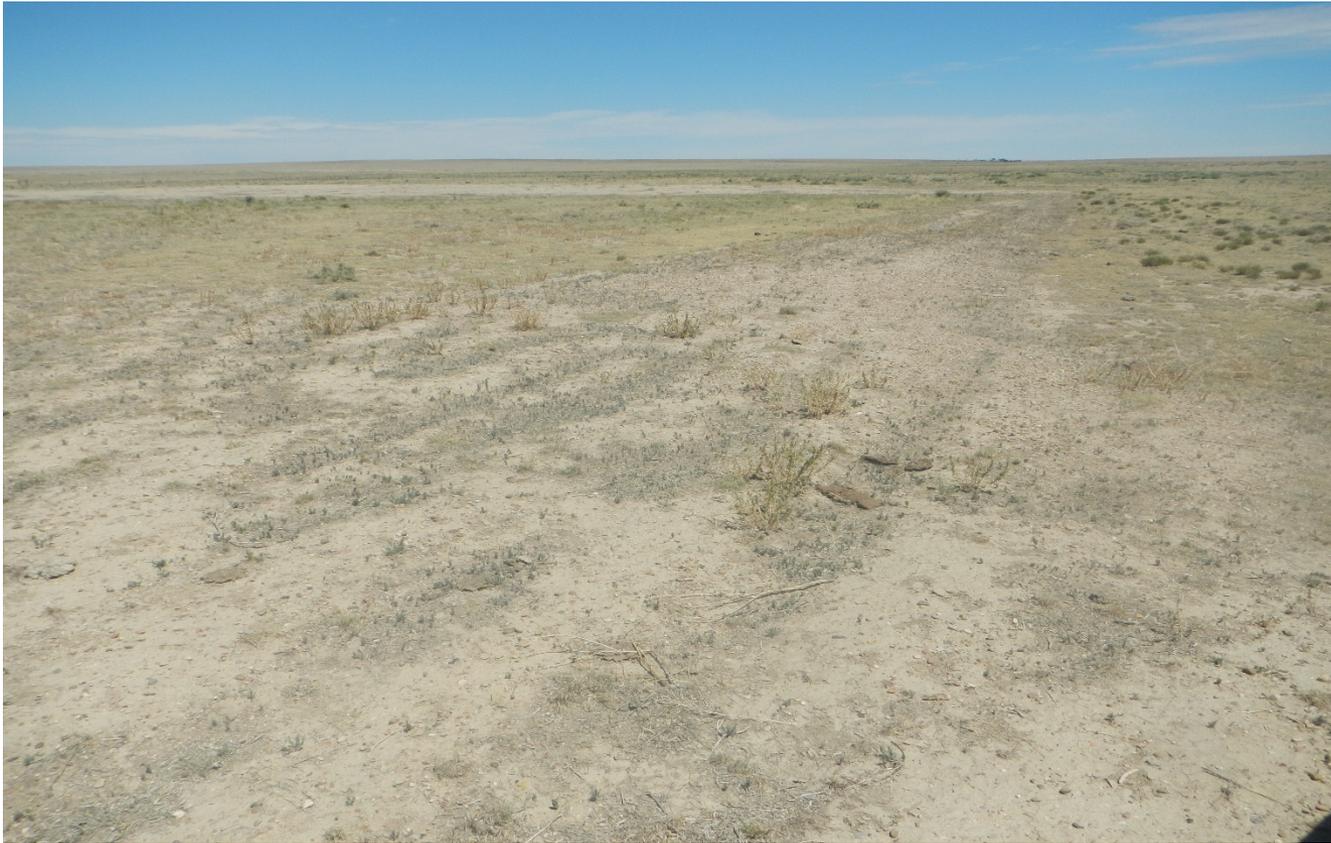
**Photo 5.** Facing northwest at the location.

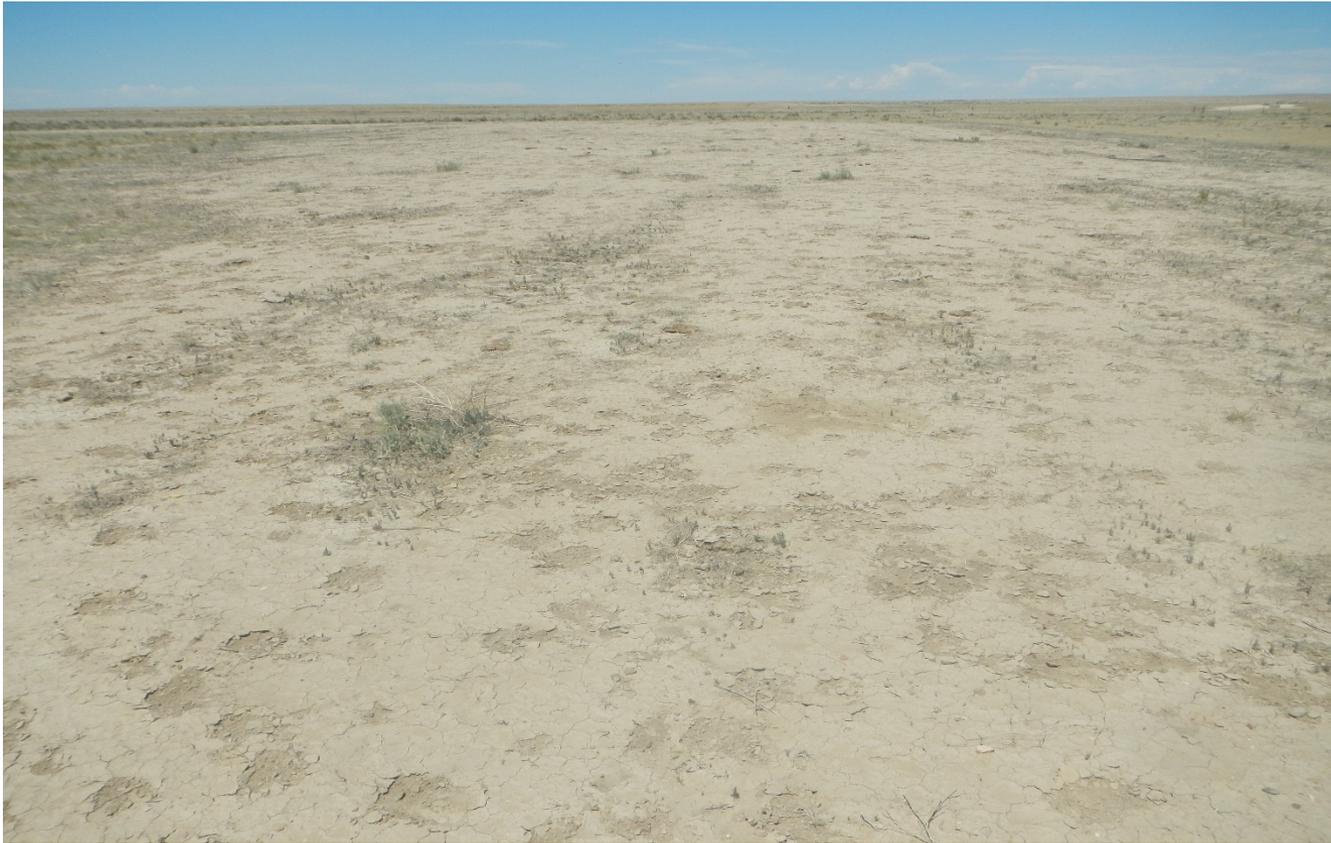
**Photo 6.** Northeast side of the location facing west. This area does not have adequate vegetation growth which is approximately 300 ft. x 100ft.

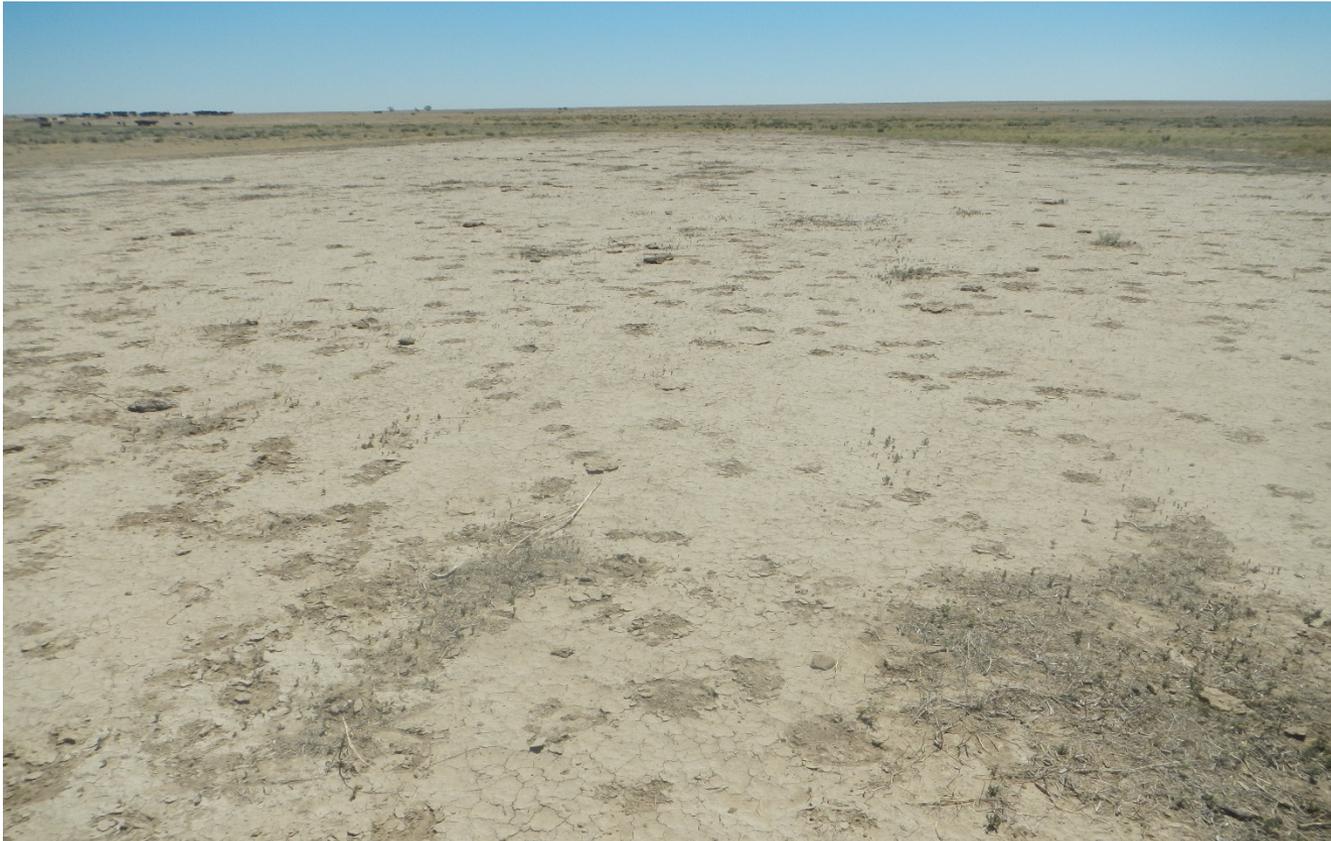
**Photo 7.** Northwest side of the location facing east. This area does not have adequate vegetation growth which is approximately 300 ft. x 100ft.

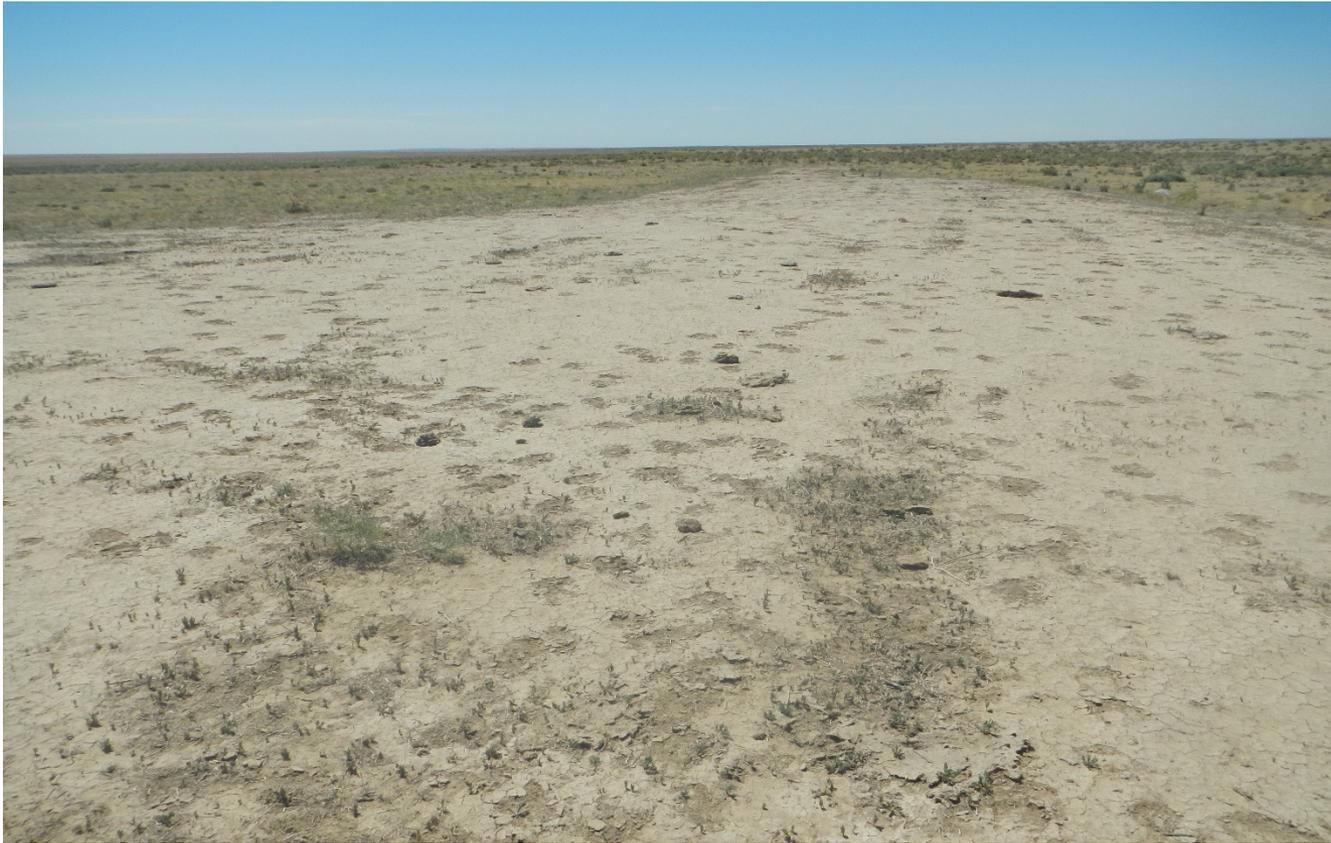
**Photo 8.** Northwest side of the location facing south. This area does not have adequate vegetation growth which is approximately 300 ft. x 70ft.

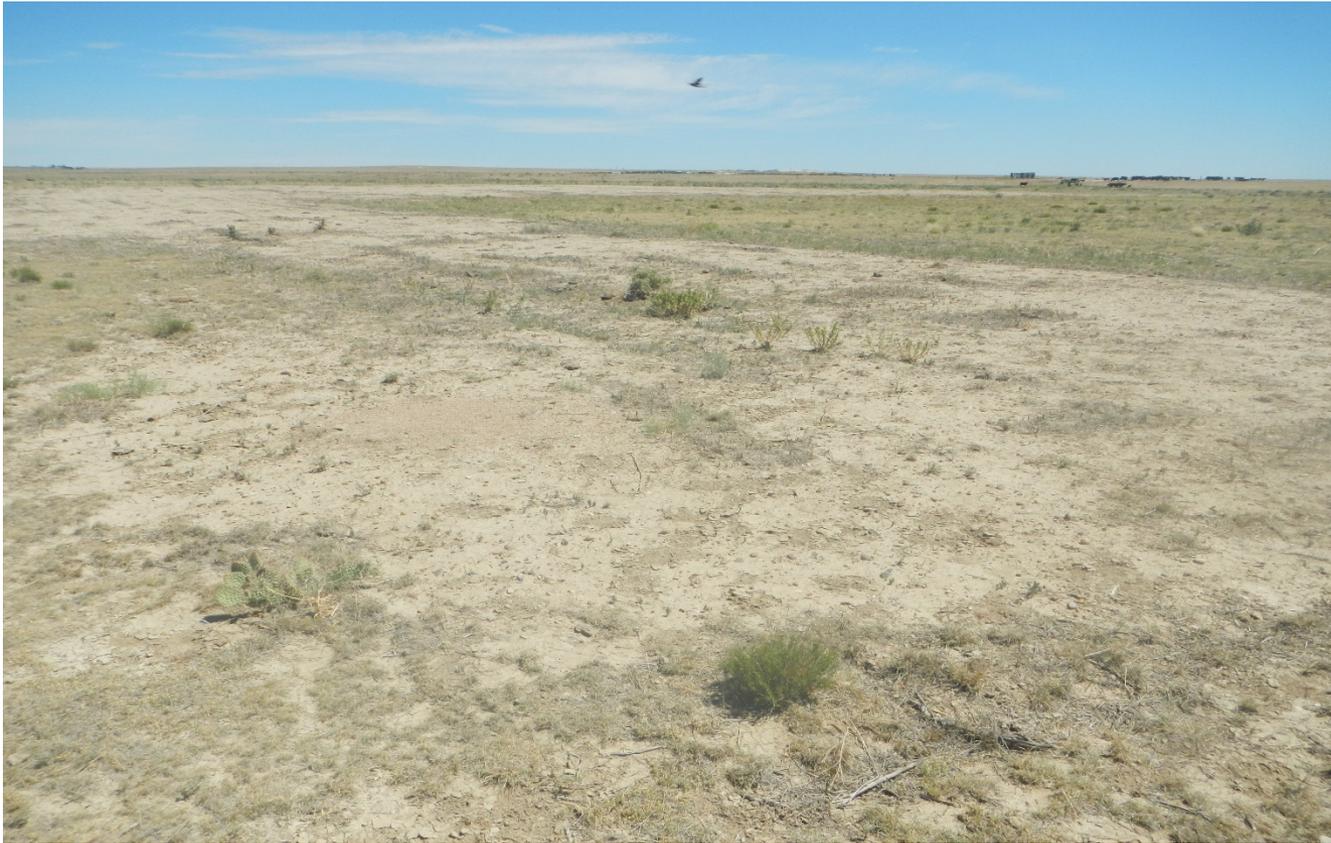
**Photo 9.** Facing northeast toward the location. Vegetation has established in the center of the location. However, the perimeter area of the location has not established vegetation.

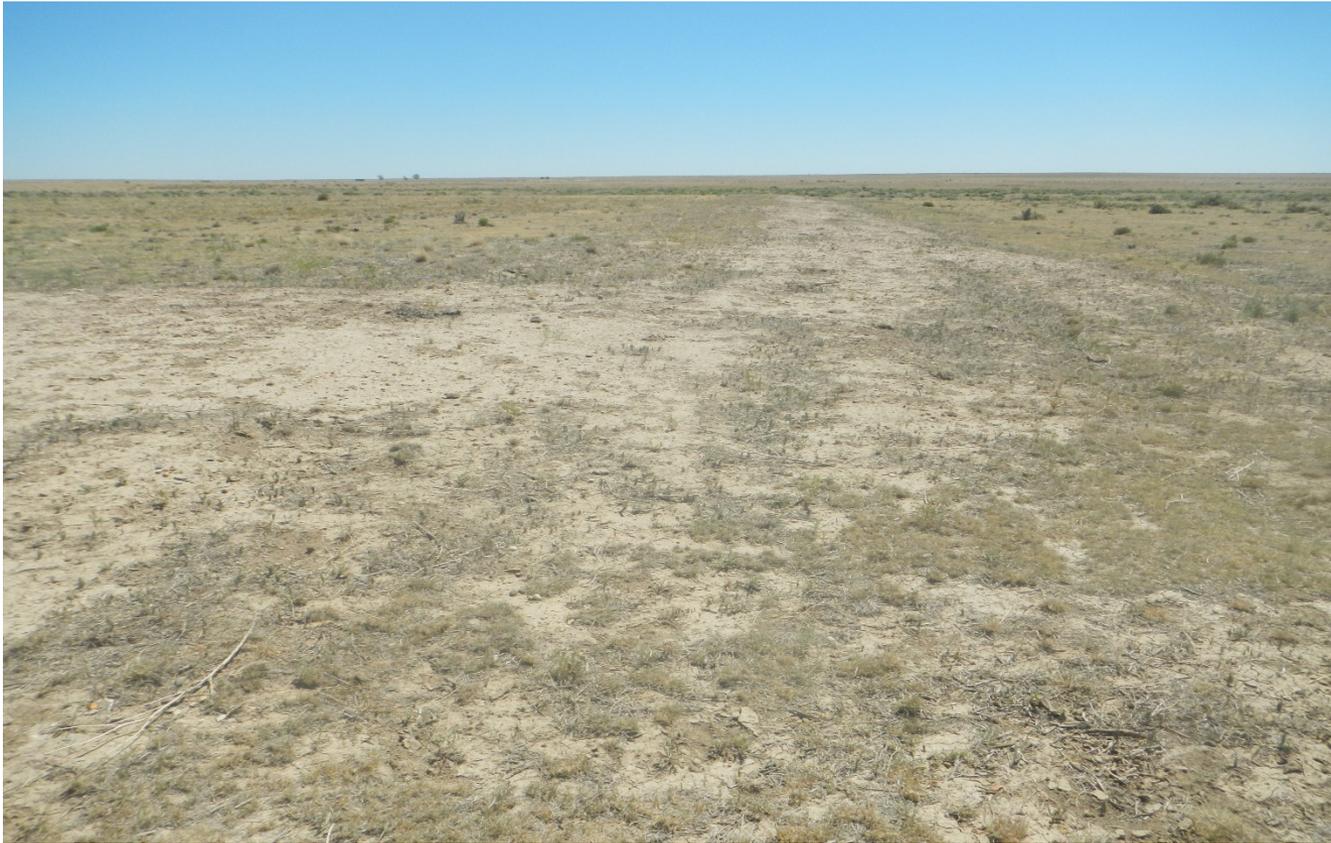
**Photo 10.** Southwest side of the location facing east. This area does not have adequate vegetation growth which is approximately 300 ft. x 40ft.

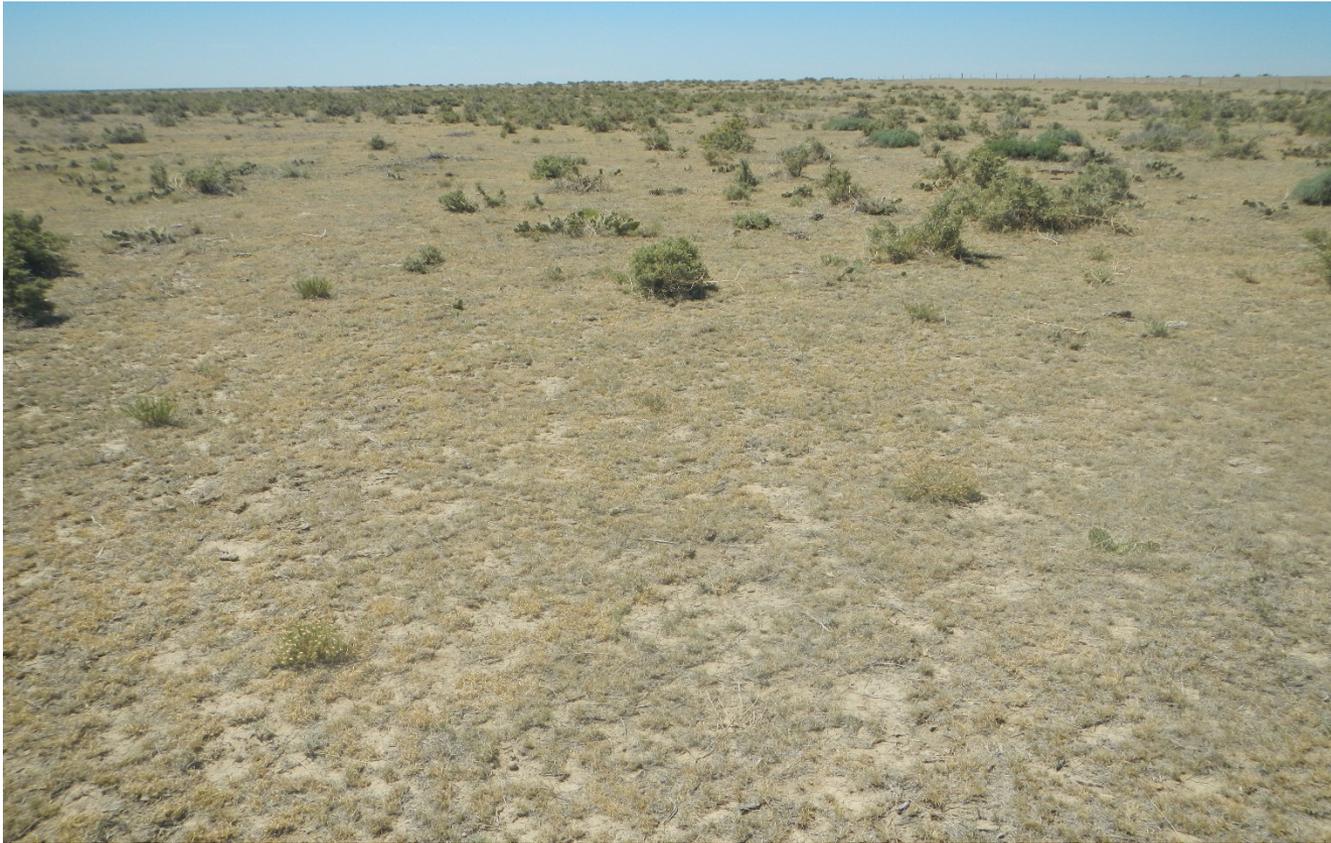
**Photo 11.** Facing south toward the surrounding undisturbed reference area, which consists of Blue grama grassland and shrubland.
