Final Reclamation Inspection

Operator: NOBLE ENERGY INC - #100322

Location ID: 327954

Inspection Photos
Location Name: MYERS #14-21
Location ID: 327954

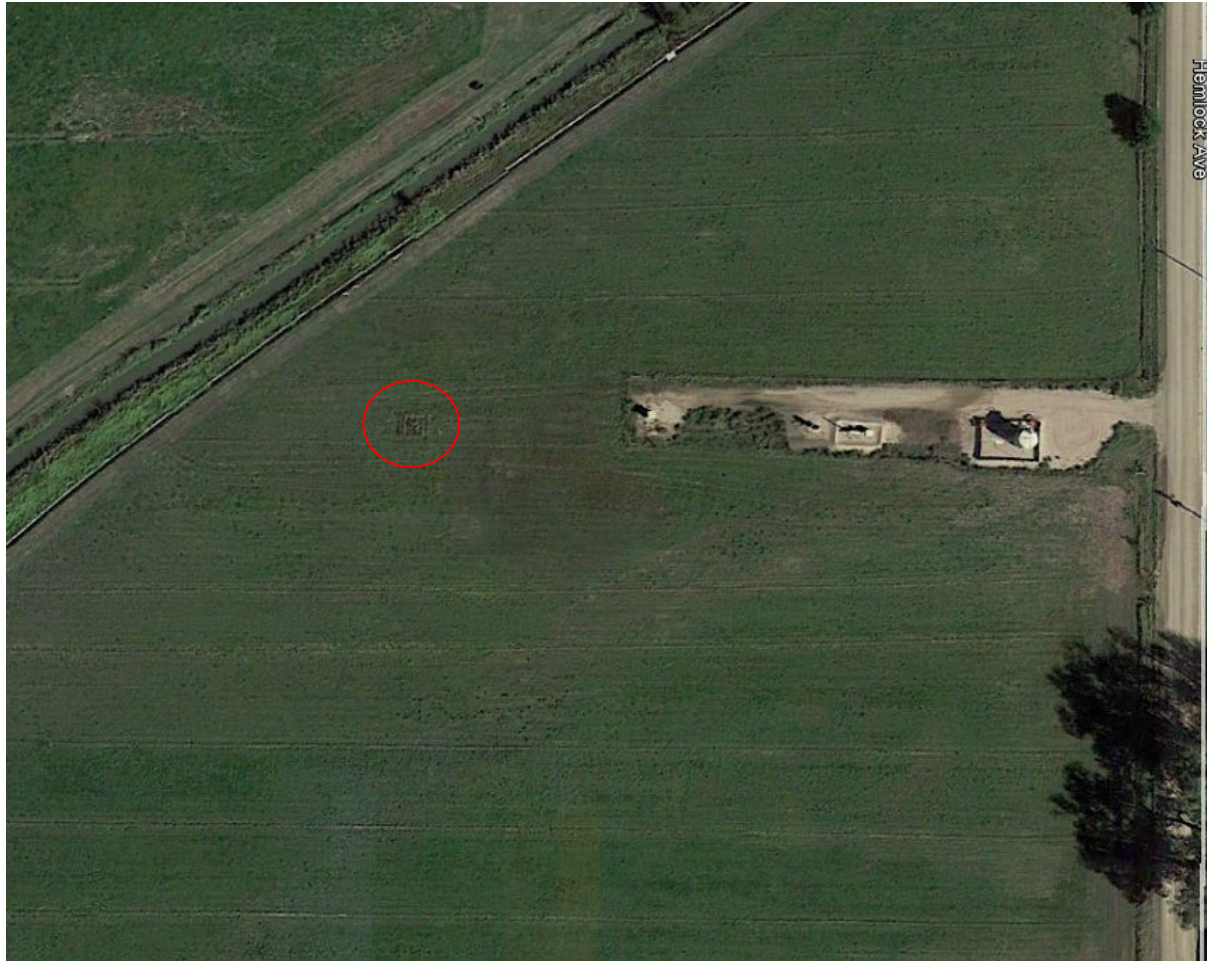
Photo 1. Google Earth aerial imagery taken September 7, 2016 illustrating the well location (red circle) and production facility during active operations.

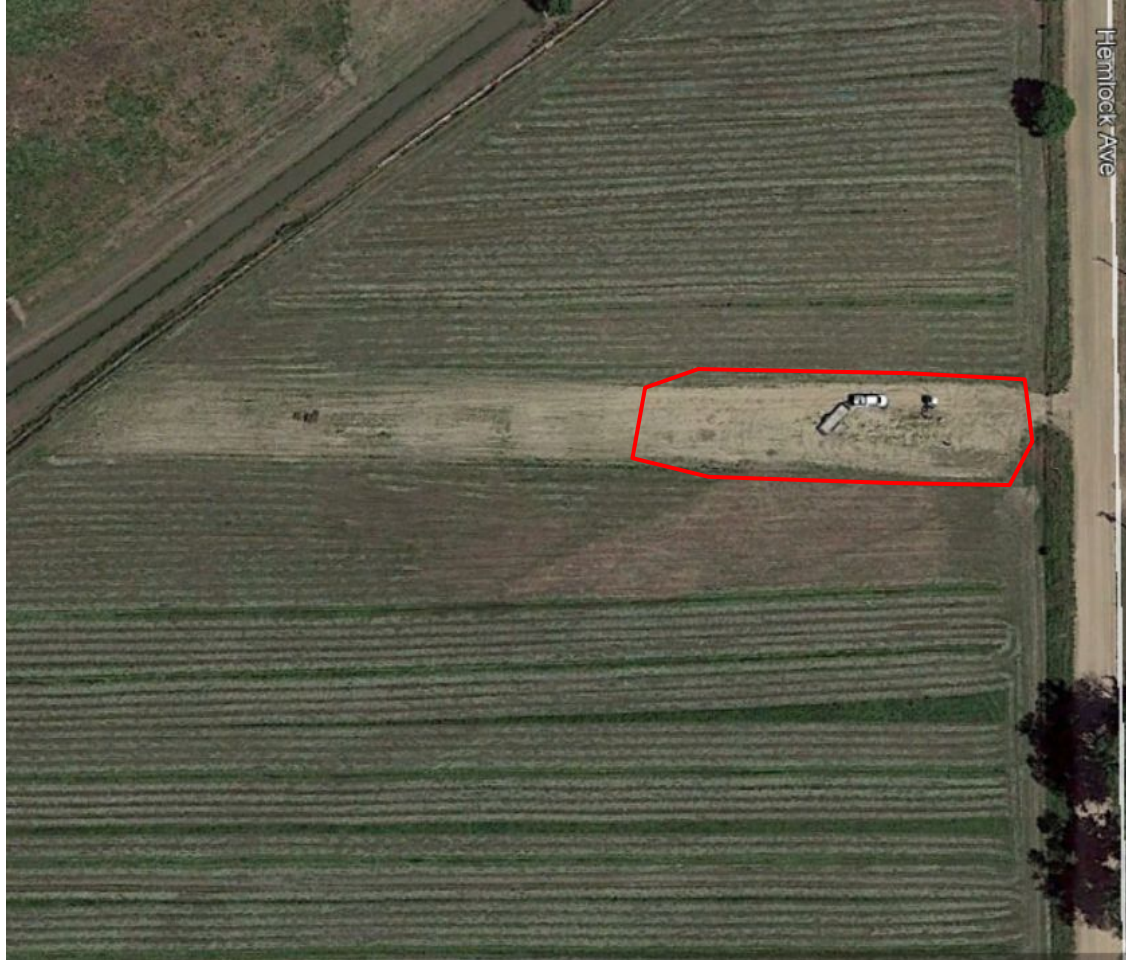
Photo 2. Google Earth aerial imagery taken July 17, 2019.

This complaint is in regards to an approximate area (red polygon) where soil material was added due to subsidence. Complainant believes the soil material added is poor quality soil.

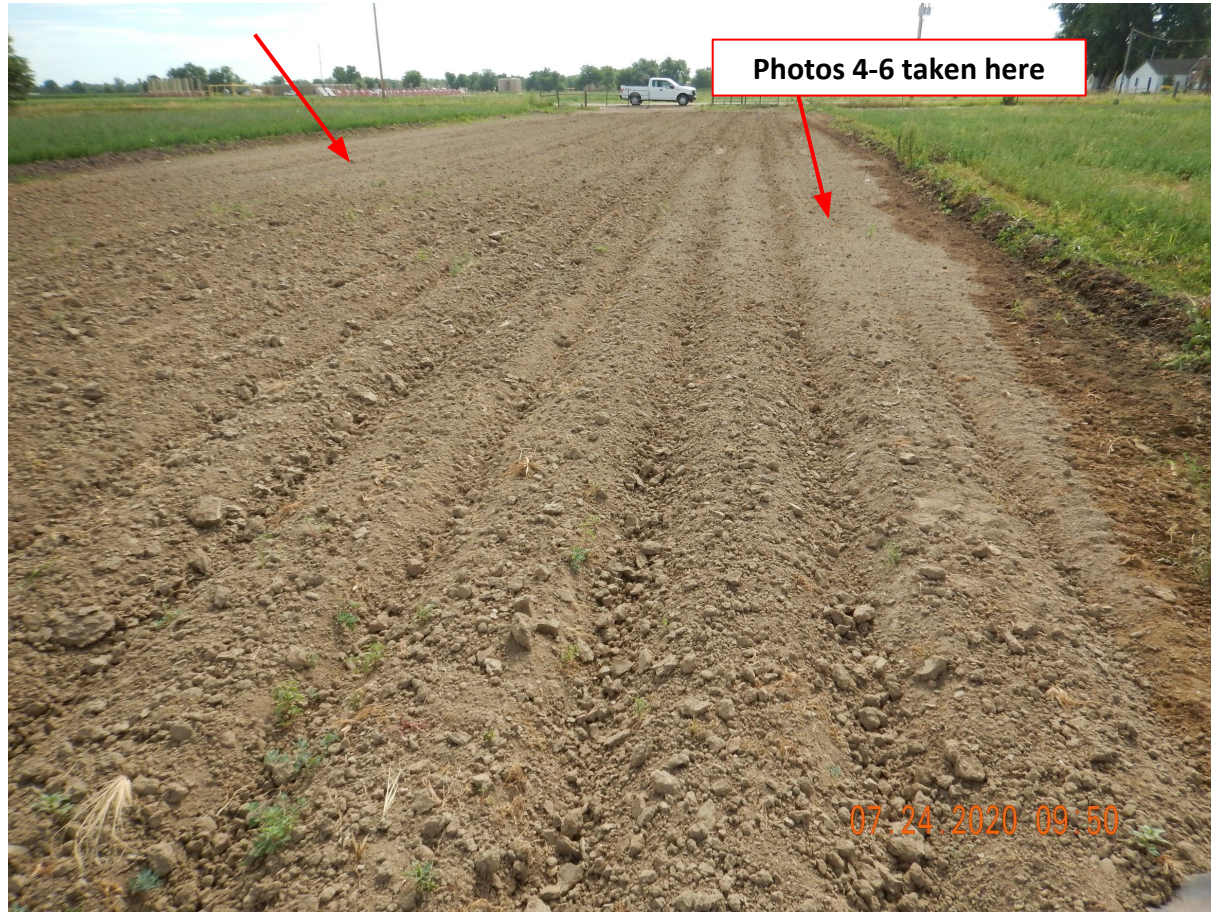
Photo 3. Photo taken from the western area of subsidence, facing East. Photo illustrates Operator has added soil material to correct subsidence, tilled the added soil material, and recontoured the area. Complainant indicated that poor quality soil was added.

The arrows highlight areas of questionable soil material. The questionable soil material appears to have a high silt content which does not appear to be consistent with reference soils.

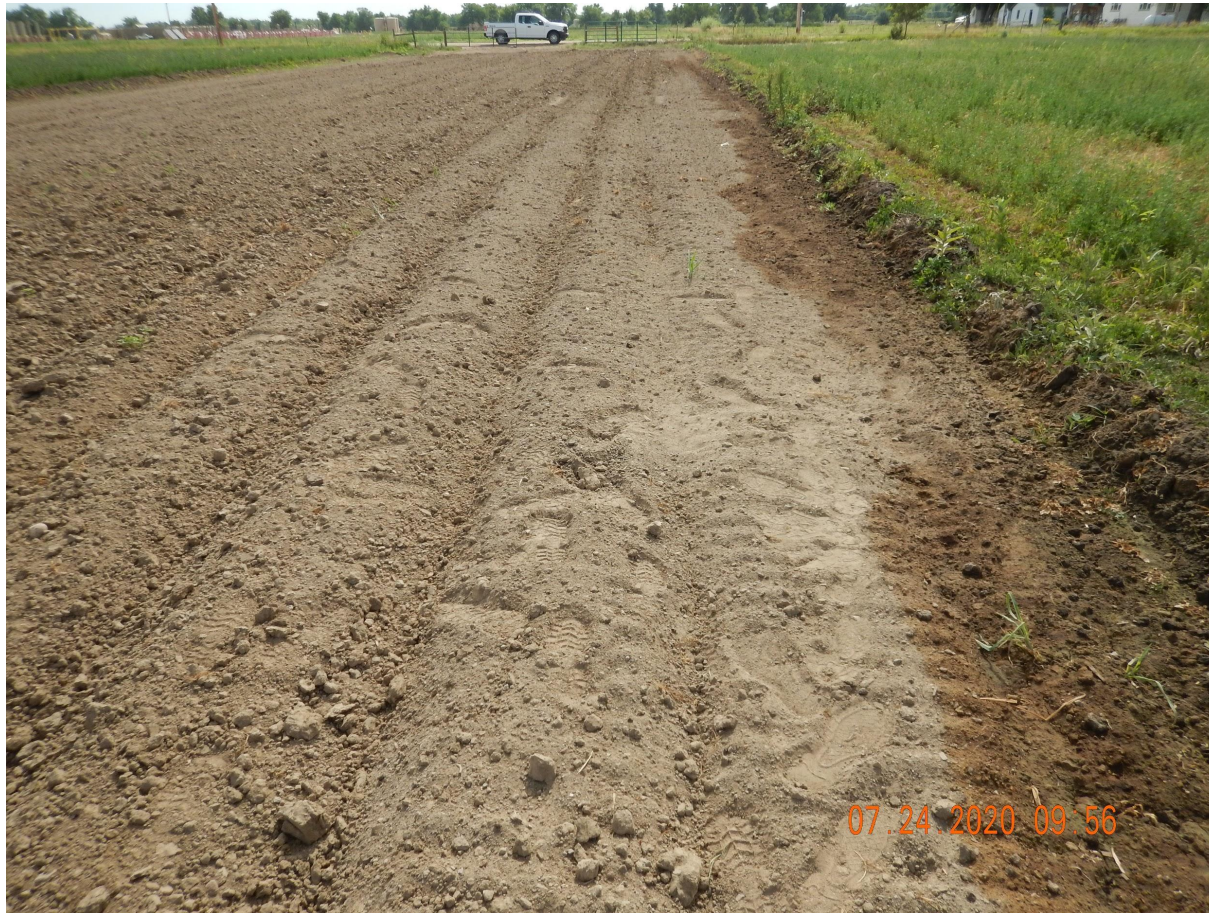
Photo 4. Close up photo taken from the questionable soil material which appears to have a high silt content, facing East.

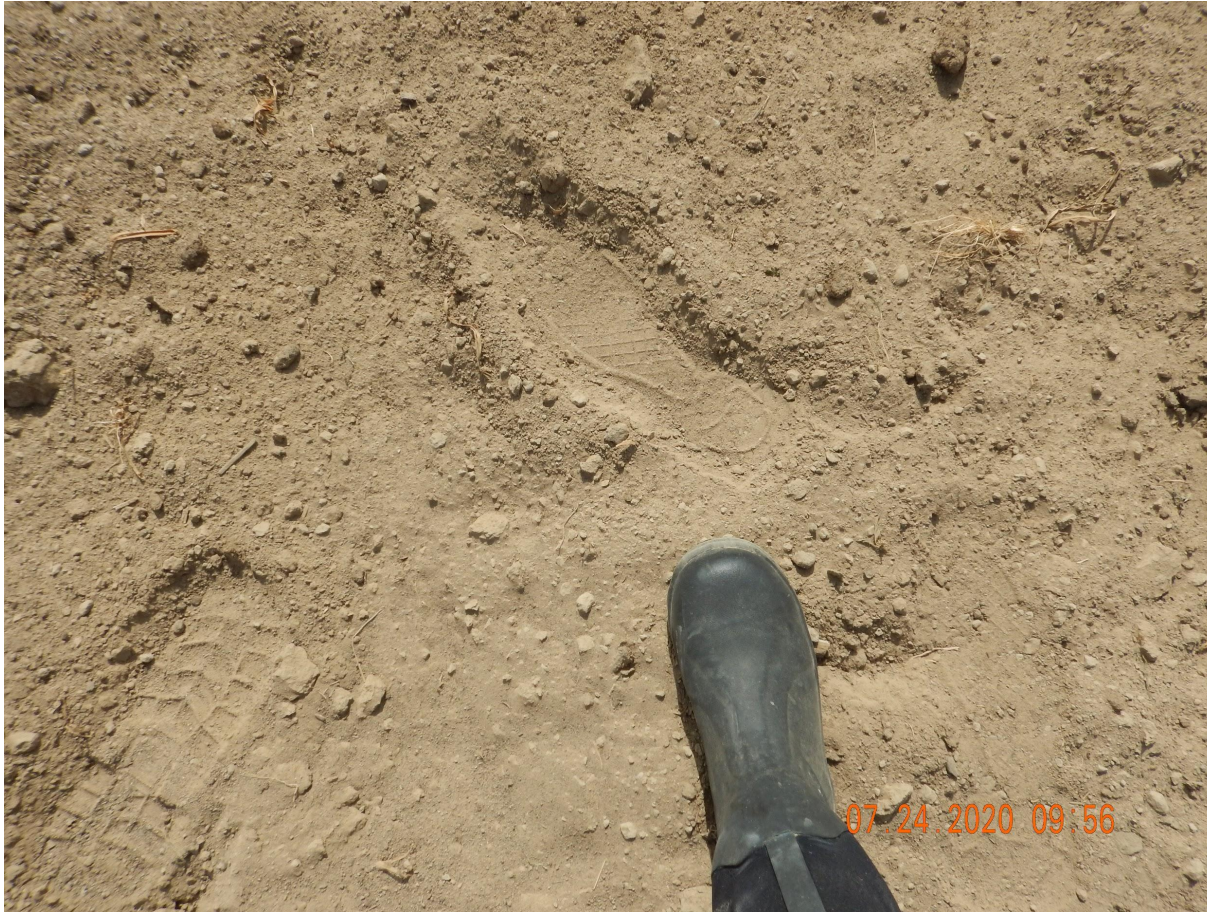
Photo 5. Close up photo taken from the questionable soil material which appears to have a high silt content.

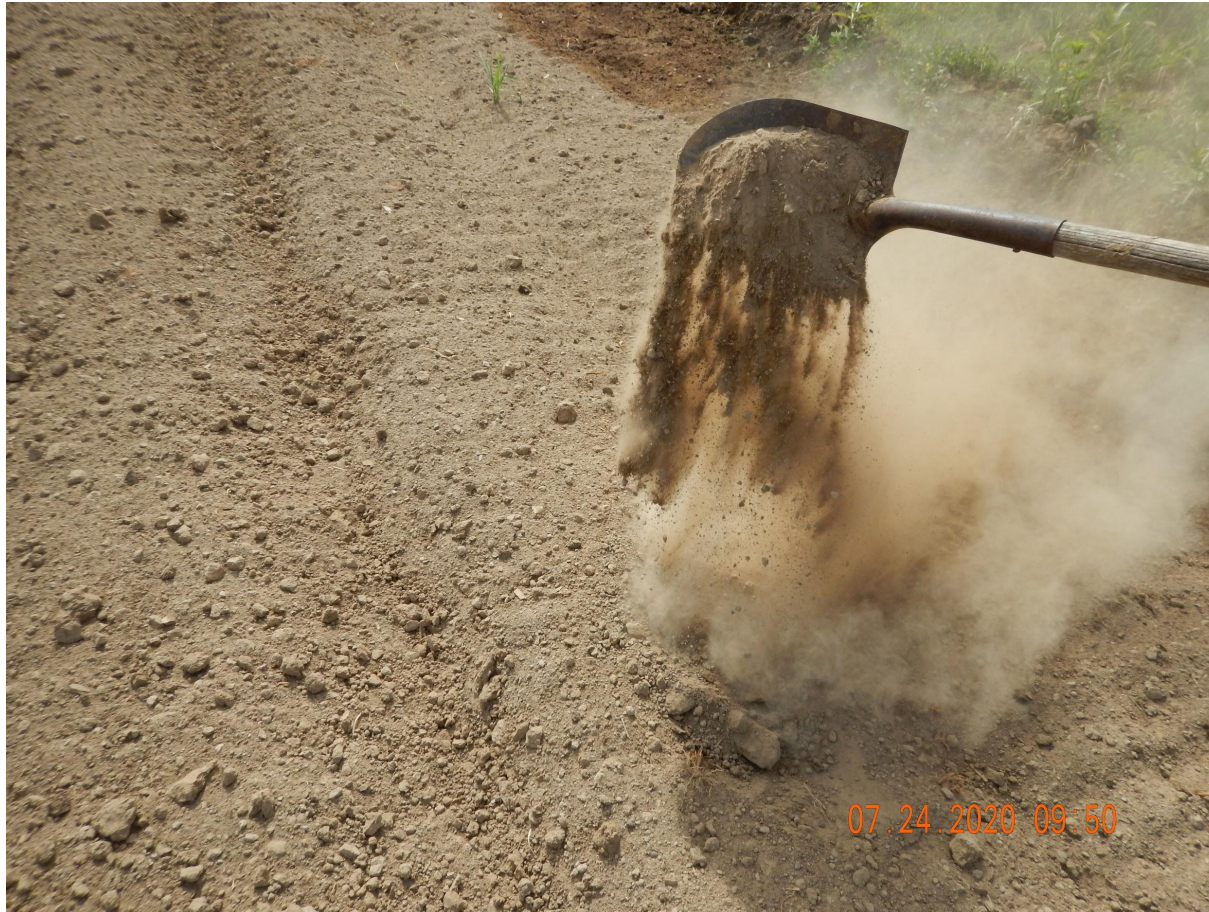
Photo 6. Close up photo taken from the questionable soil material which appears to have a high silt content.

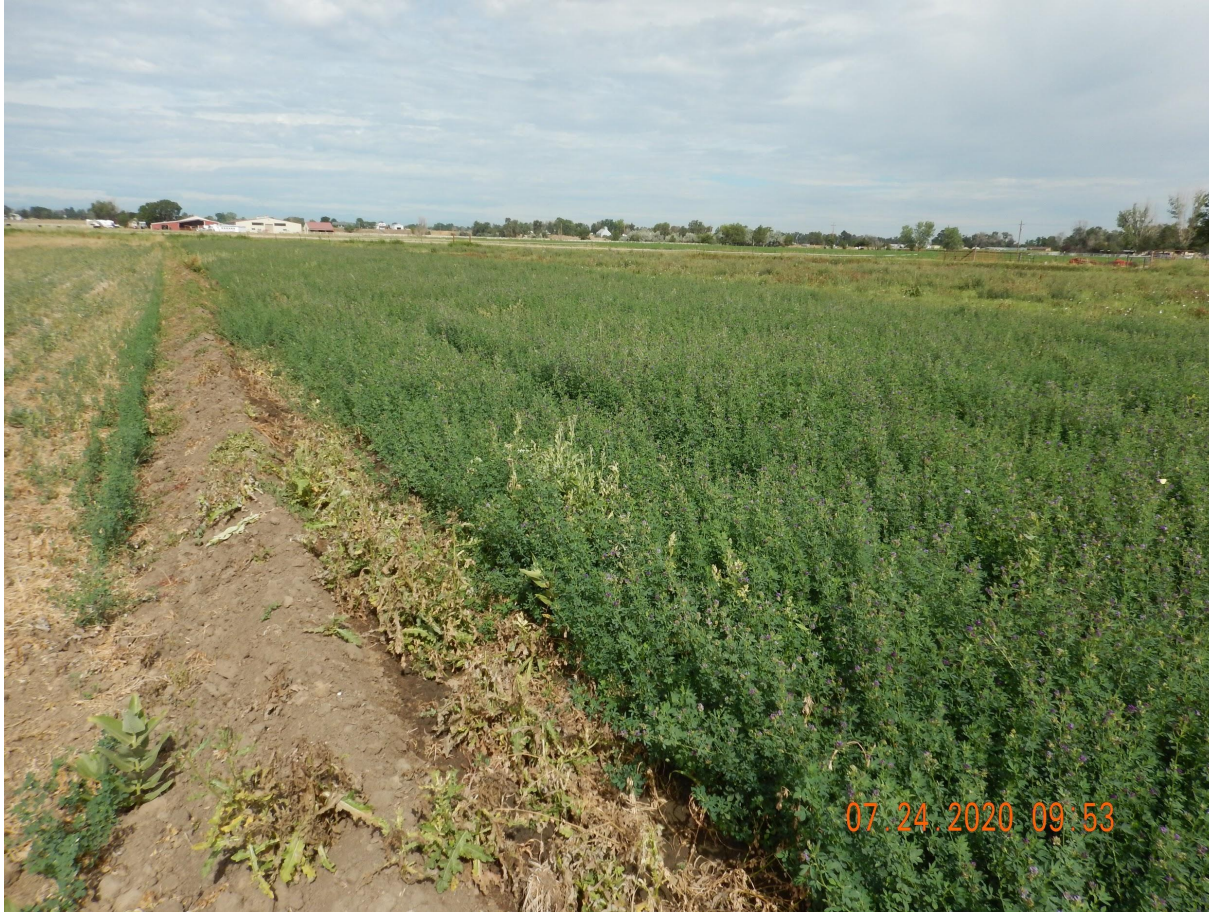
Photo 7. Reference photo taken north of the disturbance area, facing West. Photo illustrates the surface owner has converted to alfalfa crop production.
