Inspection Photos

Location Name: ELDRIDGE 25-02 1

API#: 05-071-07432

INSP. #: 695102998

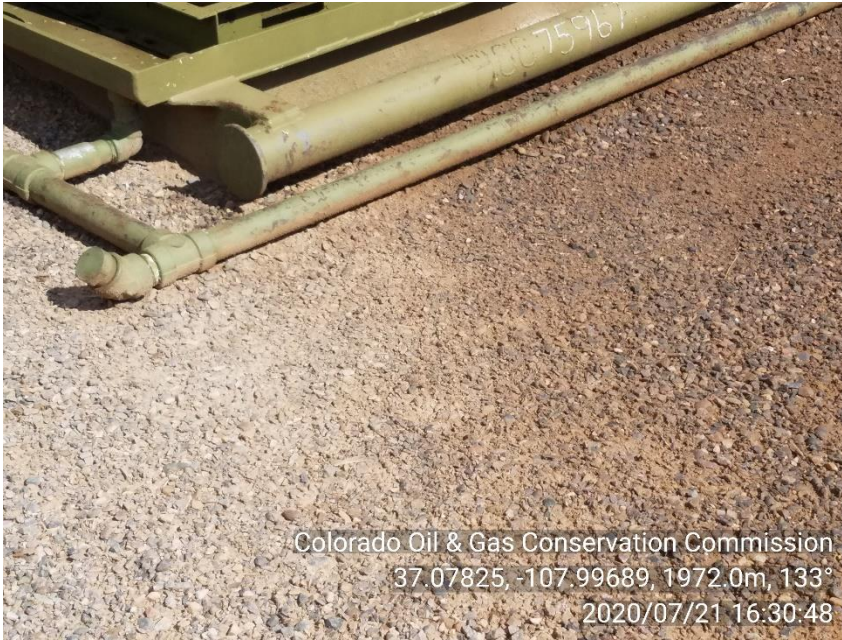
PHOTO 3: AREA OF IMPACTED SOIL NEAR FRONT OF COMPRESSOR. Conduct maintenance on equipment, cleanup stained material and review self inspection processes. CA DATE 10-21-20.

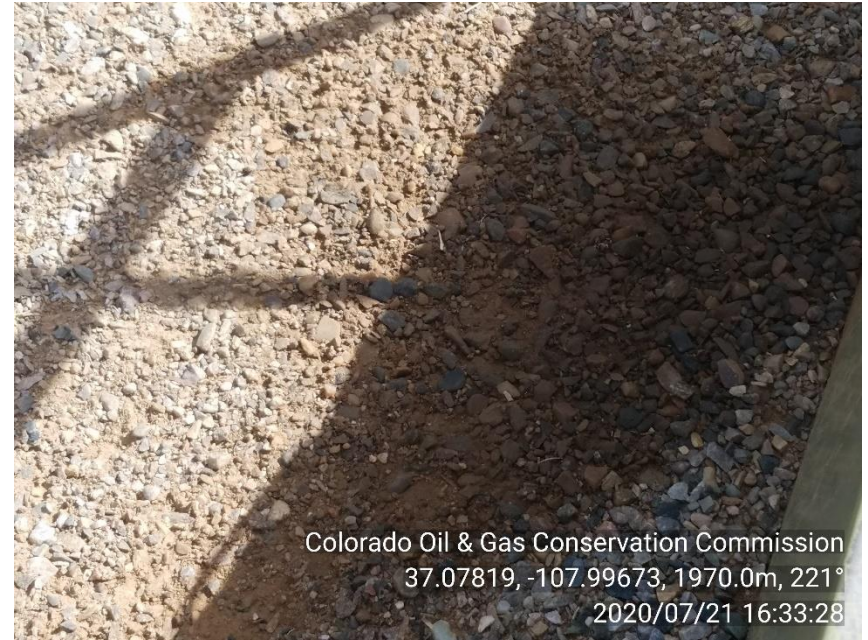
PHOTO 4: AREA OF IMPACTED SOIL NEAR FRONT OF GAS ENGINE OIL TANK. Conduct maintenance on equipment, cleanup stained material and review self inspection processes. CA DATE 10-21-20.

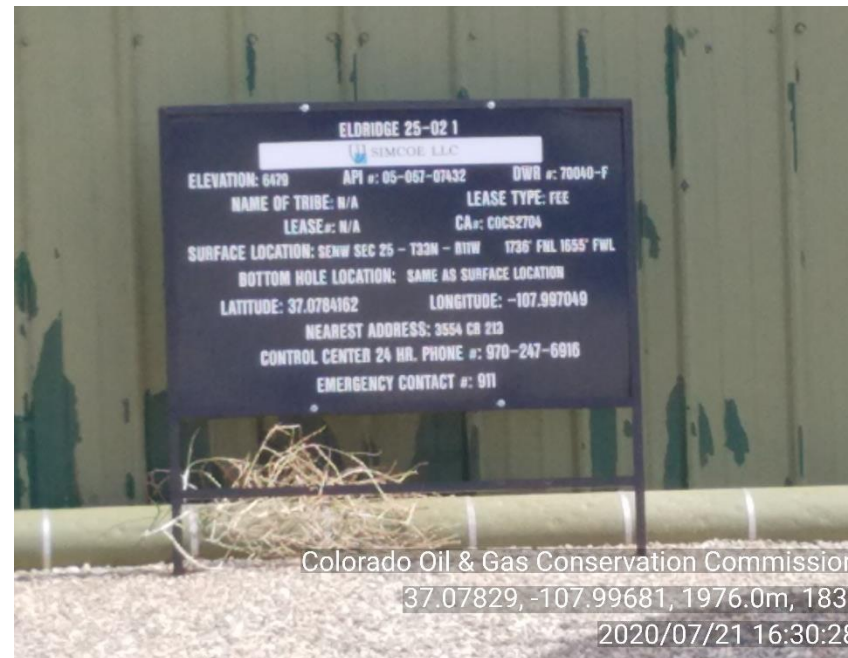
PHOTO 2: WELL SIGN
