Re: Mautz Pit; COGCC Facility #444993 – Hydrostatic Pit Integrity Test
SE ¼ NW ¼ of Section 19, Township 2 South, Range 98 West, 6th P.M.
Rio Blanco County, Colorado

Hydrostatic Pit Testing

Mautz Ranch Produced Water Pit

Hydrostatic Pit Test

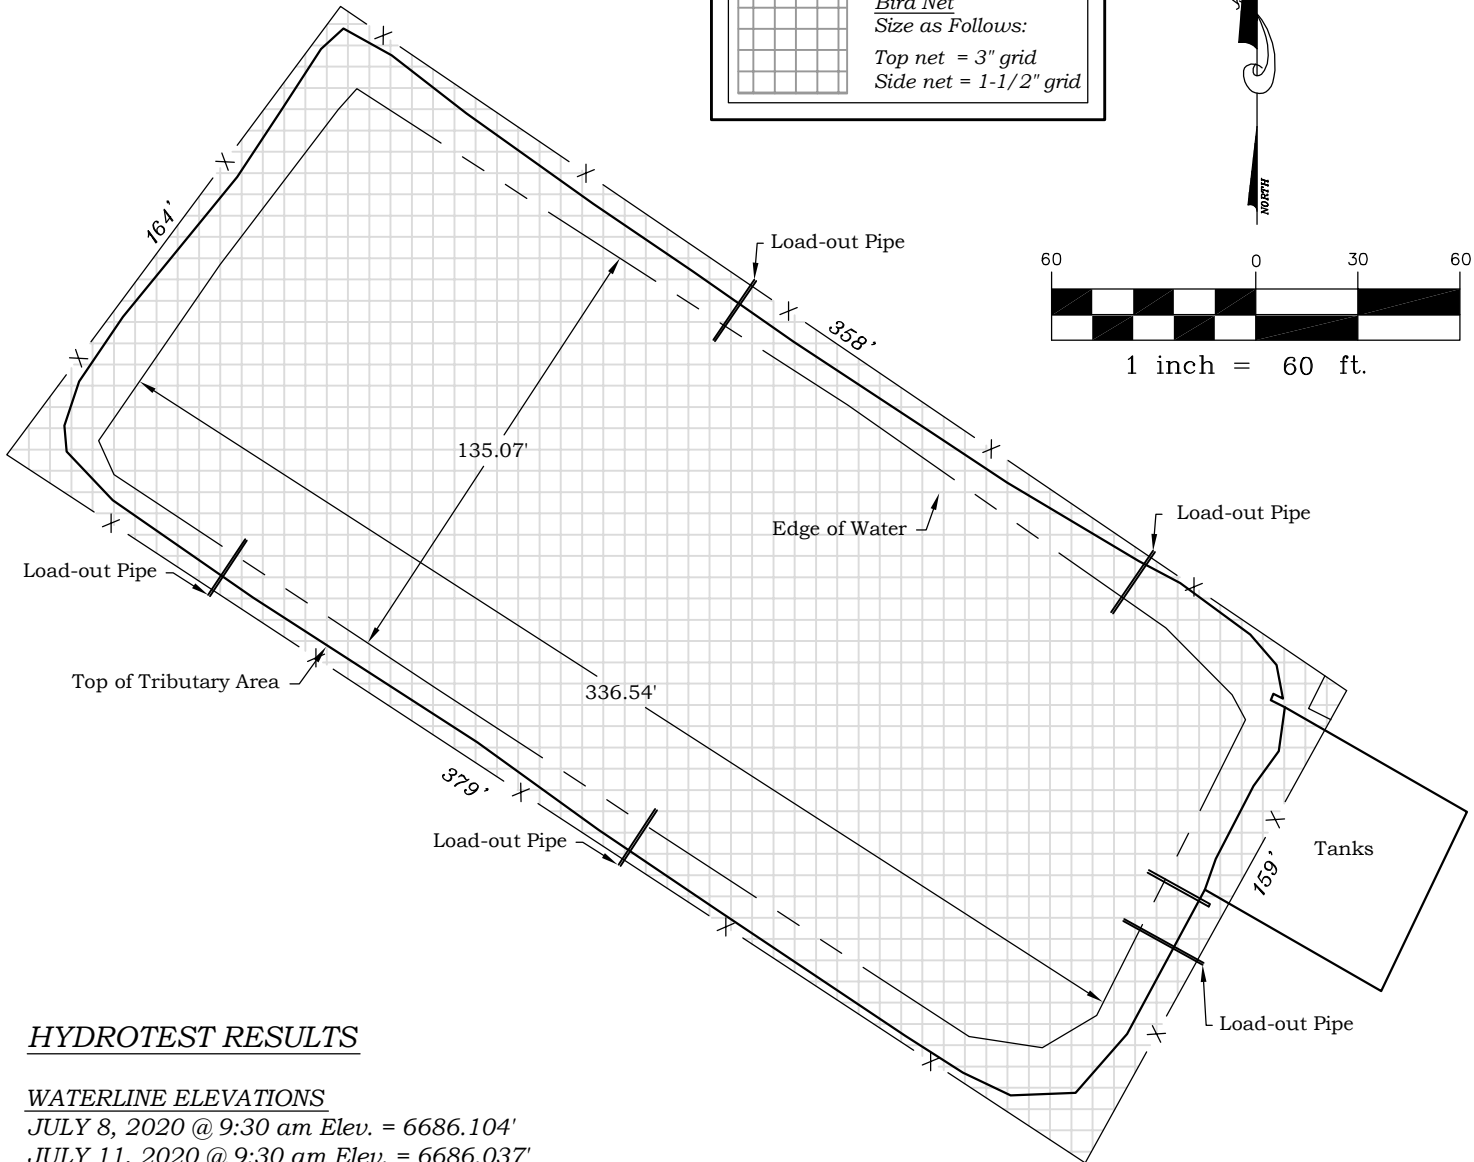
HYDRO-TEST EXHIBIT

WATERLINE ELEVATIONS

JULY 8, 2020 @ 9:30 am Elev. = 6686.104'

JULY 11, 2020 @ 9:30 am Elev. = 6686.037'

PIT AREA (INCLUDING TANK AREA) = 57,018 SQ. FT.
WATER SURFACE AREA = 44,011 SQ. FT.

TRIBUTARY AREA = 13,007 SQ. FT.
