Inspection Photos

Operator: TEP ROCKY MOUNTAIN LLC - 96850

Location ID: 334816

Garfield County, CO

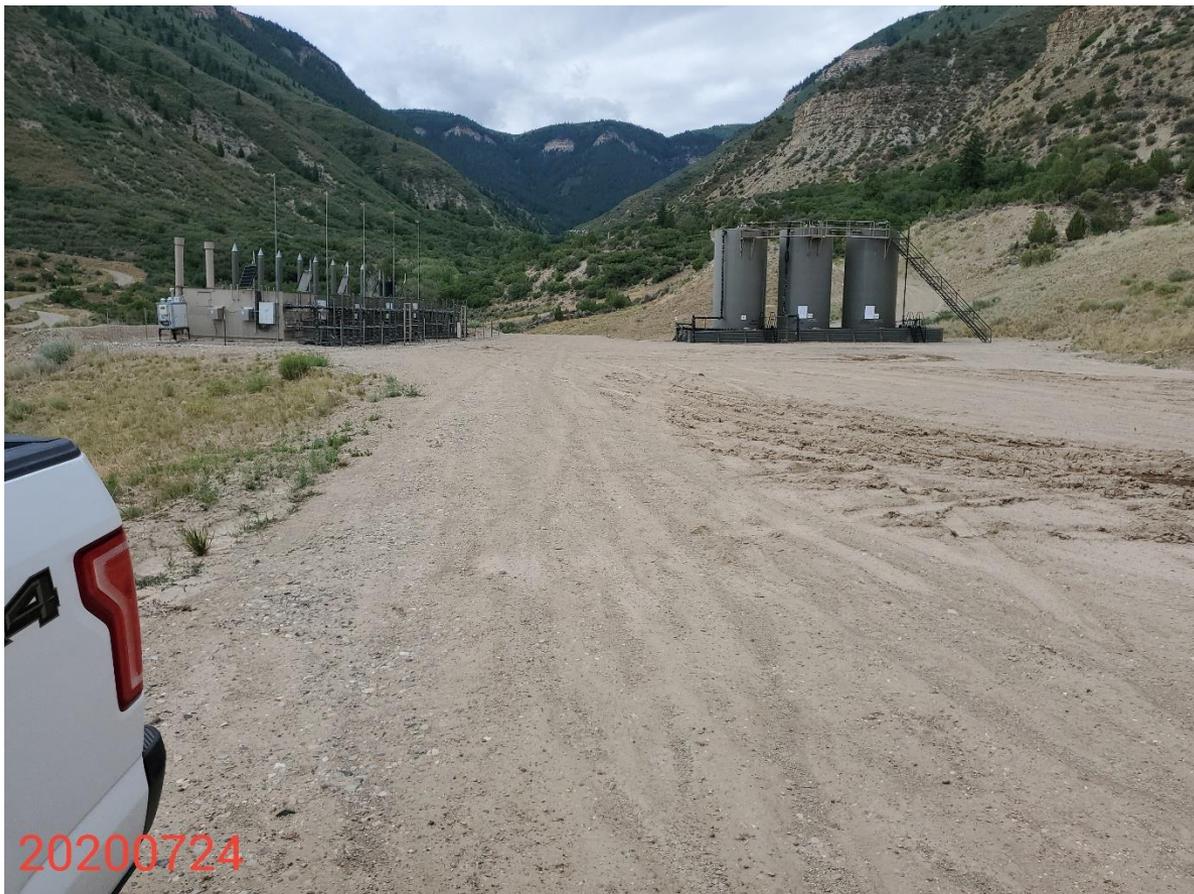
Photo 1: Photo taken from the east end of the production area, facing south. Photos 1-4 provide an overview of the Location from south, southwest, northwest to north.

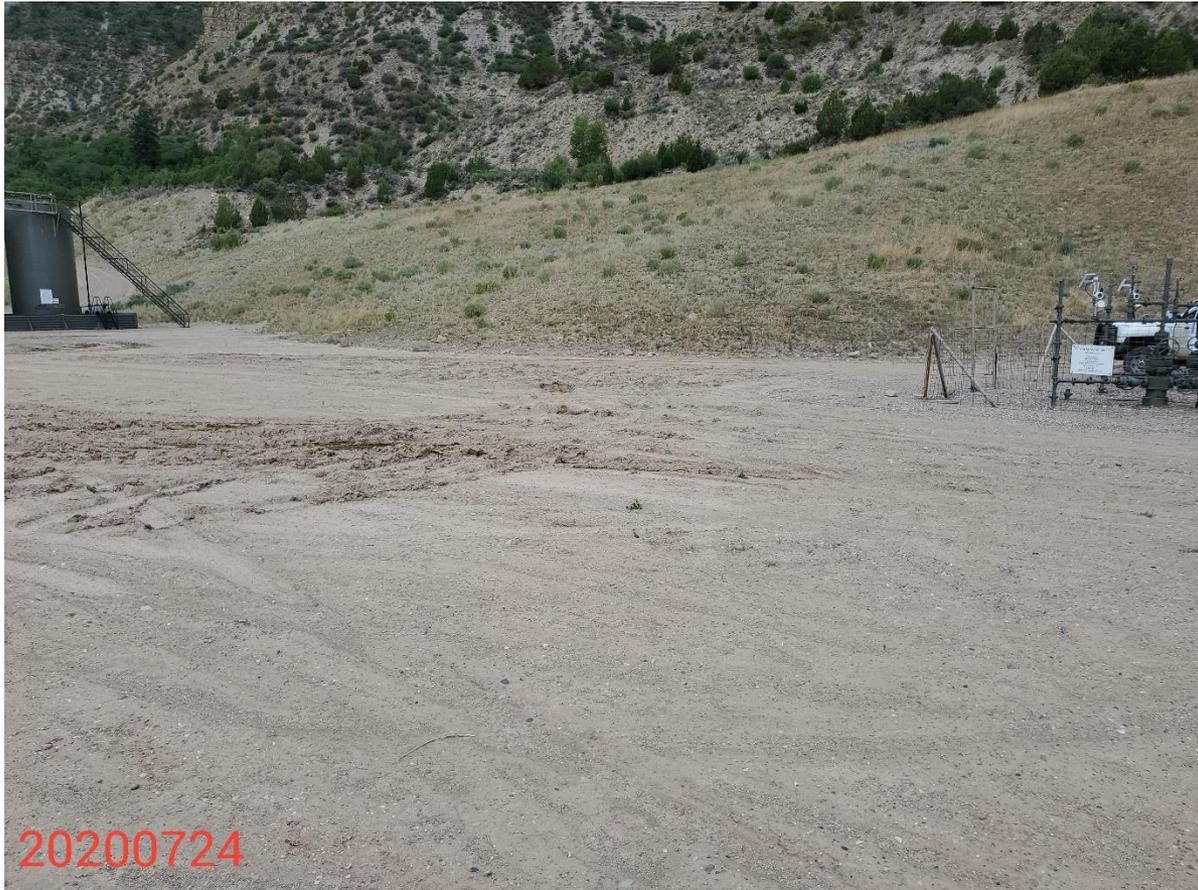
Photo 2: See comments under photo 1.

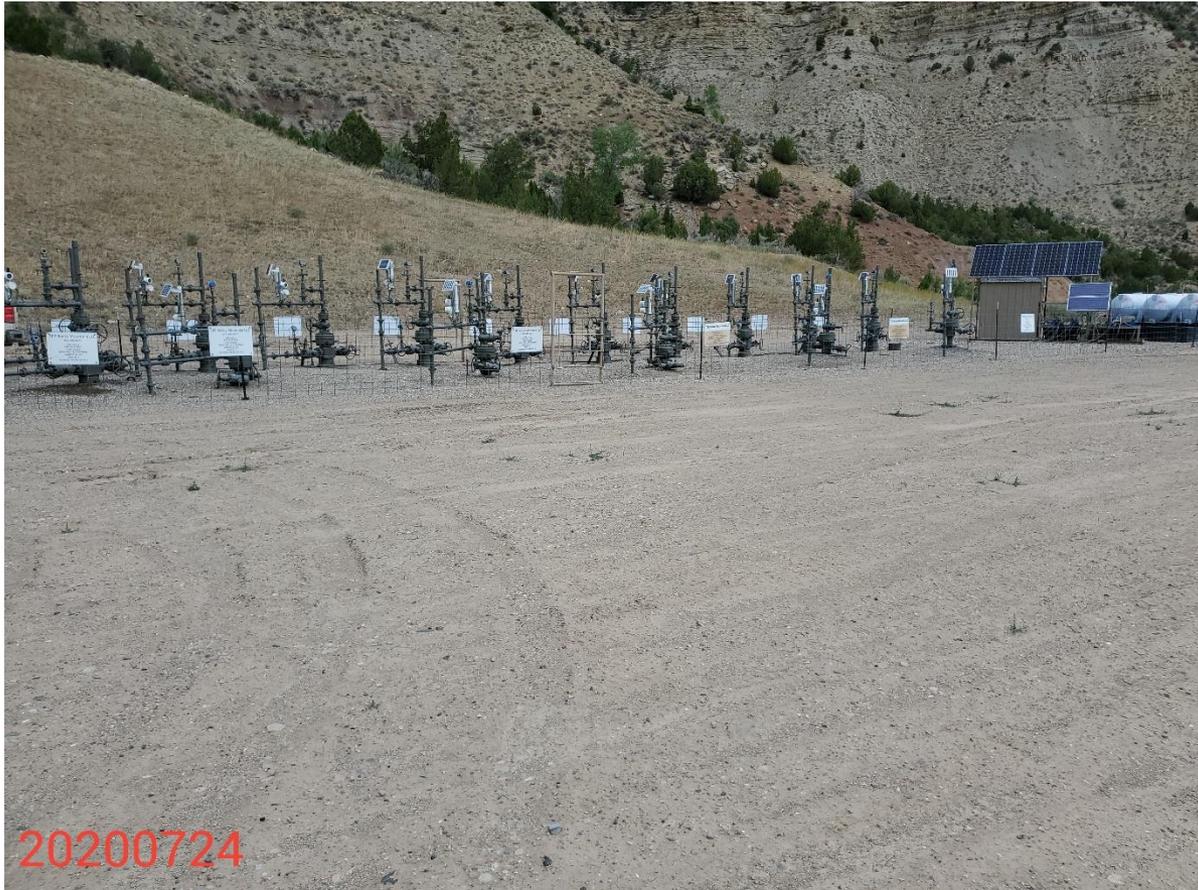
Photo 3: See comments under photo 1.

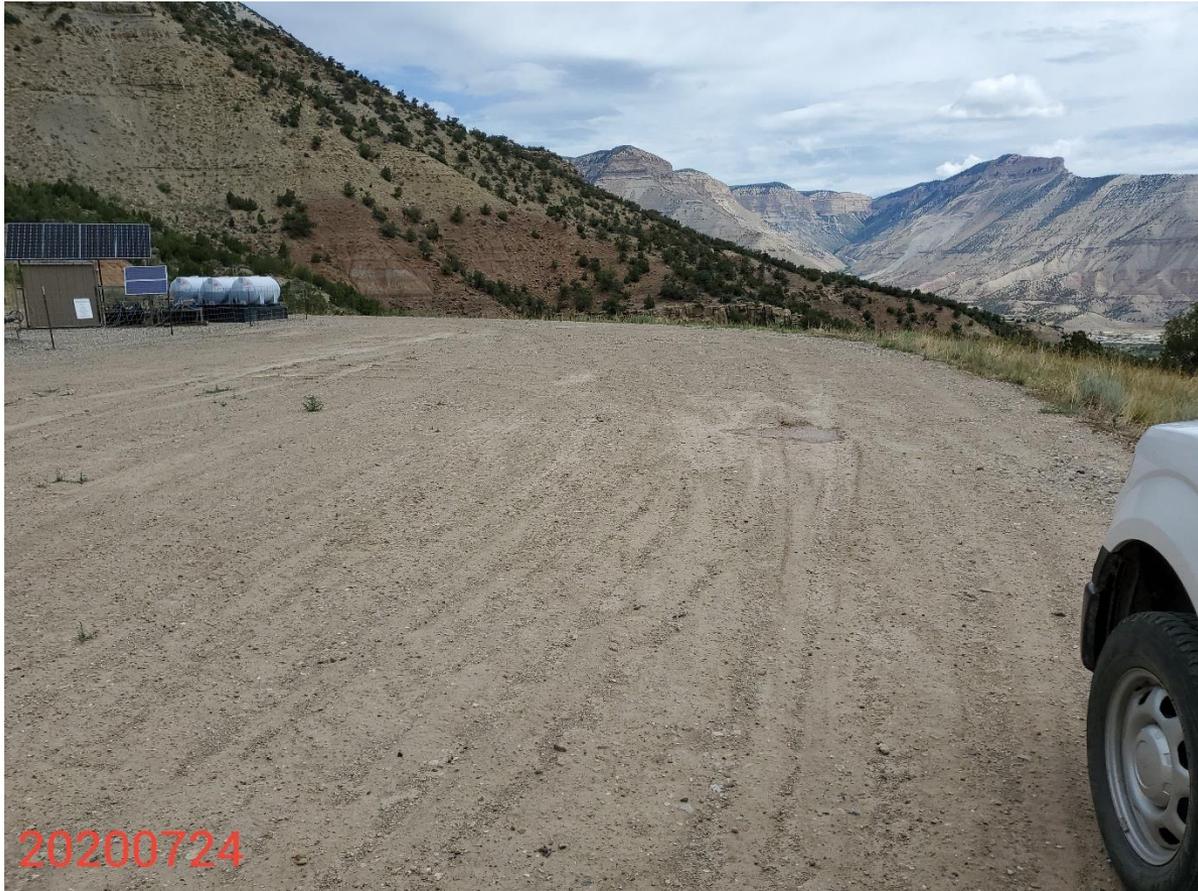
Photo 4: See comments under photo 1.

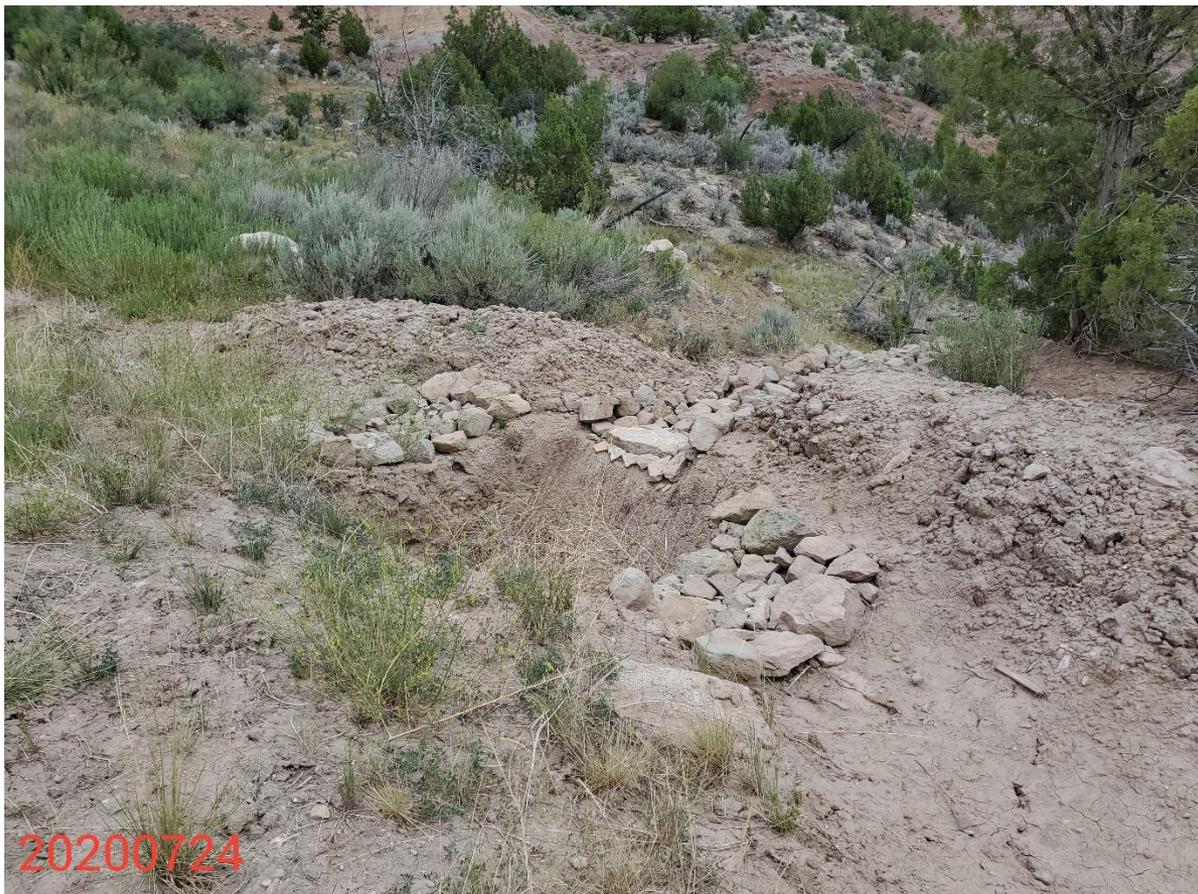
Photo 5: Photo taken from the north end of the Location, facing north. Photo shows sediment trap. BMP appears to be in proper functioning condition.

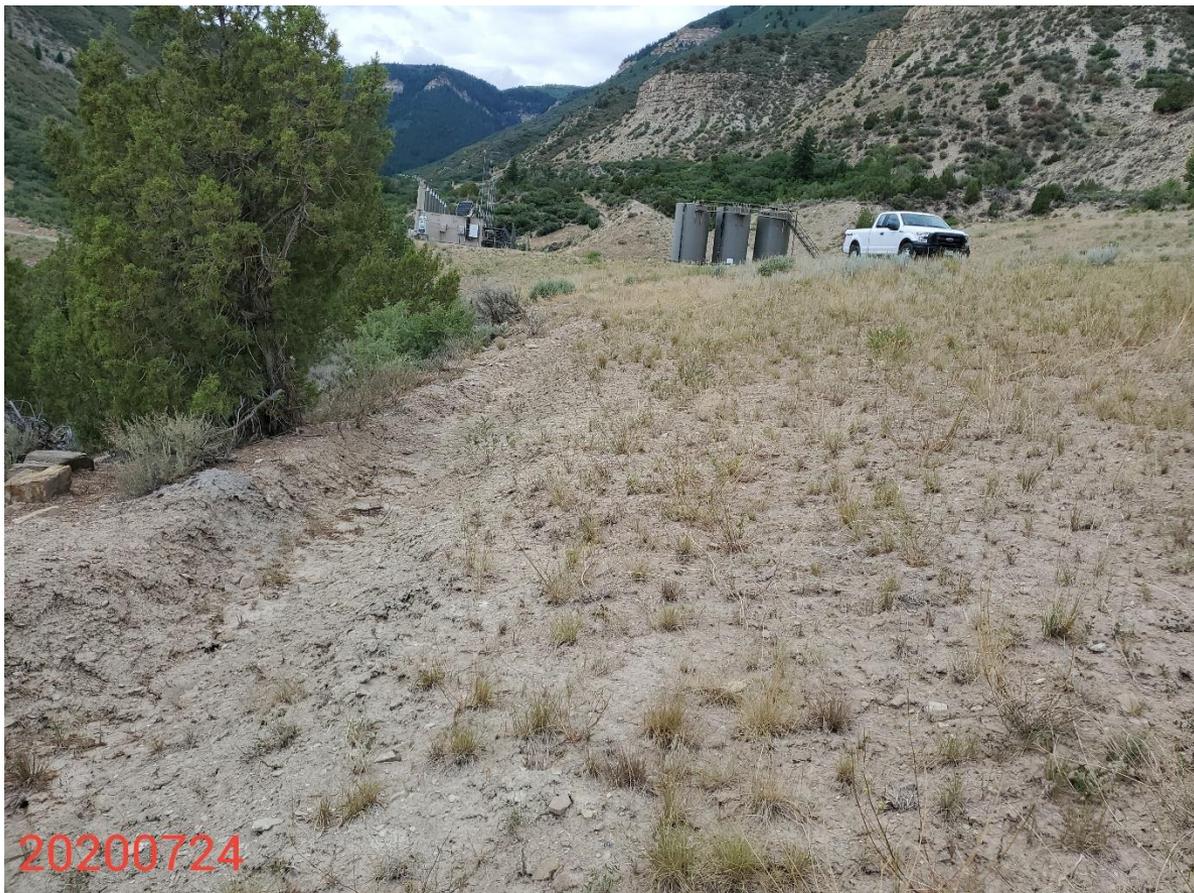
Photo 6: Photo taken from the northeast end of the Location, facing south. Photo shows stormwater diversion ditch along the eastern perimeter of the Location.

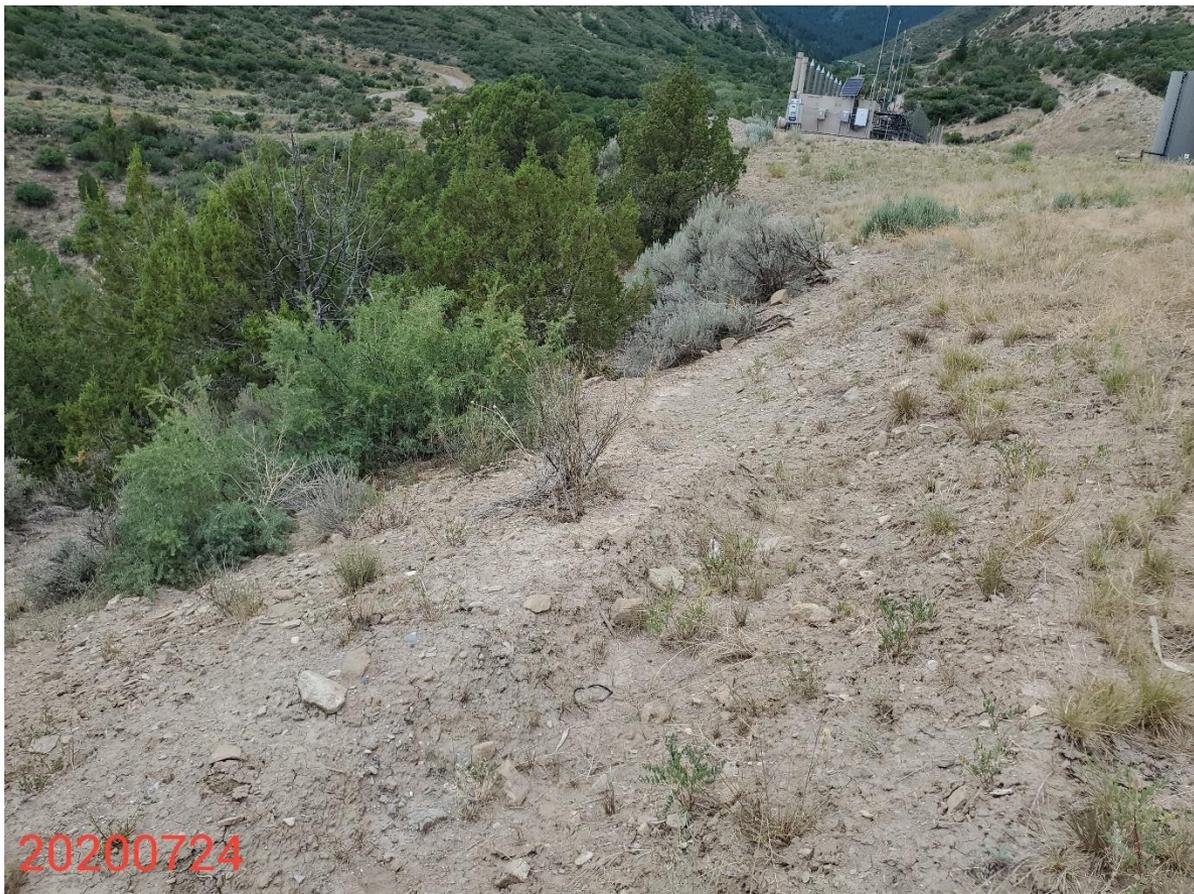
Photo 7: Photo taken from the east end of the Location facing southeast. Photo shows perimeter stormwater BMPs as missing or insufficient.

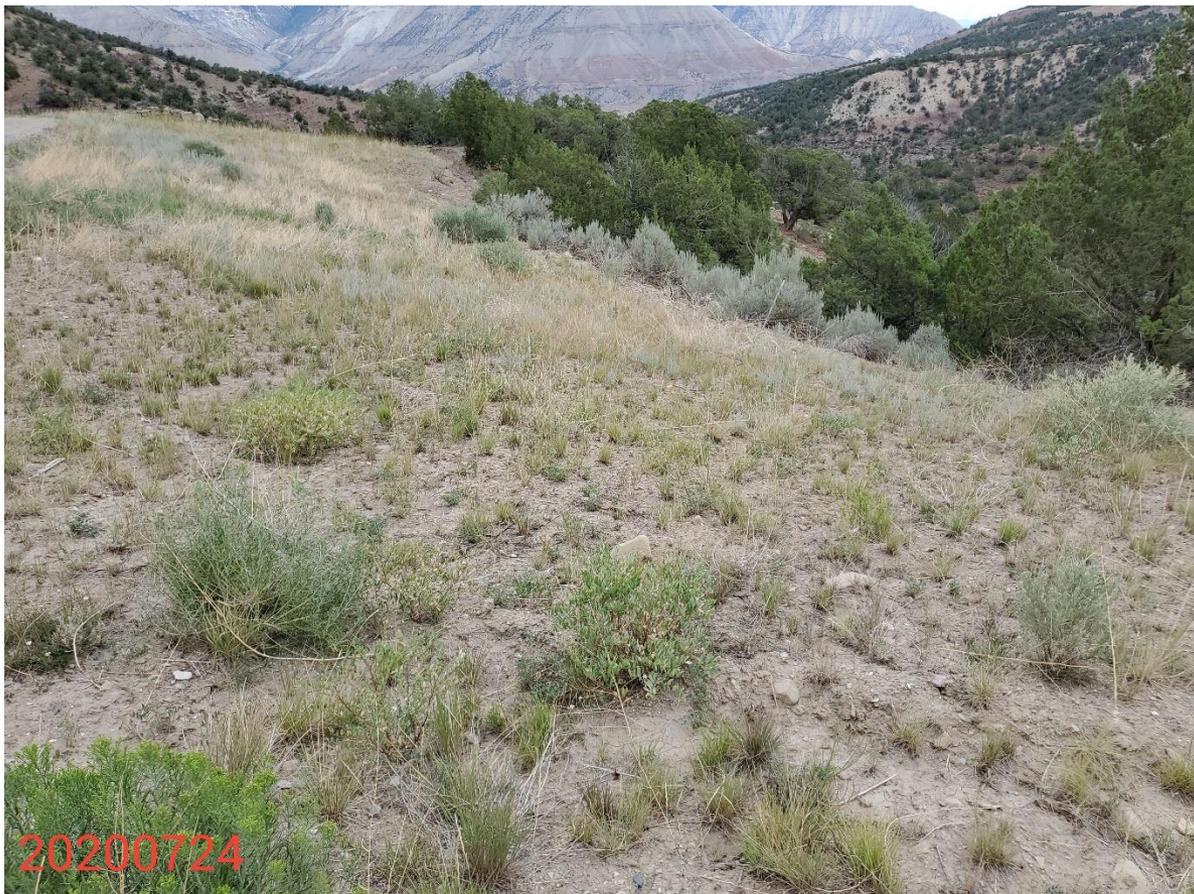
Photo 8: Photo taken from the east end of the Location facing northeast. Photo shows perimeter stormwater BMPs as missing or insufficient.

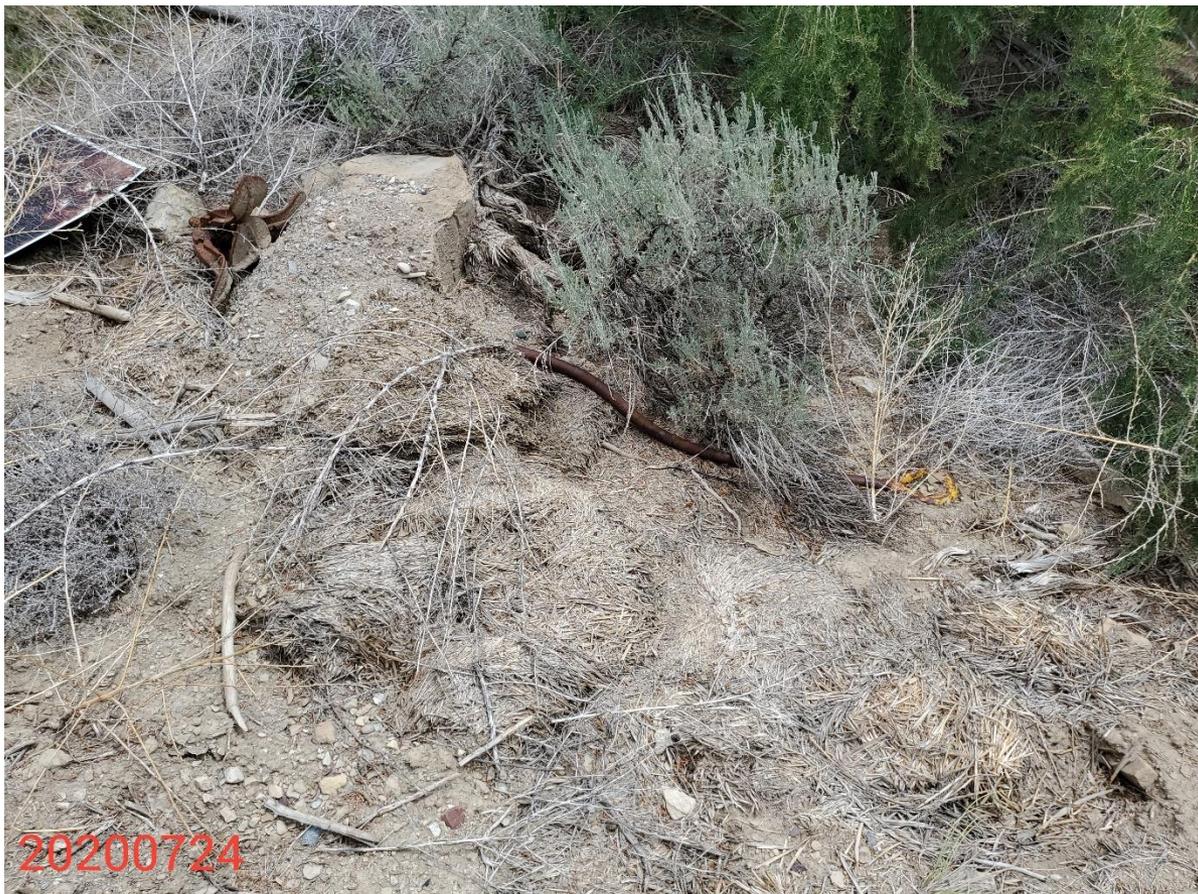
Photo 9: Photo taken from the below the east end of the Location. Photo shows sediment deposition due to runoff. Photo also shows what appears to be an anchor, as well as other debris from the pad.

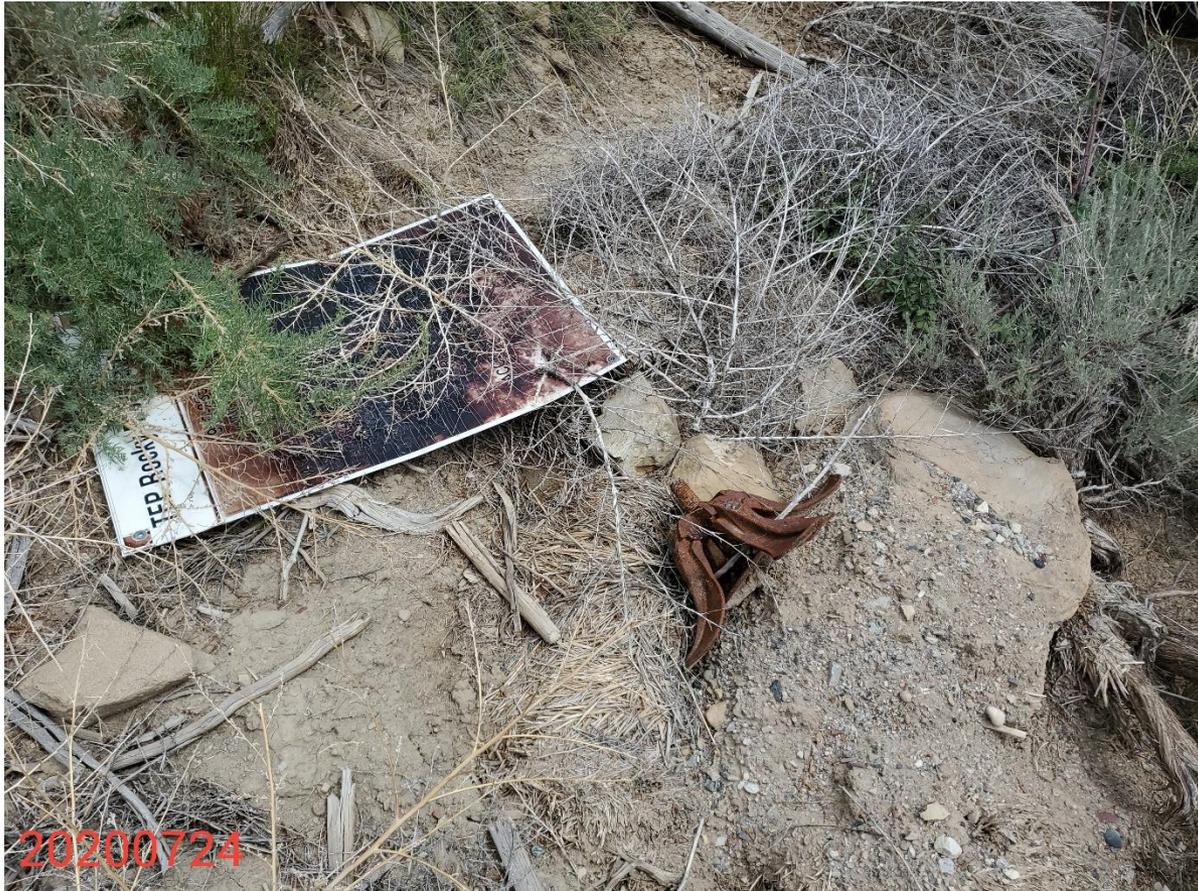
Photo 10: Continued from photo 9. Photo shows trash debris (metal, TEP Sign).

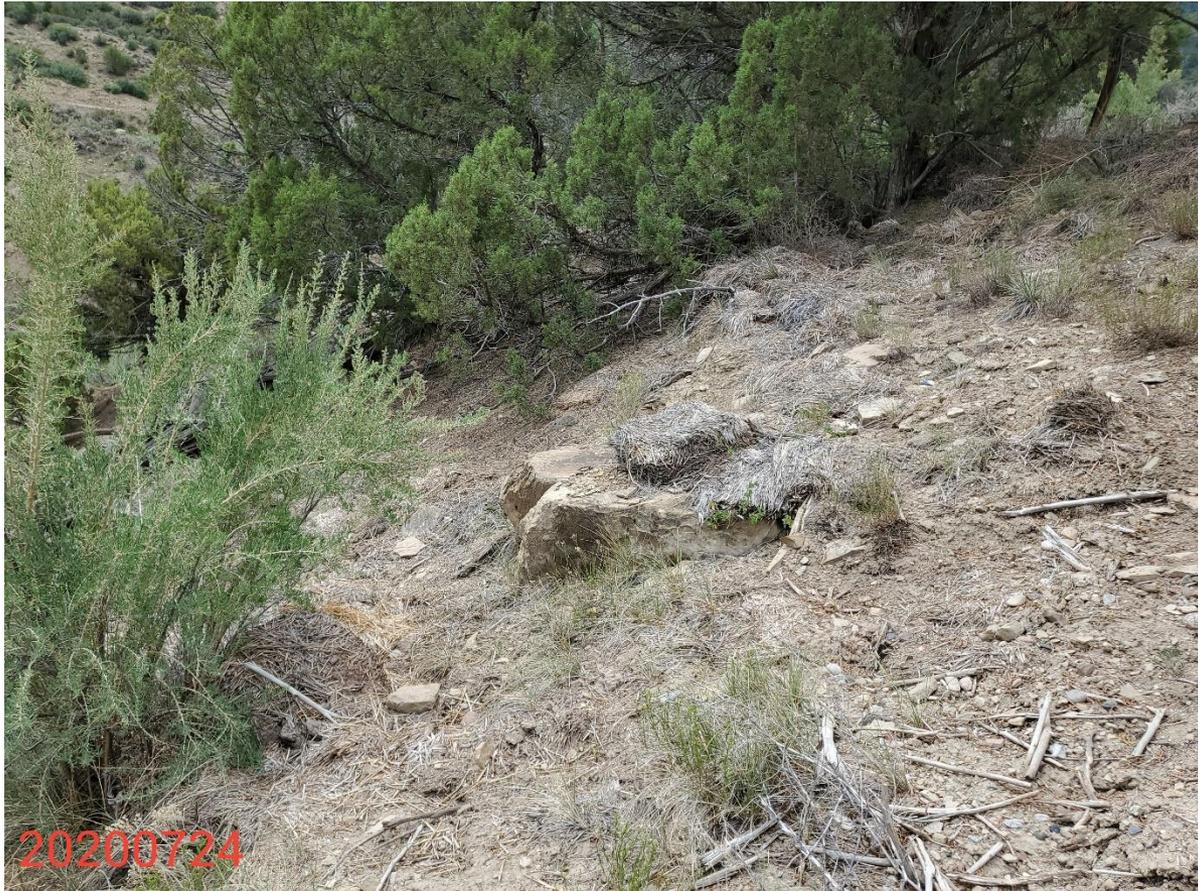
Photo 11: Continued from photo 9. Photo shows remnants of hay bale BMPs.

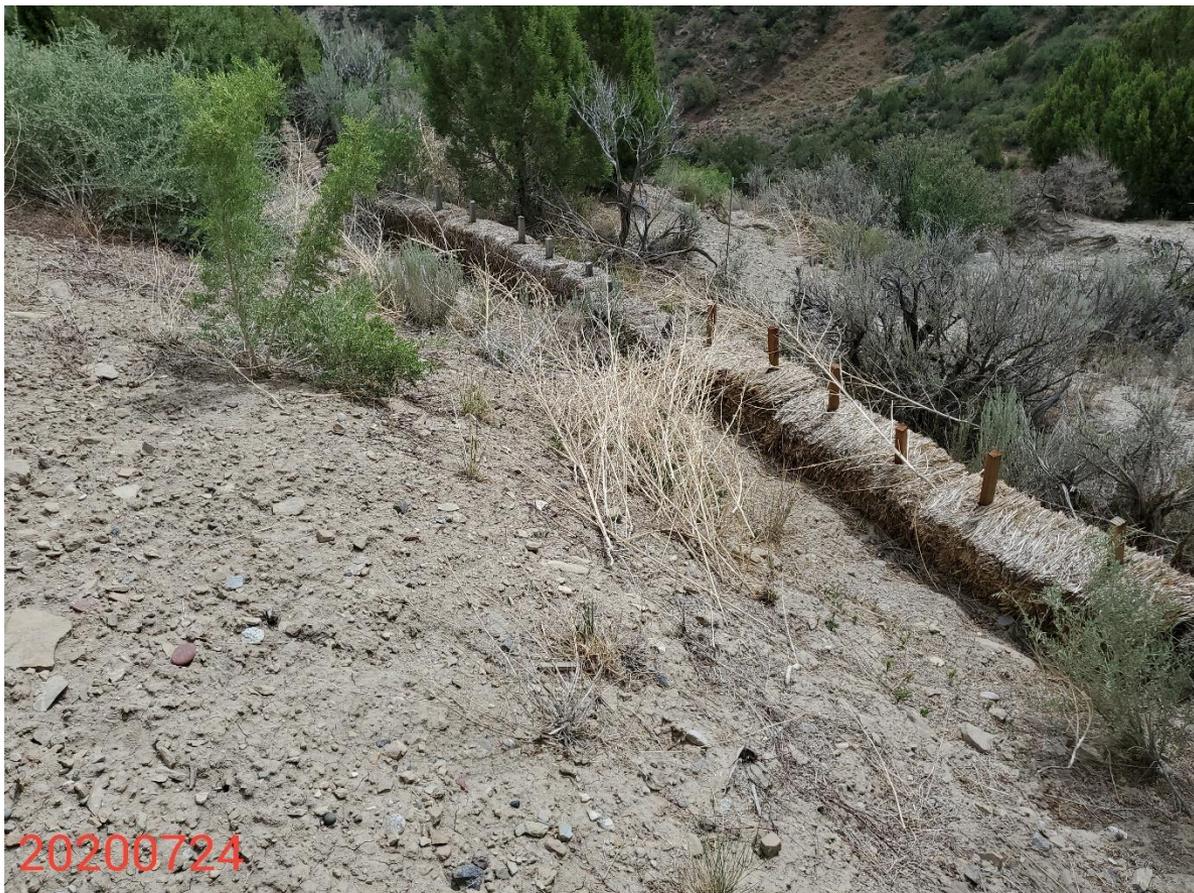
Photo 12: Photo taken from the southeast end of the Location. Photo shows hay bale BMPs. BMP appears to be in proper functioning condition.

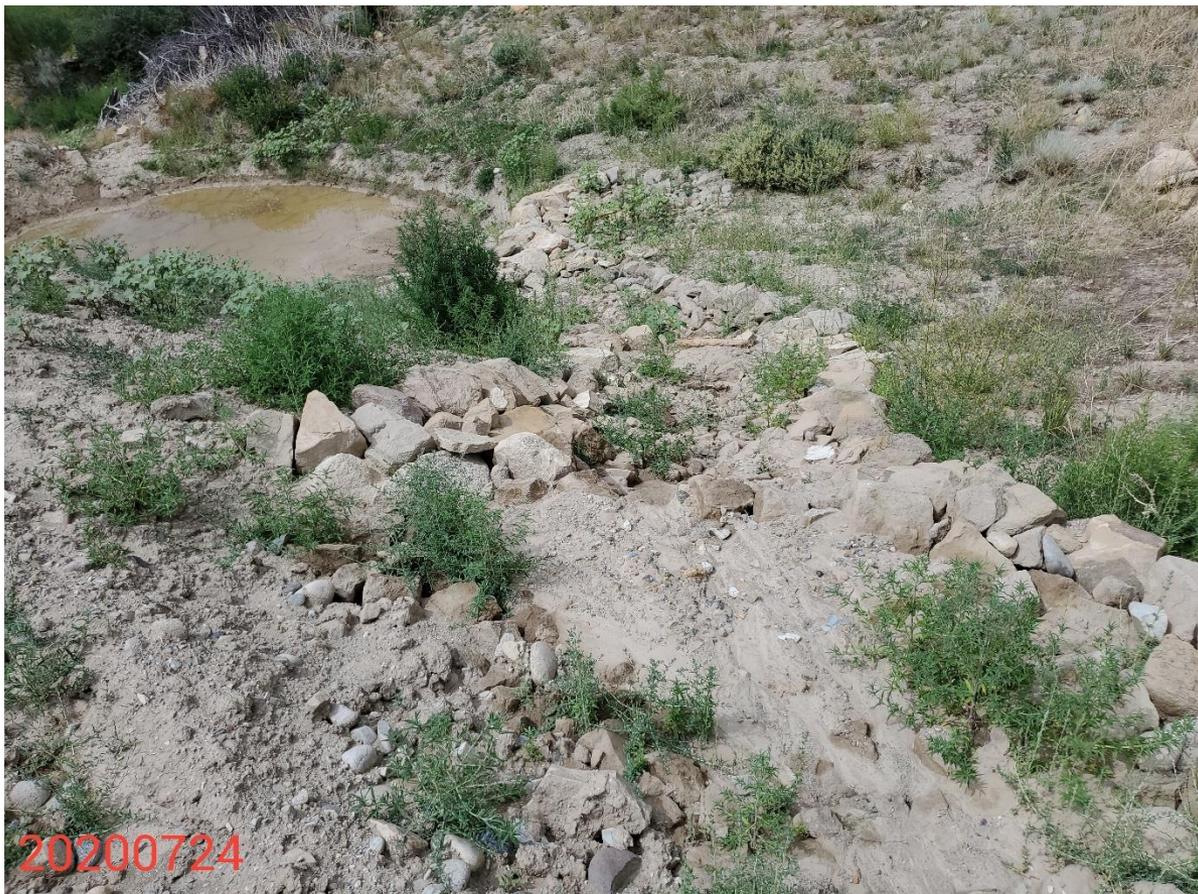
Photo 13: Photo taken from the sediment trap south of the Location, facing south.

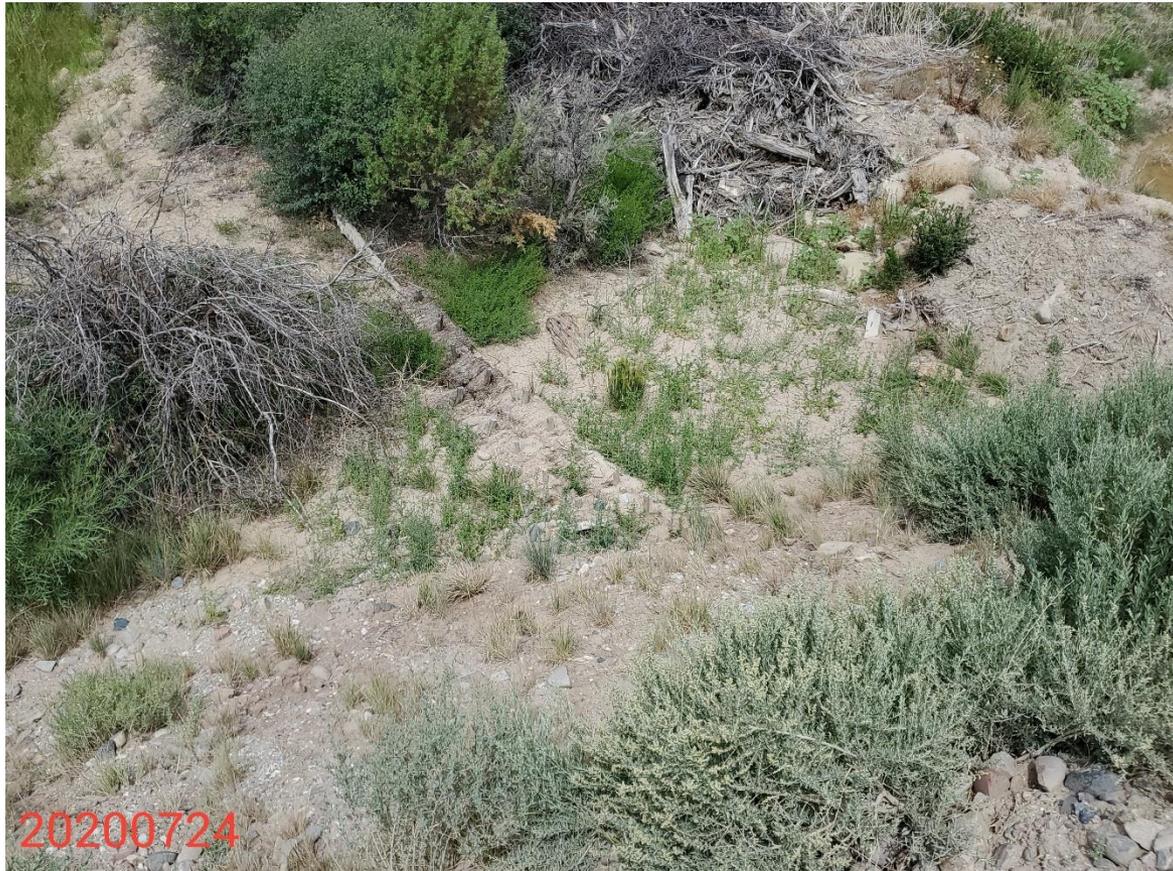
Photo 14: Photo taken from the sediment trap to the south of the Location. Photo shows hay bale BMP installed at outlet of trap has filled with sediment, and is no longer in proper functioning condition.

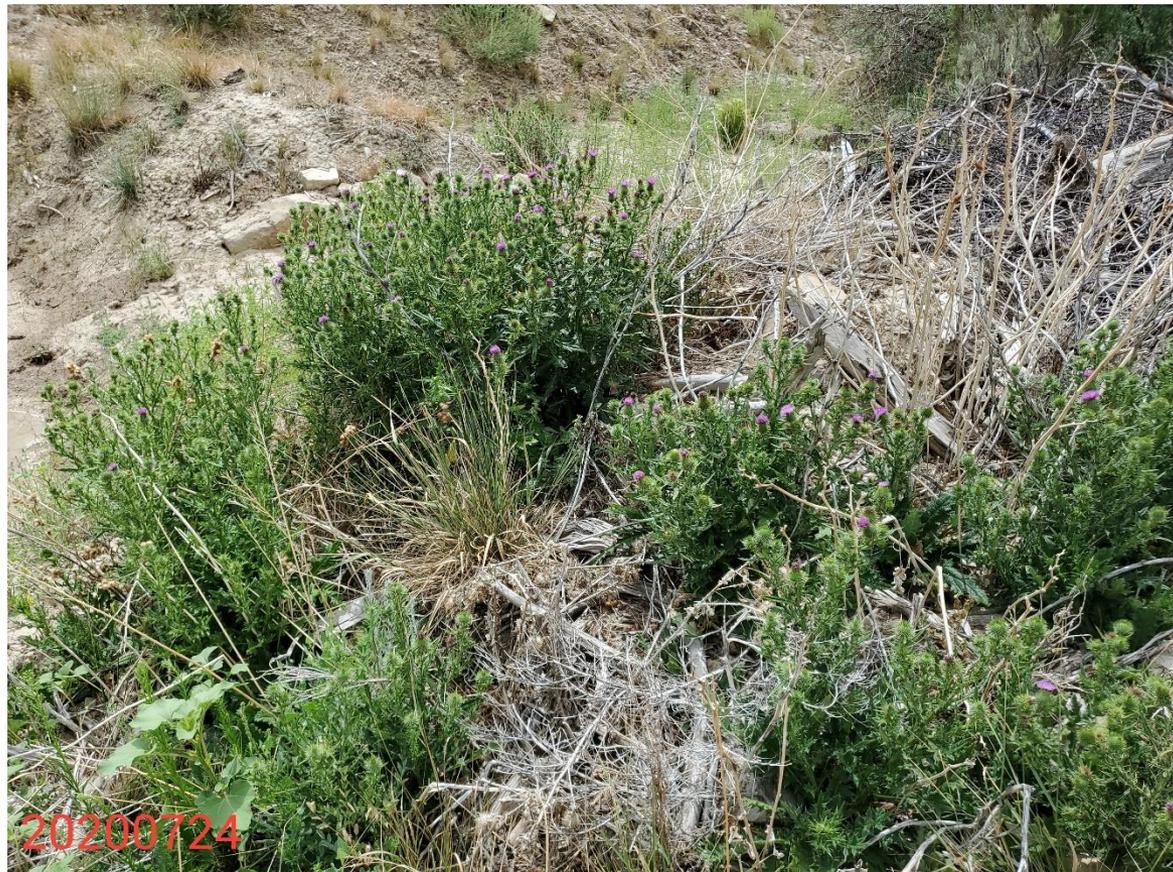
Photo 15: “Photo taken from the sediment trap to the south of the Location. Photo shows Bull thistle establishing at BMP. This is a Colorado State listed noxious weed and requires management.

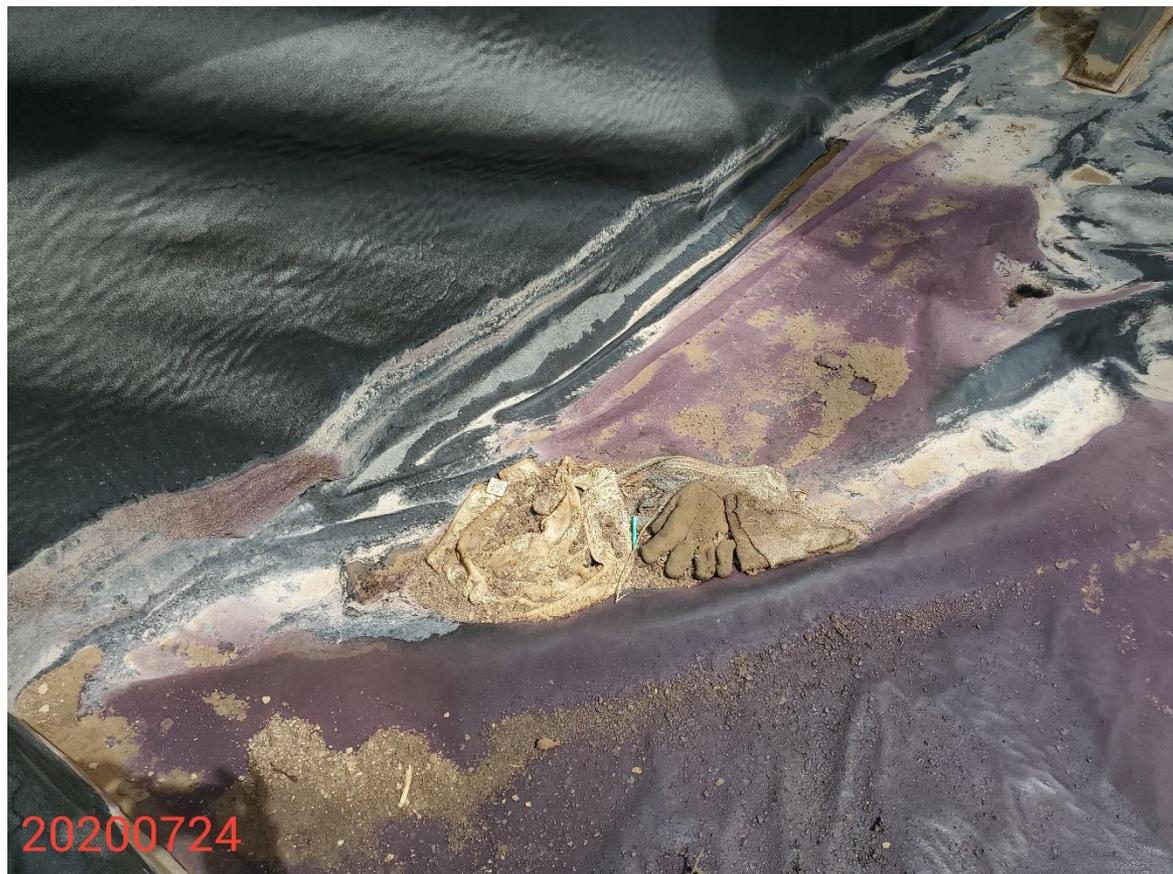
Photo 16: Photo taken from the containment berm at the tanks. Photo shows trash debris stored within containment.
