Inspection Photos

API: 055-06295

Operator: PETROGLYPH OPERATING CO INC

Inspection Date: 7/27/2020

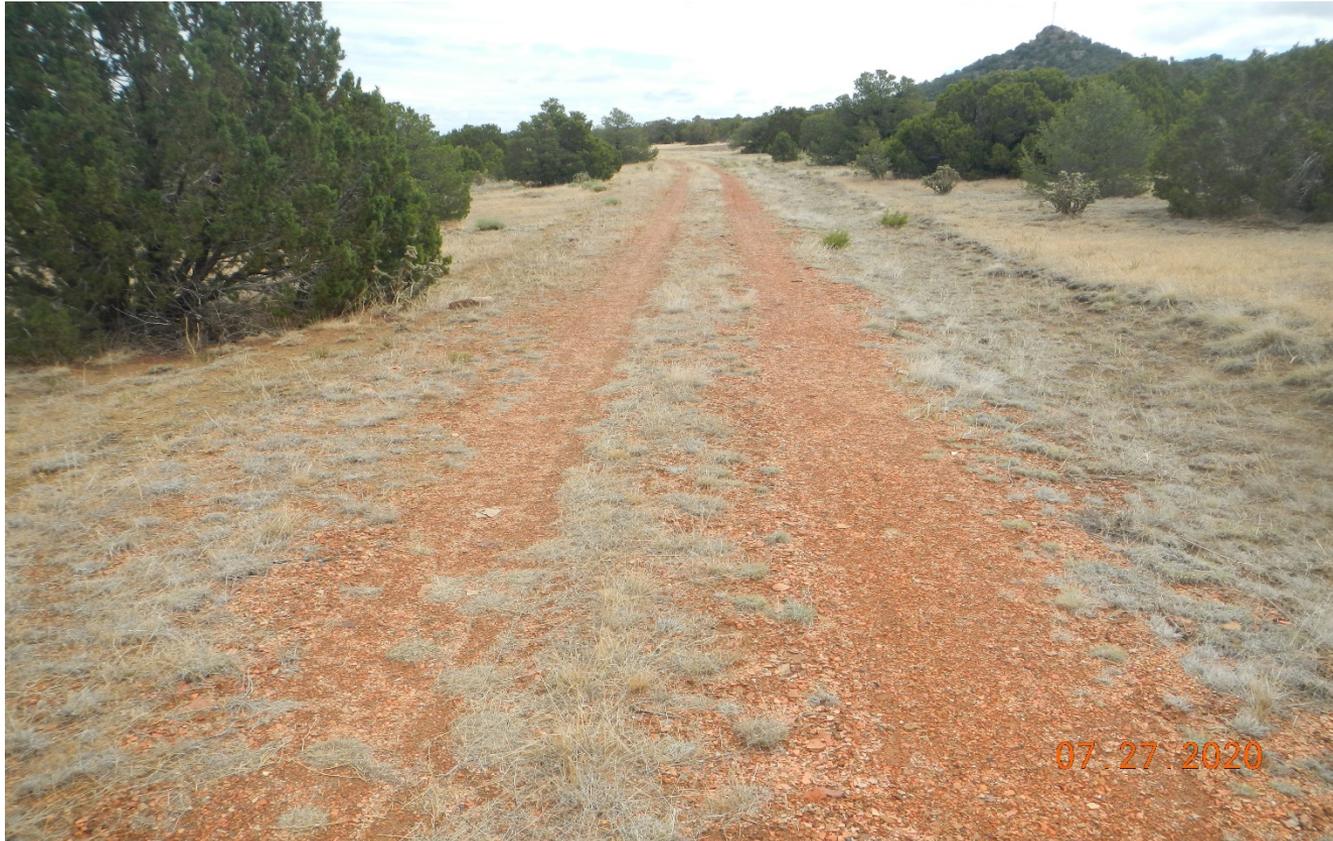
Photo 1. Facing northeast toward the access road which has not been reclaimed. Gravel remains along the road.

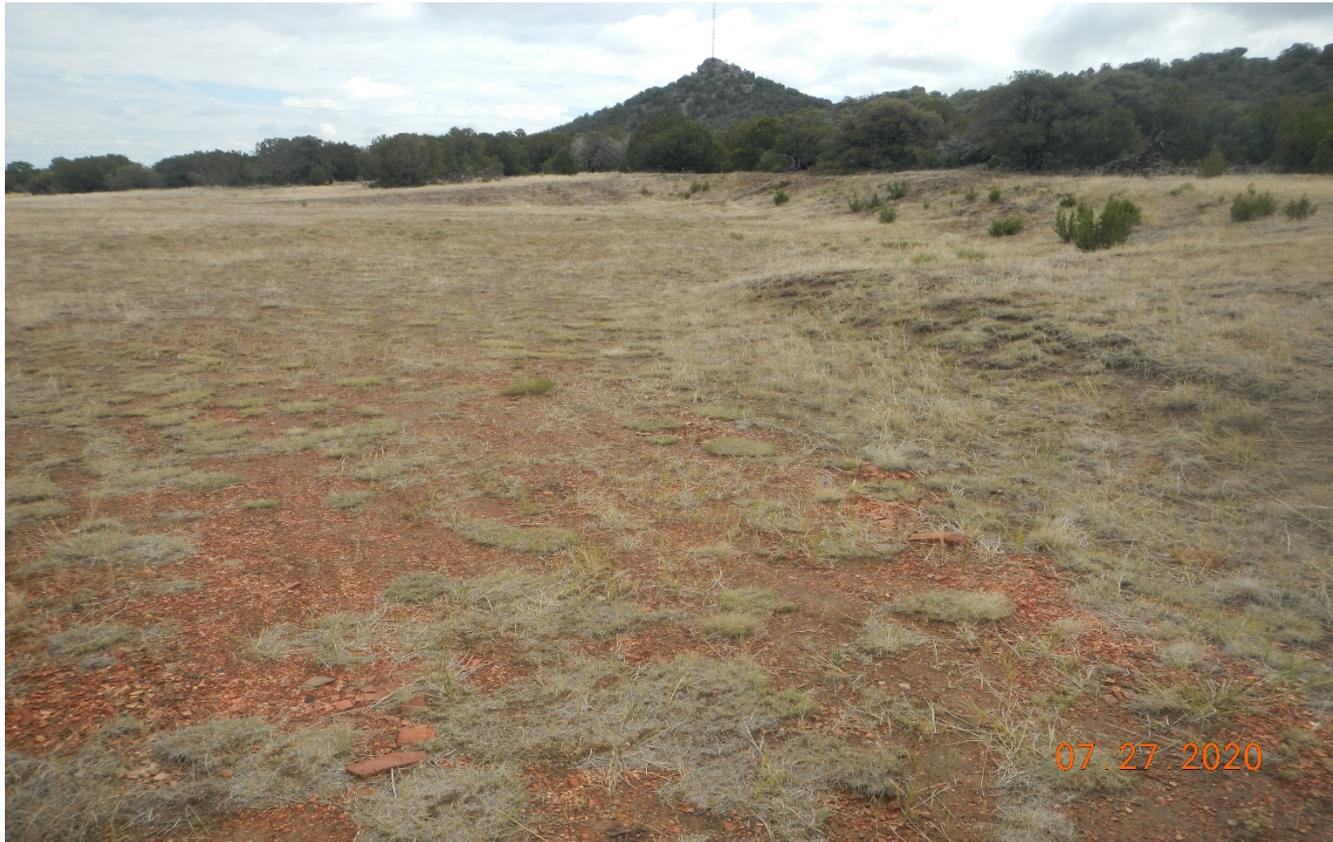
Photo 2. Facing east toward the location. The location has not been recontoured.

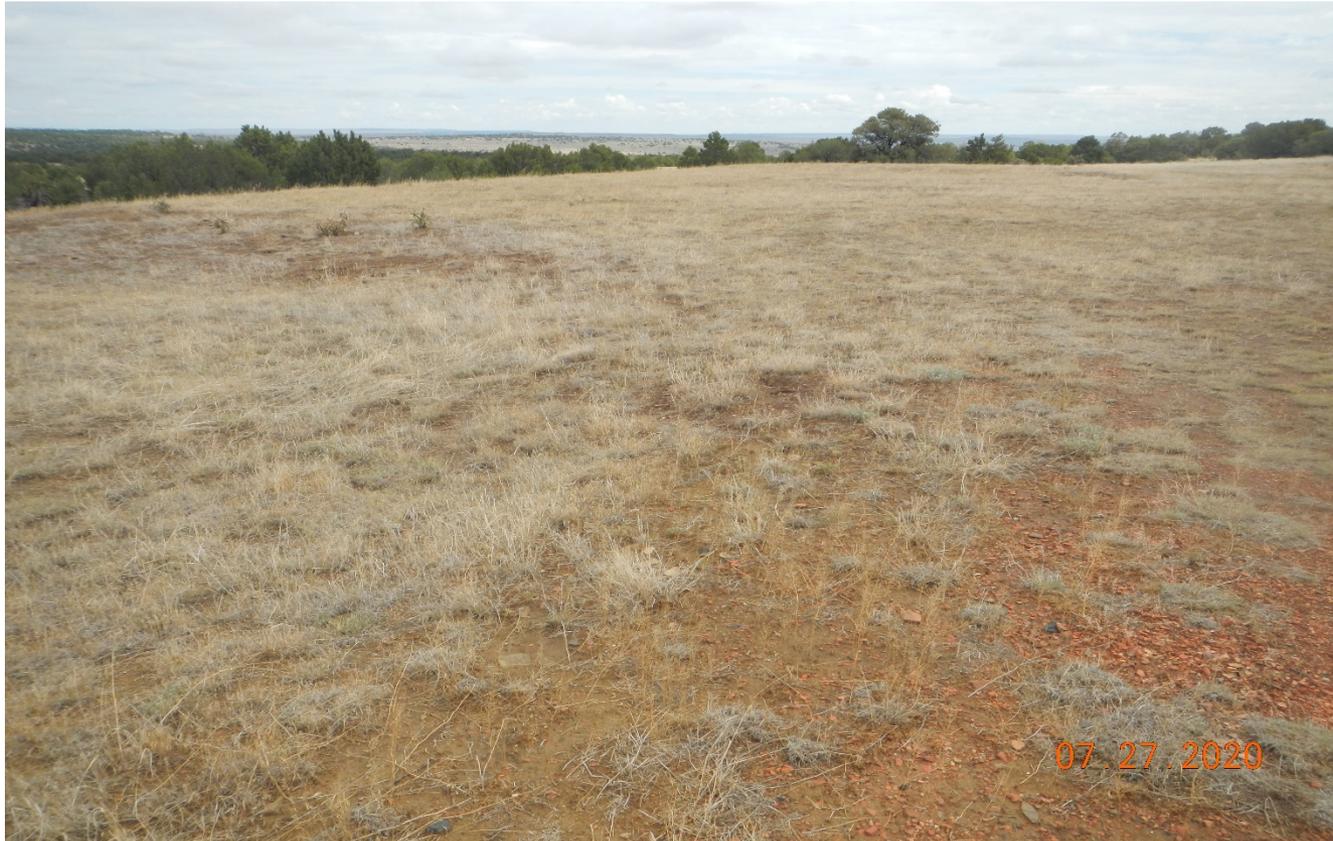
Photo 3. Facing northeast toward the location. The location has not been recontoured.

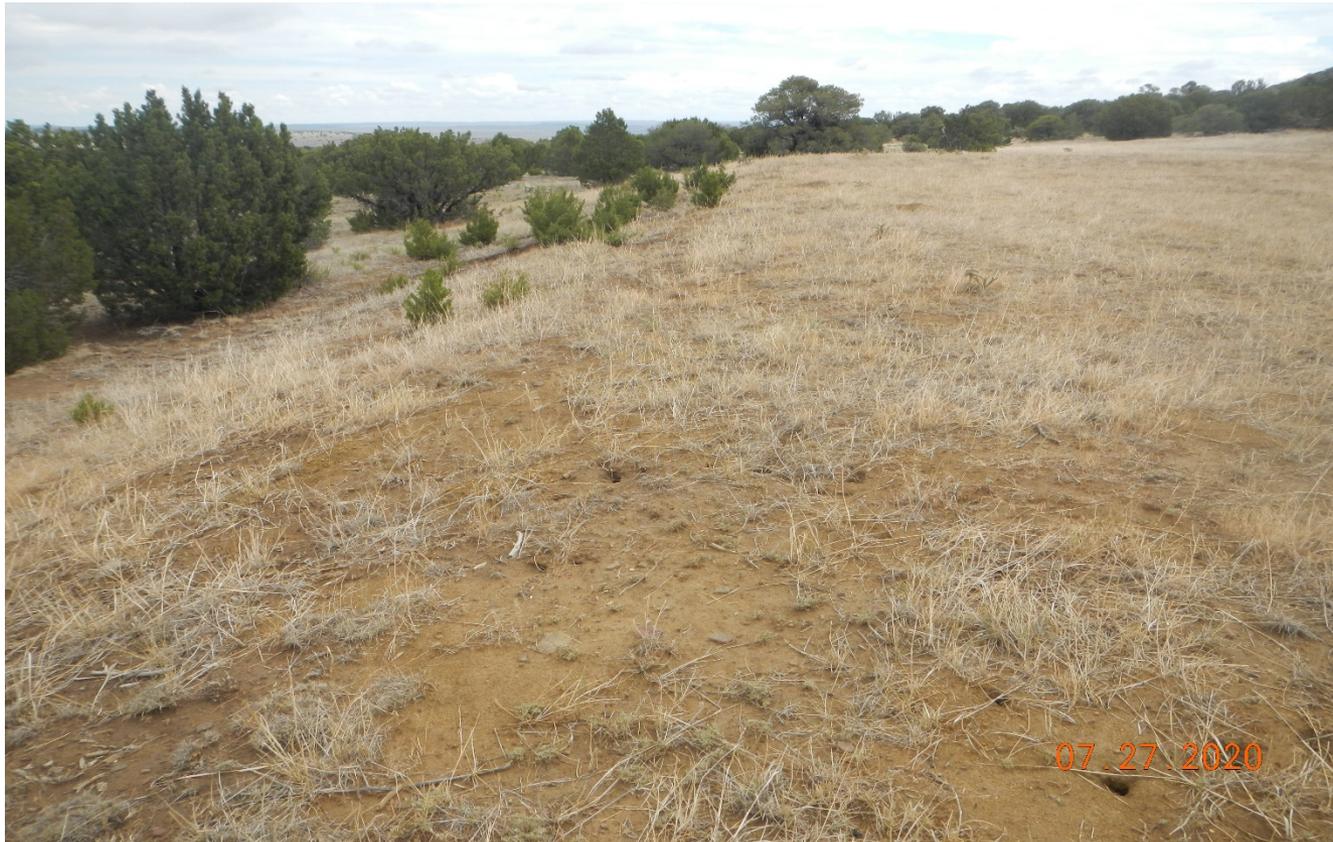
Photo 4. Facing northeast along the fill slope.

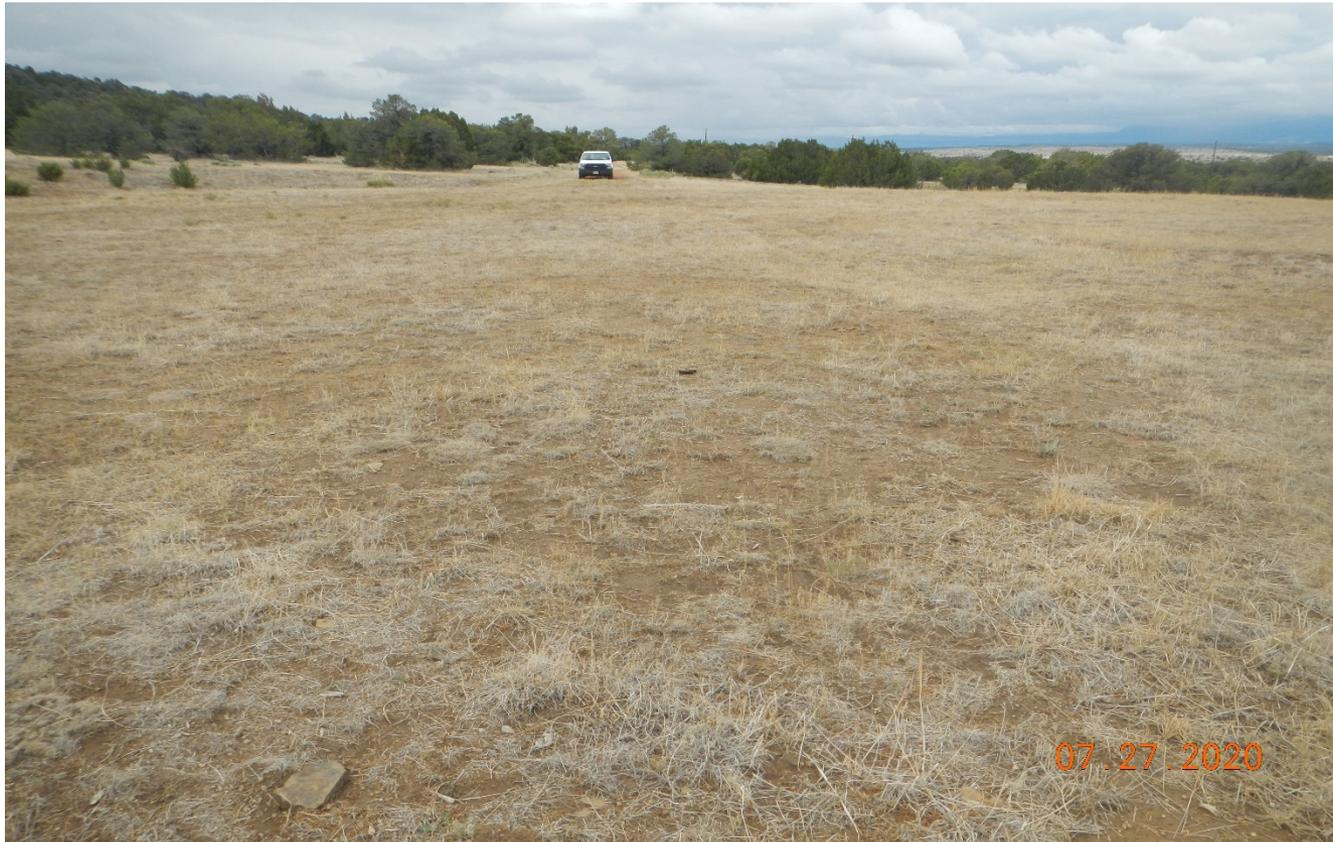
Photo 5. Facing southwest at the location.

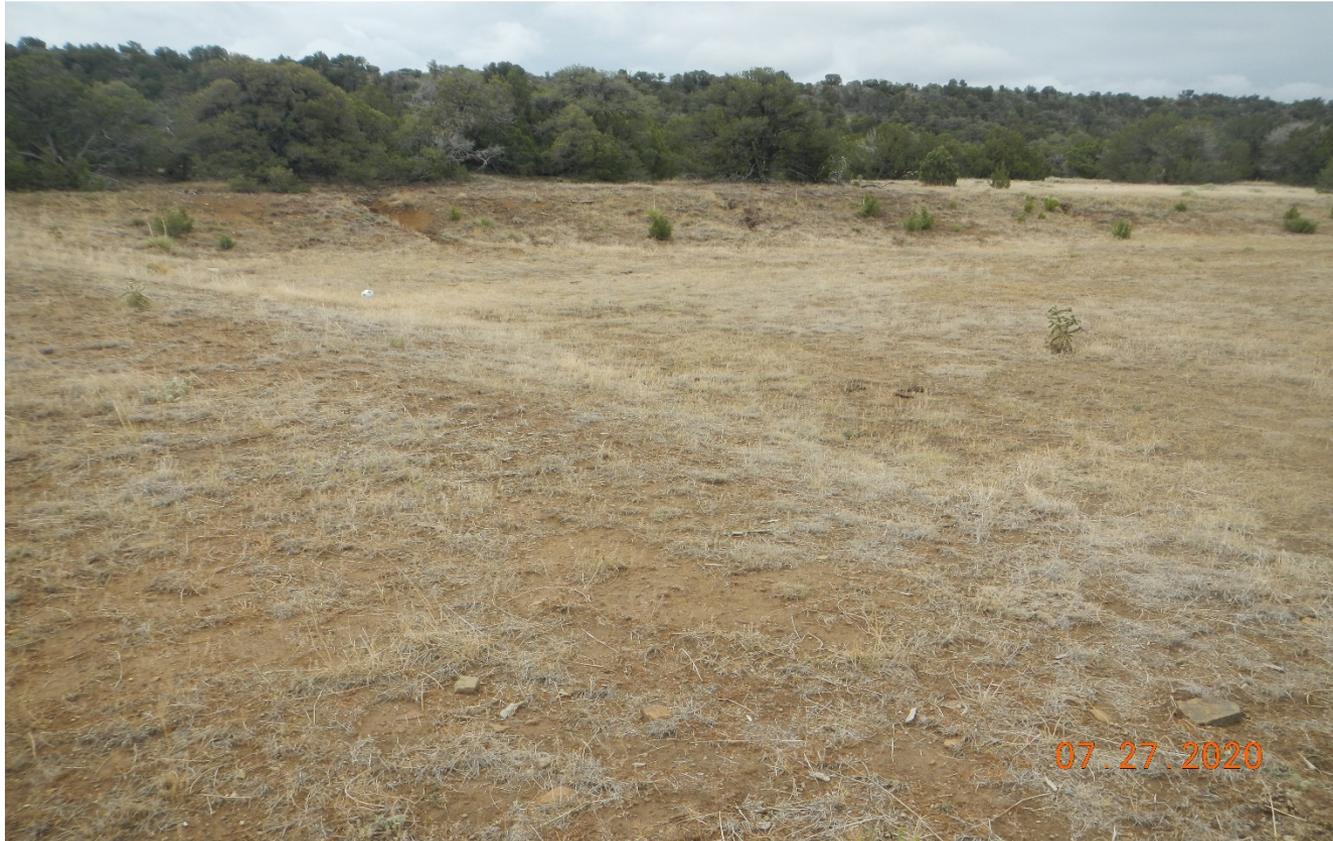
Photo 6. Facing south toward the cut slope.

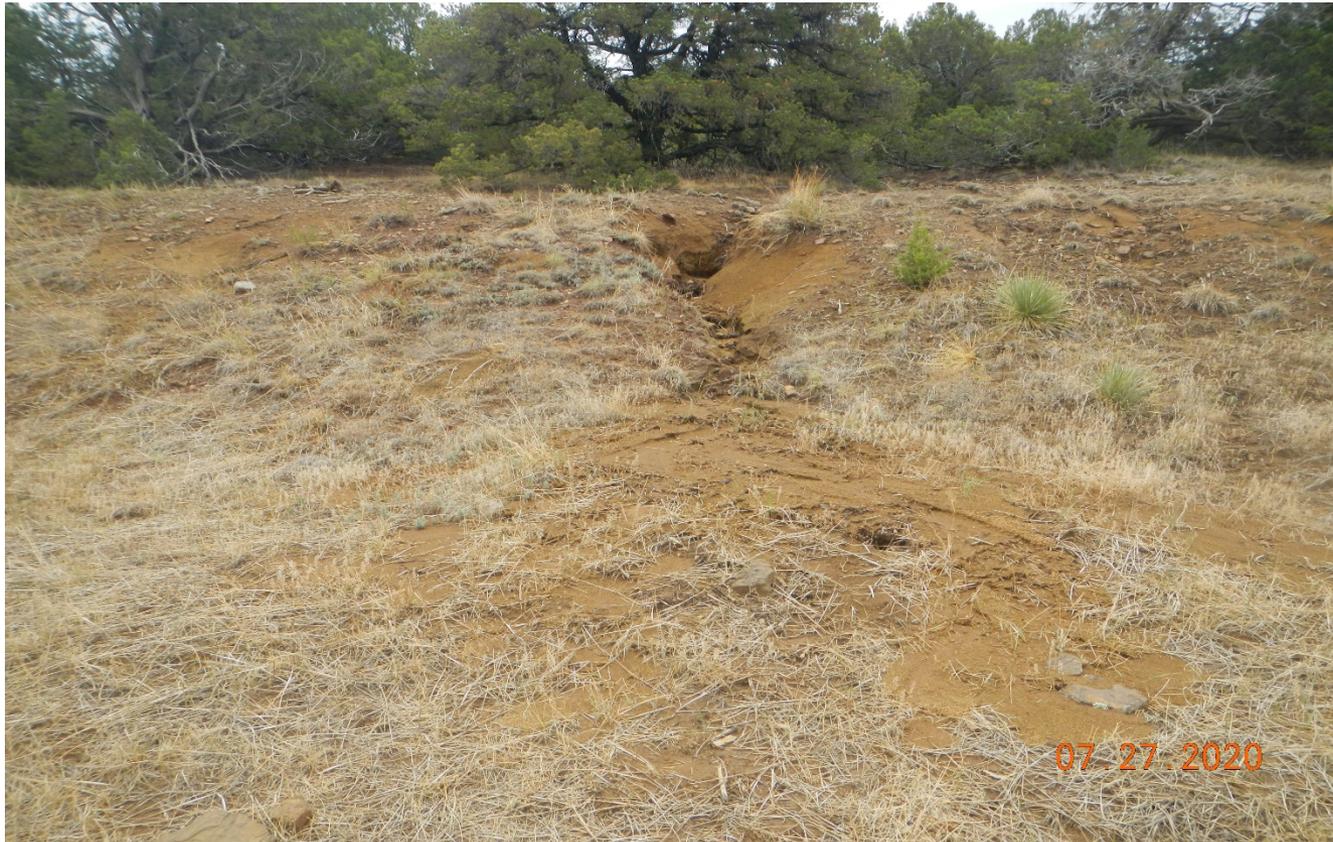
Photo 7. There is an erosion channel that has developed along the cut slope.

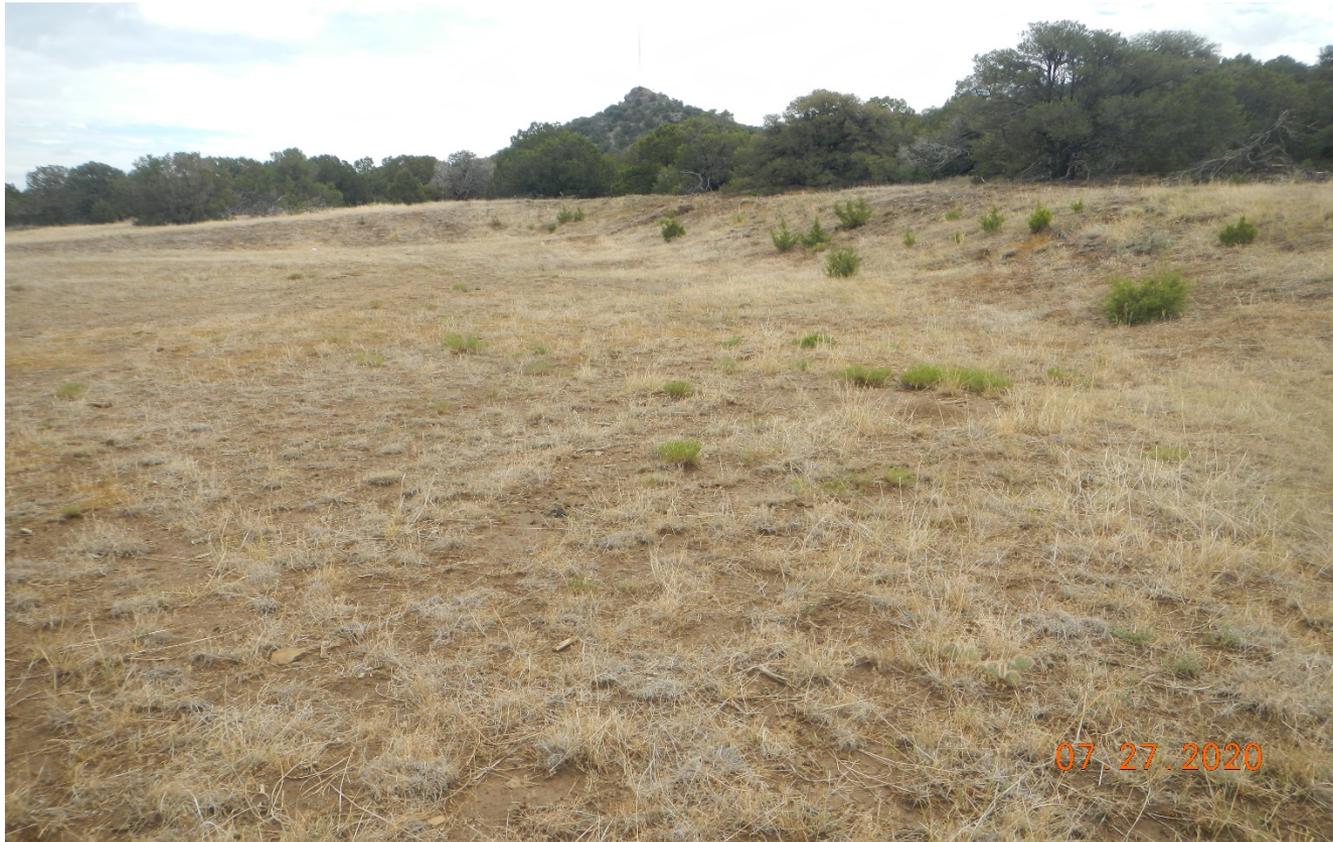
Photo 8. Facing east toward the cut slope.

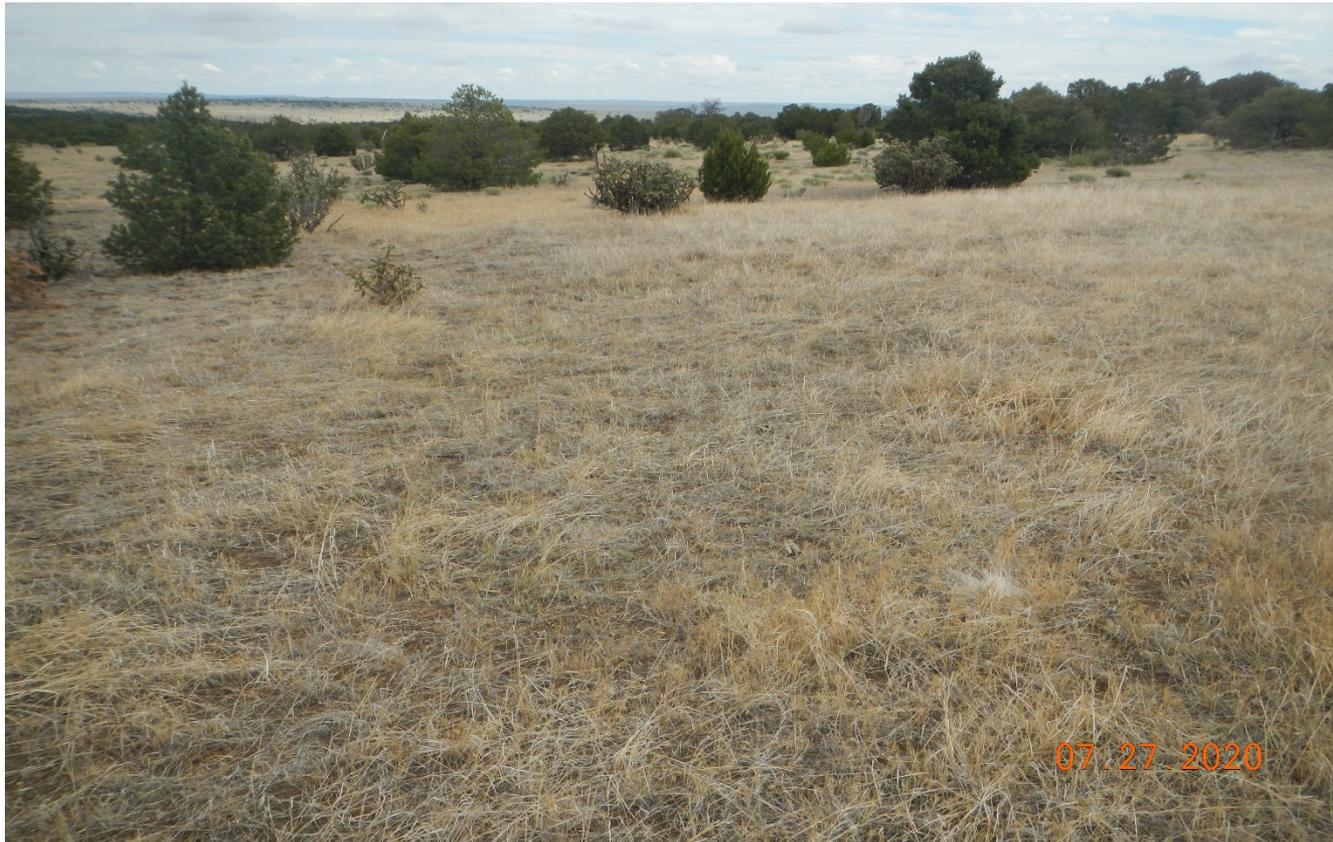
Photo 9. Facing northeast toward the surrounding undisturbed area.
